Prepared by Sakhalin Environment Watch Nongovernmental Organization www.sakhalin.environment.ru

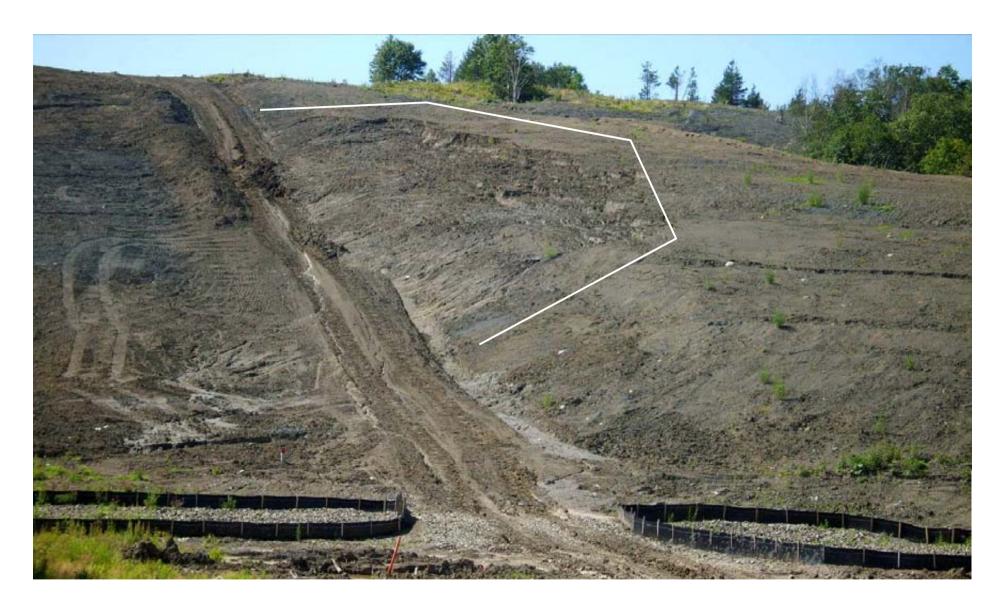
PK 411.2. A section of the route to the north from the crossing over the upper reach of the Vulkanka River. Makarov District.

The area of the landslide occurrences over the pipeline route is marked with a white line. The slipped soil is partially covering the service drive. September 1, 2007.

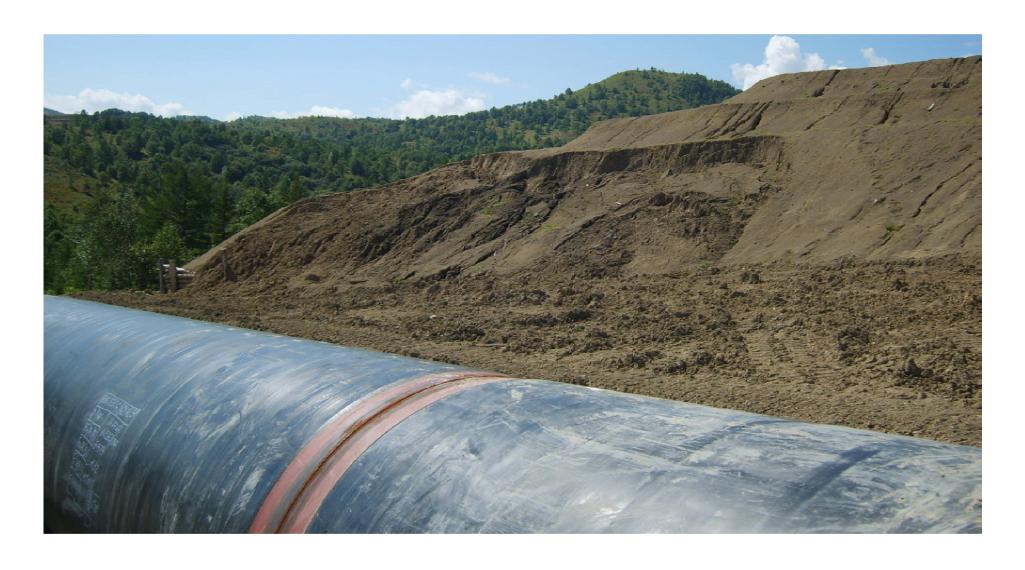
PK 403.7 A typical soil storage site over the pipeline route outside the right-of-way, in the landslide hazardous section (further north from the Pugachyovo Village, in the Vostochnaya River Basin), Makarov Region.

Those spoil banks should have had been removed by November 1, 2006 pursuant to the directive of September 18, 2006 issued by the Federal Service for Supervision of Natural Resource Usage, with the parcels of land occupied thereby reclaimed. Instead of this, the soil is left in place and landslides are being developed on the bank. *September 1, 2007*

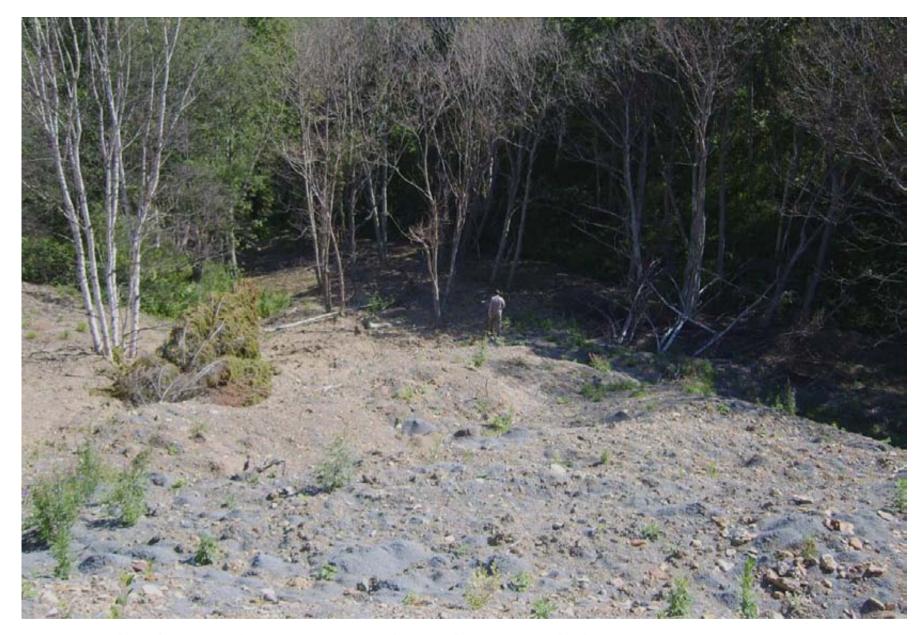
PK 388.6. A section of the route in the Verkhnyaya River Basin. Makarov District.

The mud flow which came down from the spoil bank onto the adjacent parcel of forest at the edge of the route about a year ago. No measures associated with the clearing of the forest reserves and elimination of the violation have not since been taken. The trees overburdened with soil (in the background) have already died since then. September 1, 2007.

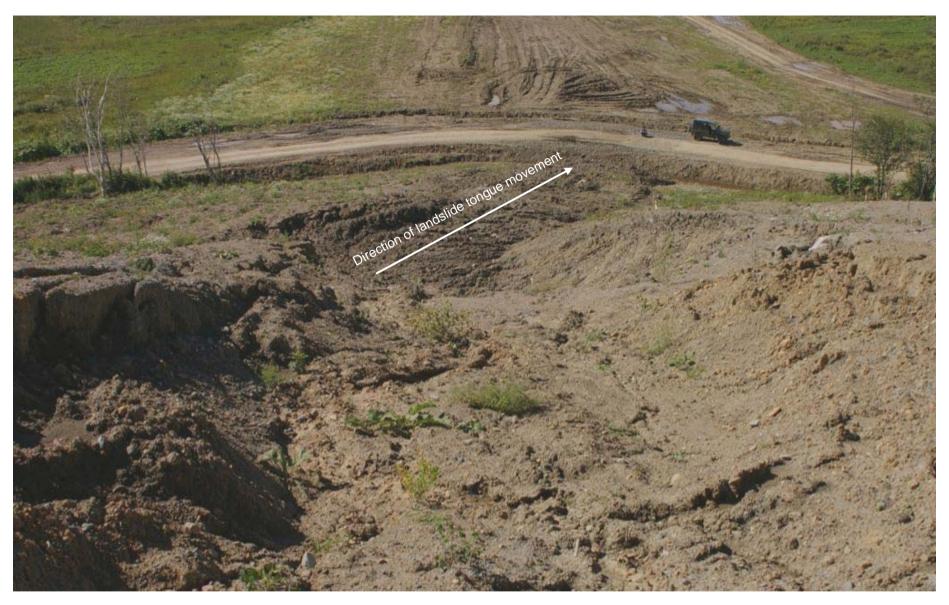
**PK 504.7.** A section of the route to the north from the Ay River. Dolinsk District. (the principal site of the inspection conducted in October 2006 by the Committee of the Ministry of Natural Resources of the Russian Federation). The situation here has but gone from bad to worse, in spite of the fact that on August 8, 2007 an inspection was conducted here by the Federal Service for Supervision of Natural Resource Usage in Sakhalin Region and directives were issued regarding the elimination of the violations. The mud flow continues in development making the trench over the installed pipes deeper and carrying the bulks of soil into the stream, a tributary of the Ay River, flowing beneath the hillside. *August 31, 2007.*

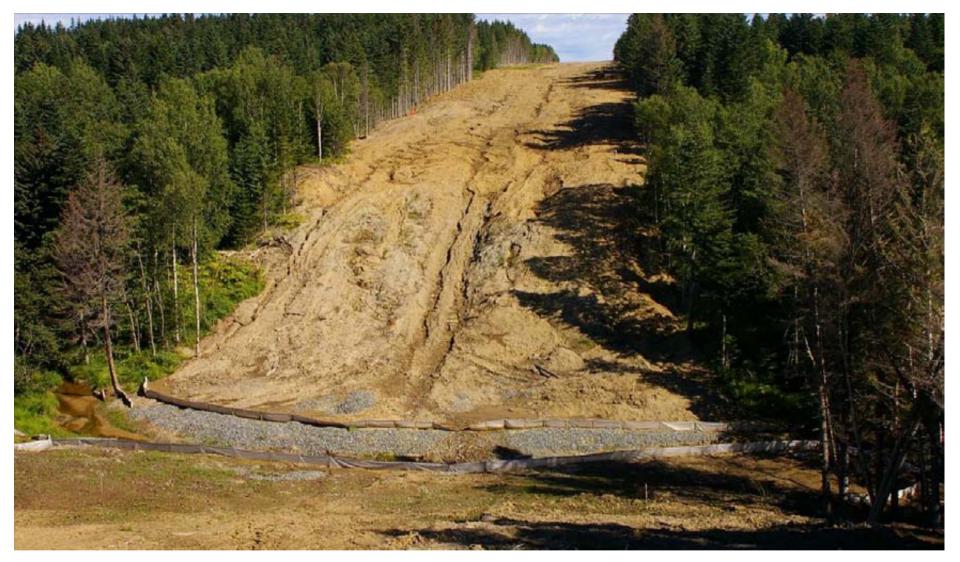
PK 504.3. A section of the crossing over the Podgornaya River (the left tributary of the Ay River). Dolinsk District. In that section, an inspection of the Federal Service for Supervision of Natural Resource Usage (the Committee was chaired by Mr. O.L. Mitvol, Deputy Manager of the Service) was conducted on September 15, 2007. It has been almost a year since the directive was issued, and over one and a half year since the completion of the construction, yet the remediation has not been conducted so far. As a result, erosion processes have been aggressively developed on the hillside leading to the river pollution. The main erosion drainages lines on the hillside coincide with the tracing ruts of the service access road along the route, which should have had been backfilled as far back as a year ago. *August 31, 2007*.

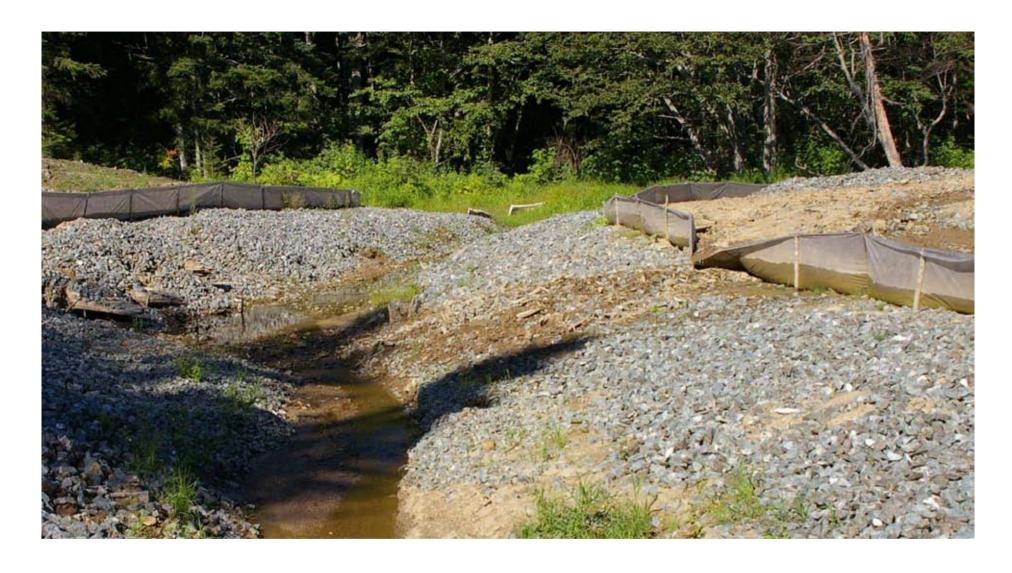
PK 504.3. A section of the crossing over the Podgornaya River. Dolinsk District.

(The same site as the one on the preceding slide). It can be well seen that the interim measures of the water bodies protection are inefficient and are not protecting the river from the pollution with the soil being washed down from the route.

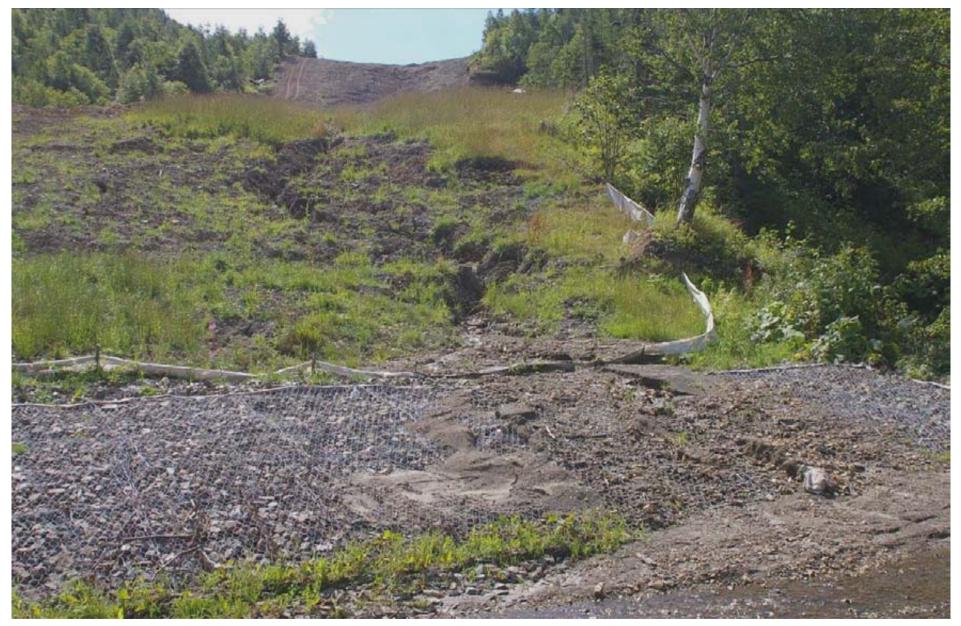
PK 460.2. A section of the route crossing over the Krasnaya River (the right bank). Dolinsk District.

The active gully and the outwash tail of the soil to the riverbed – right over the bank protection structures – may well be seen in the foreground. *August 31, 2007.*

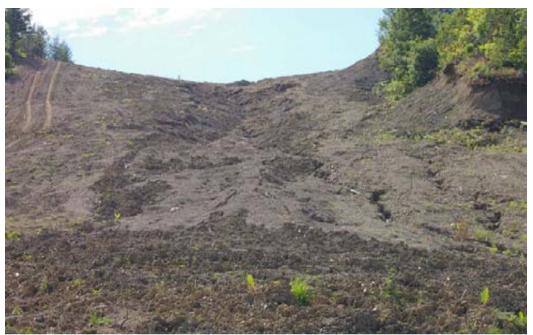
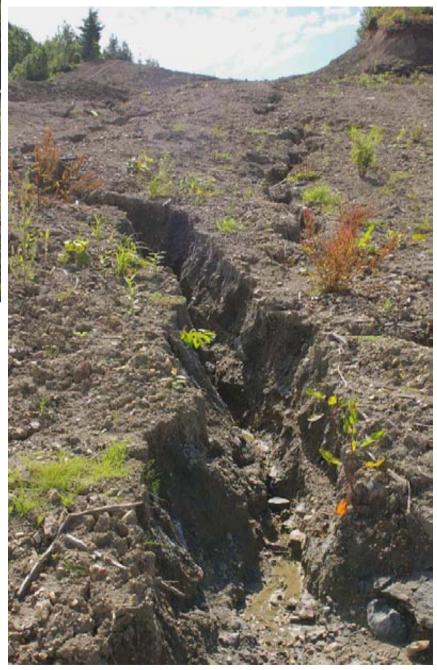
The mud flow continues in development over the already installed pipelines, threatening with the damage thereto (the left image). In addition thereto, by contrast to July, gullies have already occurred as a consequence of the erosion processes.

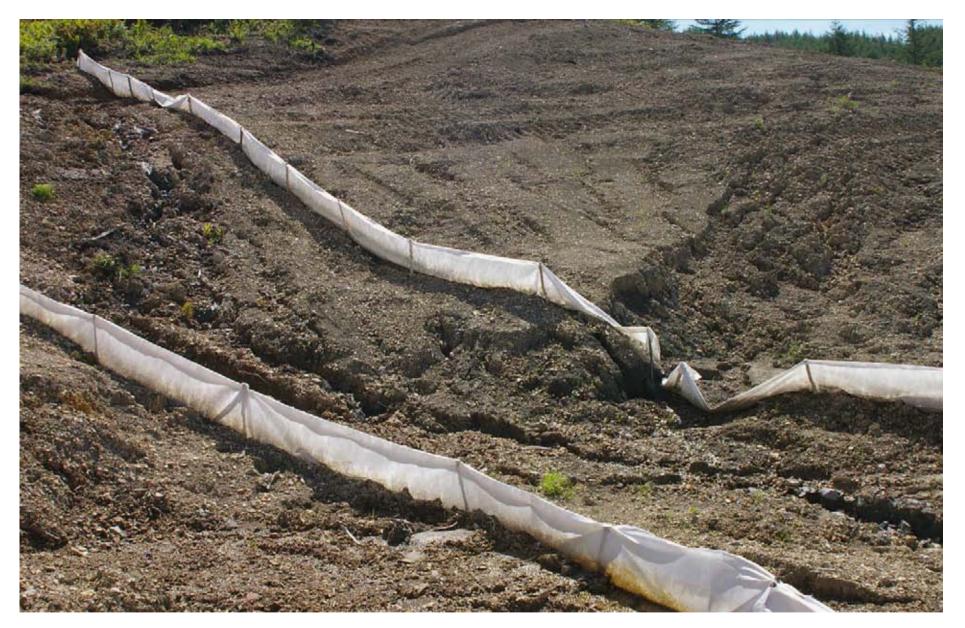
PK 460.7. A route section to the south from the Krasnaya River (the right bank). Dolinsk District.

The operator should have had conducted a complete work package associated with the continuous remediation here as early as a year ago, strengthening the slopes with various geotechnical means, restoring the fertile soil layer, planting perennial grasses etc. Instead of this, the geotextile mud filters remain the sole environmental action here, being helpless in preventing the erosion and soil slip processes. *August 31, 2007.*

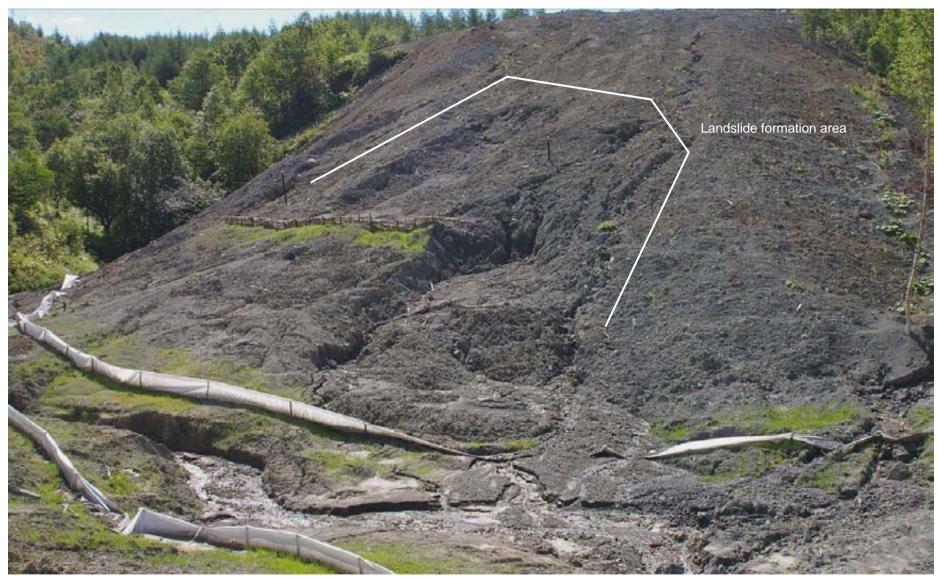
PK 461.0. The landslide on the left bank of the right tributary of the Krasnaya River, which came down in June 2007. Dolinsk District.

At the moment, the mass of the landslide is being eroded by the stream and stream waters flowing down the slope. Moreover, the growth of gullies has already been starting here. The 'know-how' in the form of a short hurdle across the landslide, which has already came down, is taking no effect at all. The traces of the recently planted grass may be seen as narrow strips along the stream banks and beside the hurdle, which are slowing down neither the erosion processes, nor the landslide ones. *August 31, 2007.*

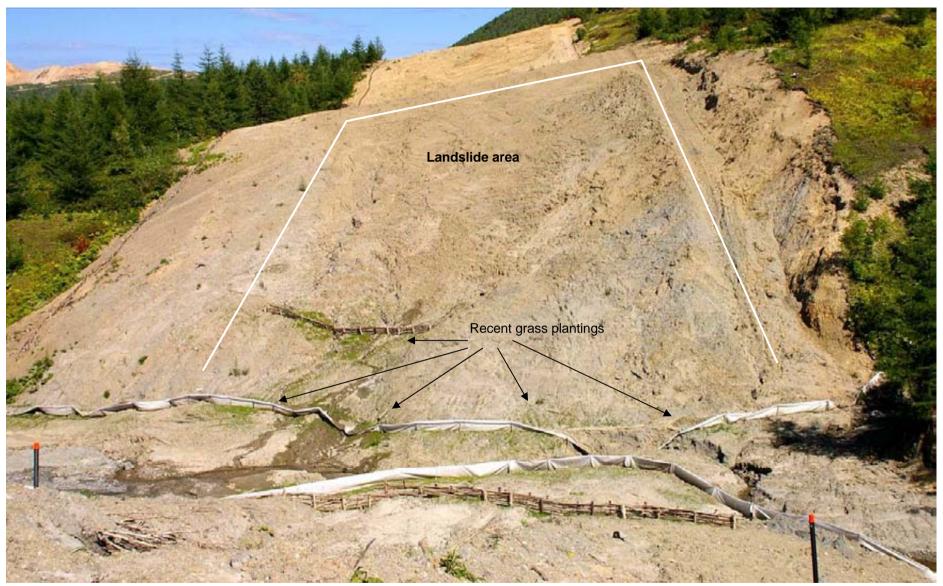
**PK 461.0.** The landslide area on the left bank of the right tributary of the Krasnaya River. Dolinsk District. (the very site as the one on the preceding slide, yet on the opposite bank of the stream). It is well seen that the recent local plantings of grass are having no effect upon the landslide processes. Clots of soil continue in sliding down into the stream. While floods, the process becomes much more large-scale. Down the slope, phreatic discharges may be seen being one of the primary causes of the soil liquefaction. *August 31, 2007*.

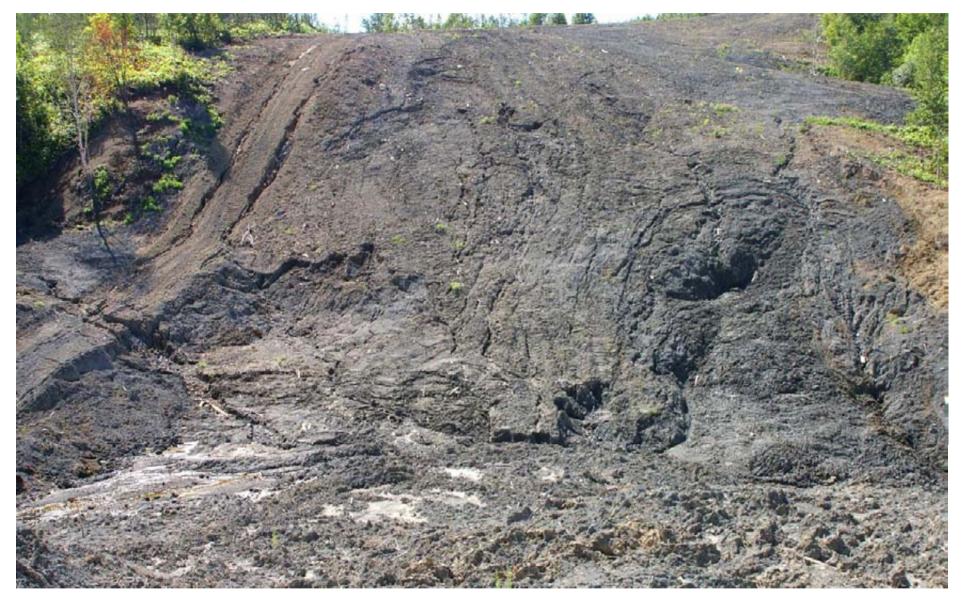
PK 461.6. Another right tributary of the Krasnaya River located 600 meters southward, the left bank of the stream. Dolinsk District.

There are absolutely no protective measures whatsoever here, not even cosmetic ones. The concentric lines of the areas, where clots of soil are torn off, mark the landslide formation areas varying in their scale. An erosion scour runs across the embankment of the temporary service drive having no culvert facility. The tracing ruts have been gradually becoming gullies. *August 31, 2007.*

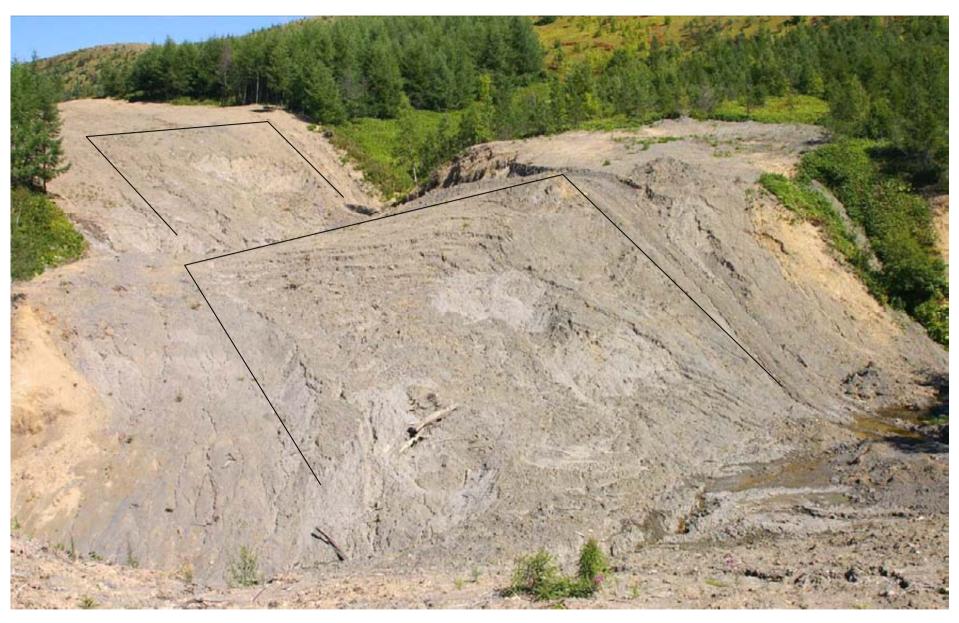
**PK 461.6. The right tributary of the Krasnaya River, the right bank of the stream. Dolinsk District** (the very site as the one on the preceding slide). Again, no protective measures at all. The landslide areas are marked with black lines. It is well seen that the situation is typical and is reoccurring. The soil sliding down into the stream is being continuously eroded; many tons of the muddy sediment have been polluting the spawning areas lying downstream. *August 31, 2007.*

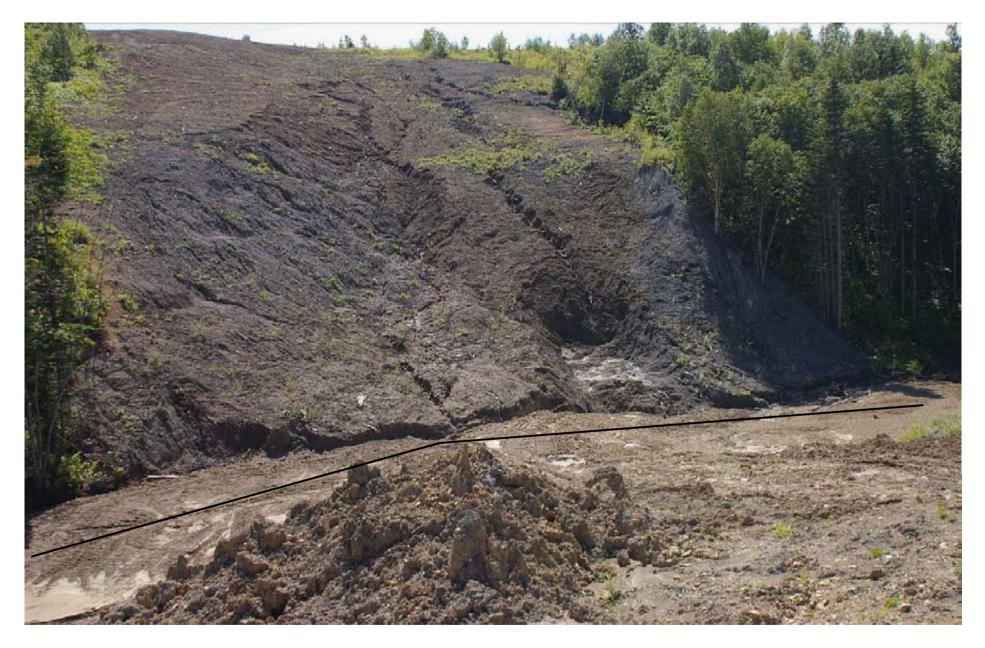
PK 462.6. A section of the route in the crossover point over the left tributary of the Baklanovka River (flows into the Sea of Okhotsk). Dolinsk District. Again, the typical situation where landslides of various scales are being formed. The line marks the former streambed which is now completely overwhelmed with the sediment drifted down. The need for urgent remediation work is obvious. *August 31, 2007.*

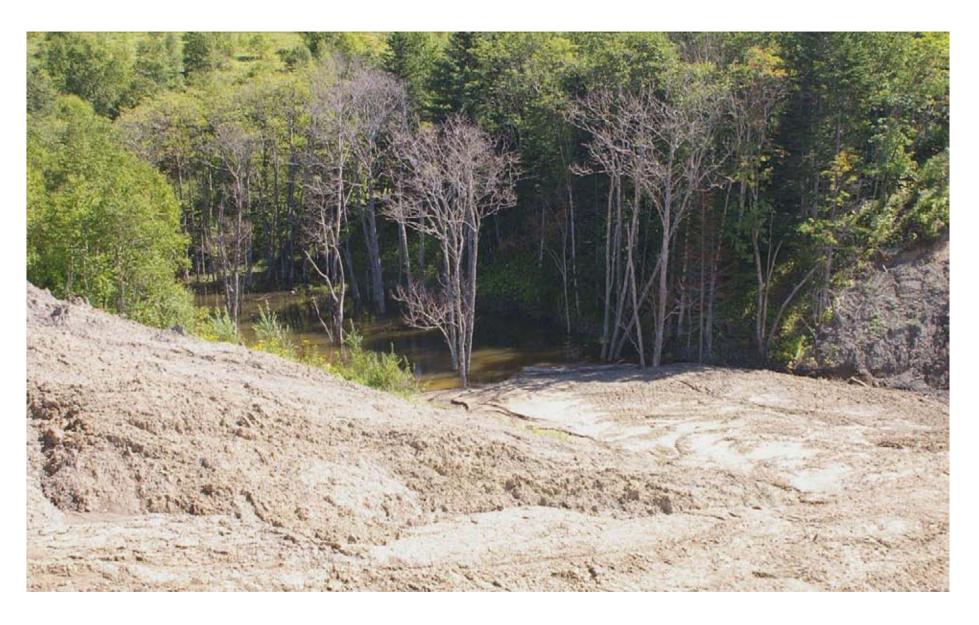
**PK 462.6.** A section of the crossing over the left tributary of the Baklanovka River. Dolinsk District (the same site as the one on the preceding slide). A massive landslide blocked the riverbed having completely disturbed the hydrologic characteristics thereof. The trees in the stream floodplain are dying as a consequence. *August 31, 2007.*

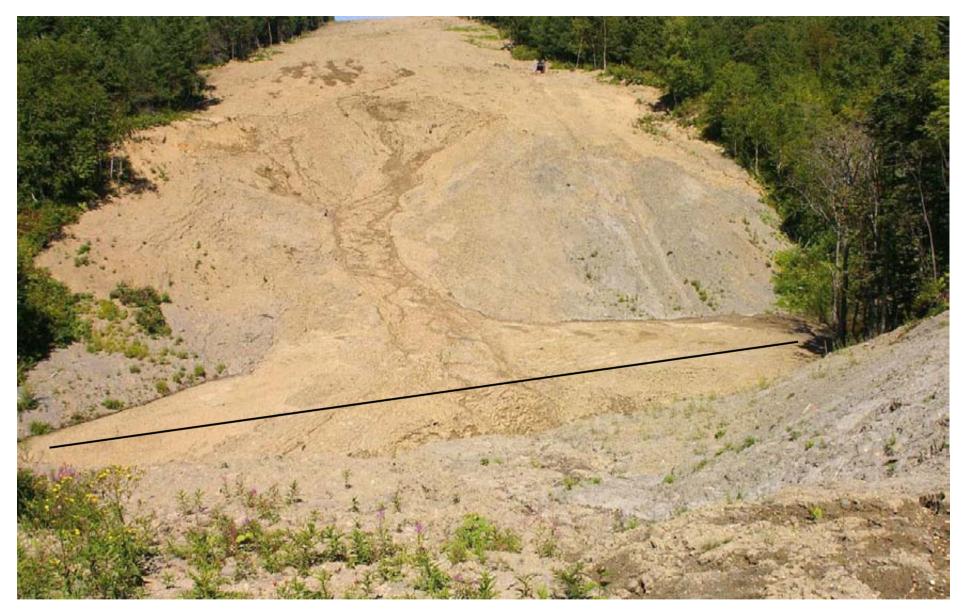
**PK 462.6.** A section of the crossing over the left tributary of the Baklanovka River. Dolinsk Region (the same site as the one on the preceding slide). A huge landslide from the bank-side of the stream, which completely submerge the flood plain of the stream. The former streambed is marked with a line. The dark spots upon the slope are phreatic discharges inducing landslide processes. Under such conditions, it will be extremely difficult to stop the formation of landslides. It is crucial to promptly make and implement major engineering solution regarding the control over the landslides. *August 31, 2007.*
