One indicative example on the Sakhalin II pipeline: same place during last four months

(according results of public monitoring conducted by
Sakhalin Environment Watch in 2007)

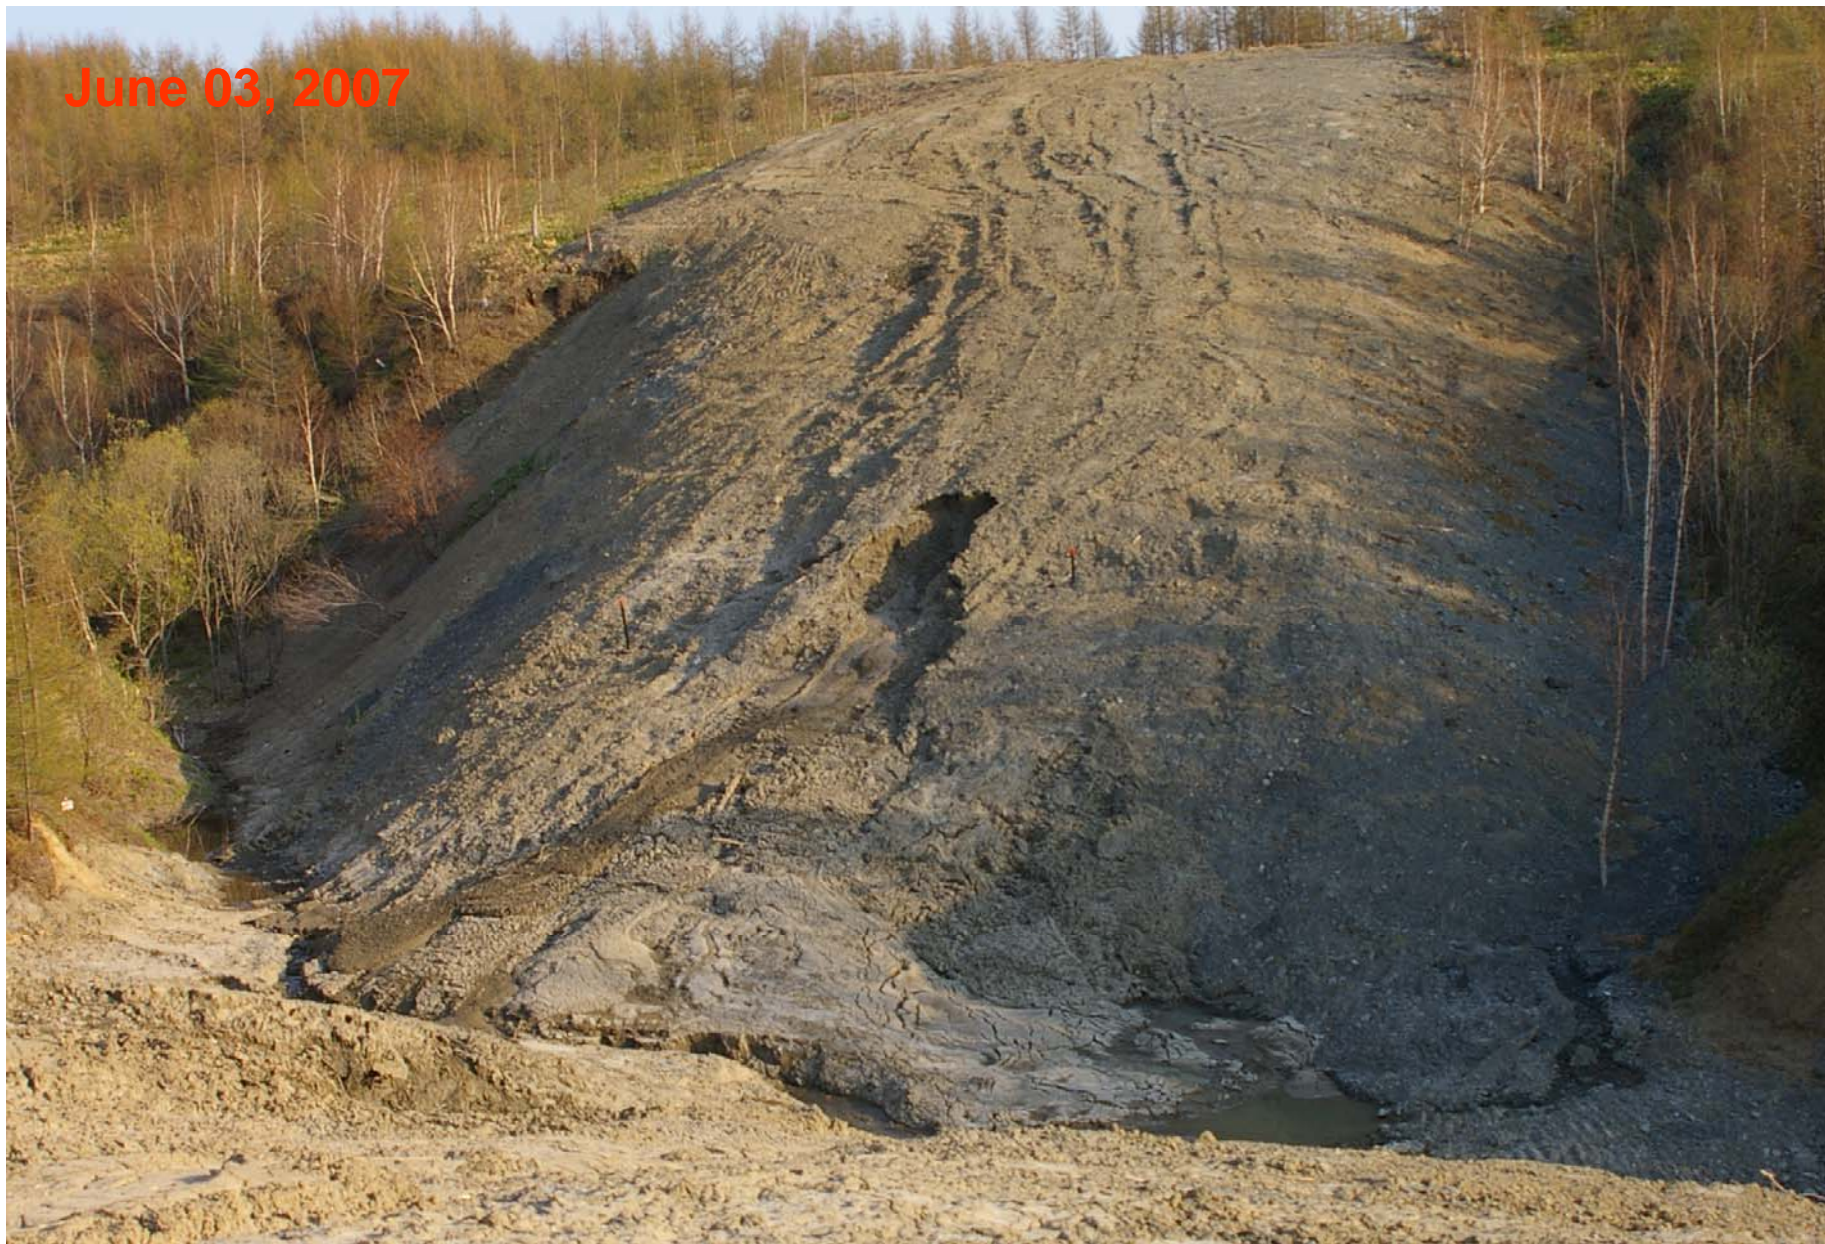
KP 461,0. The landslide on the left bank of the Krasnaya River right tributary. Dolinsk District.

A beginning of land slides processes. First land slide came down in May here, during a melting season. Construction in this area has been completed more than a year ago, however final restoration has not been completed.

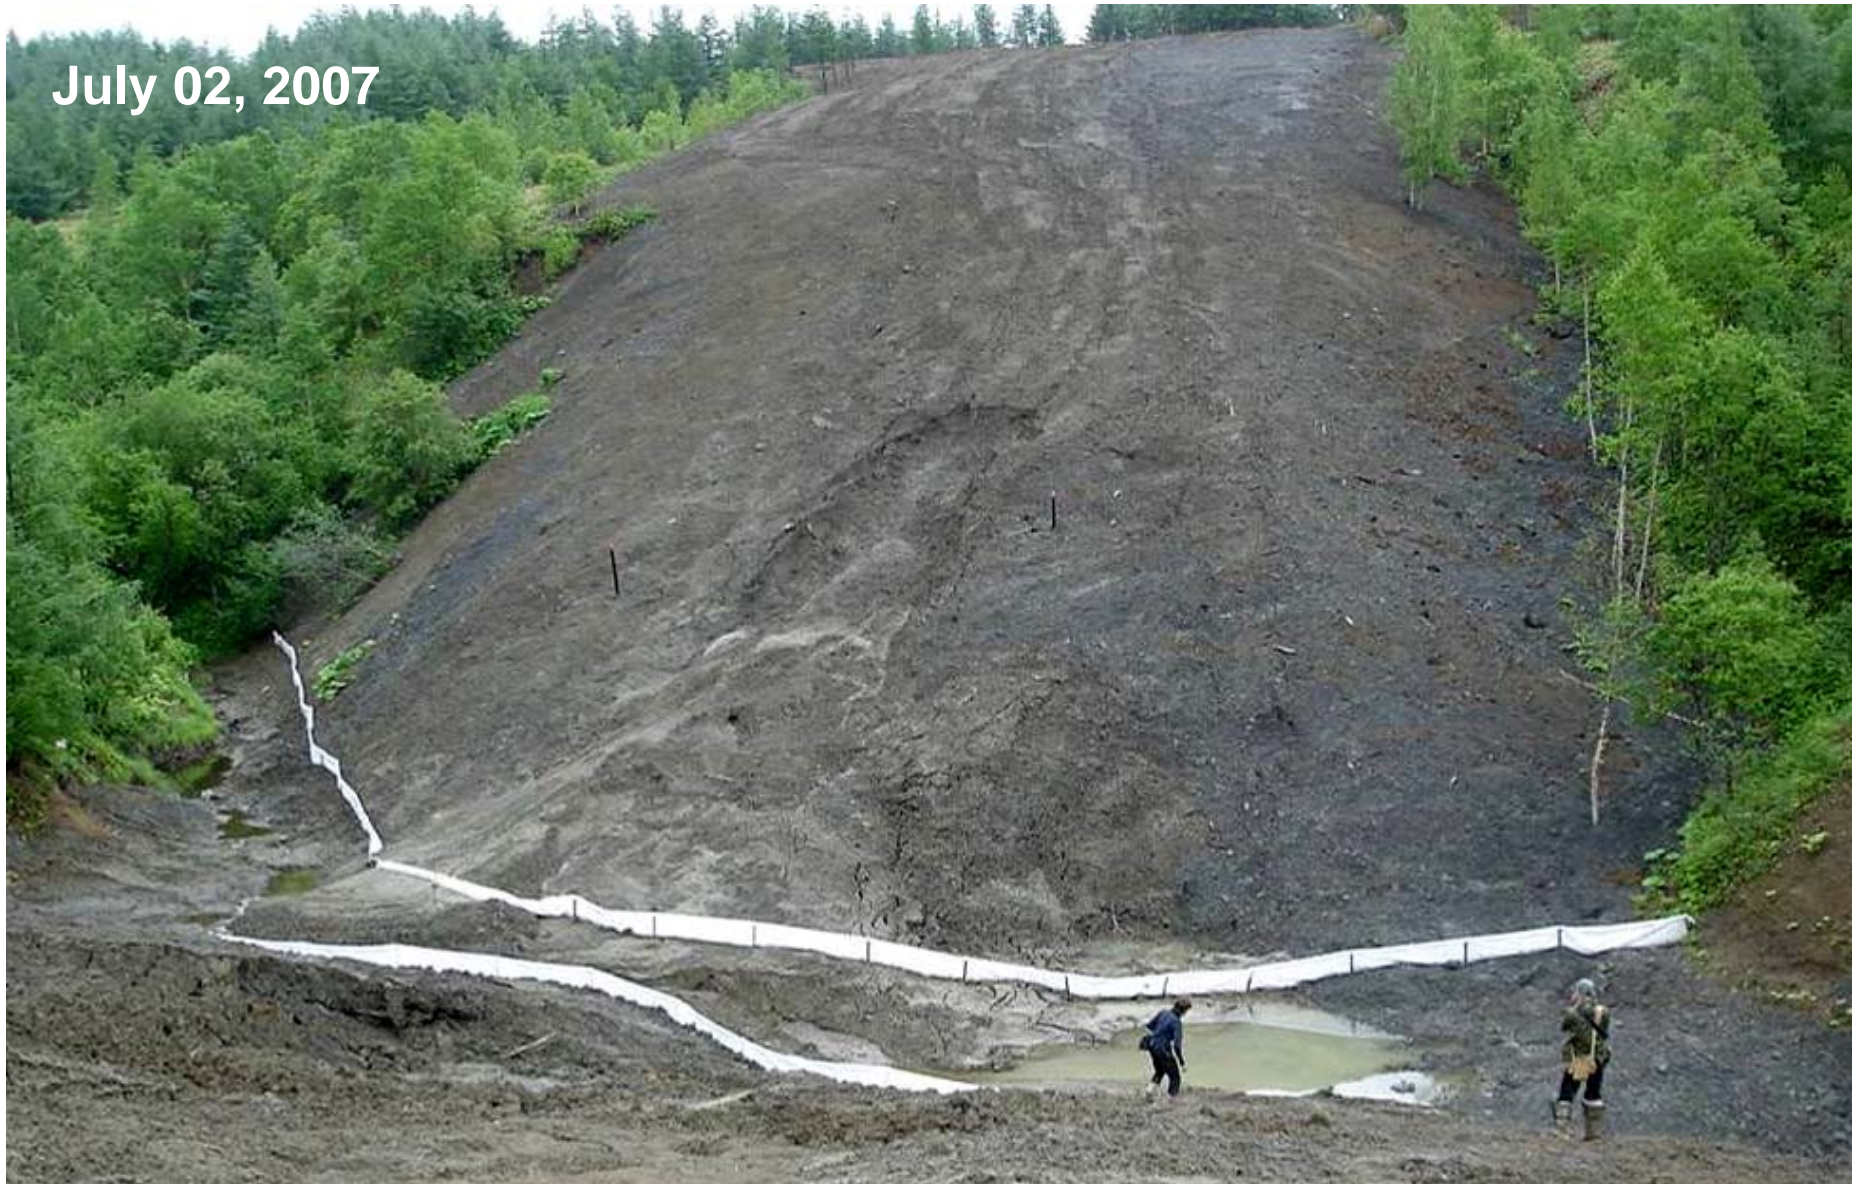
KP 461,0. The landslide on the left bank of the Krasnaya River right tributary. Dolinsk District.

A large scope of backfilling soil over the laid pipes slid into the stream, shutting off water flow. Volume of the landslide is about 300 m³. For some purposes, silt fences were placed directly on the «body» of the landslides which was still moving.

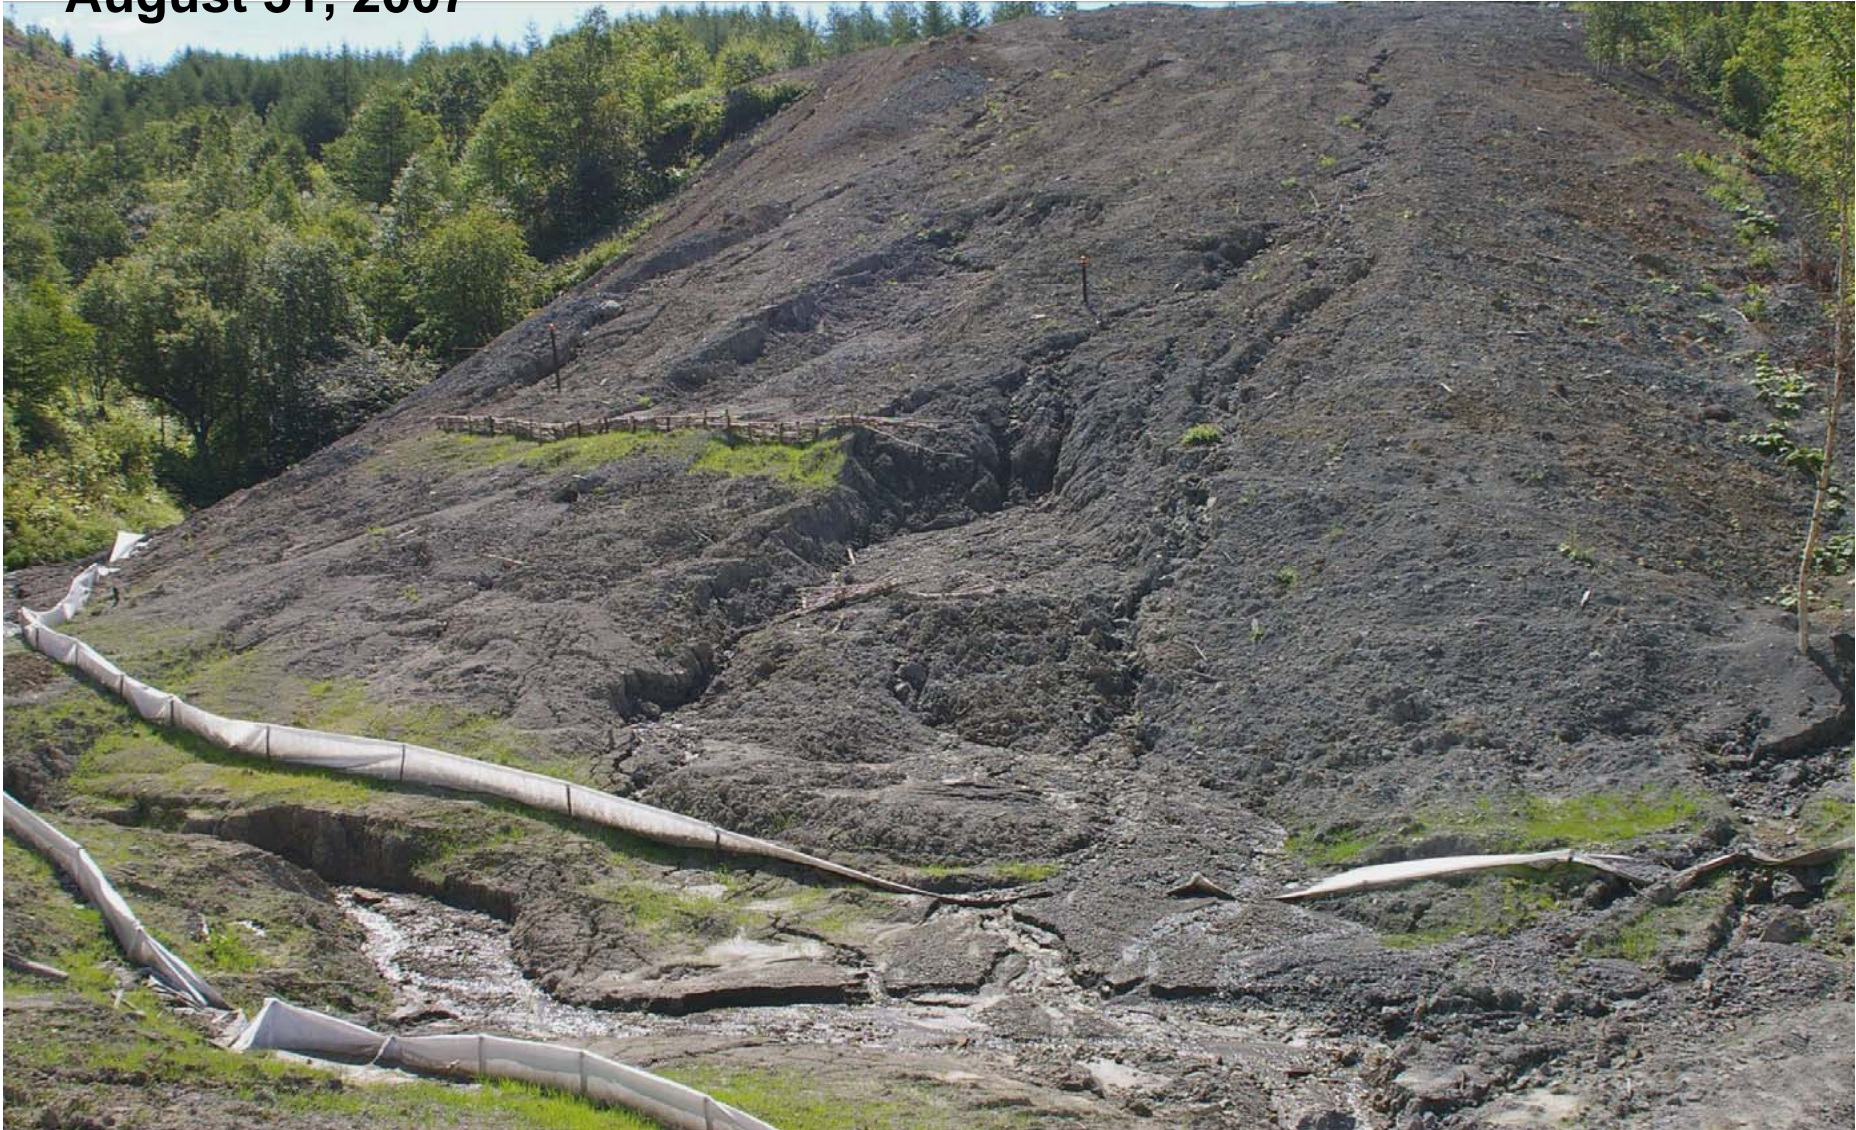
KP 461,0. The landslide on the left bank of the Krasnaya River right tributary. Dolinsk District.

At the moment, the mass of the landslide is being eroded by the stream and stream waters flowing down the slope. Moreover, the growth of gullies has already been starting here. The SEIC's 'know-how' in the form of a short hurdle across the landslide, which has already come down, is taking no effect at all. The traces of the recently planted grass may be seen as narrow strips along the stream banks and beside the hurdle, which are slowing down neither the erosion processes, nor the landslide ones.

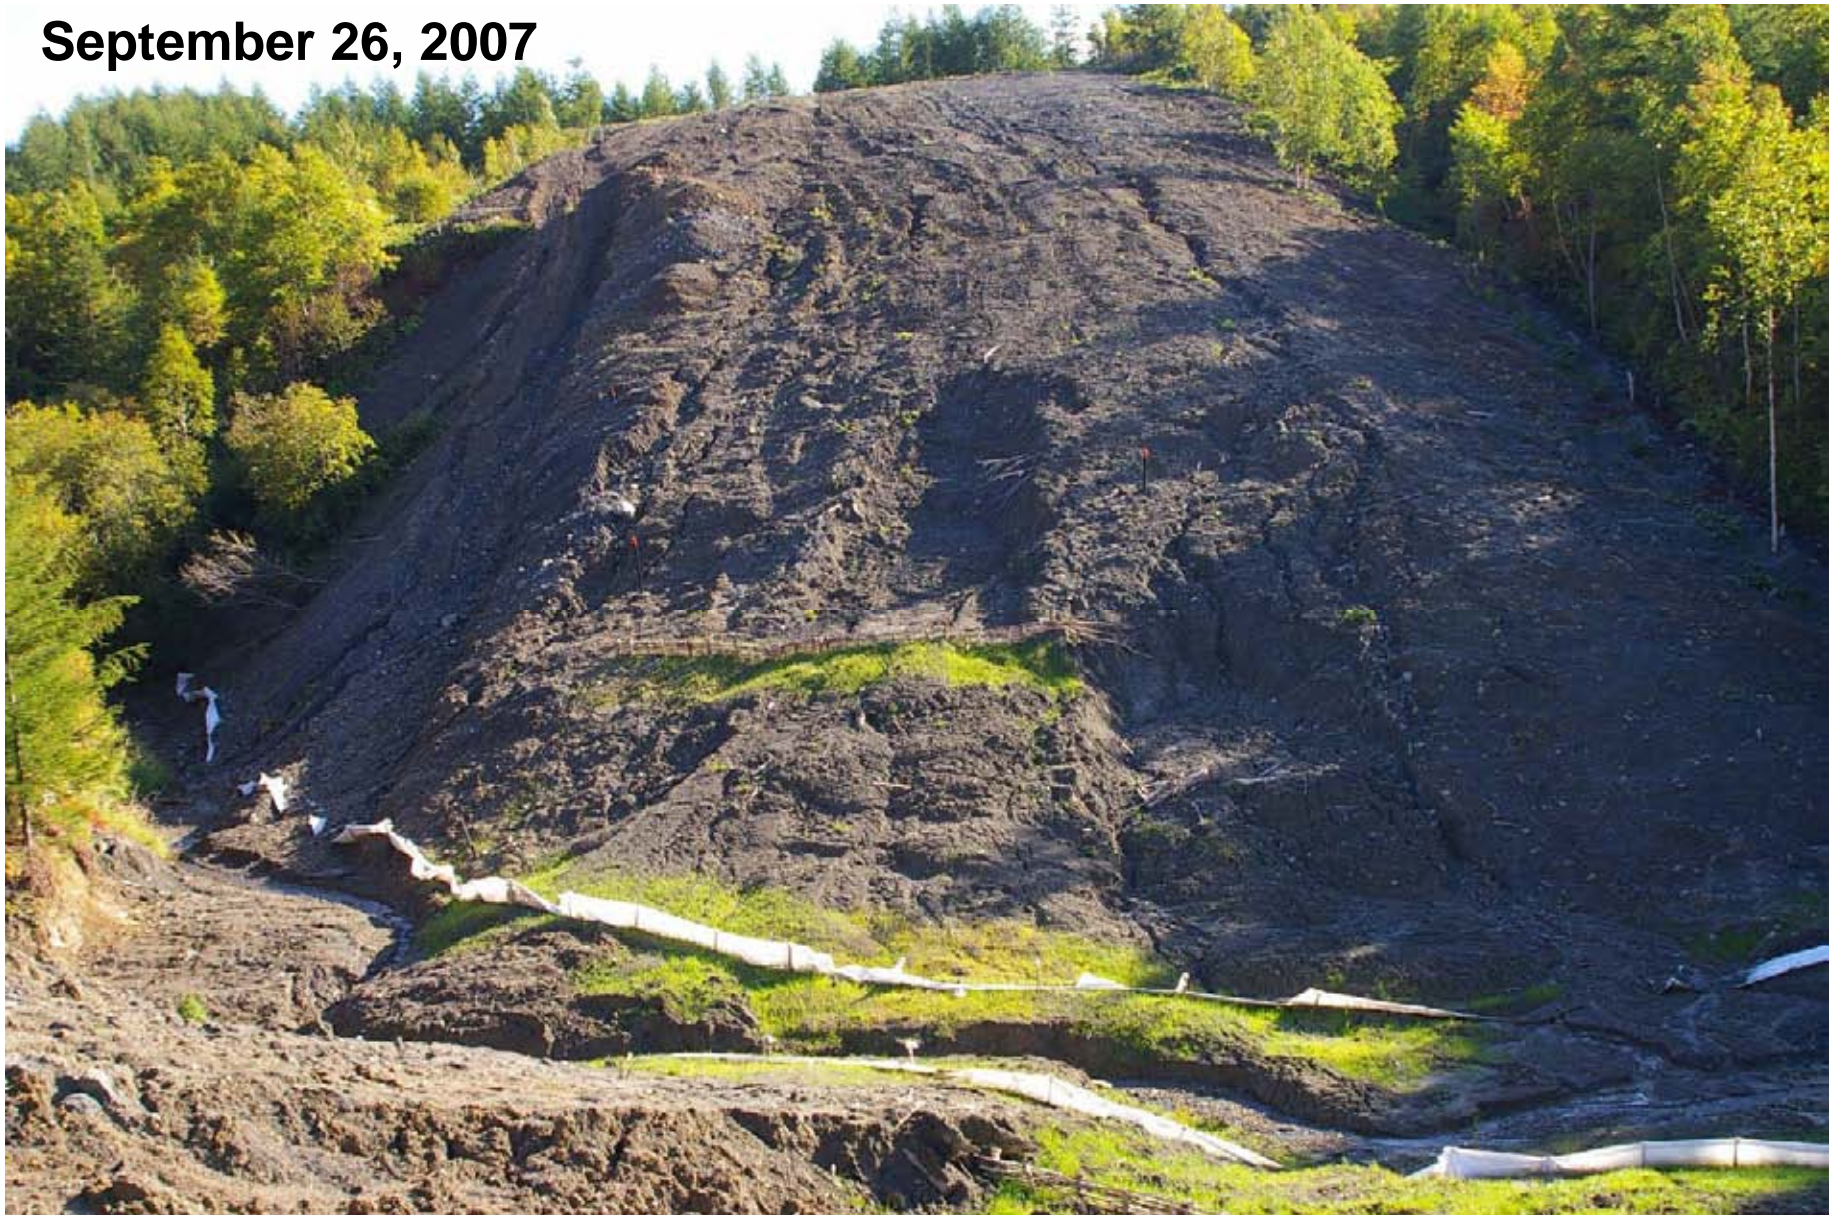
KP 461,0. The landslide on the left bank of the Krasnaya River right tributary. Dolinsk District. More than 4 months after the first land slide occurred on the slope, SEIC has not undertaken adequate, effective measures for control of land slides and erosion processes. Fences installed on the moving mud and very limited grass planting don't help at all.

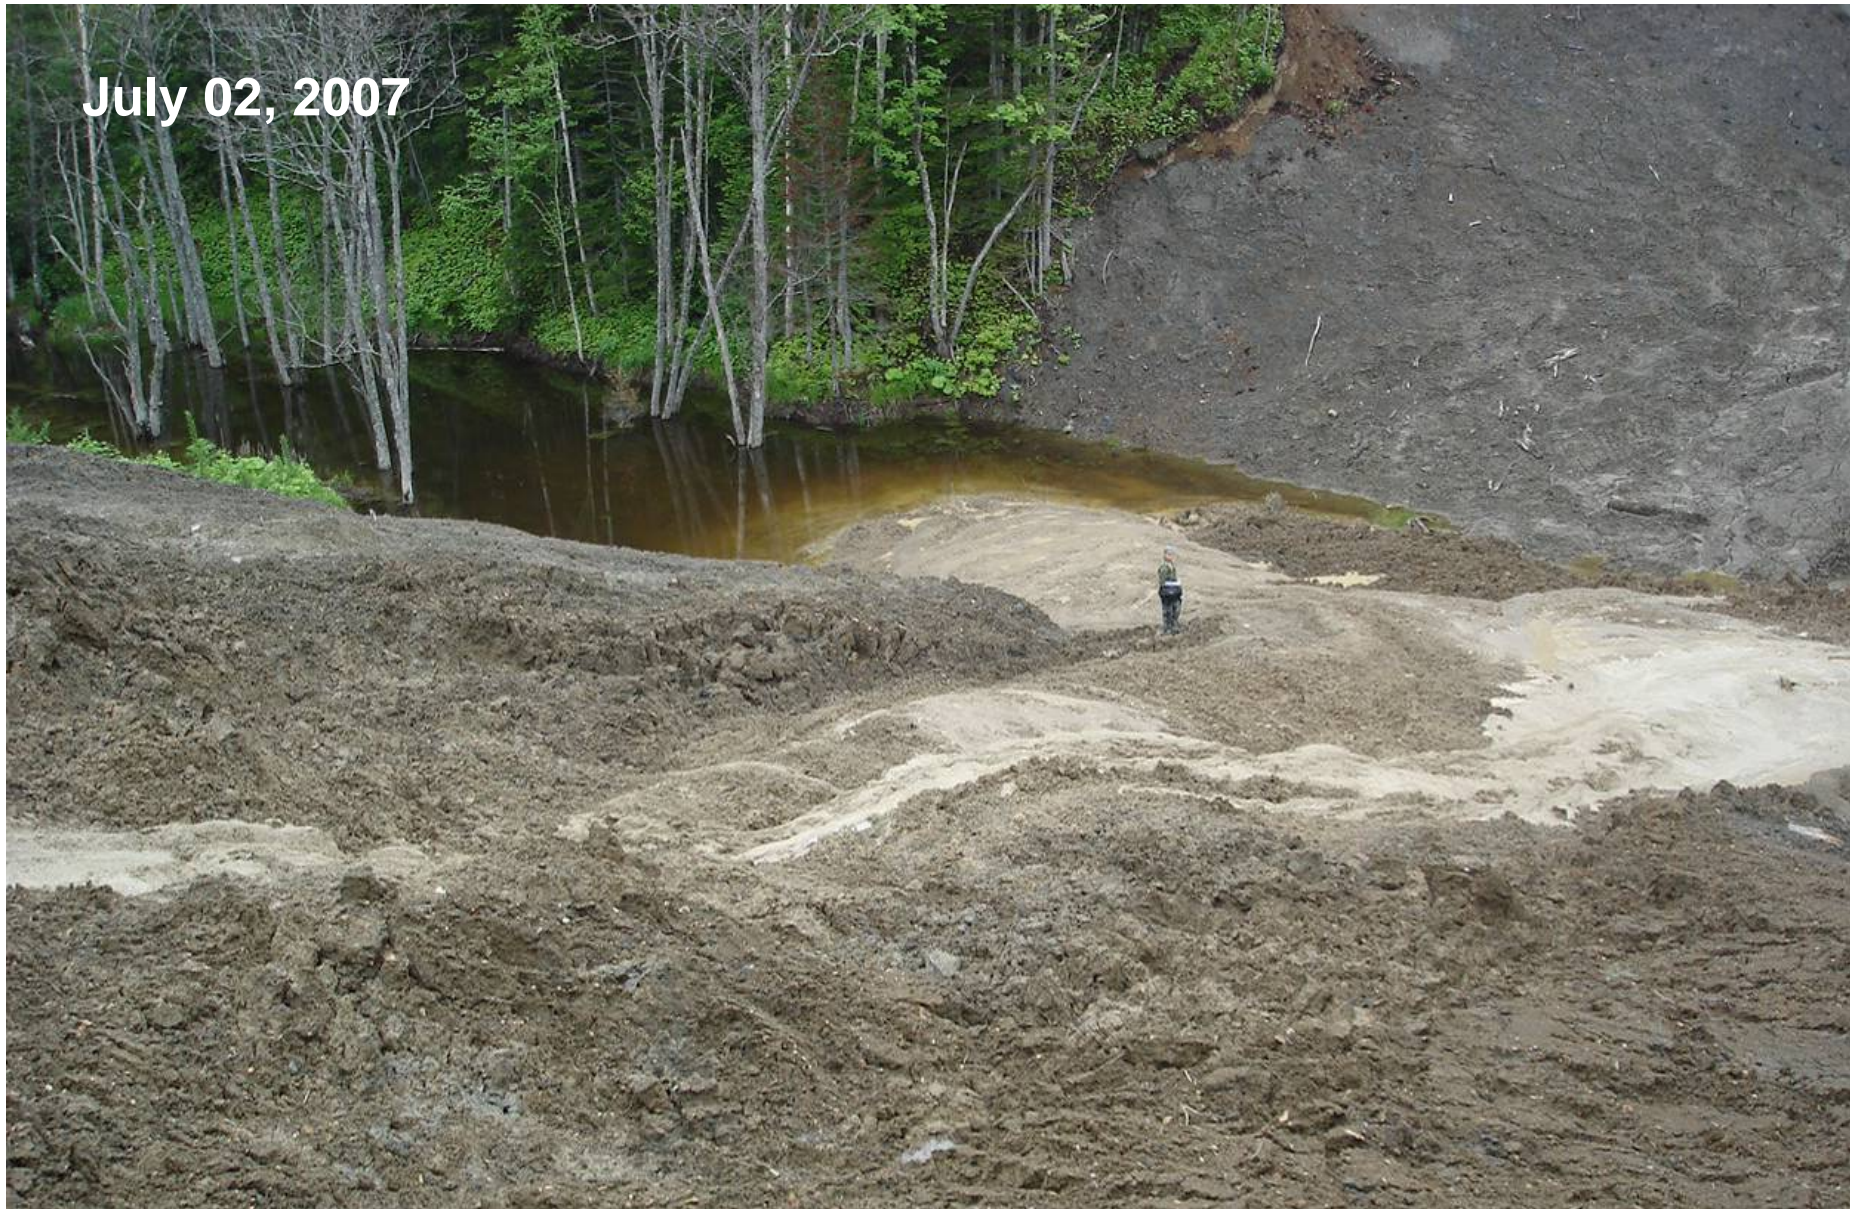
KP 462,6. The landslide on the right bank of the left tributary of the Baklanovka River, Dolinsk District.
The landslide completely blocked the stream's bed, blocking water flow. An artificial pond has been created. Hydrological regime of the waterways was violated.

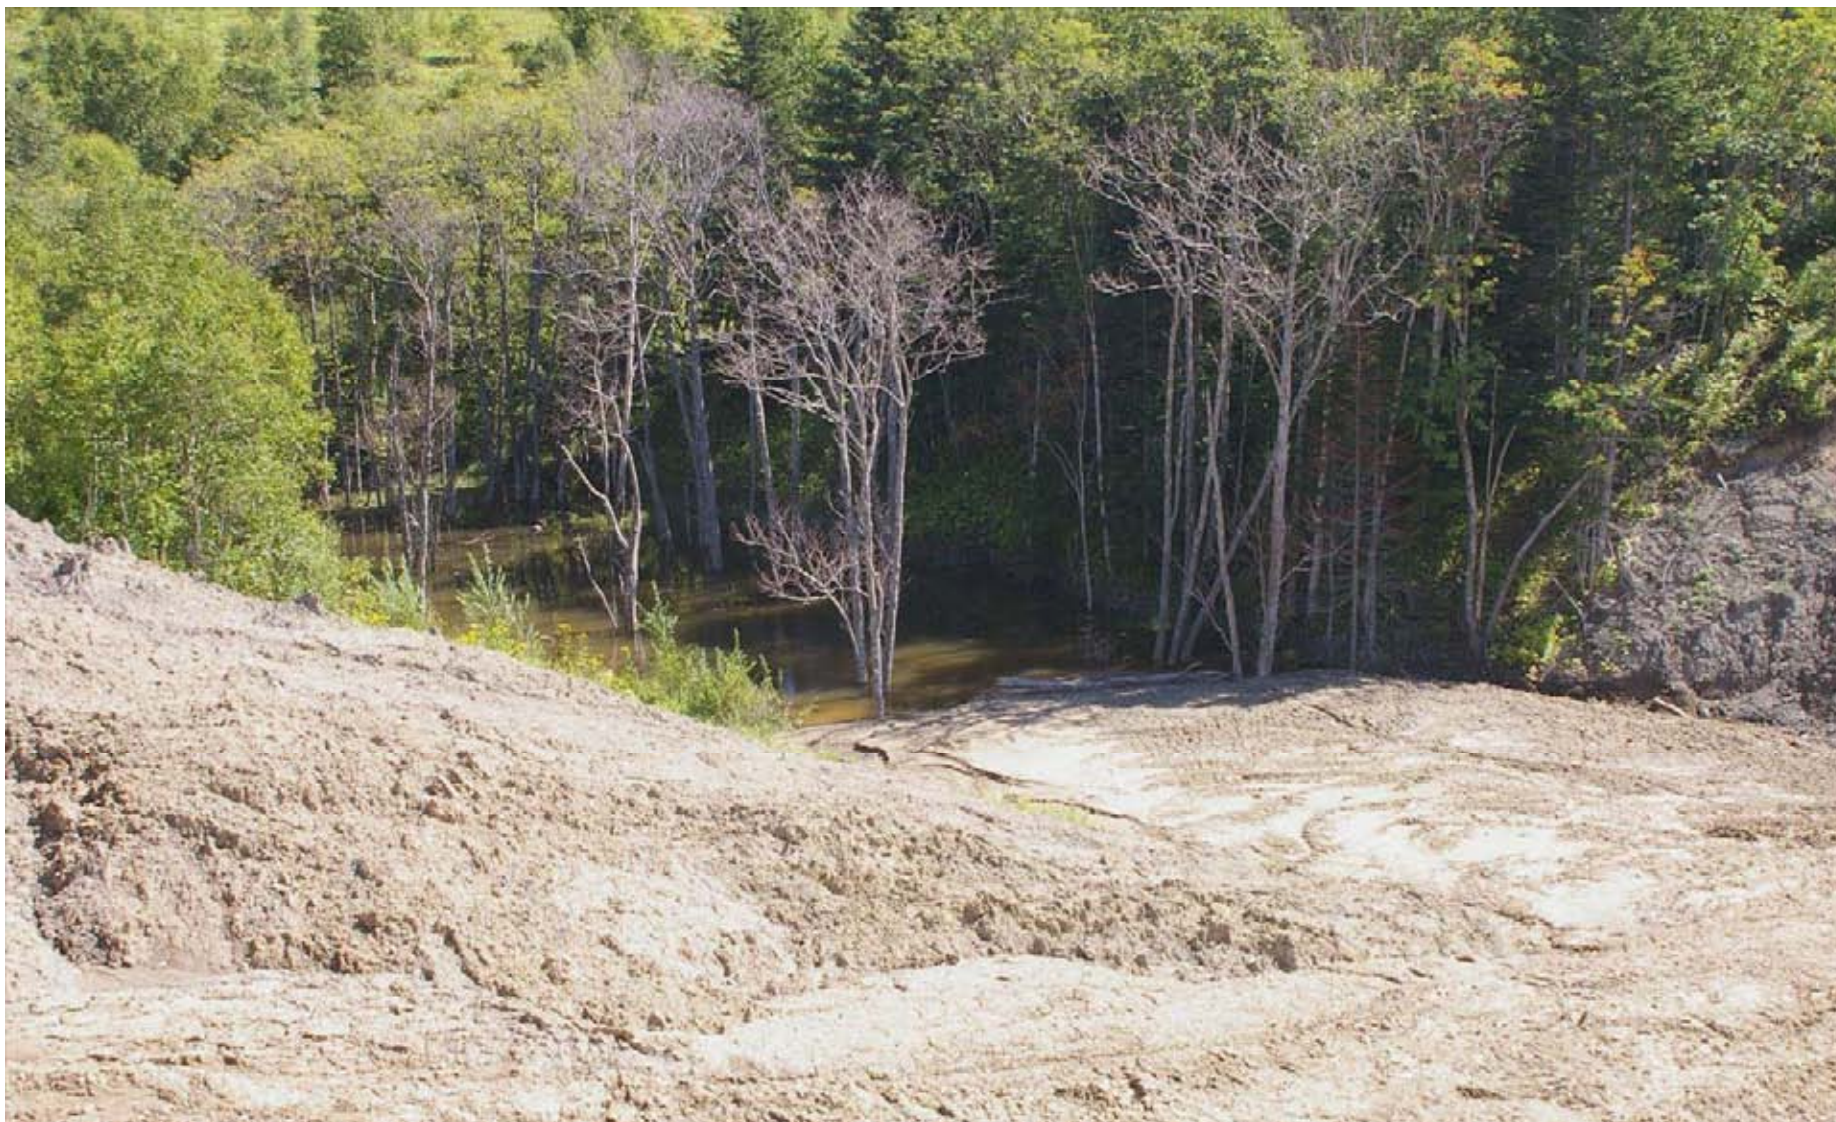
KP 462,6. The landslide on the right bank of the left tributary of the Baklanovka River, Dolinsk District.
No changed two months later

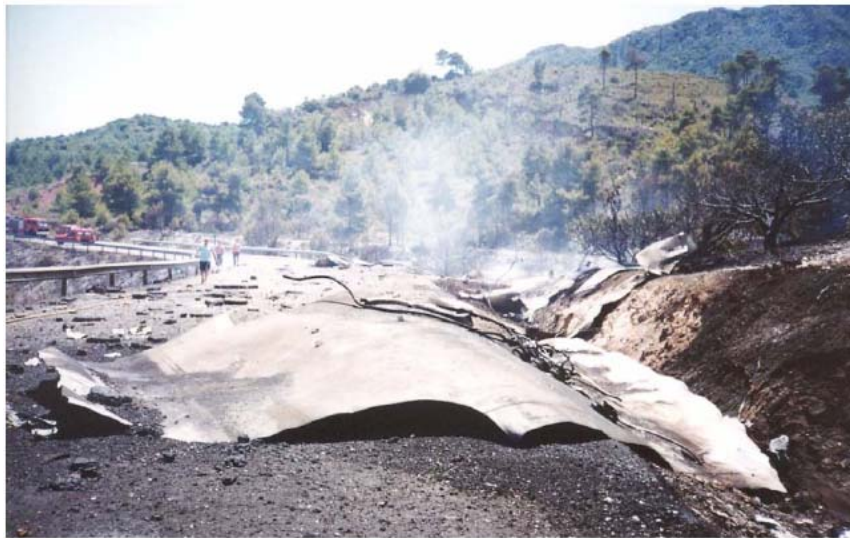
Fig. 4. Central part of the tank.

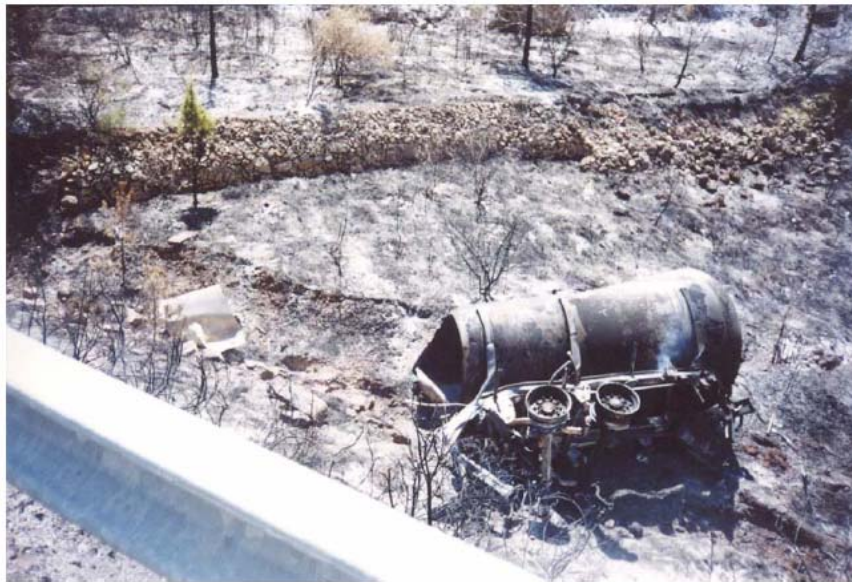
Fig. 2. Rear piece of the tank.

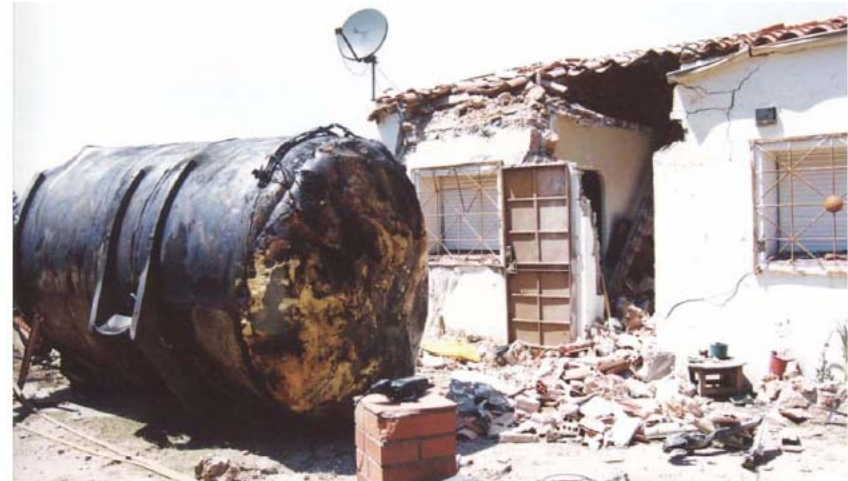
Fig. 3. Front piece of the tank.
