# PHOTOREPORT

in accordance with findings of the public ecological inspection of  
pipelines constructions (under Sakhalin II Project)

July, 2007

Prepared by the Non-Governmental Organization Sakhalin Environment Watch

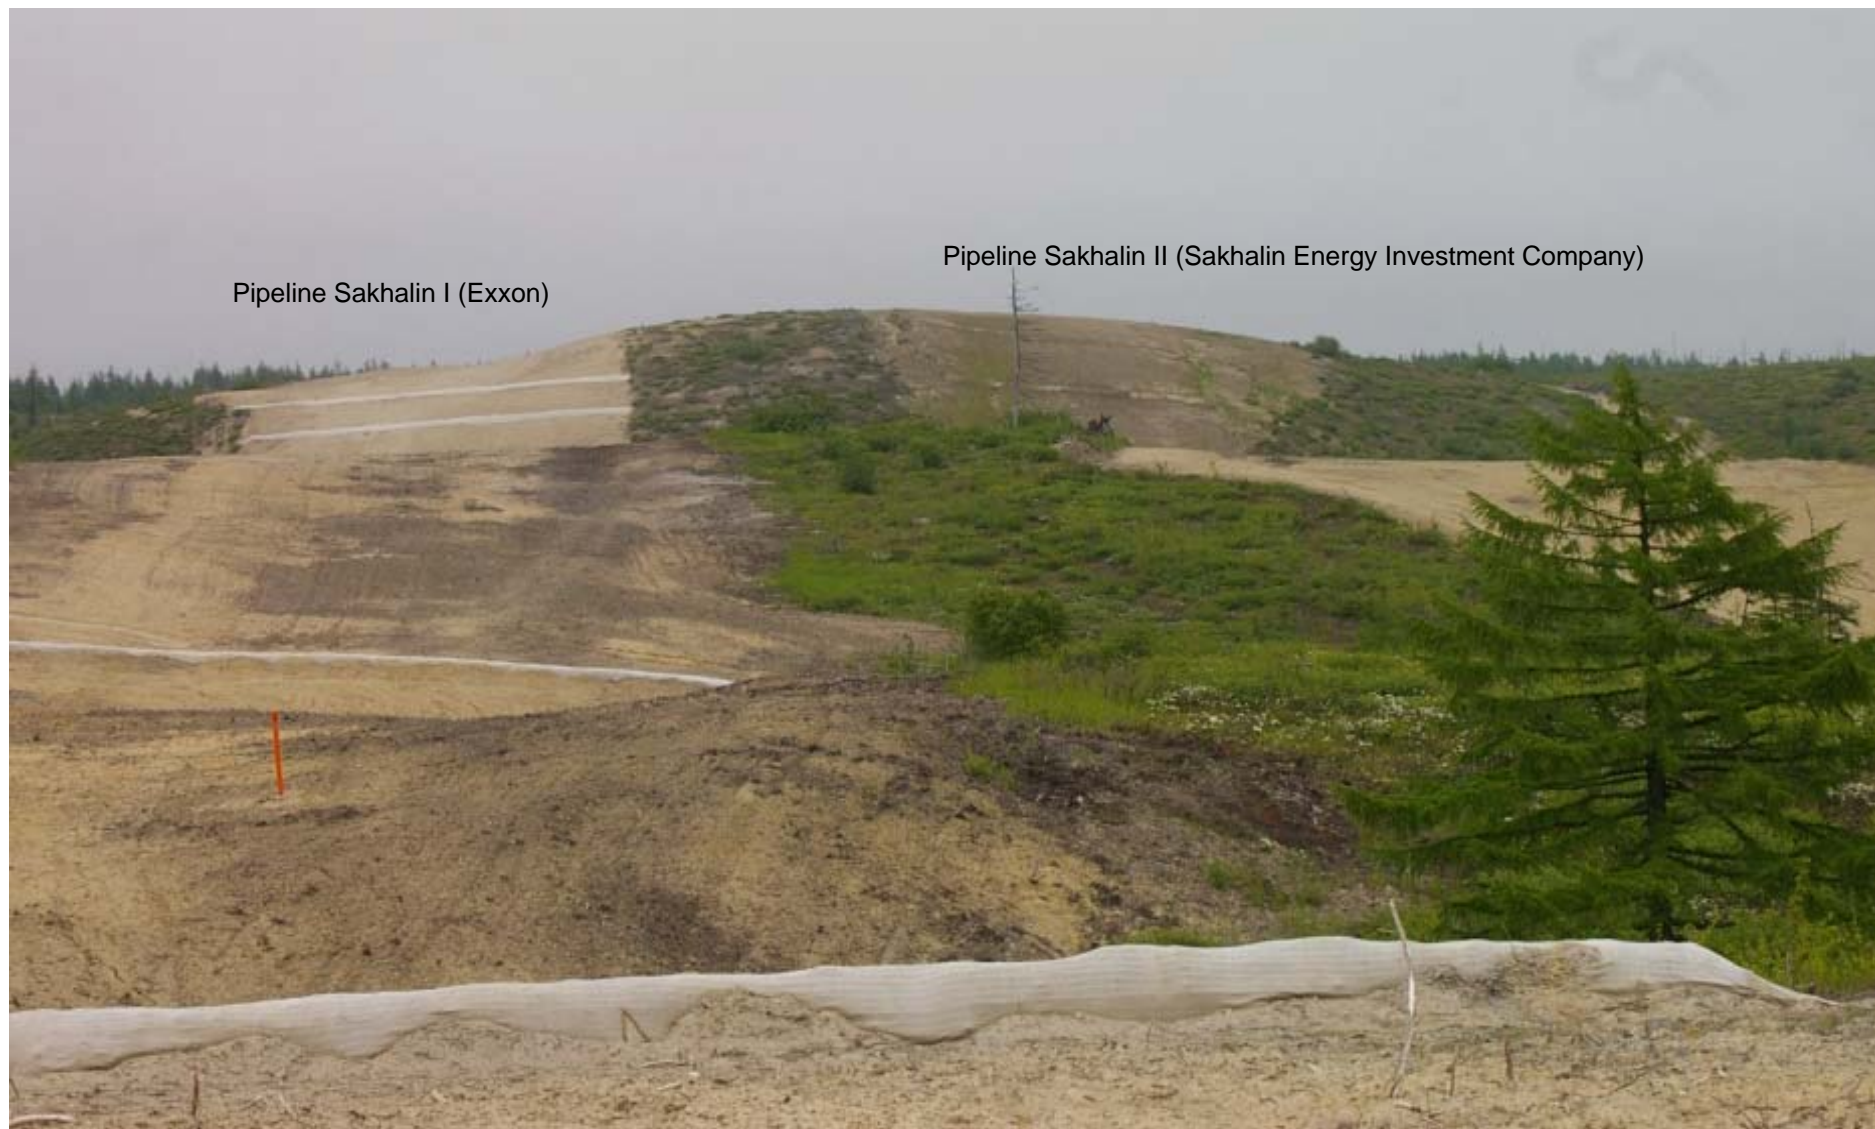
**KP 18** (northern section, from 0 till 35 km). **Upstream of the Khoyambusibin river (empties into Chayvo Bay). Nogliki District.** General plan of Sakhalin 2 pipeline route where it is parallel to the Sakhalin I pipeline route. Distance between two pipelines is about 100 m. *July 4, 2007.*

Both pipelines (Sakhalin-1 and Sakhalin-2) were built at this section by the same subcontractor - LLC "Construction and Erection Company 4», Ufa city, Bashkiriya, Russia. Both pipelines were built here more than one year ago.

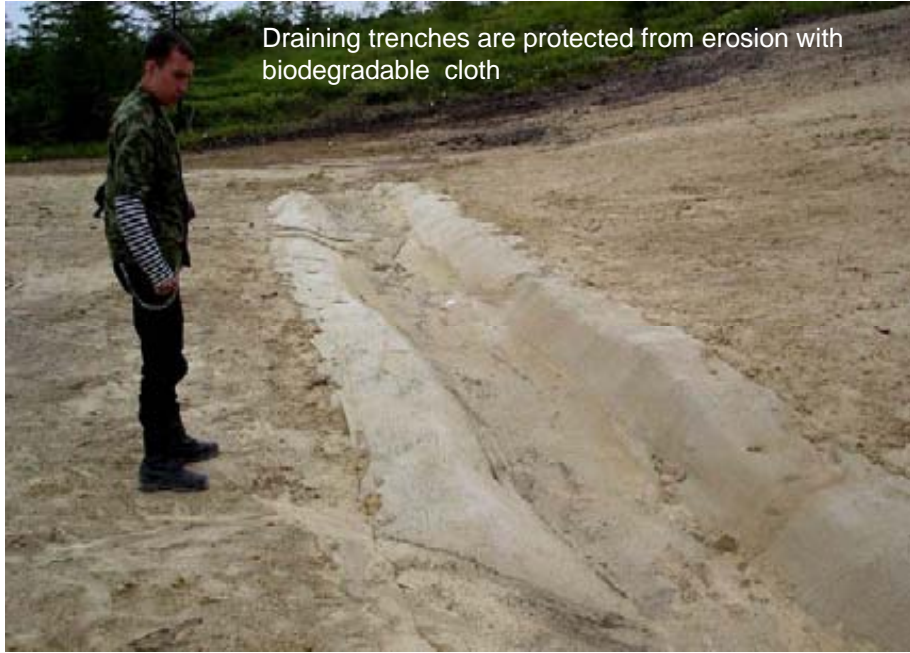
Draining trenches are protected from erosion with biodegradable cloth

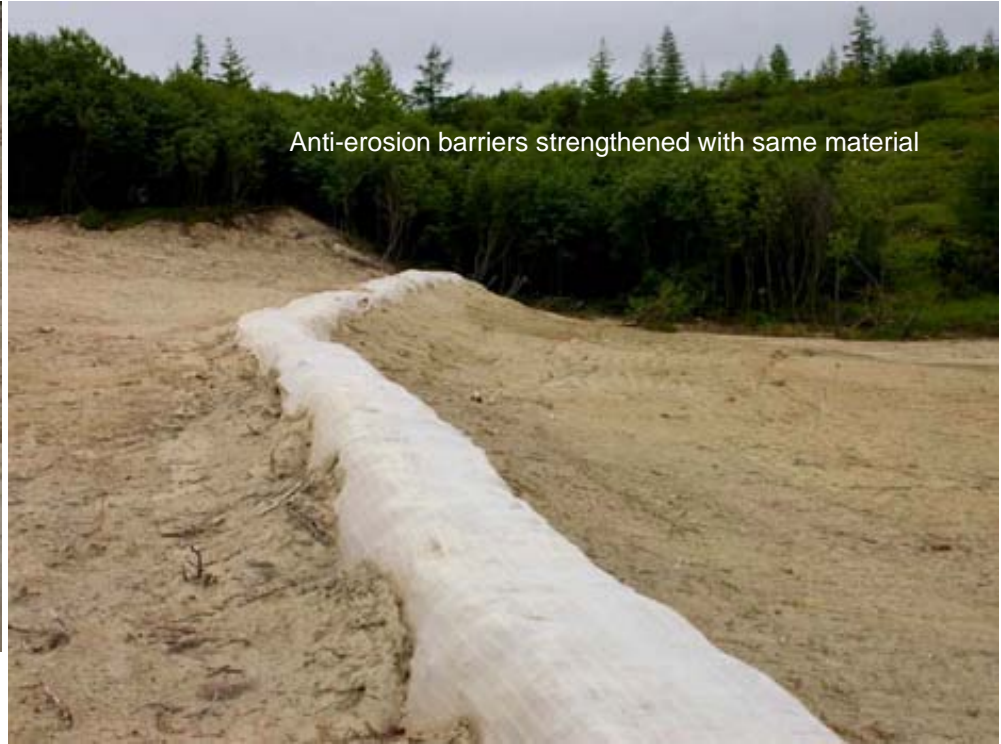
Anti-erosion barriers strengthened with same material

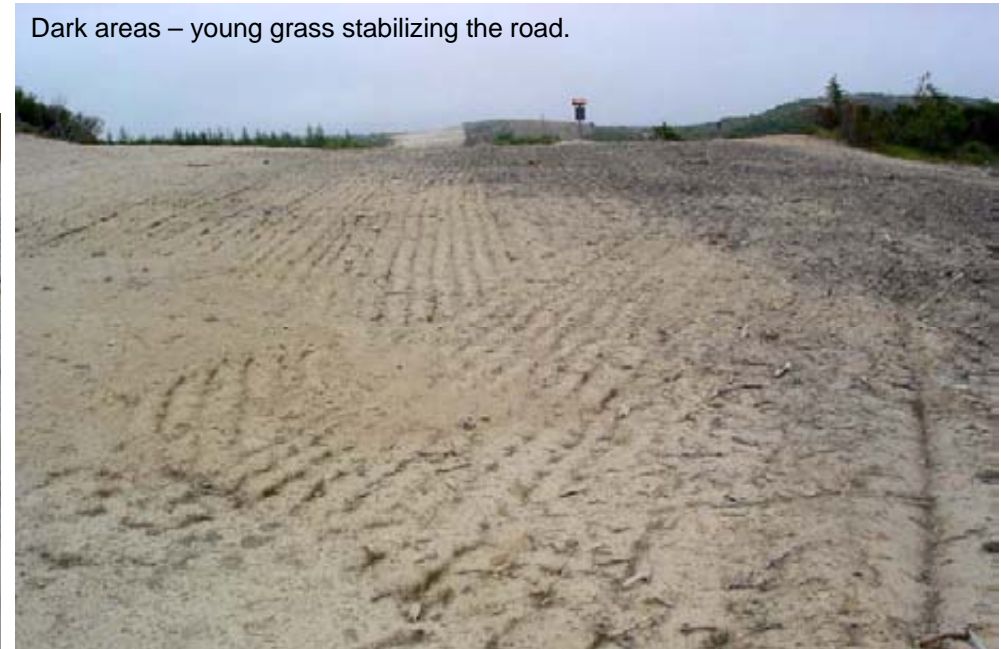
Dark areas – young grass stabilizing the road.

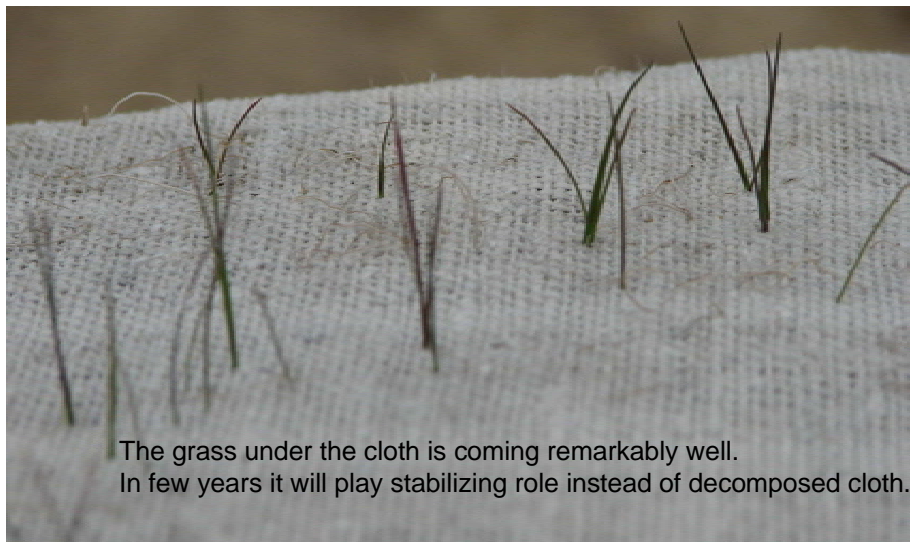
The grass under the cloth is coming remarkably well.  
In few years it will play stabilizing role instead of decomposed cloth.

Anti-erosion barriers are not protected against washing-out and will be destroyed soon. The grass has not been planted.

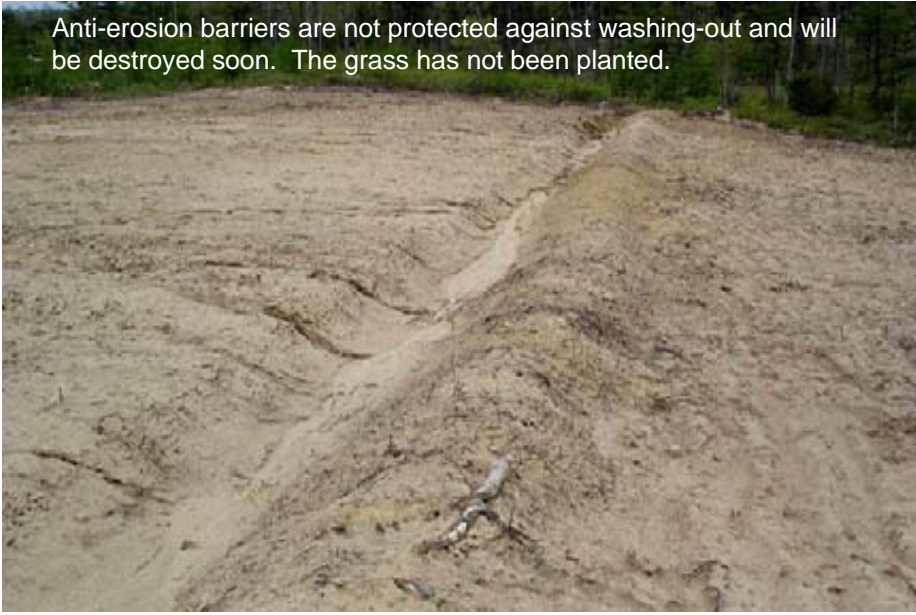
Re-cultivation along the route of the pipeline has never been carried out despite the fact that more than one year had been passed since the completion of the construction. We can observe active general erosion as a result of the construction.

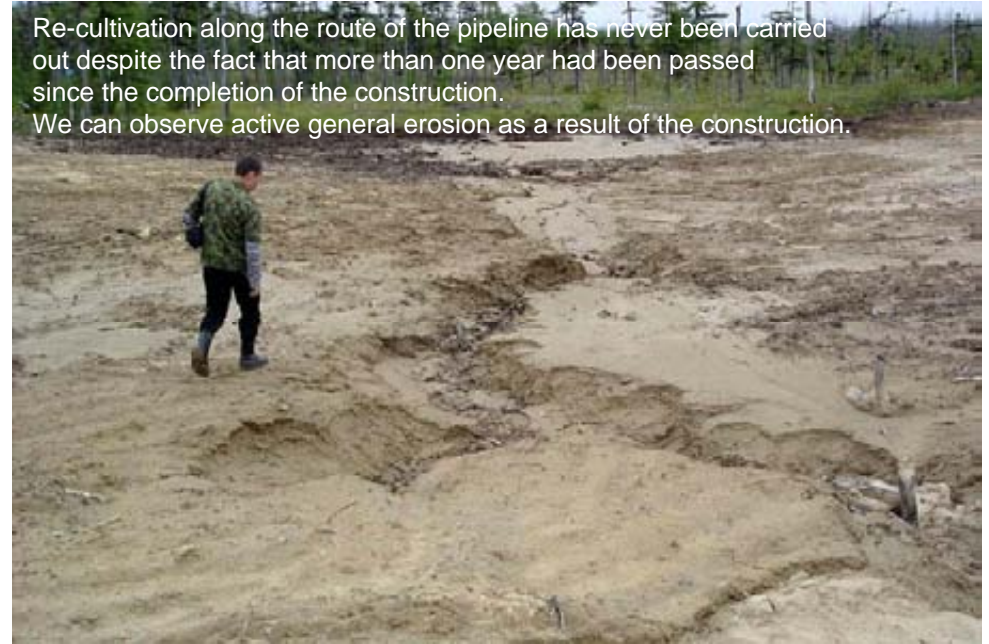
**SEIC's Pipeline (Sakhalin II pipeline project). KP 18. Upstream of the Khoyambusibin River, Nogliki District**

Negative aspects are obvious in comparison with Sakhalin I – actively developing erosion processes, protection measures are absent or do not work. July 4, 2007.

Deep erosive wash-out developed during only one season. Such processes threaten not only river ecosystems but integrity of the pipelines themselves.

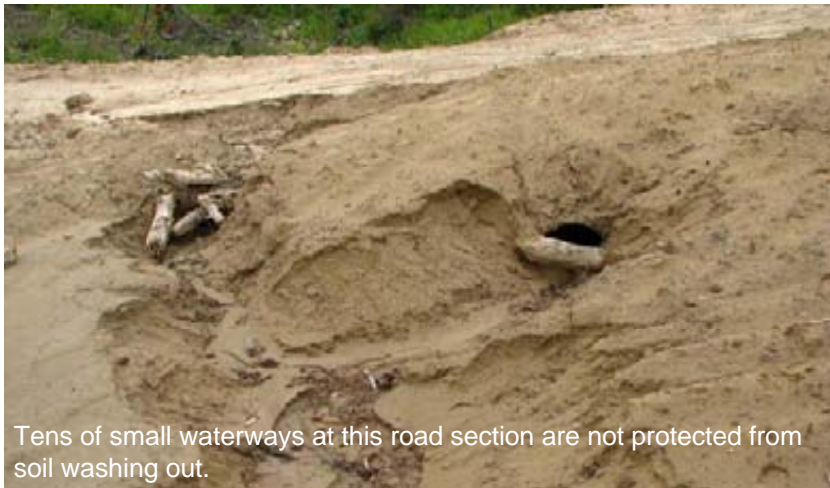
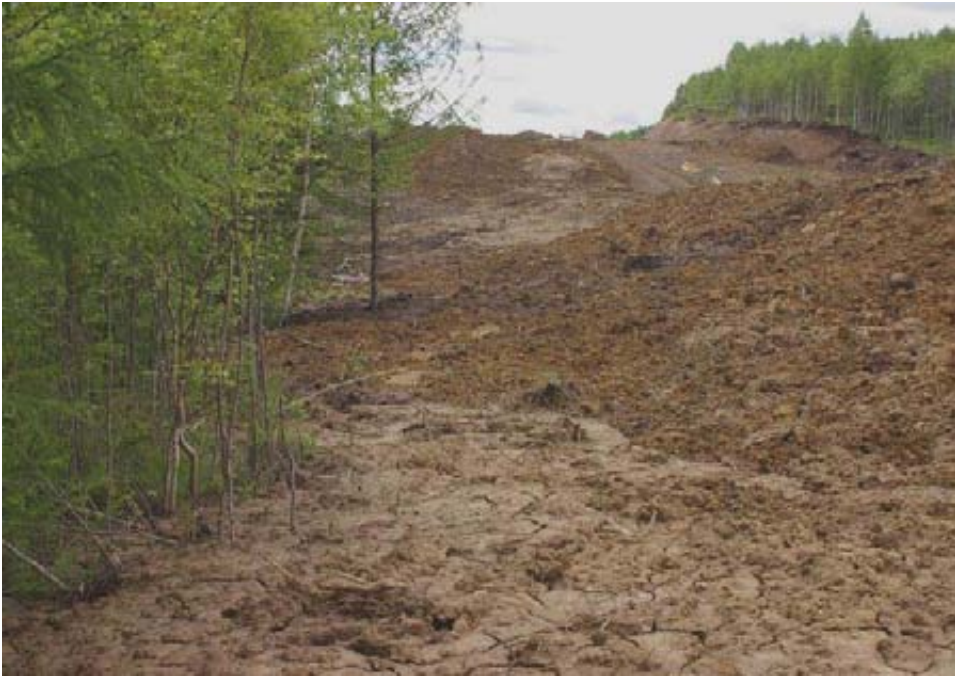
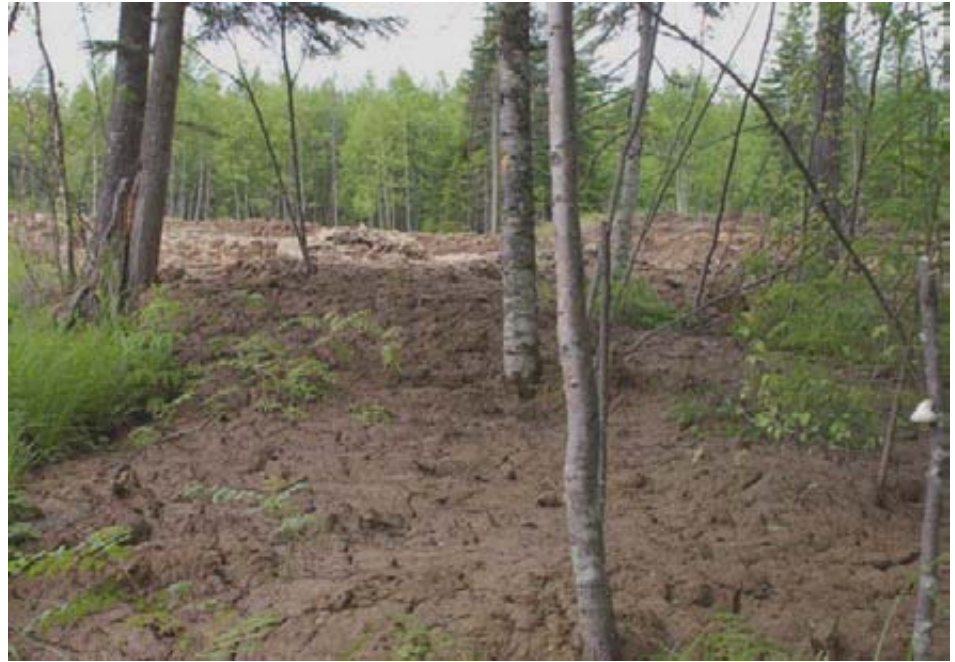
**KP 223,8. Construction of the active seismic fault pipeline crossing to the west of the Smirnykh village. Smirnykh District.**

When it is raining, soil refuses, located outside of the pipe-bend, are sliding to the adjacent forest areas.  
*July 3, 2007.*

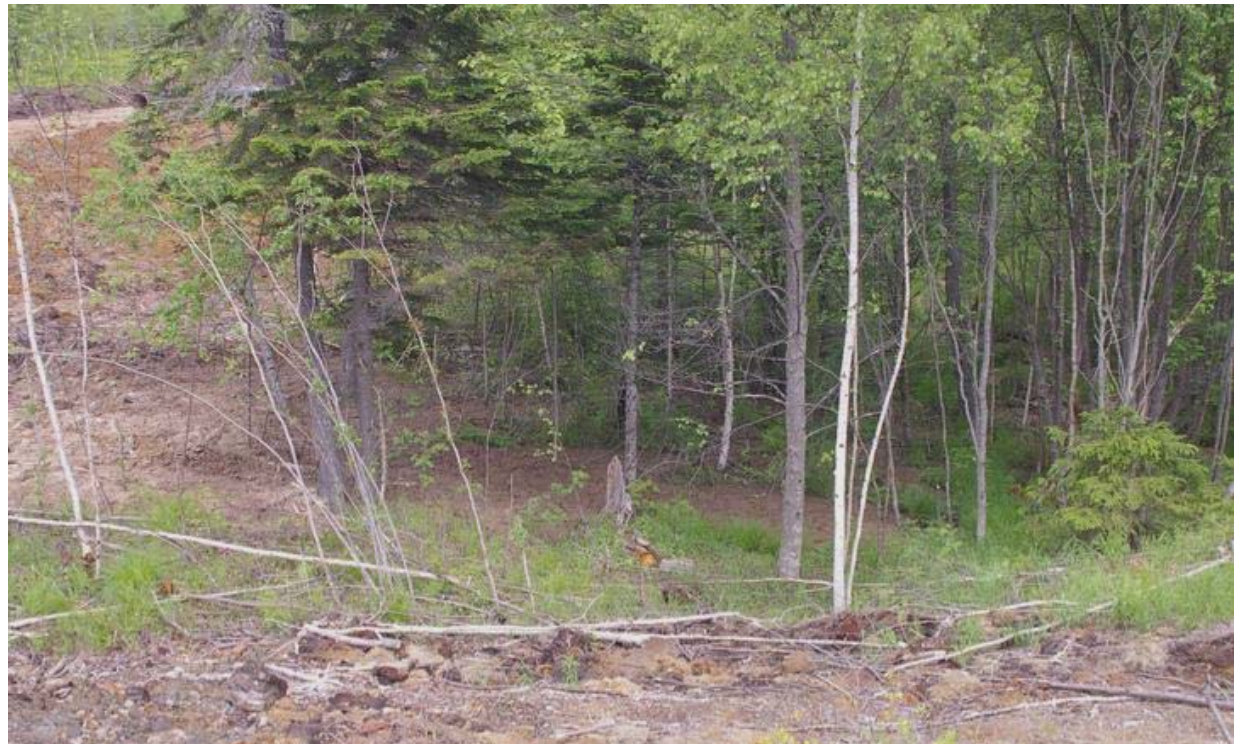
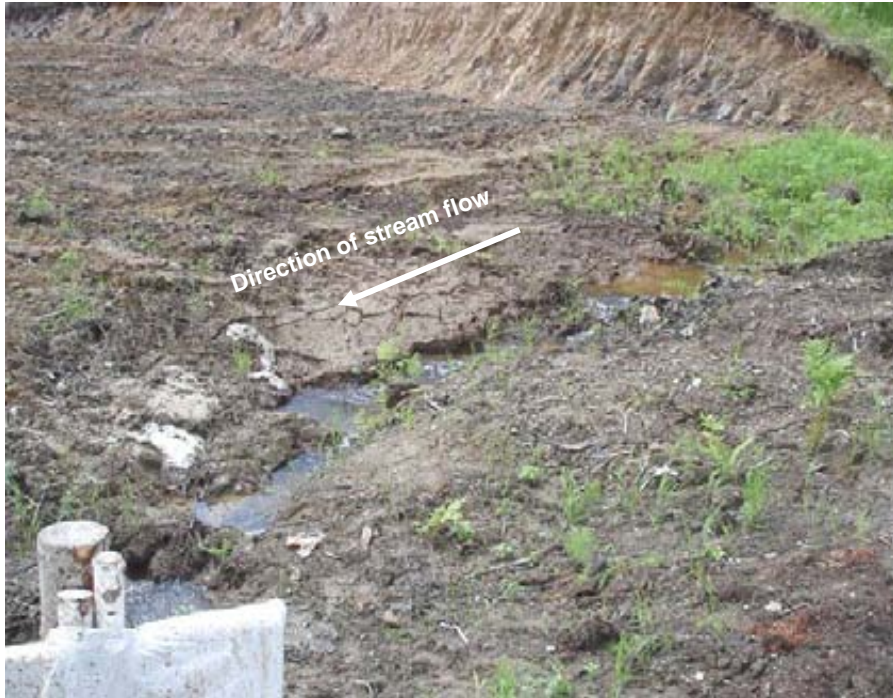
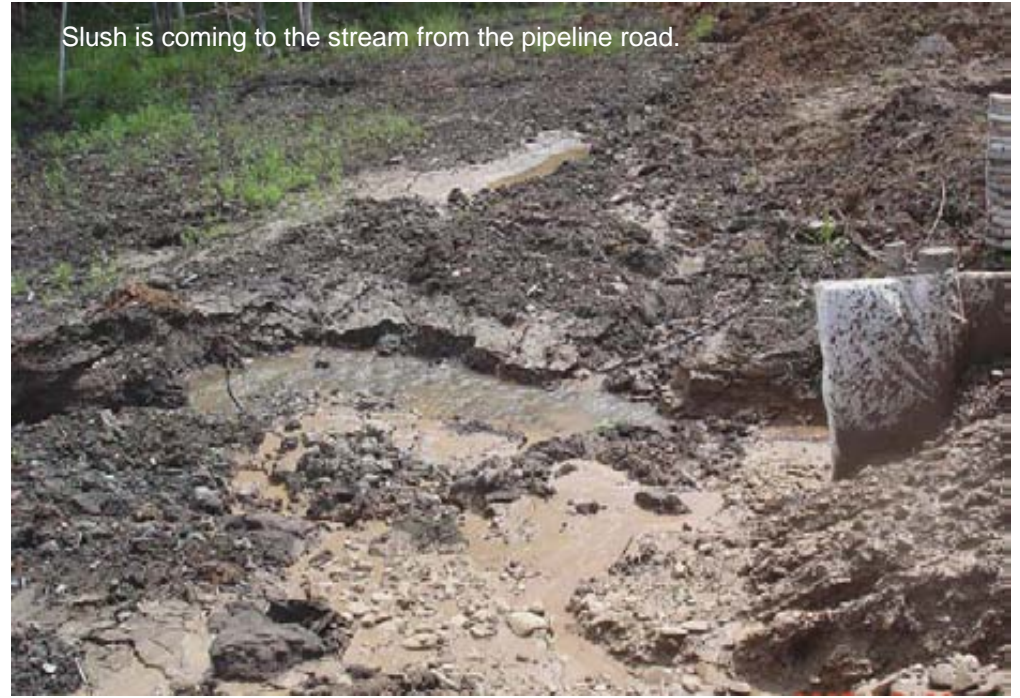
**KP 223,8. Construction of the active seismic fault pipeline crossing to the west of the Smirnykh village. Smirnykh District.**

This section has become a source of pollution of waterways because of the absence of anti-silt screens and other protection measures. *July 3, 2007.*

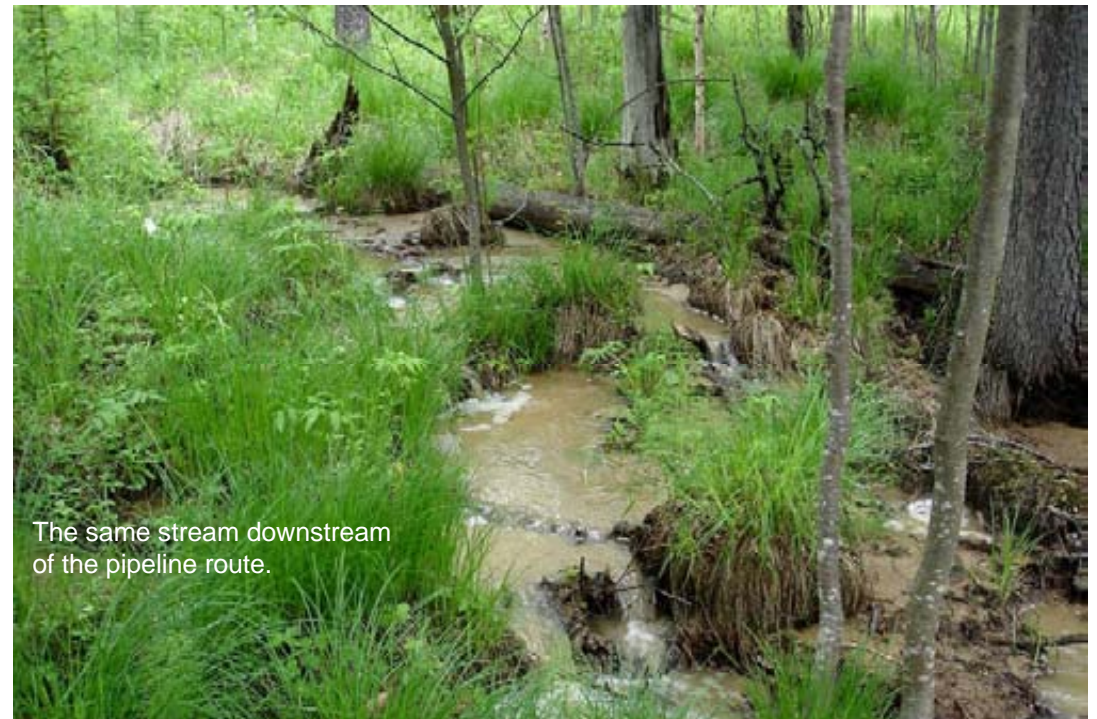
The same stream downstream of the pipeline route.

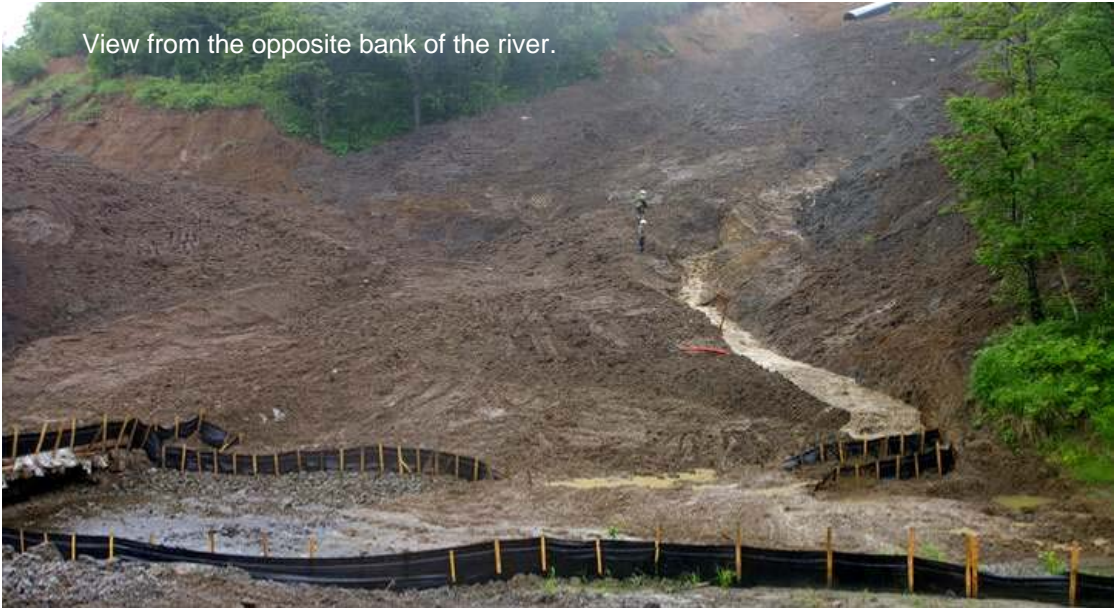
View from the opposite bank of the river.

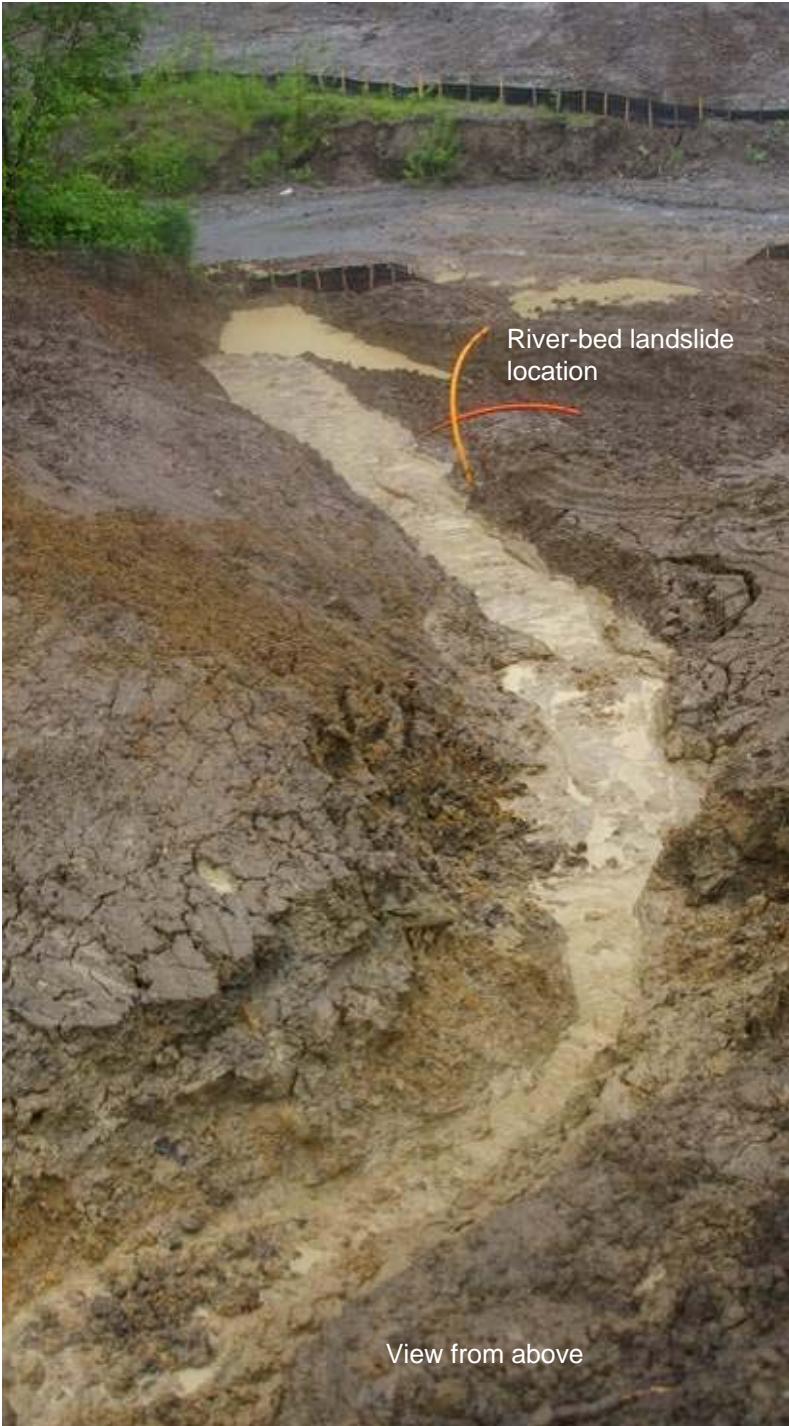
**KP 348,5. Place of crossing of Krynka River by pipelines route. Makarov District.**

Landslide-stream, moving down the pipeline route (over the gas pipe) to the bed of the spawning Krynka River. View from three sides. At the time of inspection slush was sliding down with the speed of 20 sm per minute. July 2, 2007.

River-bed landslide location

View from above

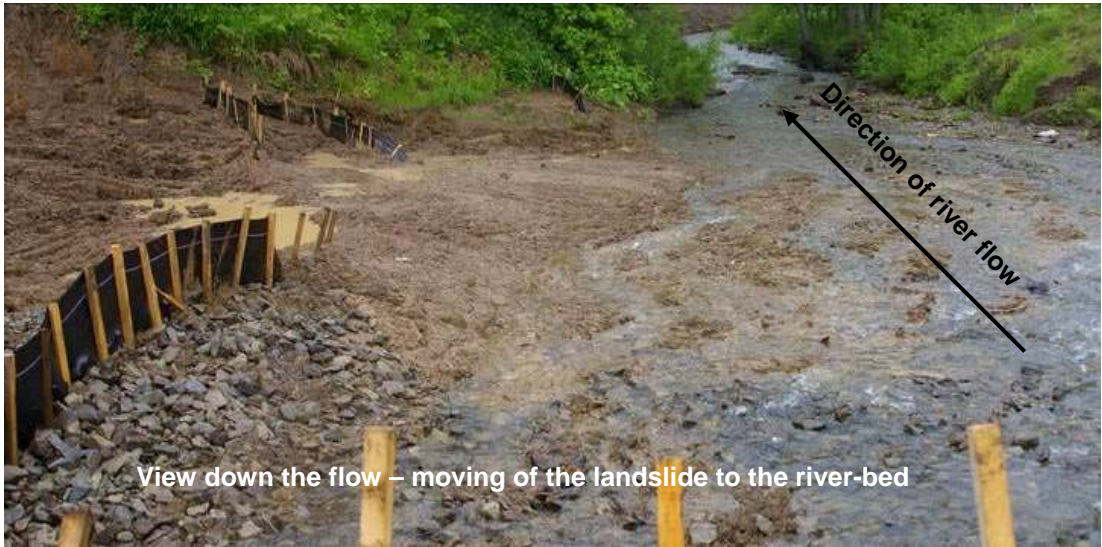
View down the flow – moving of the landslide to the river-bed

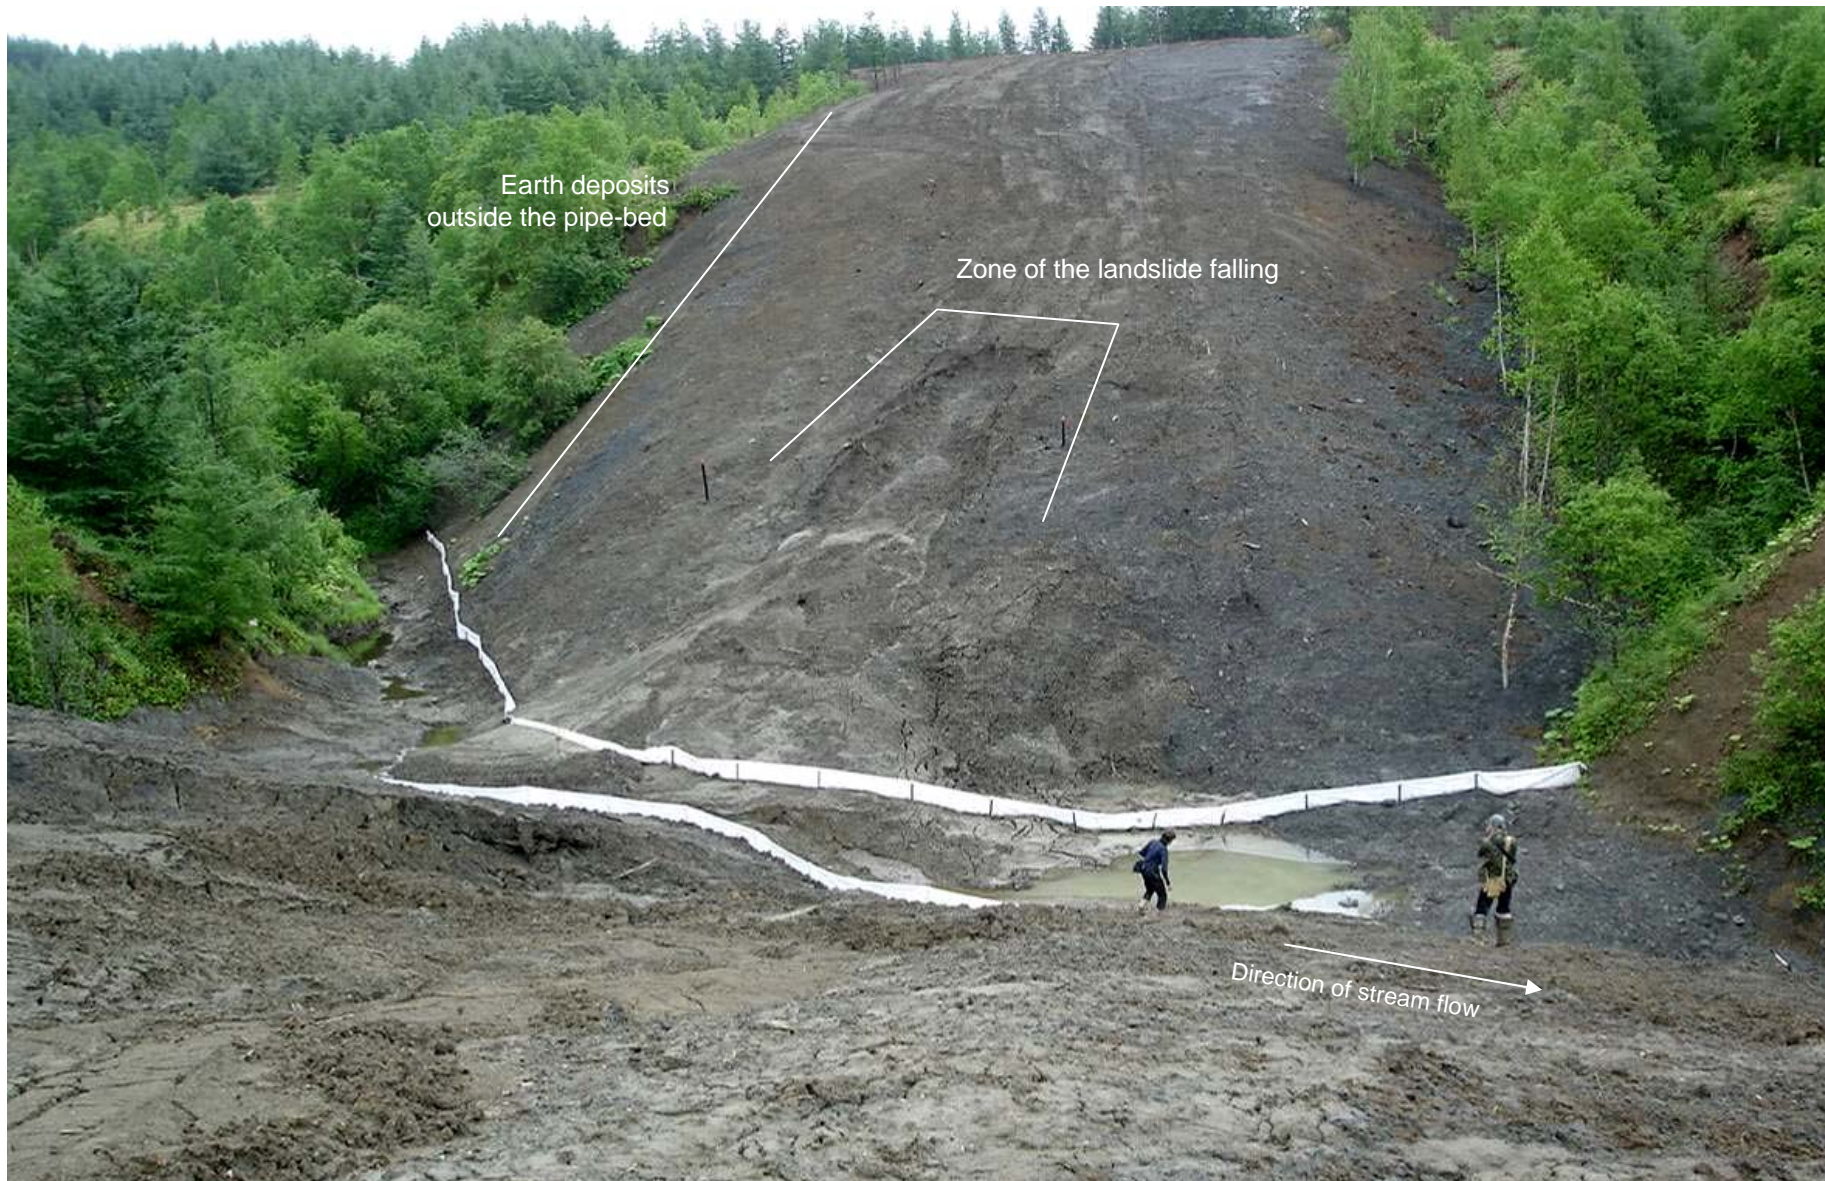
**KP 461,0. The landslide on the left bank of Krasnaya River. Dolinsk District.**

A large scope of backfilling soil over the laid pipes slid into the stream, shutting off water flow. Volume of the landslide is about 300 m<sup>3</sup>. For some purposes, silt catching barriers were placed directly on the «body» of the landslides which was still moving. Construction in this area has been completed more than one year ago, however final re-cultivation has not been completed. *July 2, 2007.*

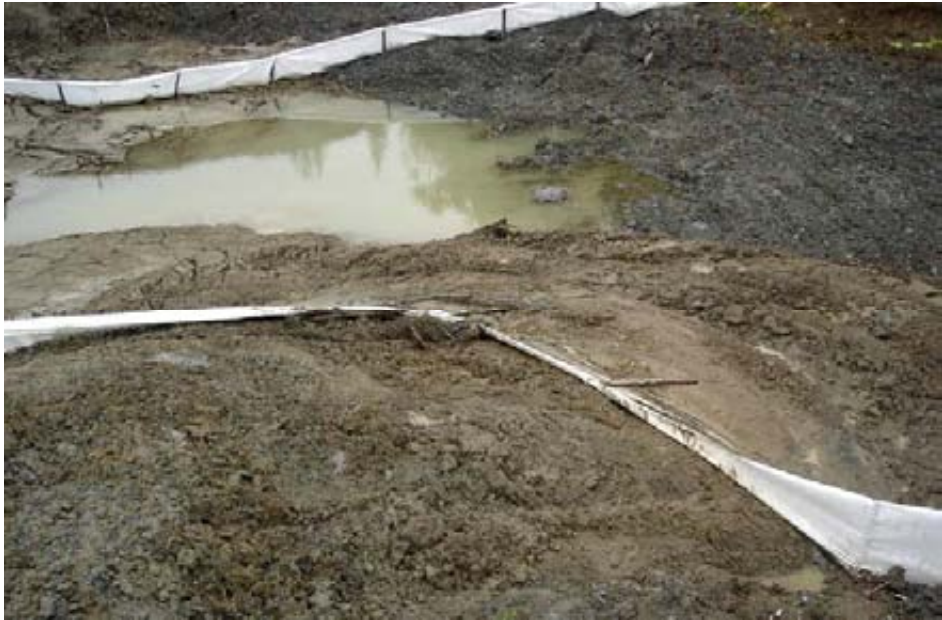
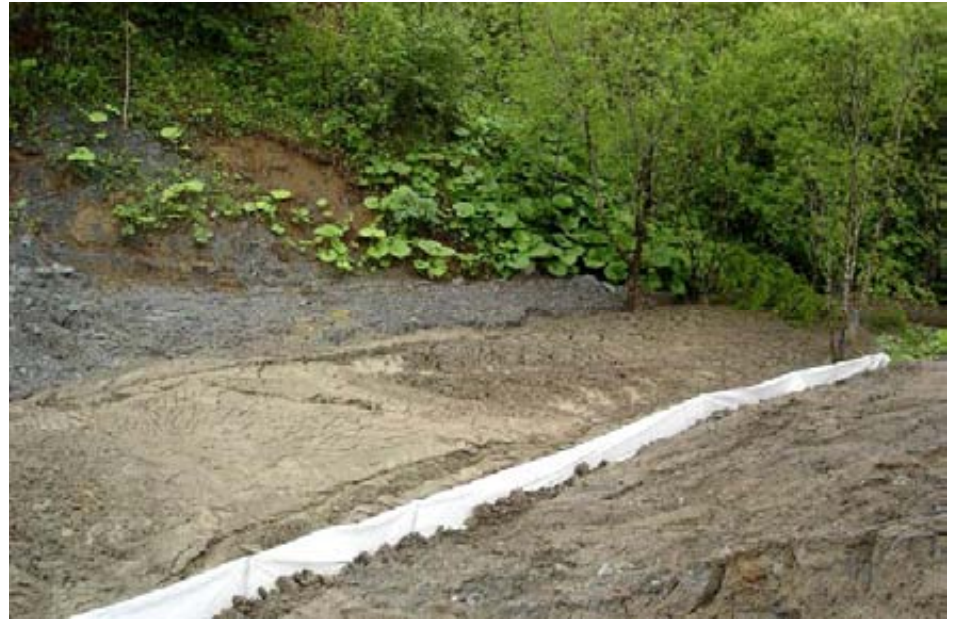
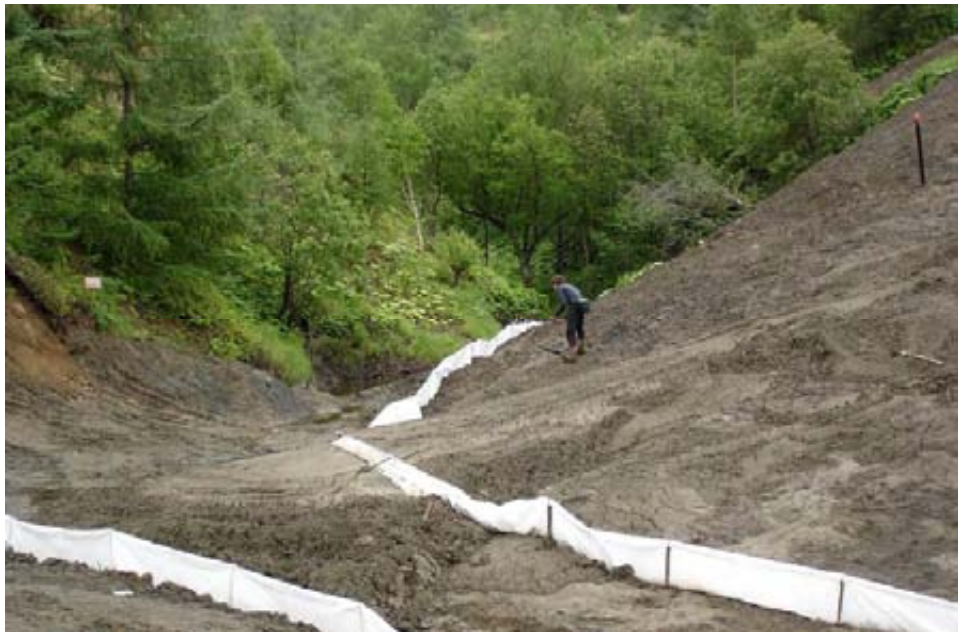
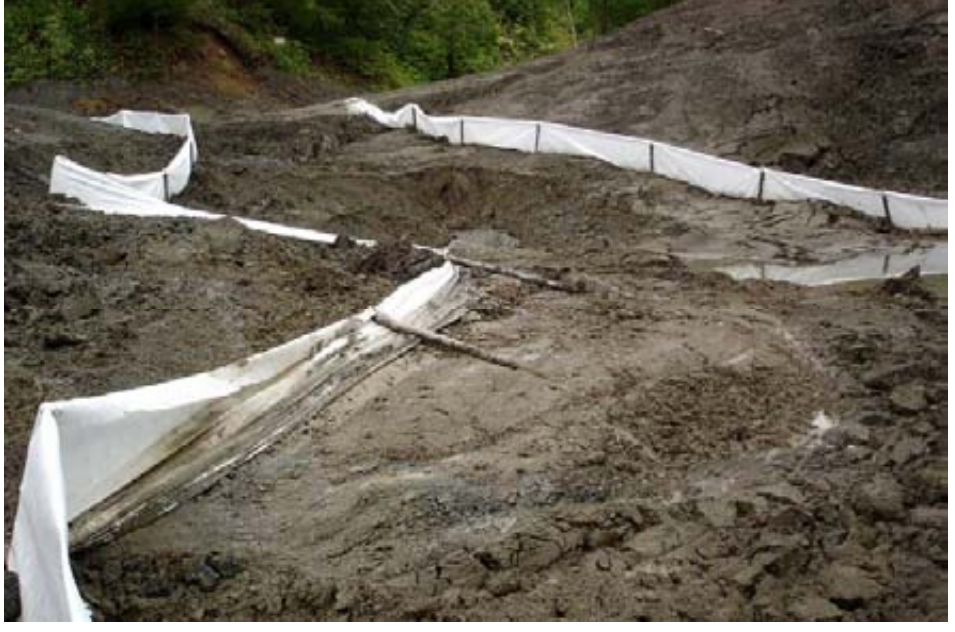
**KP 461,0. The landslide on the right bank of Krasnaya River (the same place as on the previous slide). The photos above and below show that silt protection screens made of geotechnical fabric are mounted directly on the moving “bodies” of the landslides moving to the waterways. Photo above to the right - there is slush moving instead of the water. *July 2, 2007.***

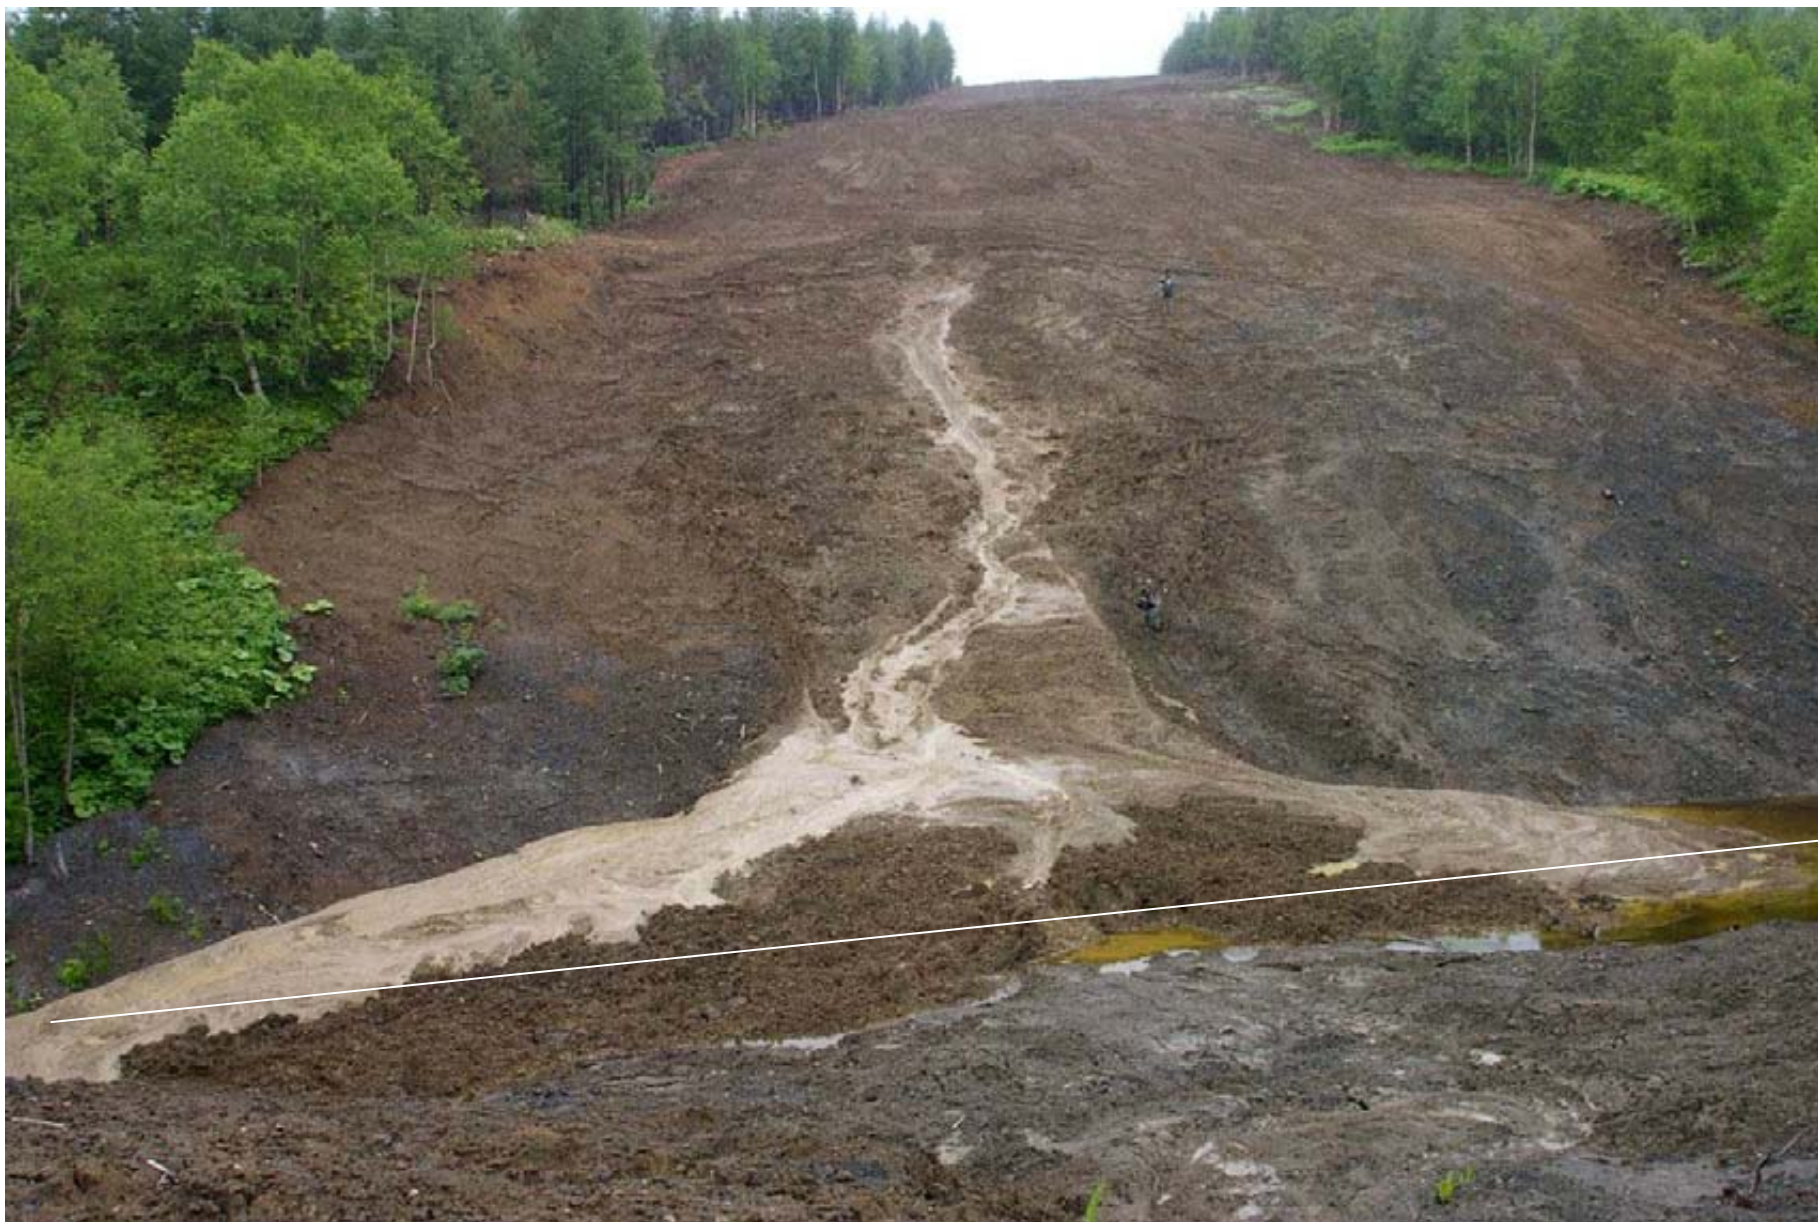
**KP 462,6. A landslide on the right bank of the left tributary of the Baklanovka River, Dolinsk District.**

Former stream-bed is marked by the white line. For the time of inspection the soil kept sliding down slowly. The construction works are over more than one year ago but the stabilization of the slopes and route re-cultivation has not been completed. Landslide protection works are absent. *July 2, 2007.*

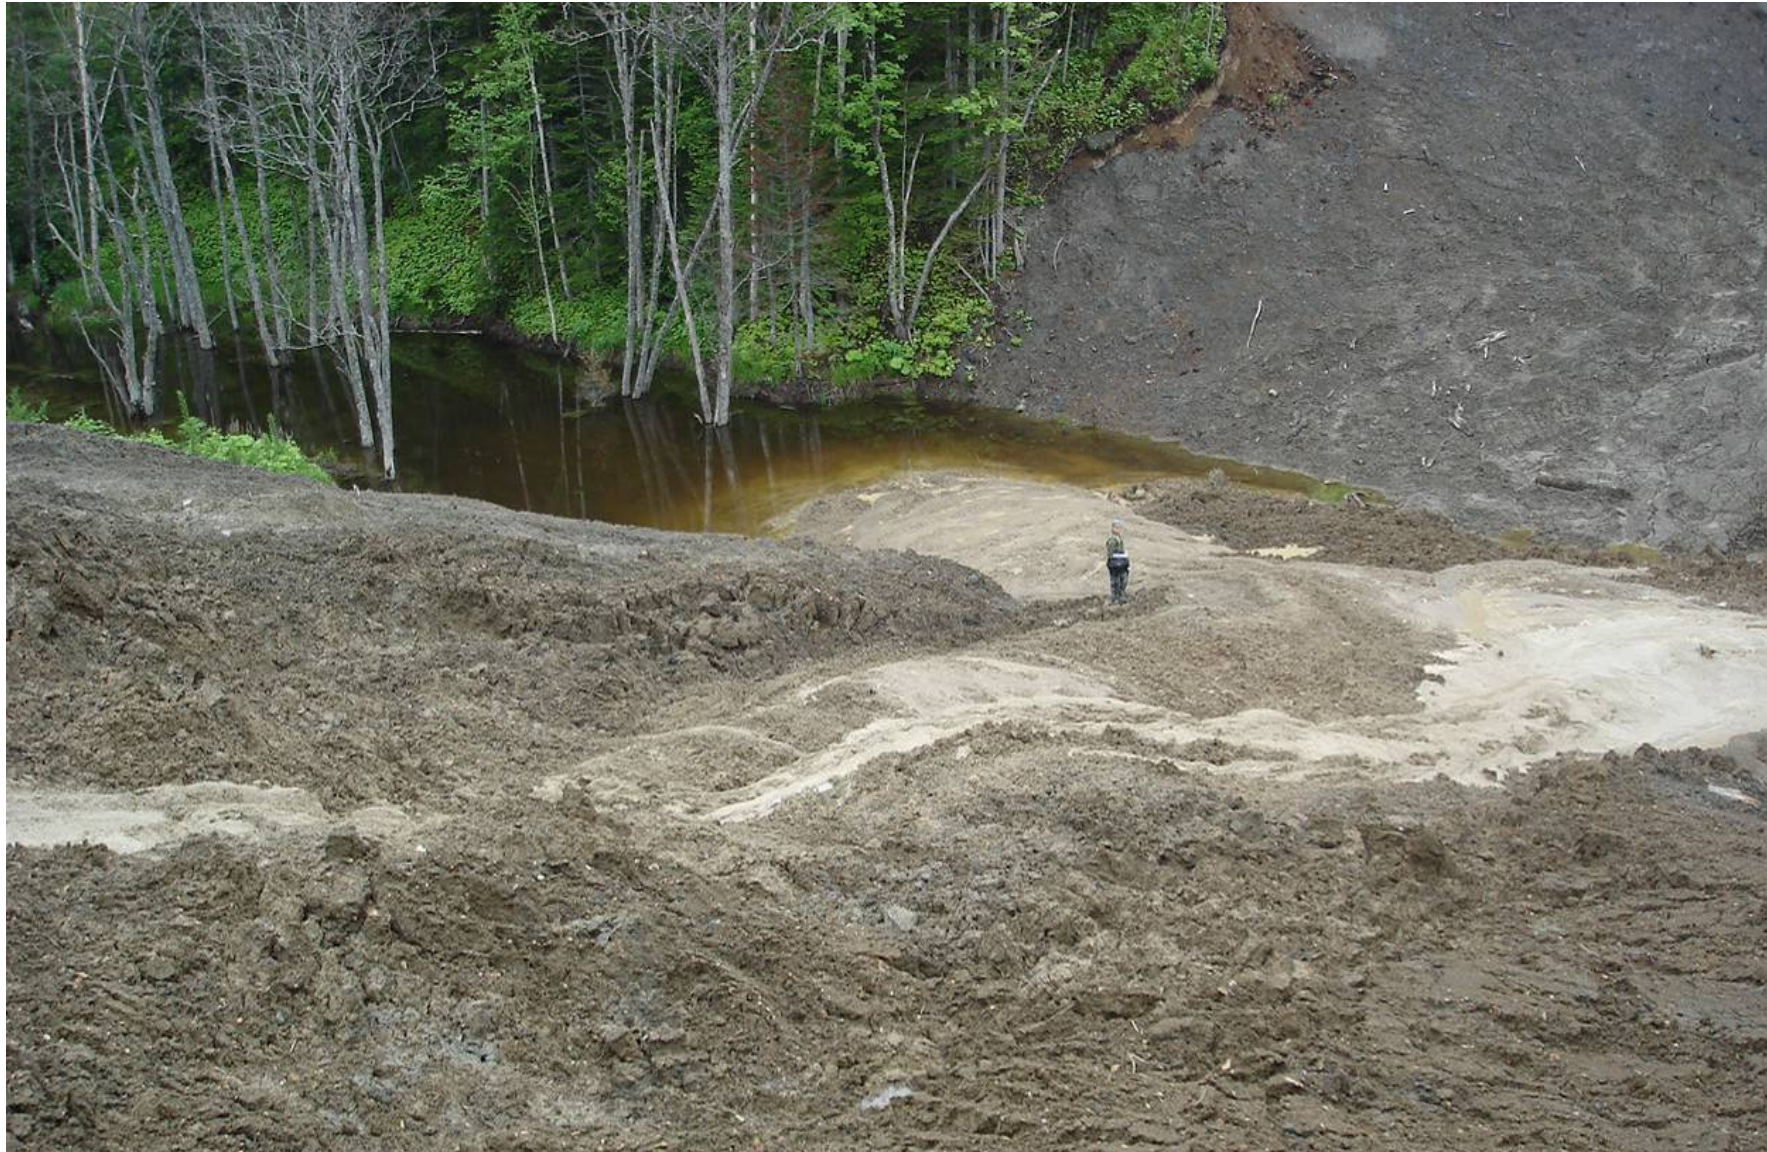
**KP 462,6. A landslide on the right bank of the left tributary of the Baklanovka River, Dolinsk District.** (the same place as on the previous slide). The landslide completely blocked the stream's bed, blocking water flow. An artificial pond has been created. Hydrological regime of the waterways was violated. Obviously, during water flooding considerable volumes of soil will be washed down the spawning Baklanovka River. *July 2, 2007.*
