# PHOTOREPORT

in accordance with findings of the public ecological inspection of  
pipelines constructions (under Sakhalin II Project)

July, 2007

Prepared by the Non-Governmental Organization Sakhalin Environment Watch

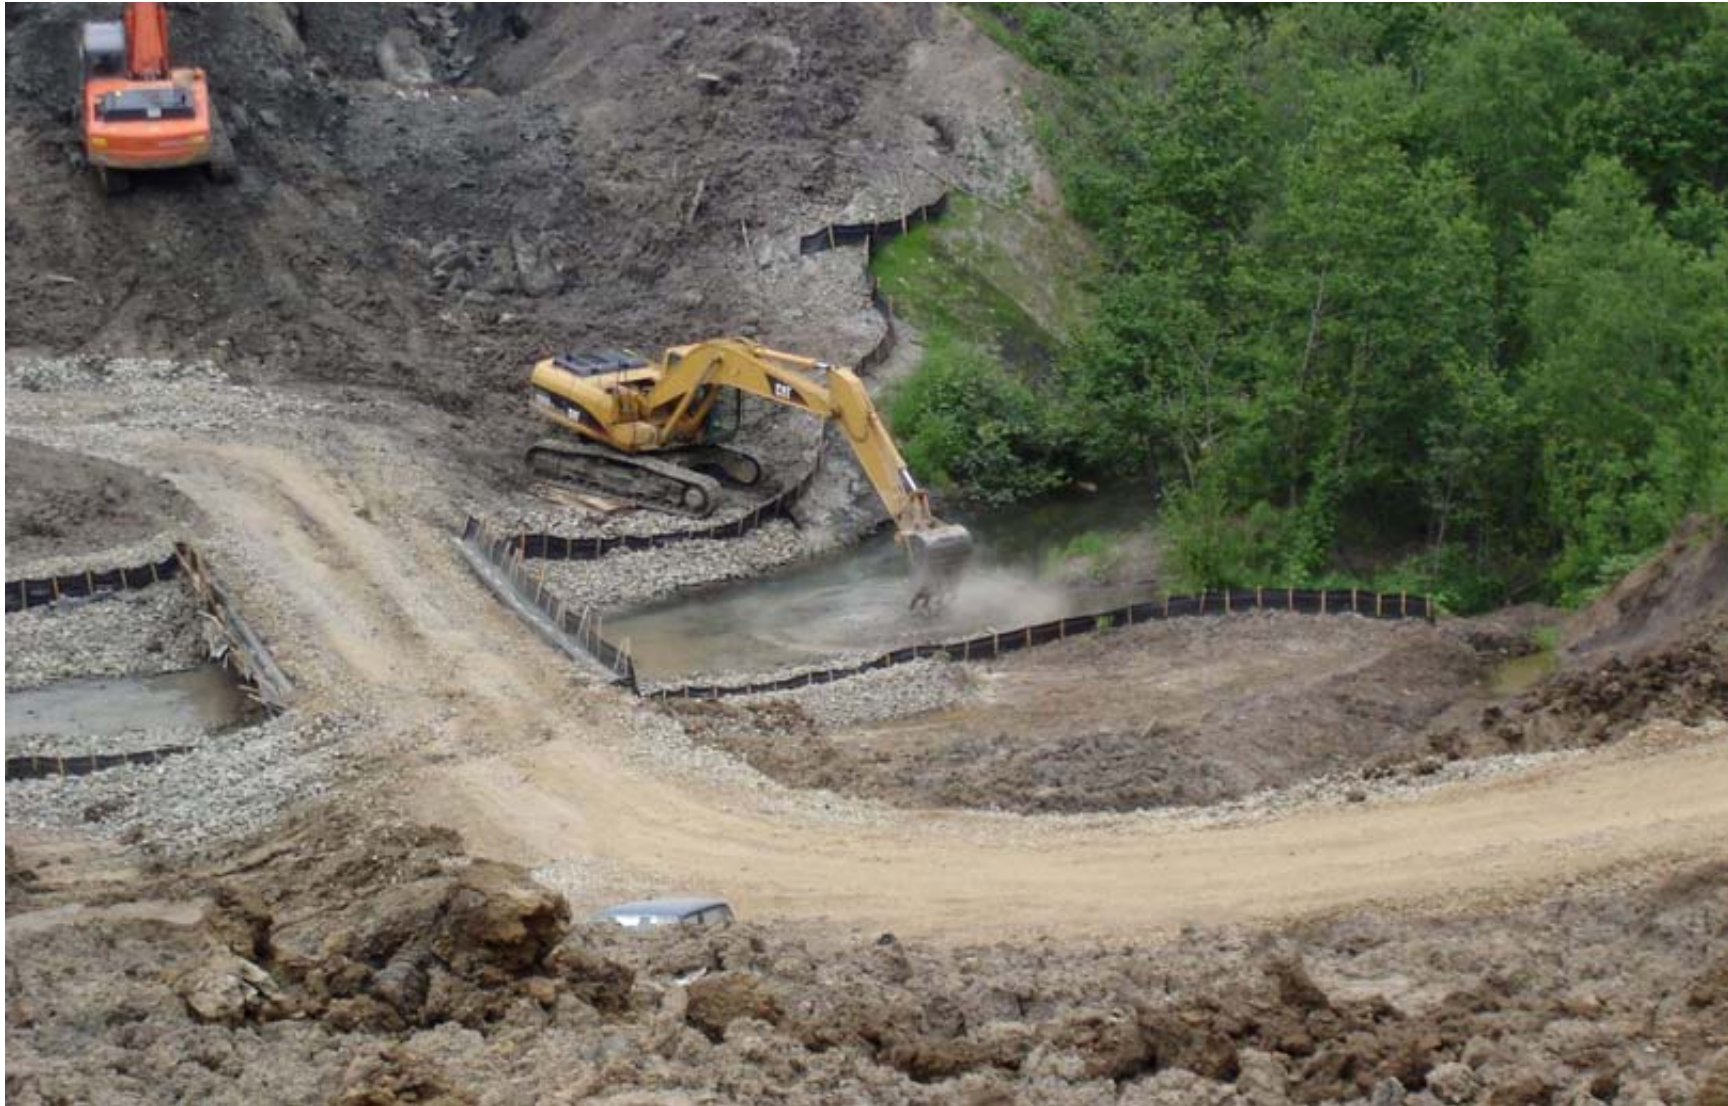
**KP 348,5. Place of Krynka River crossing by pipelines route.**

**Makarov District.** The crossing was built in winter of 2006 – 2007, however, filling of the river bed with crushed stone the constructors are doing at the beginning of July, 2007 – at the beginning of entrance of salmon for spawning. The water quality in the river consequently drastically worsened. *July 7, 2007.*

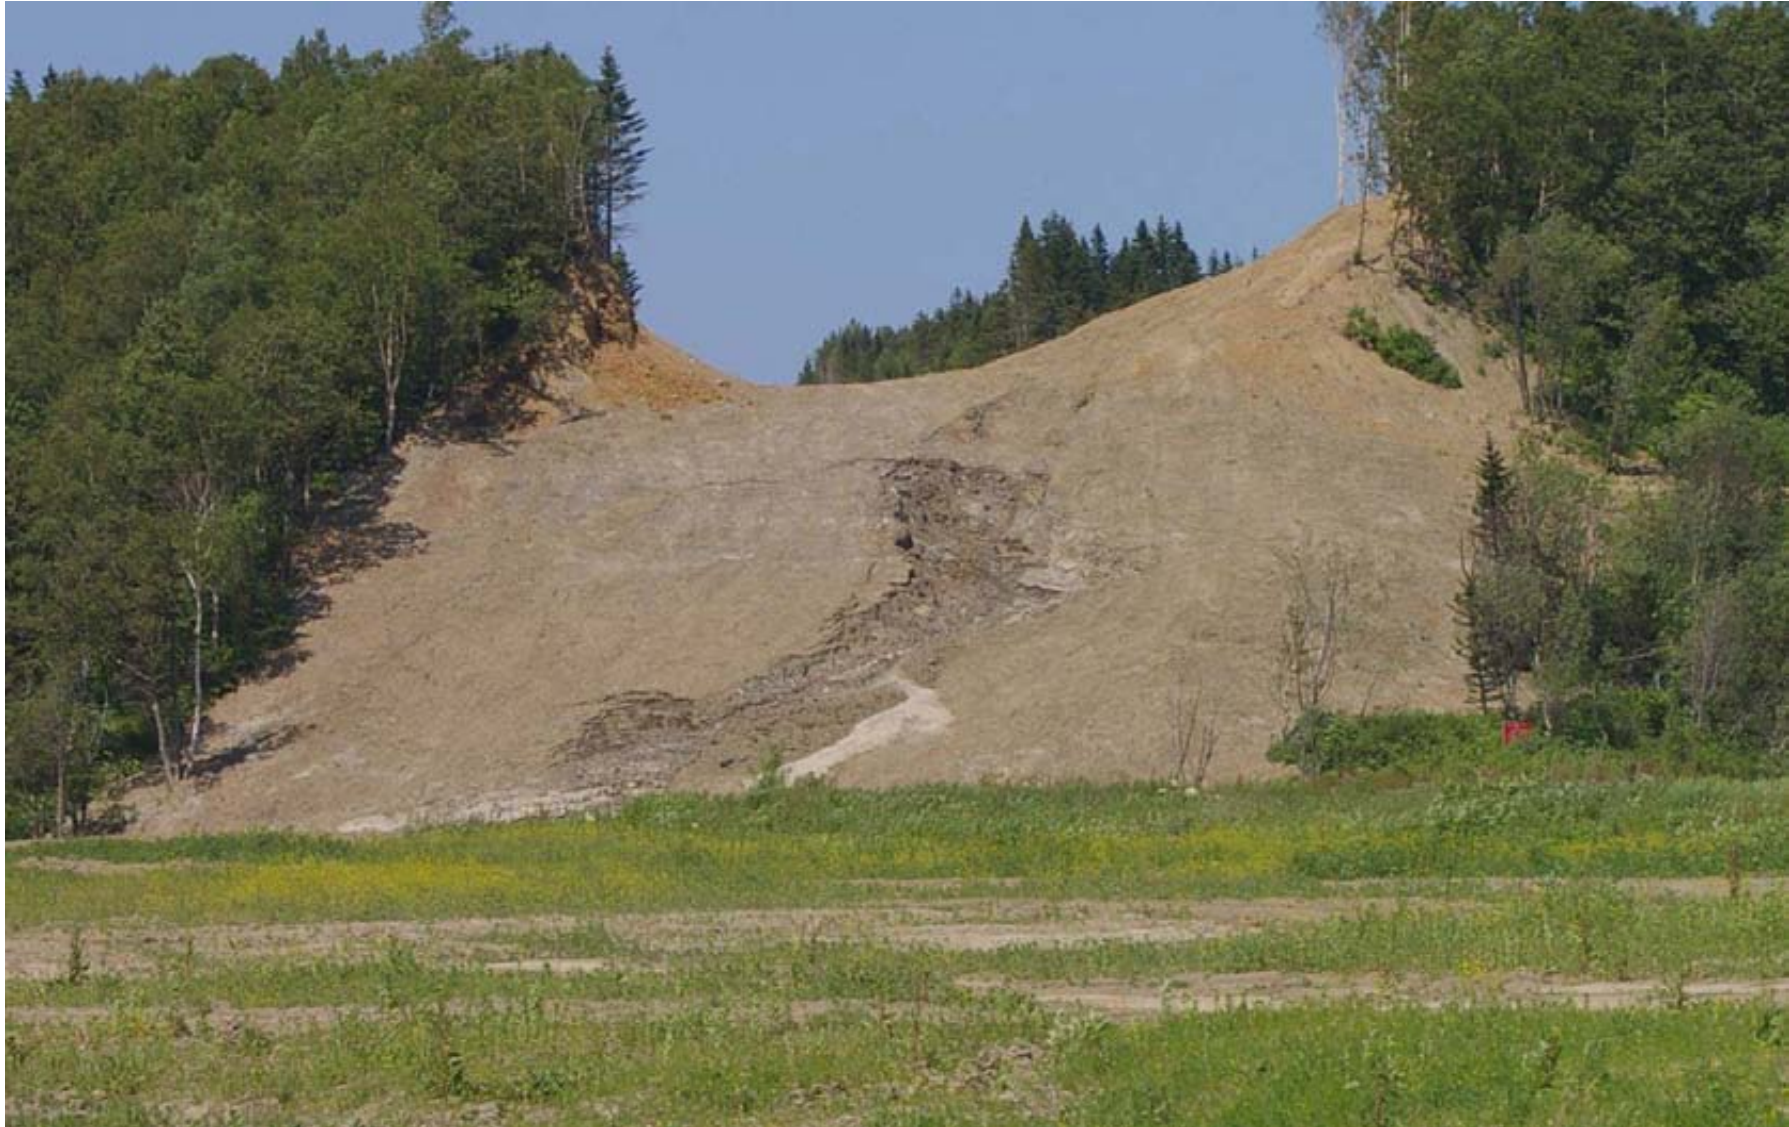
**KP 504,7. Road section to the north of Ay River. Dolinsk District.**

In the middle of October, 2006 a helicopter landed here with the Commission of the Ministry of Protection of Natural Resources headed by Yu.Trutnev, Minister of the Natural Resources. Since that time the landslide above the pipelines formed on this slope, which results in pollution of the stream flowing under the the slope, which empties into Ay River, and constitutes a danger of an accident in case of damage of the pipelines. *July 14, 2007.*

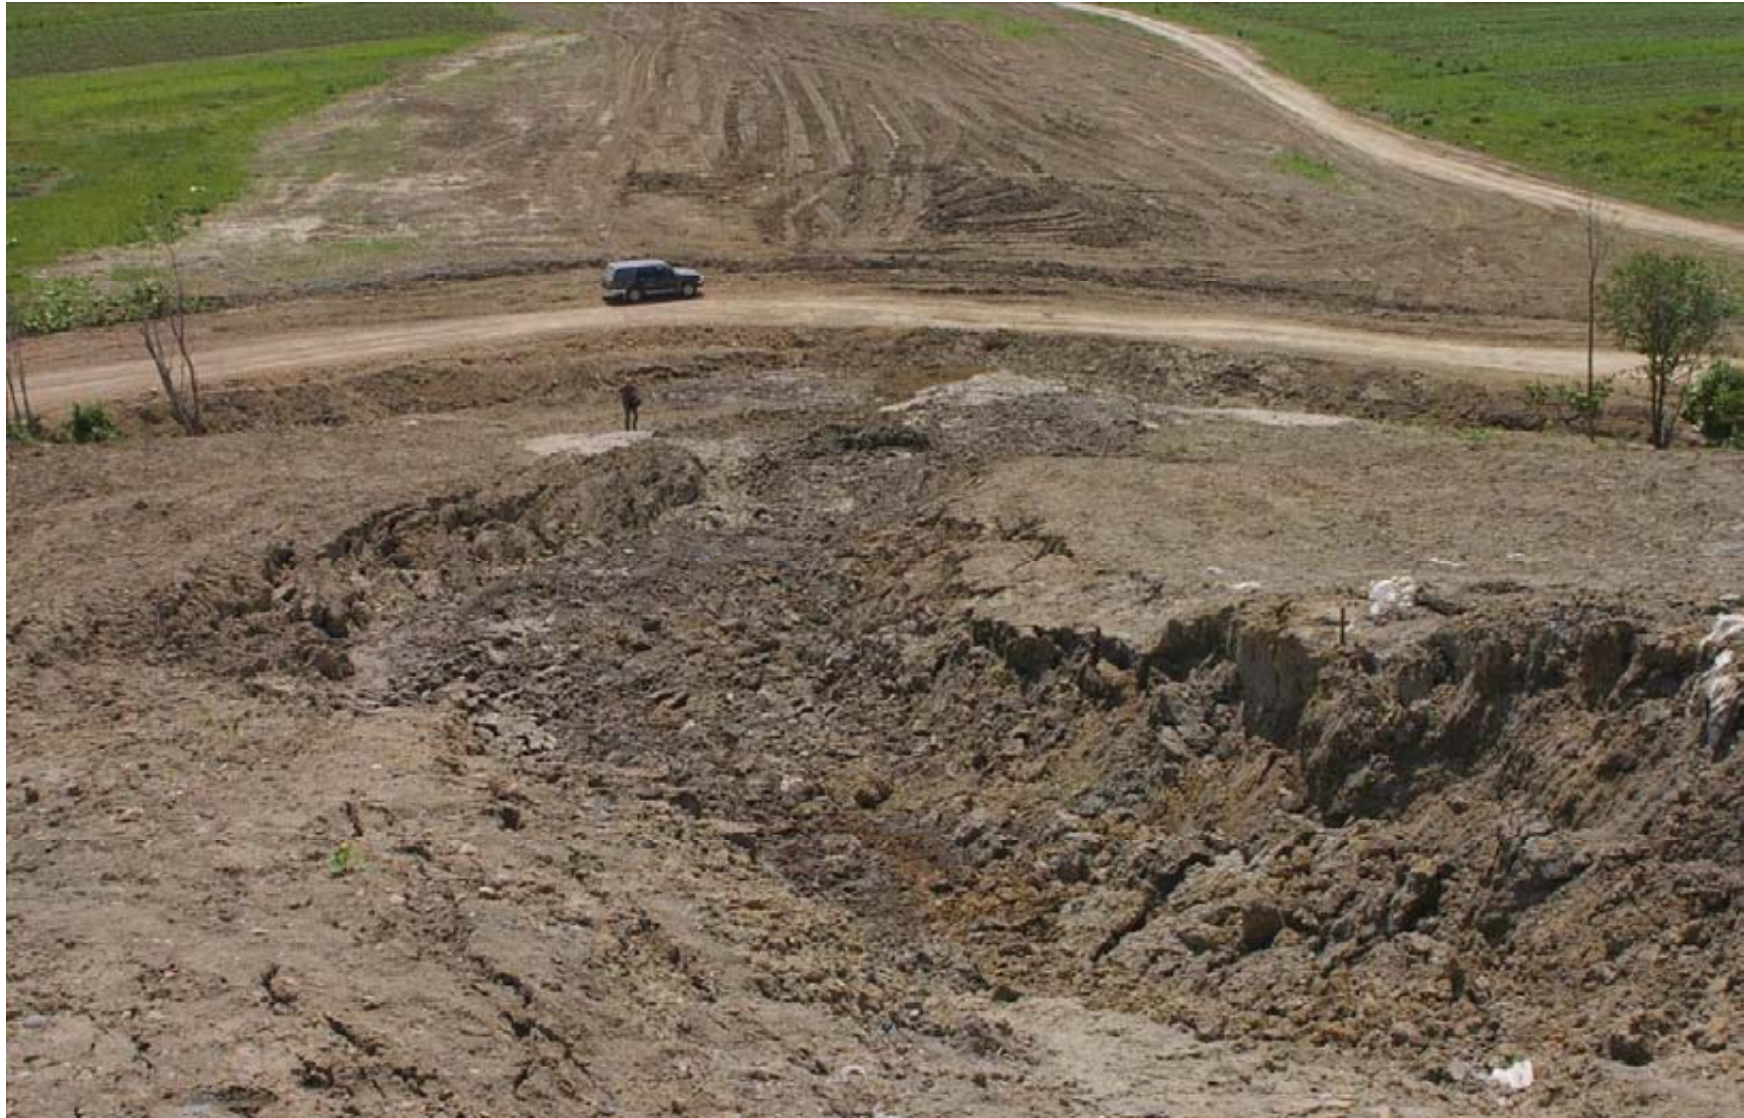
**KP 504,7. Road section to the north of Ay River.** (the same place as on the previous slide).

View overlooking the landslide falling zone. Despite of the fact that the works on pipelines laying down were completed more than one year ago, re-cultivation of the route was not made, landslide protection measures were not taken. *July 14, 2007.*

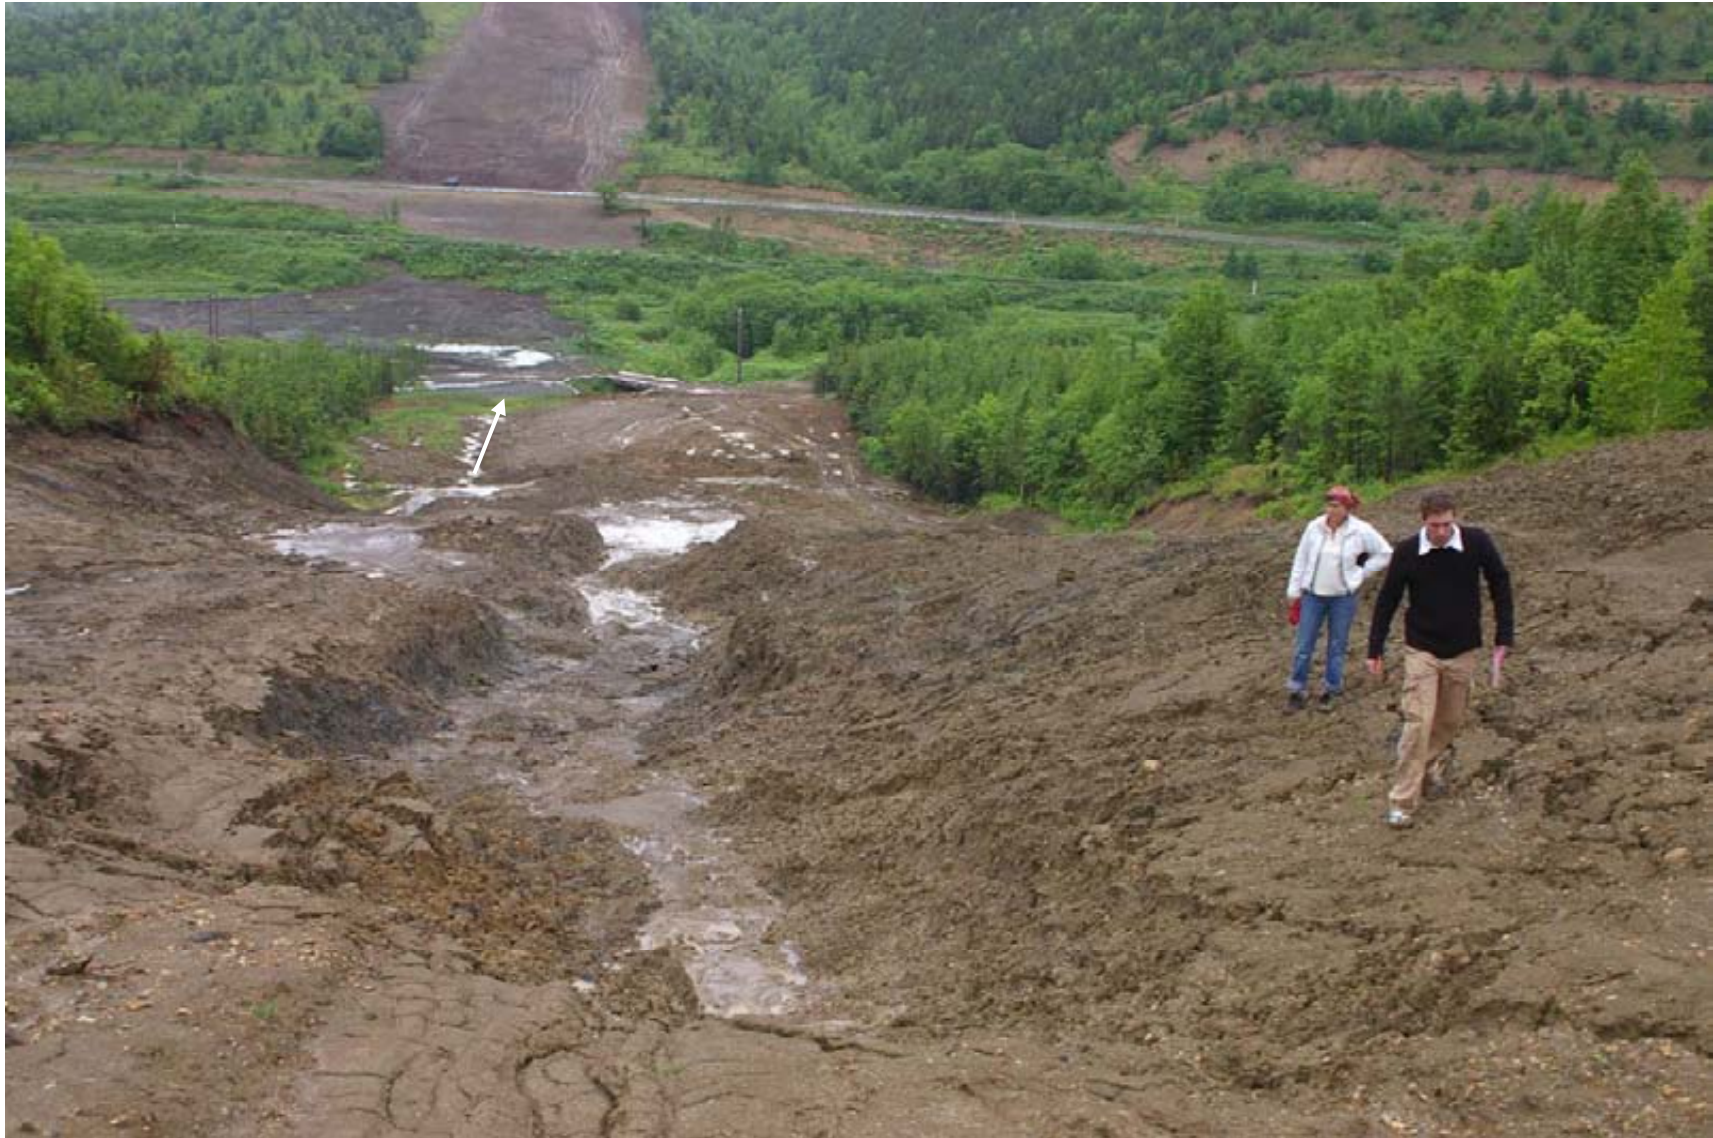
**KP 460,5. The landslide on the slope to the north from the crossing of the Krasnaya River. Dolinsk District.**

Trench dug by the landslide during several month of its existence became deeper and is filled by slush when it is raining. Due to this, the landslide-stream is penetrating buried pipelines. In the background one can see a stream of slush flowing down to the Krasnaya river (marked by the arrow). *July 22, 2007.*

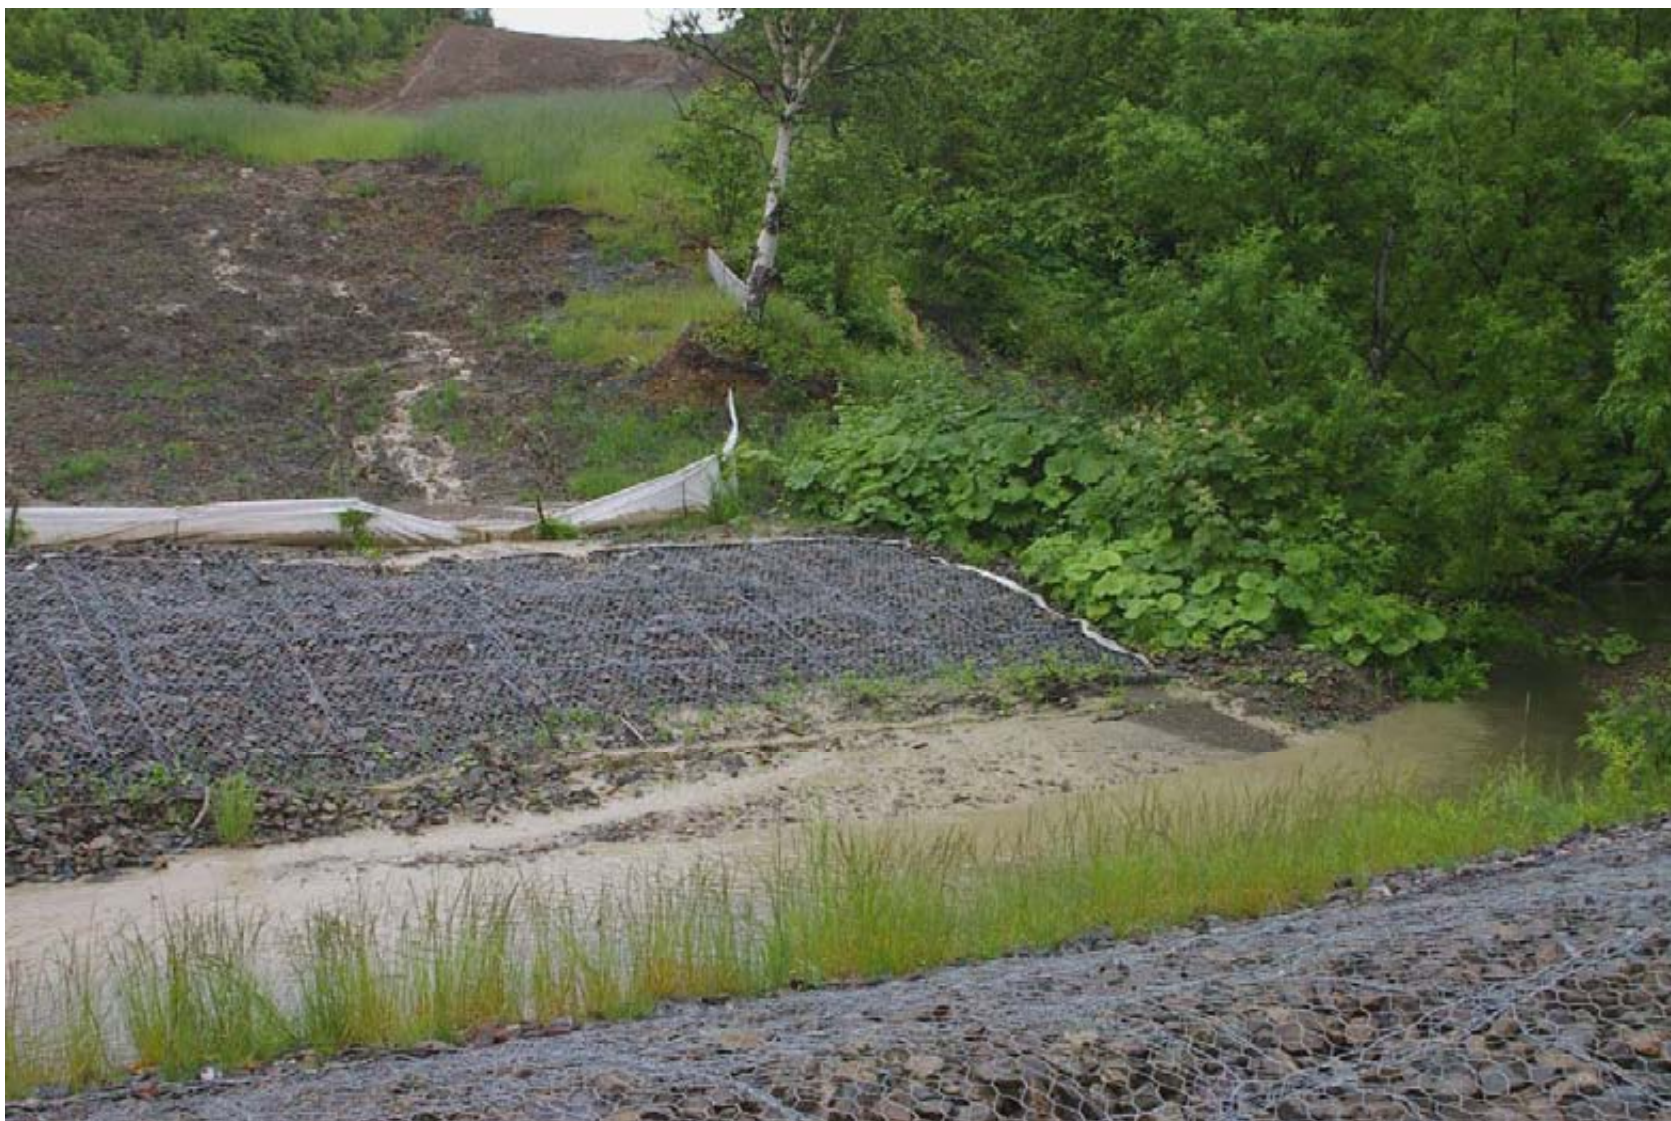
**KP 460,2. Krasnaya River crossing. Dolinsk District.**

Silt protection screens are absolutely ineffective when it is raining – mudflows (from the side of the landslide) are flowing from the pipeline RoW to the spawning Krasnaya River and the water is quickly saturating with suspended solids, which affects negatively salmon coming for spawning. *July 22, 2007.*
