Administration of Rosprirodnazor
(Federal Service for Supervision of Natural Resource Usage)
of Sakhalin Region

Photo-supplement attached to Act 01/22-LK:
Scheduled review of the fulfillment of legislation requirements
by LLC “Starstroj” during the construction of the main
pipelines for “Sakhalin II” project in the Makarov District
of Sakhalin Region

July 26, 2007

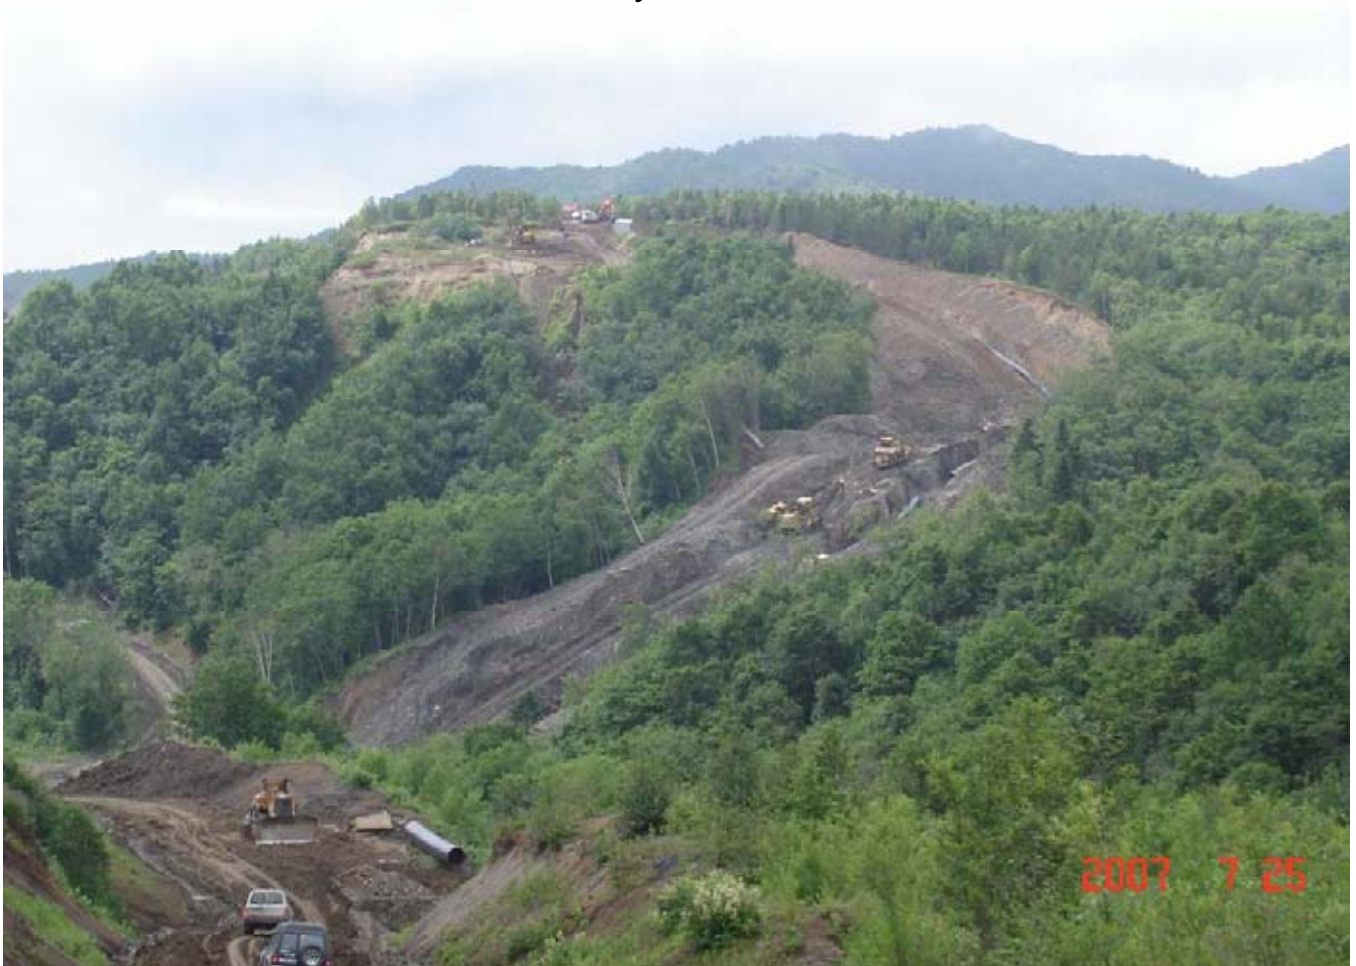
A general view of work during the laying of the gas pipeline in the area of the river-crossing over Krinka River. The location of the river-crossing is at KP 348.5. The Krinka River is a reservoir of the highest (special) category in terms of fisheries value; the area for salmon spawning that was in range of the river-crossing until the start of construction consisted of 315 m².

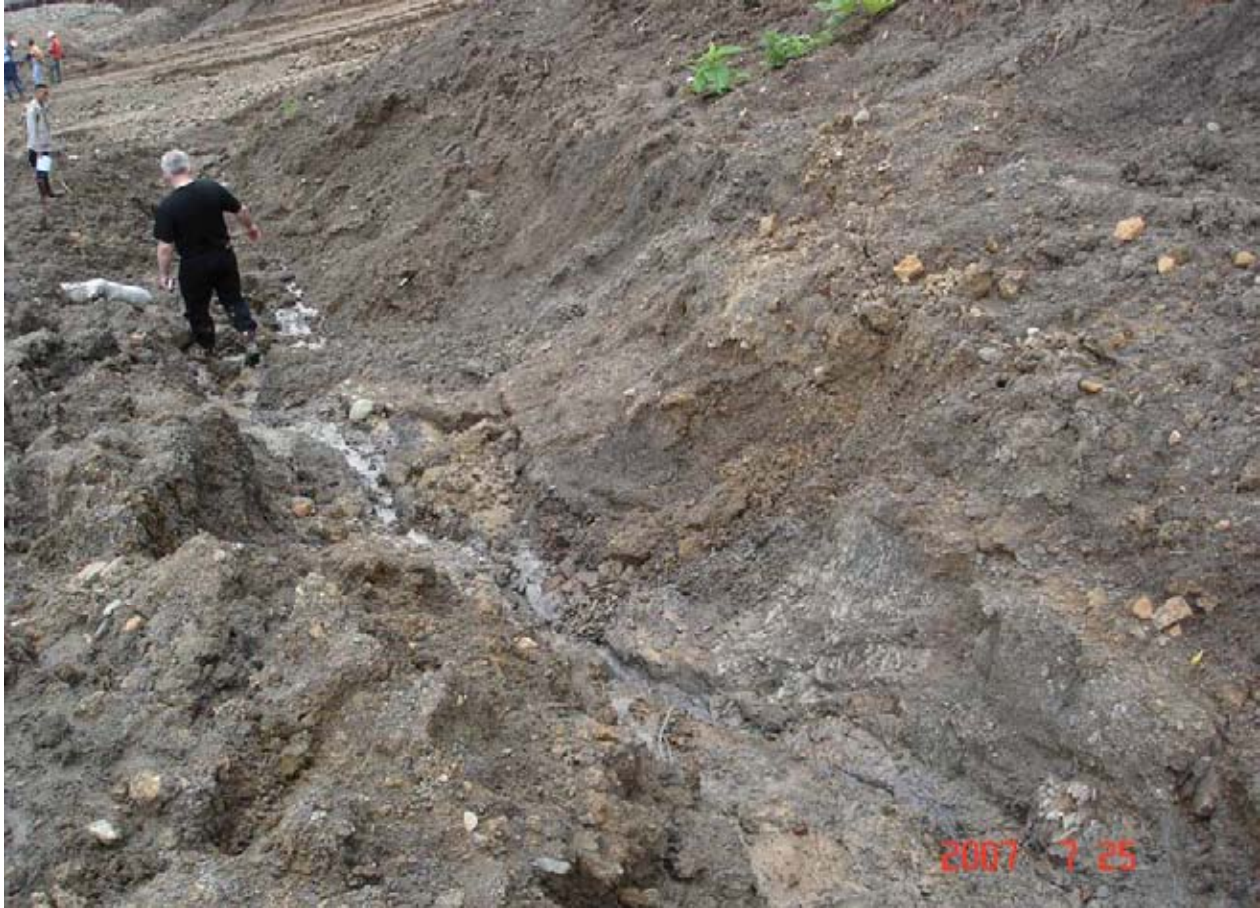
Left shore of the Krinka River, river valley slope. Active erosion processes on the pipeline route. Excavation in this section has been going on since 2005, although anti- erosion measures on the slope have been absent during this entire time.

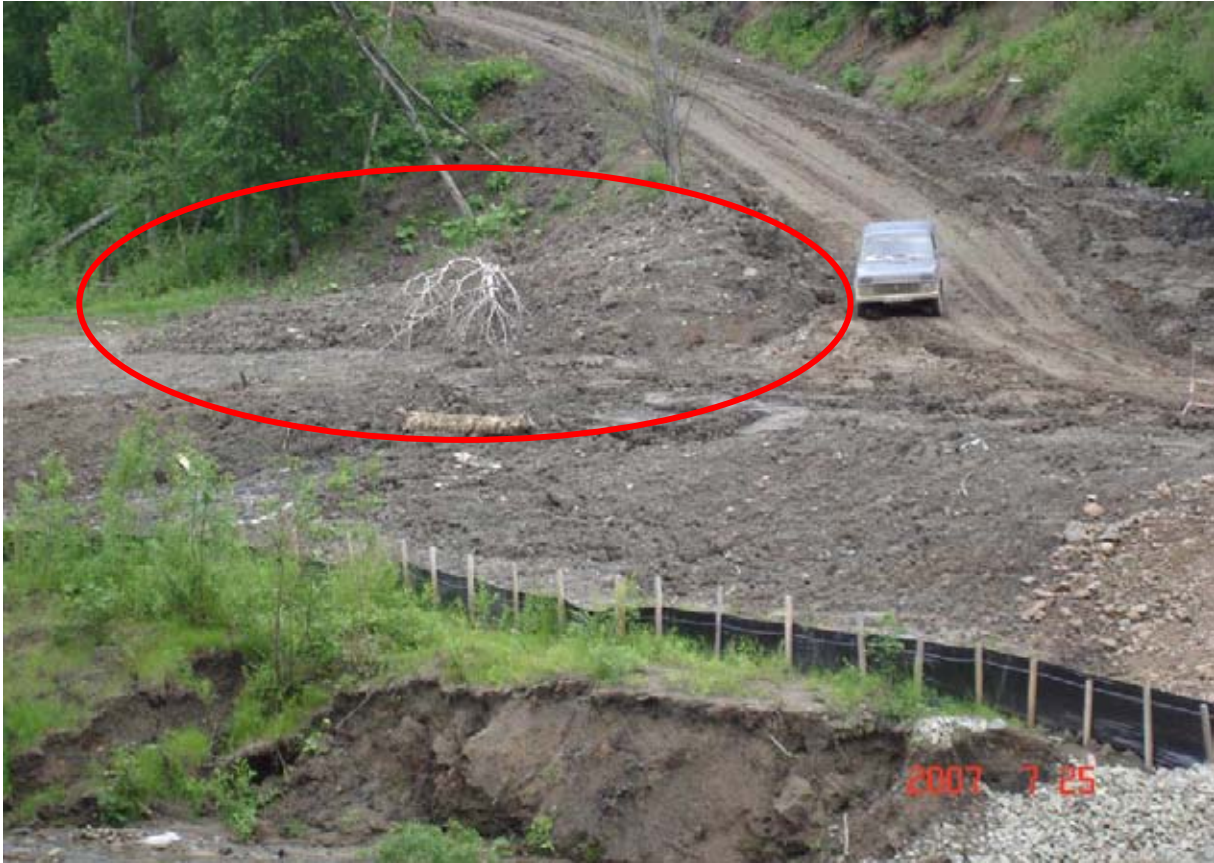
Right shore of the Krinka River. Disposal of easily-eroded waste construction soil on the protected shoreline zone of the river.

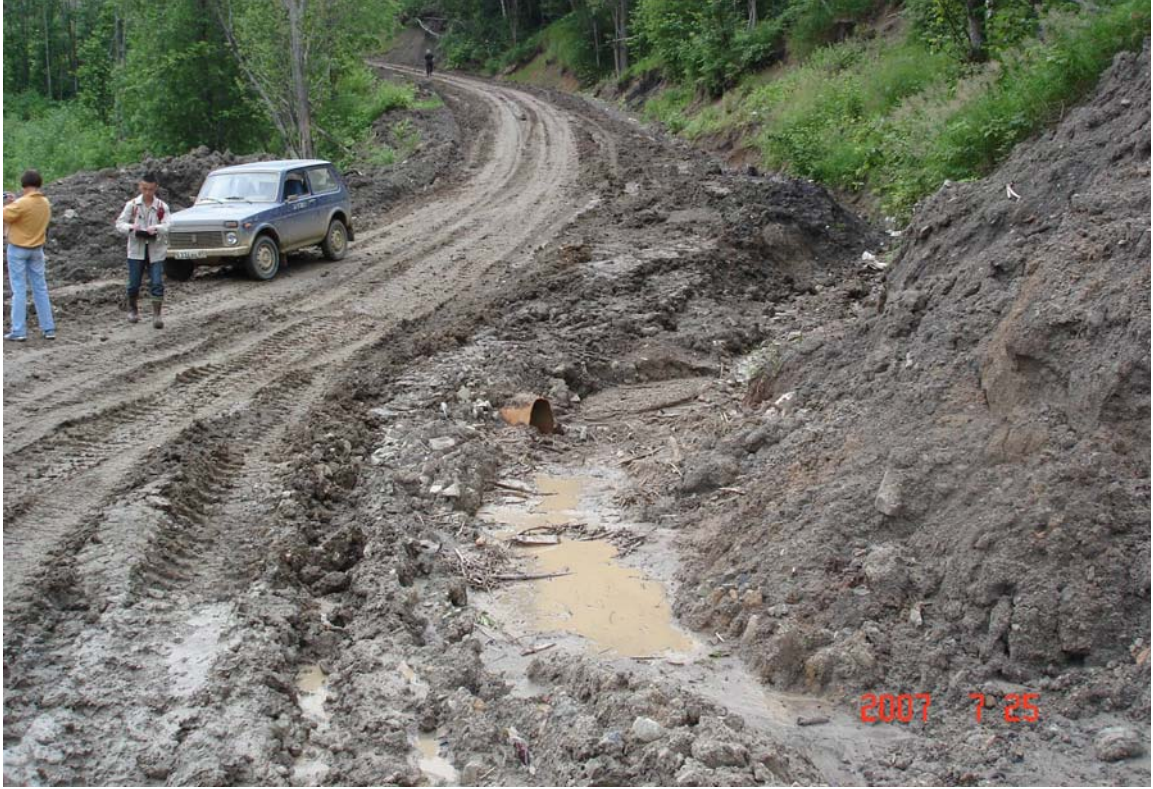
Right shore of the Krinka River. Roadside ditches along the access road, which drain into the river.

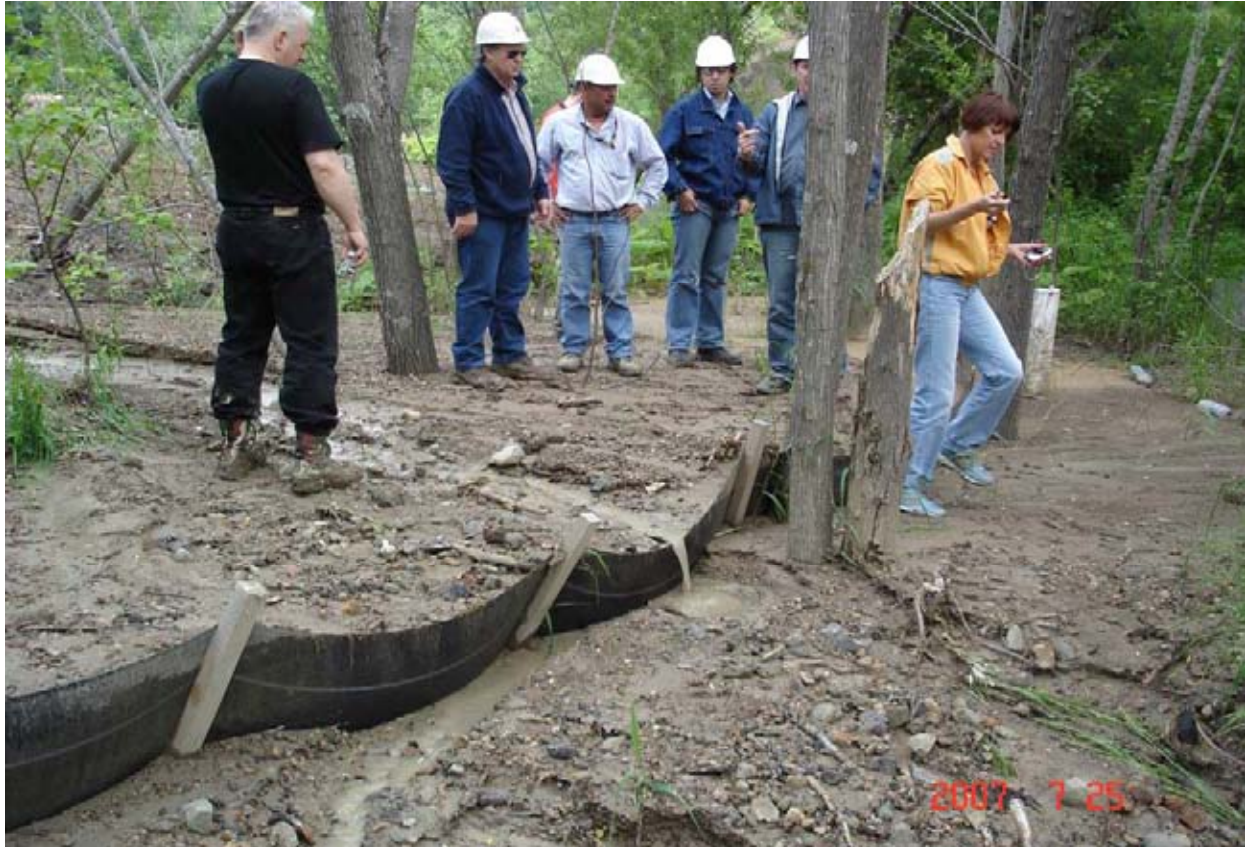
Right shore of the Krinka River, below the pipeline river-crossing. A large amount of sludge sediments on The protected shoreline zone, which is overflowing the projective screens. Unauthorized occupation of the forest in a water-protection zone, beyond the right-of-way.

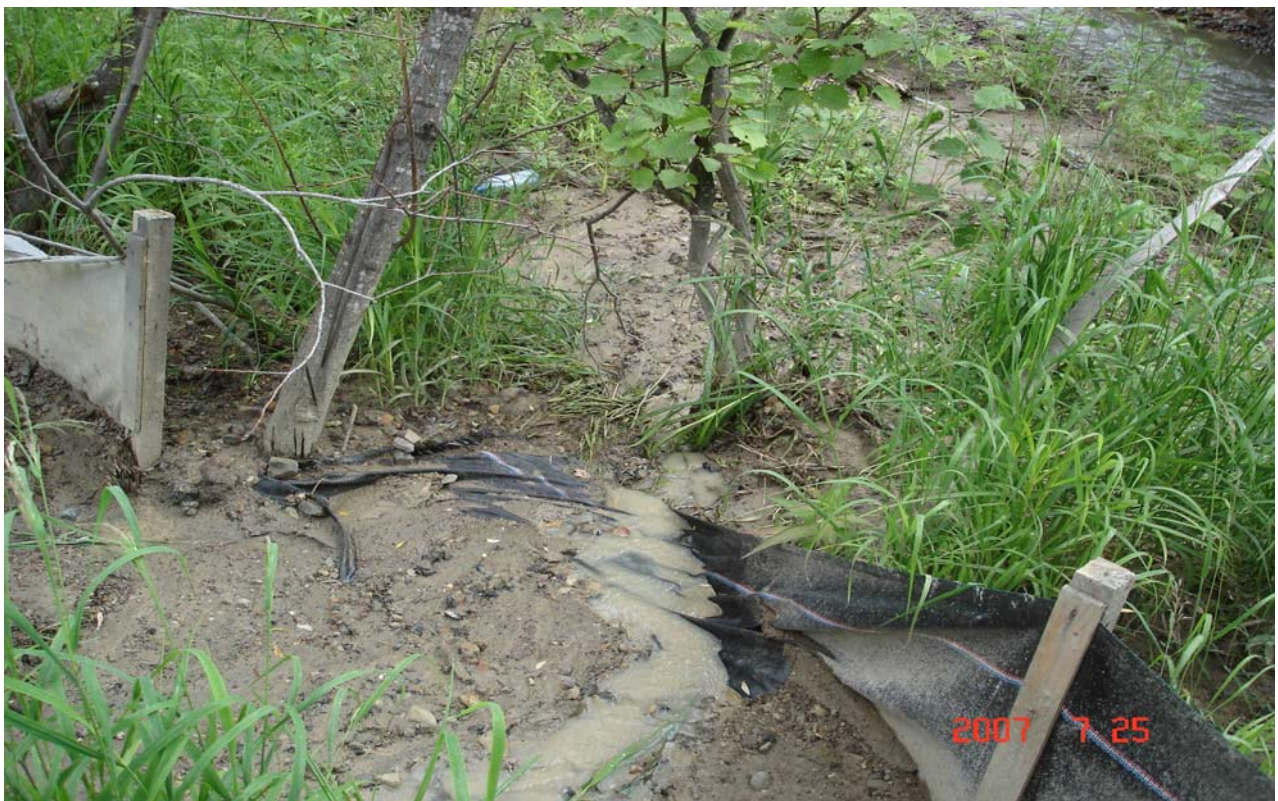
Right shore of the Krinka River, below the pipeline river-crossing. Running soil flows through the destroyed anti-sludge screens into the river.

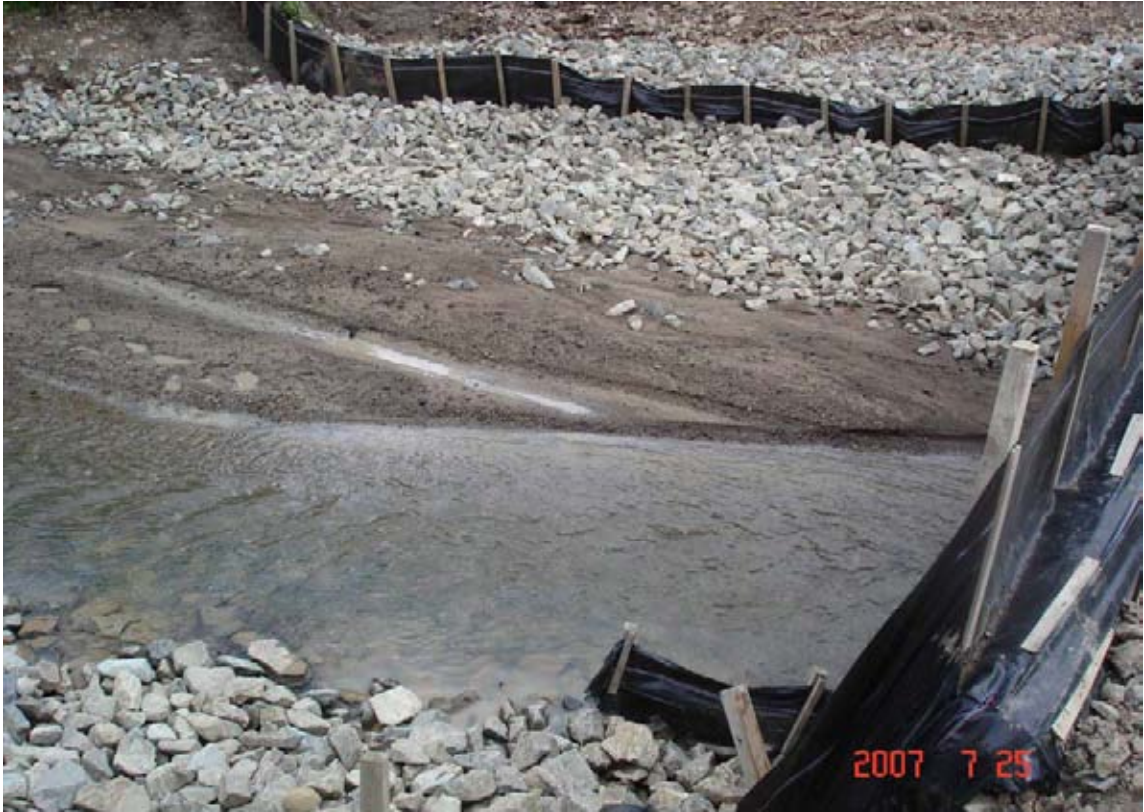
Krinka riverbed in the range of the gas pipeline crossing. July 25, 2007. In violation of the requirements of the project and responsibility of the company "Sakhalin Energy," the riverbed, where spawning grounds used to be located, the backfill consists of crushed stone instead of pebbles or gravel. In the center of the photograph sludge sediments are already visible above the crushed stone backfill. The presumed source of the sediments is the access road and the waste construction soil from the upstream pipeline route.

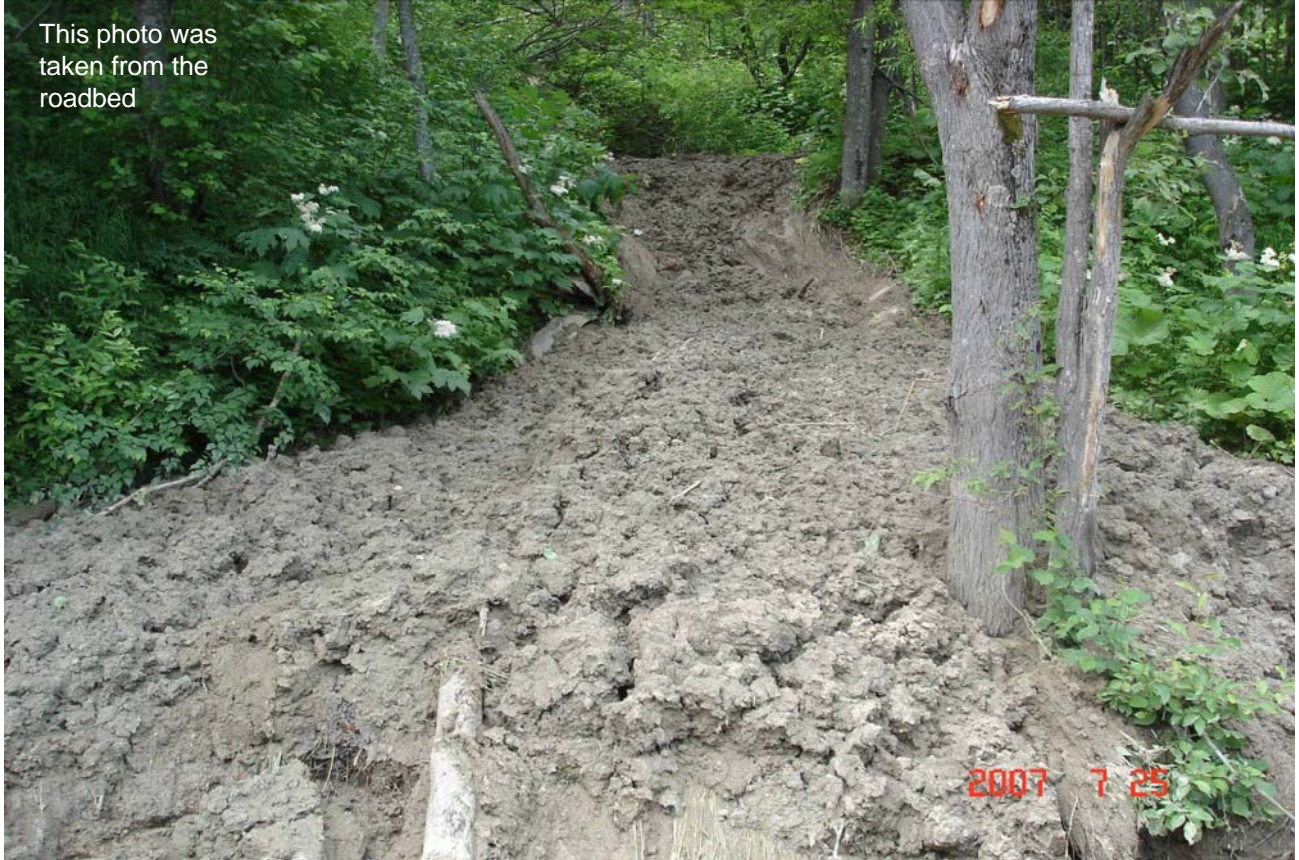
July 25, 2007. A mudflow about 100 meters in length, flowing down from the pipeline route along a forested slope of a mountain down to the access route, in a section that is adjacent to the right shore of the Krinka River.

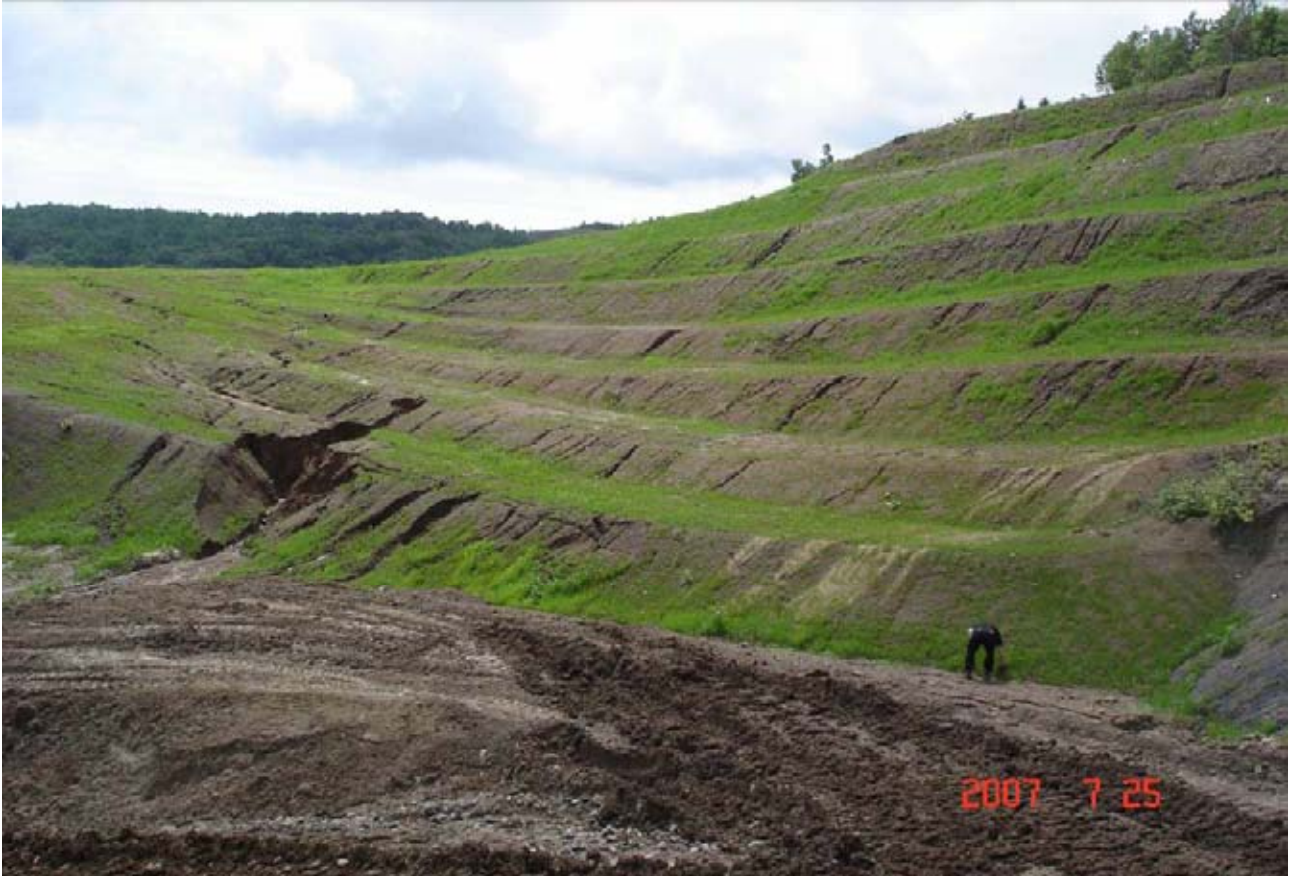
July 25, 2007. A section of the Krinka River watershed and its right tributary (Left Krinka), downstream from the pipeline route. A pile of waste construction soil that was extracted from the pipeline route, beyond the right-of-way. Despite the terracing of the slope and planting of grass, erosion is beginning on the pile.

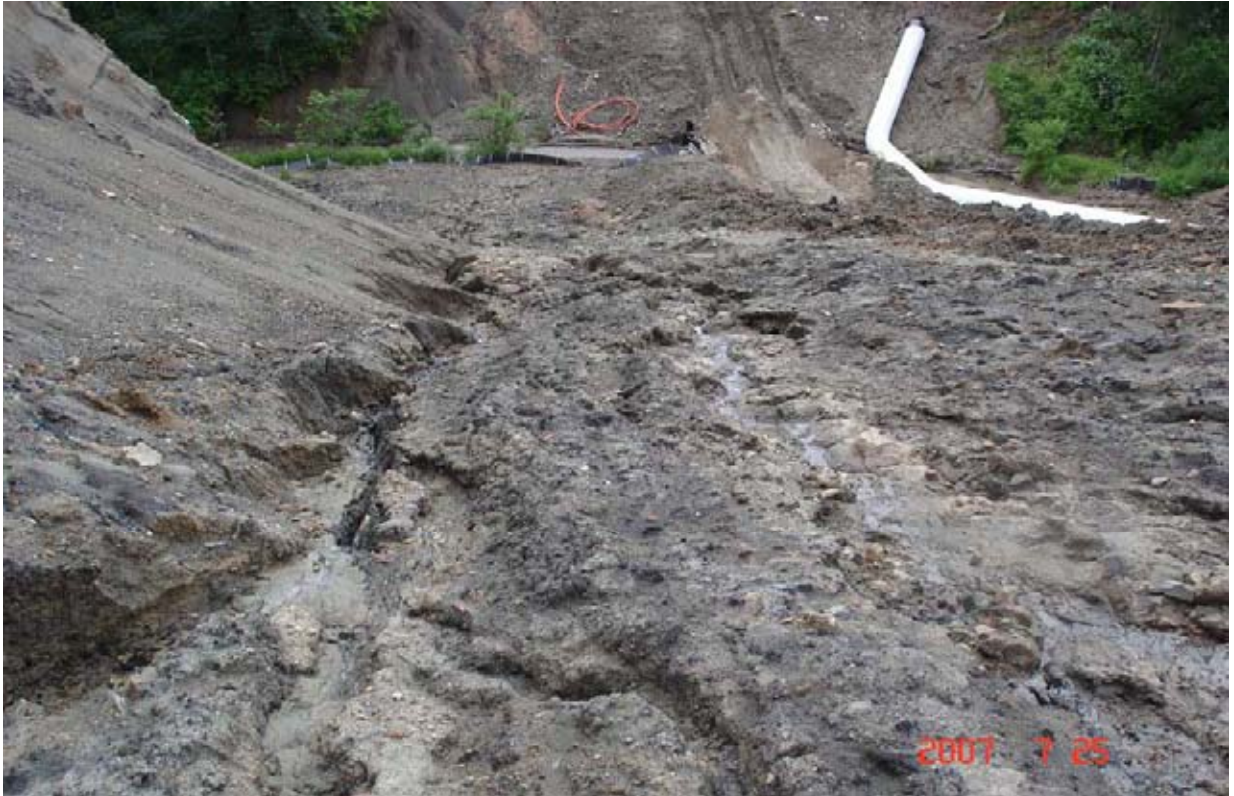
July 25, 2007. Un-numbered stream, right tributary of the Krinka River of the 1st order, a reservoir of the highest (special) category in terms of fisheries value. The area for salmon spawning in range of the river-crossing until the start of construction consisted of 44 m². The location of the river-crossing is at KP 349.18. In the background on the right one can see a length of gas pipeline that is ready to be buried. In the background on the left is erosion wash-out

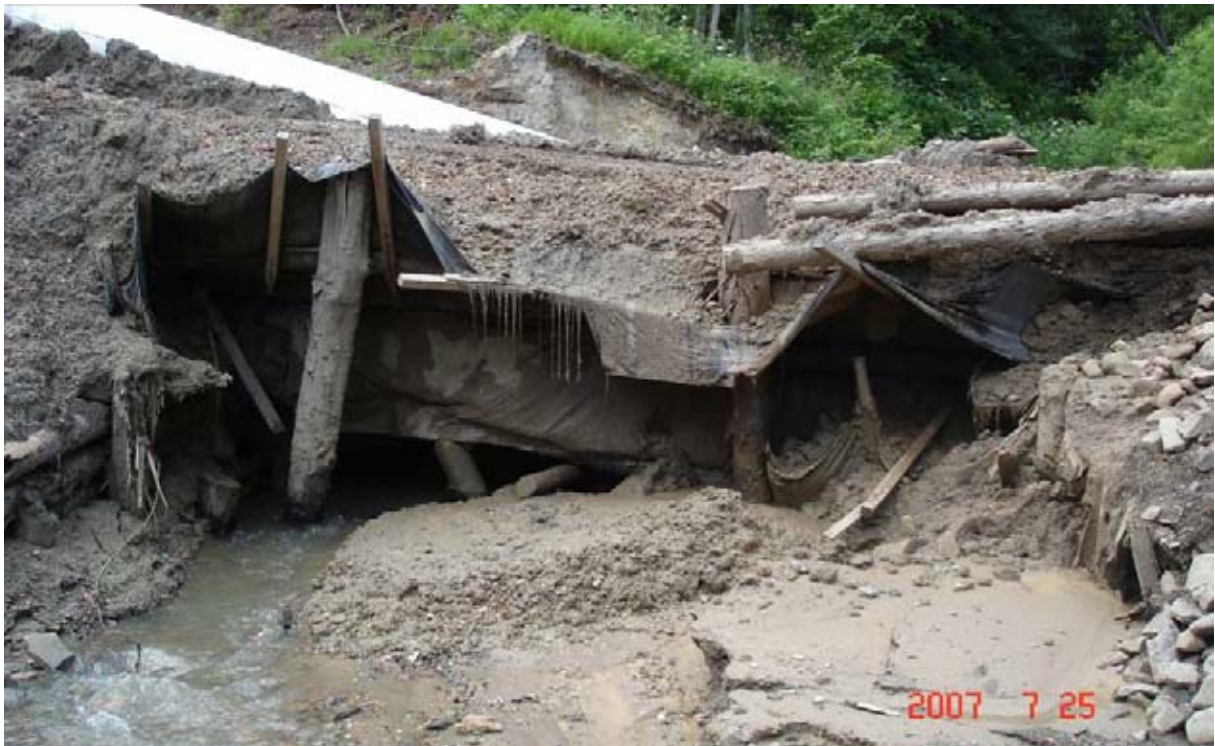
Un-numbered stream, right tributary of the Krinka River. KP 349.18. The bridge does not correspond to design requirements or matching conditions. The bridge supports have been built in the streambed. Waste construction soil is slipping into the streambed and being eroded by the water.

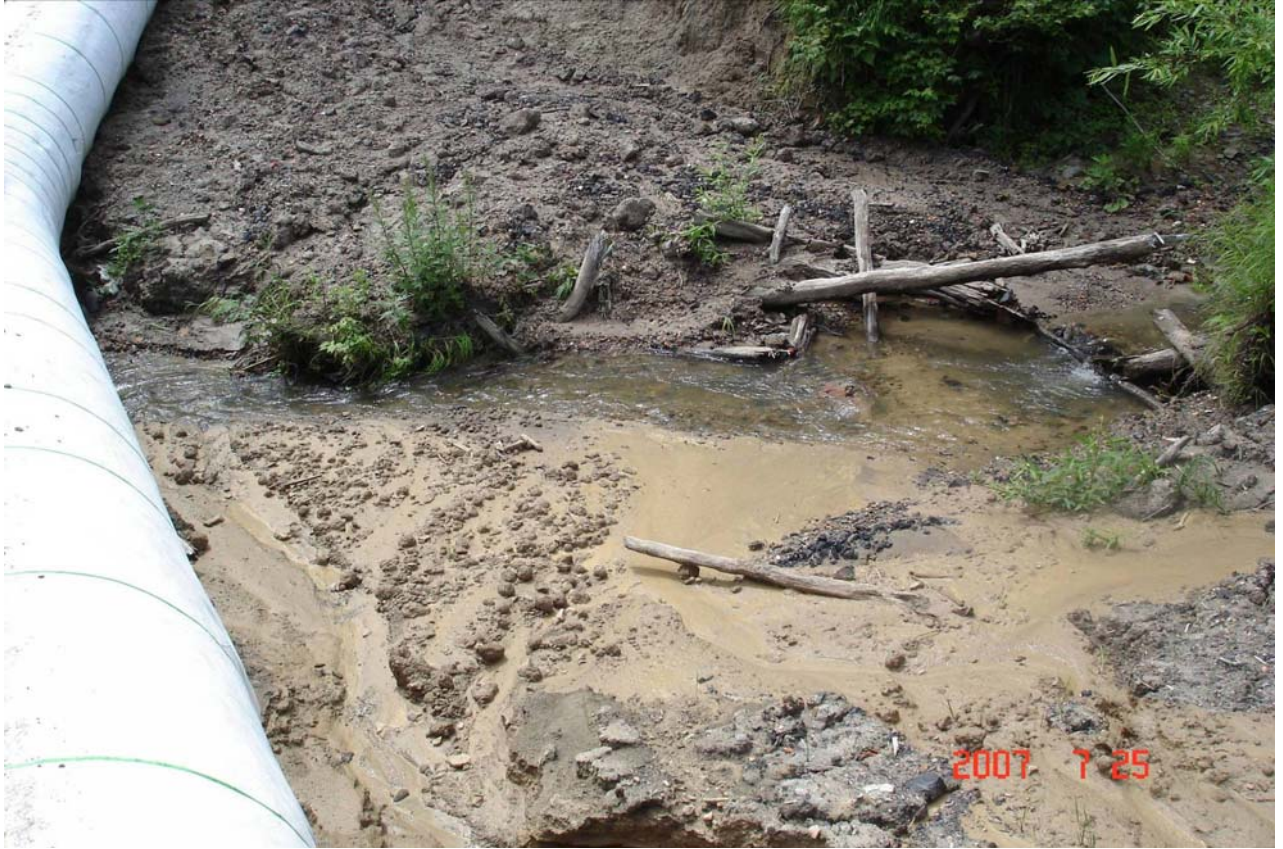
Un-numbered stream, KP 349.18. Upstream from the temporary bridge. Running soil from the pipeline route is slipping into the riverbed. Bank stabilization and anti-sludge screens are absent.

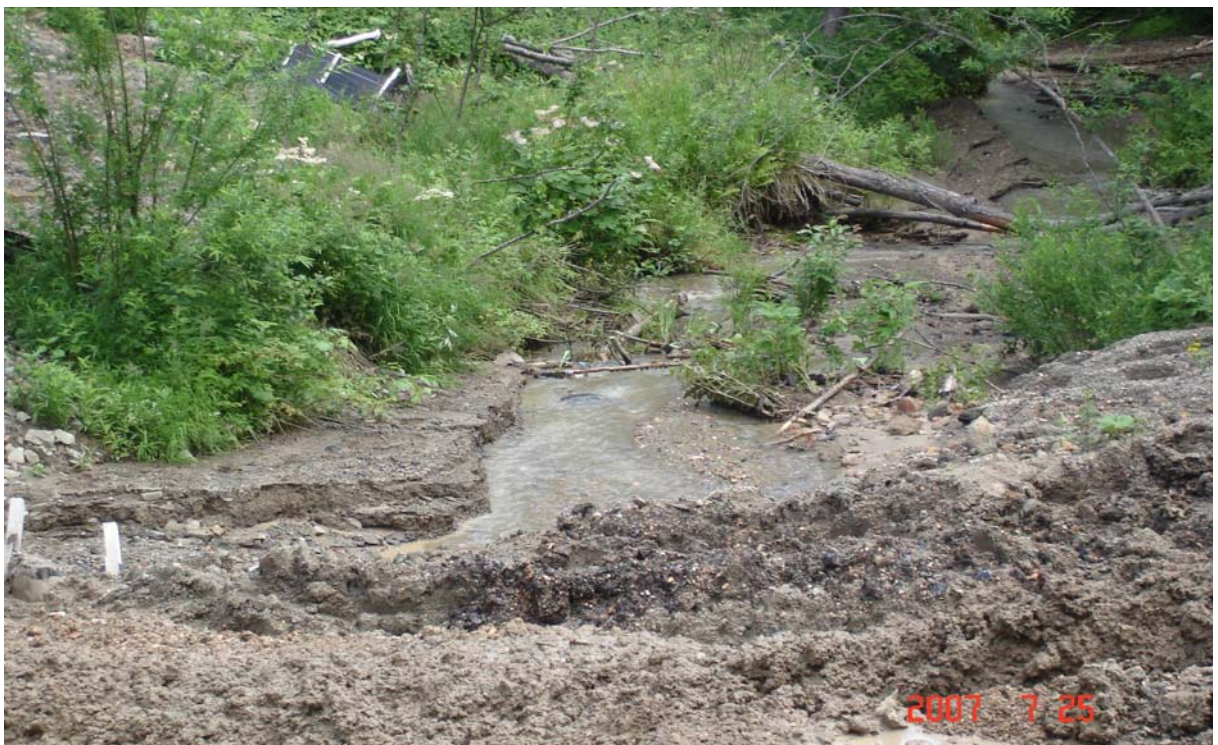
Un-numbered stream, KP 349.18. Downstream from the temporary bridge. Bank stabilization and anti-sludge screens are absent. As a result of the wash-out displaced into the stream and the slipping waste construction soil, the downstream water is very contaminated.

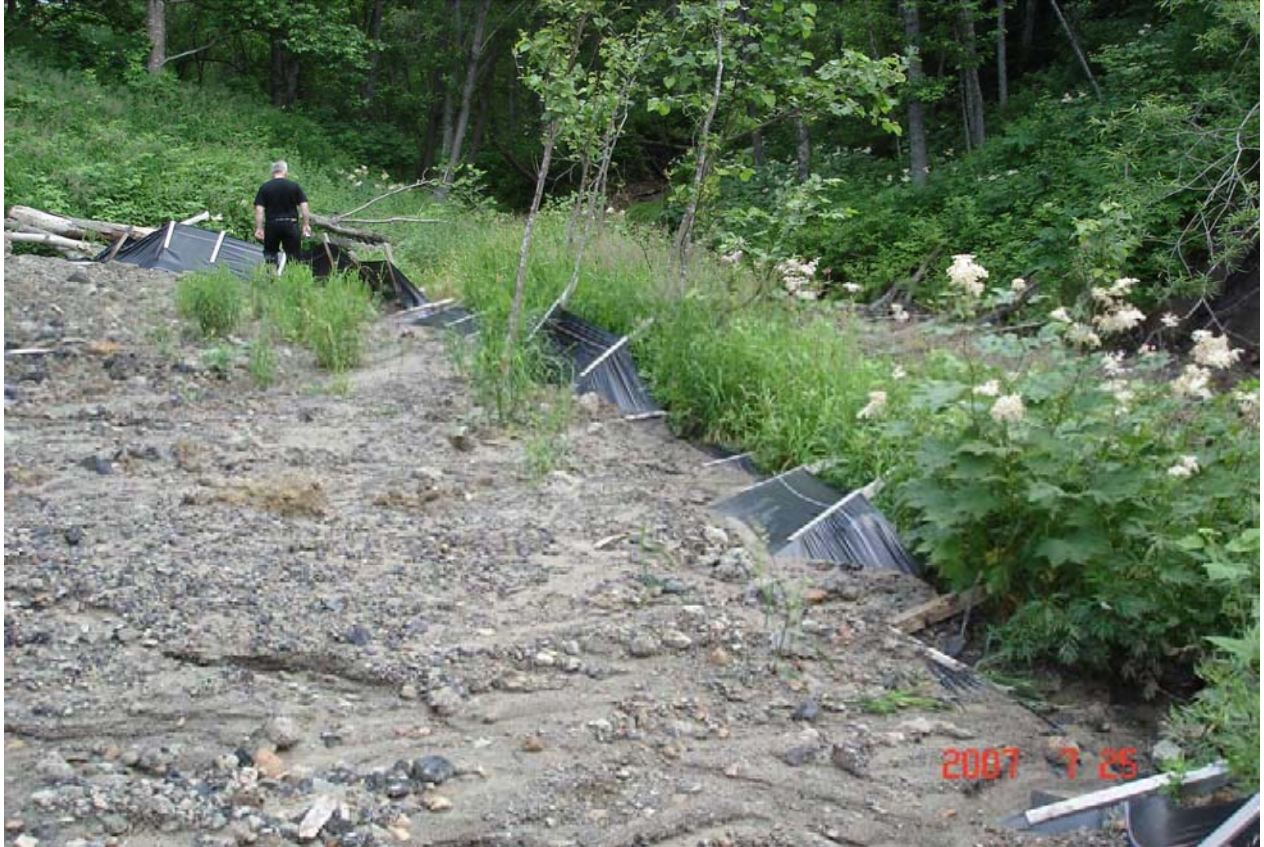
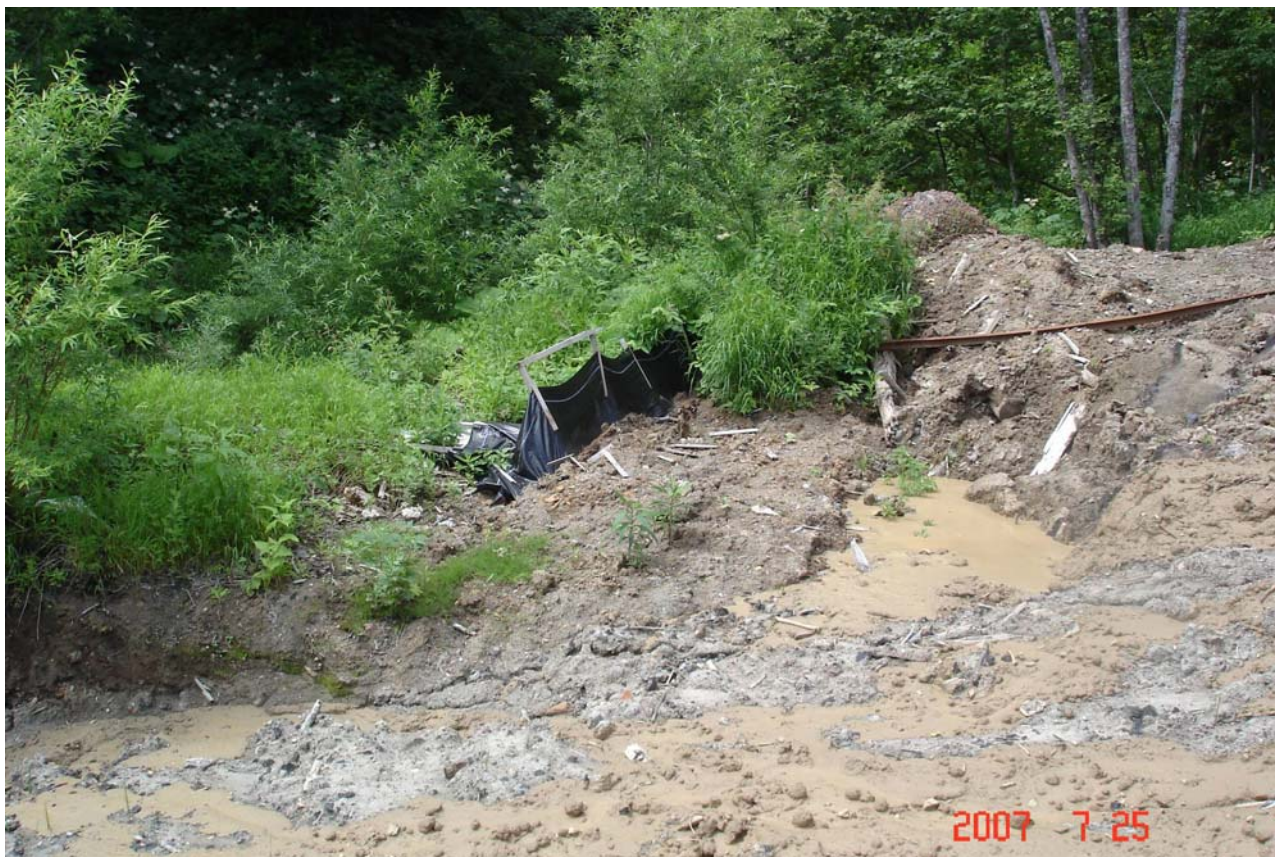
Un-numbered stream, KP 349.18. Upstream (upper photo) and downstream (lower photo) from the temporary bridge. Anti-sludge screens are destroyed and have not been repaired.

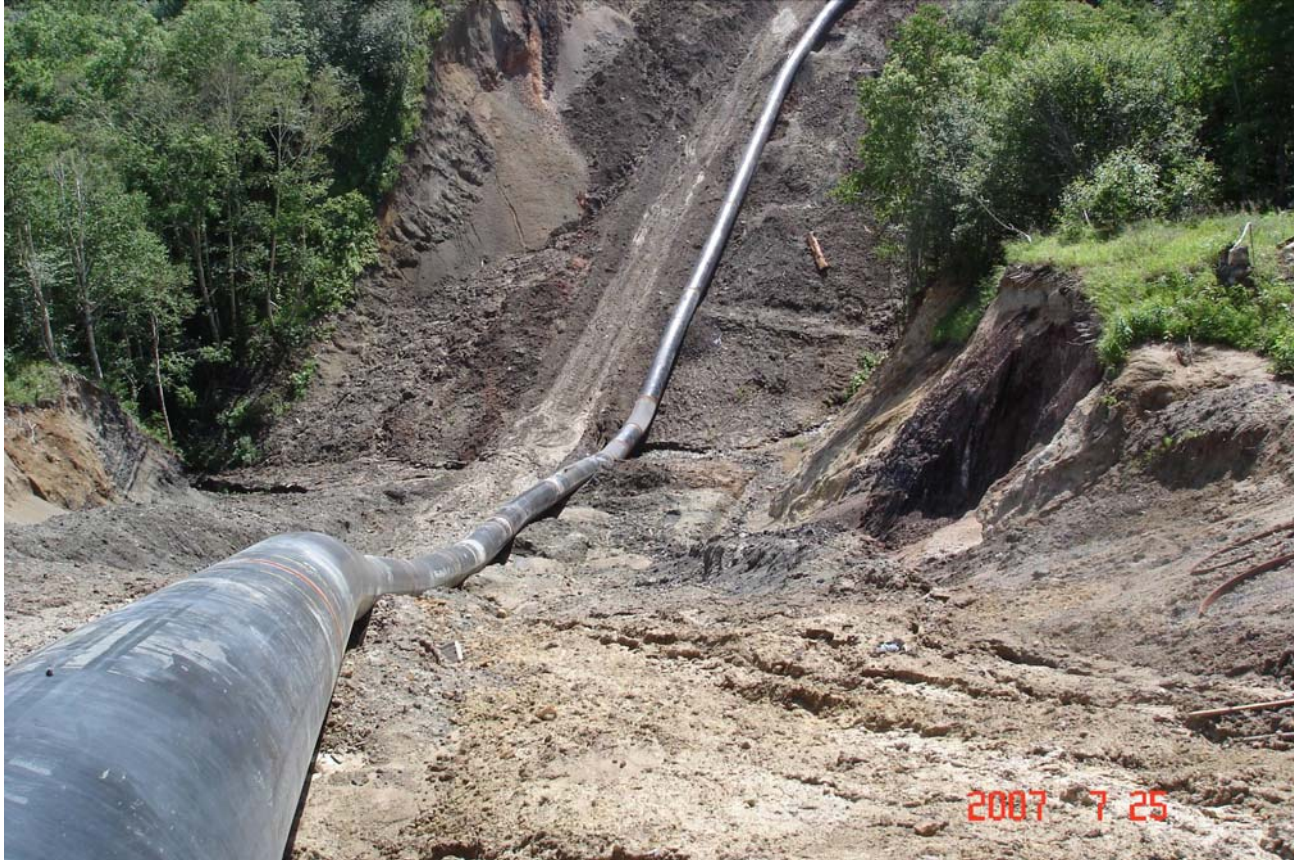
Petrovskii Stream, KP 351.1. A general view of the pipeline route stream-crossing. Anti-sludge screens and bank-stabilizers are absent. Erosion wash-outs are visible in the foreground.

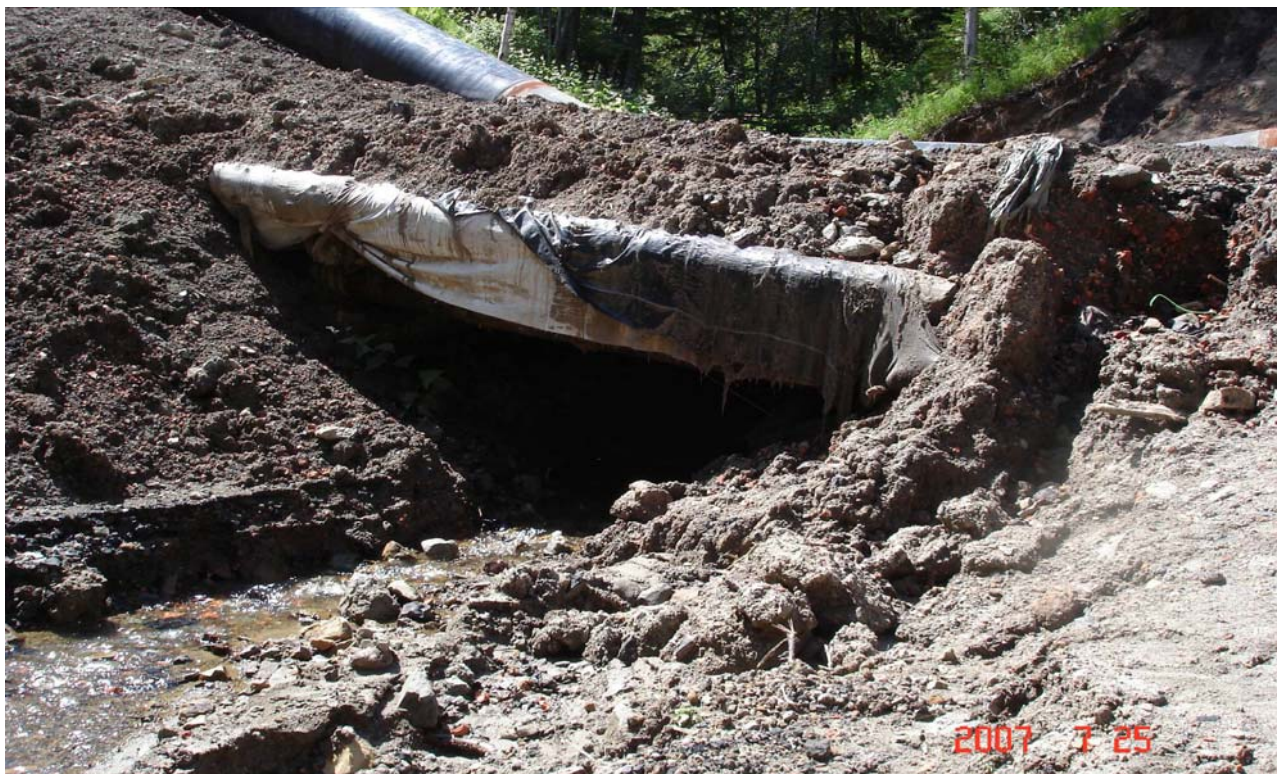
Petrovskii Stream, KP 351.1. The bridge does not correspond to design requirements and matching conditions. Waste construction soil is entering the streambed and contaminating the water.

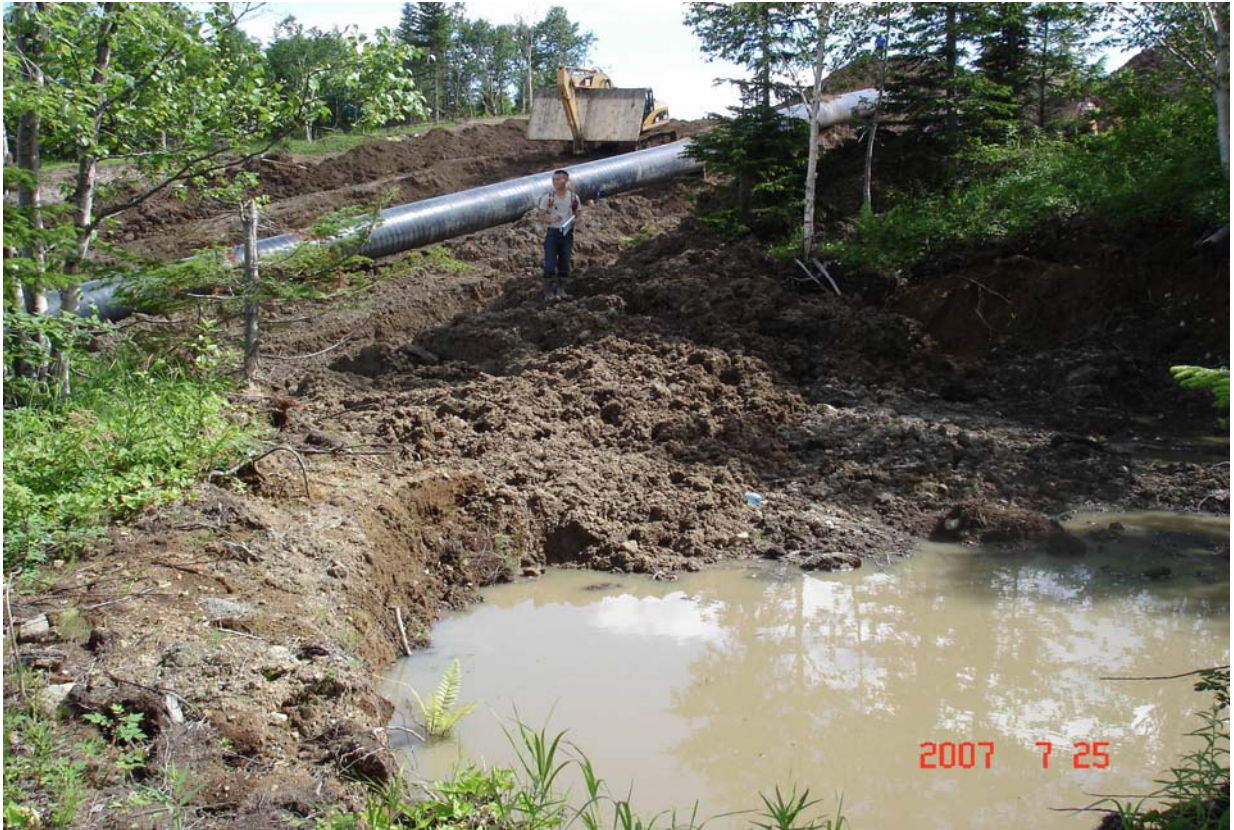
A section adjacent to the right-of-way, KP 350.6. Excavation of earth beyond the right-of-way, the destination of which the representatives of natural resource users could not explain.

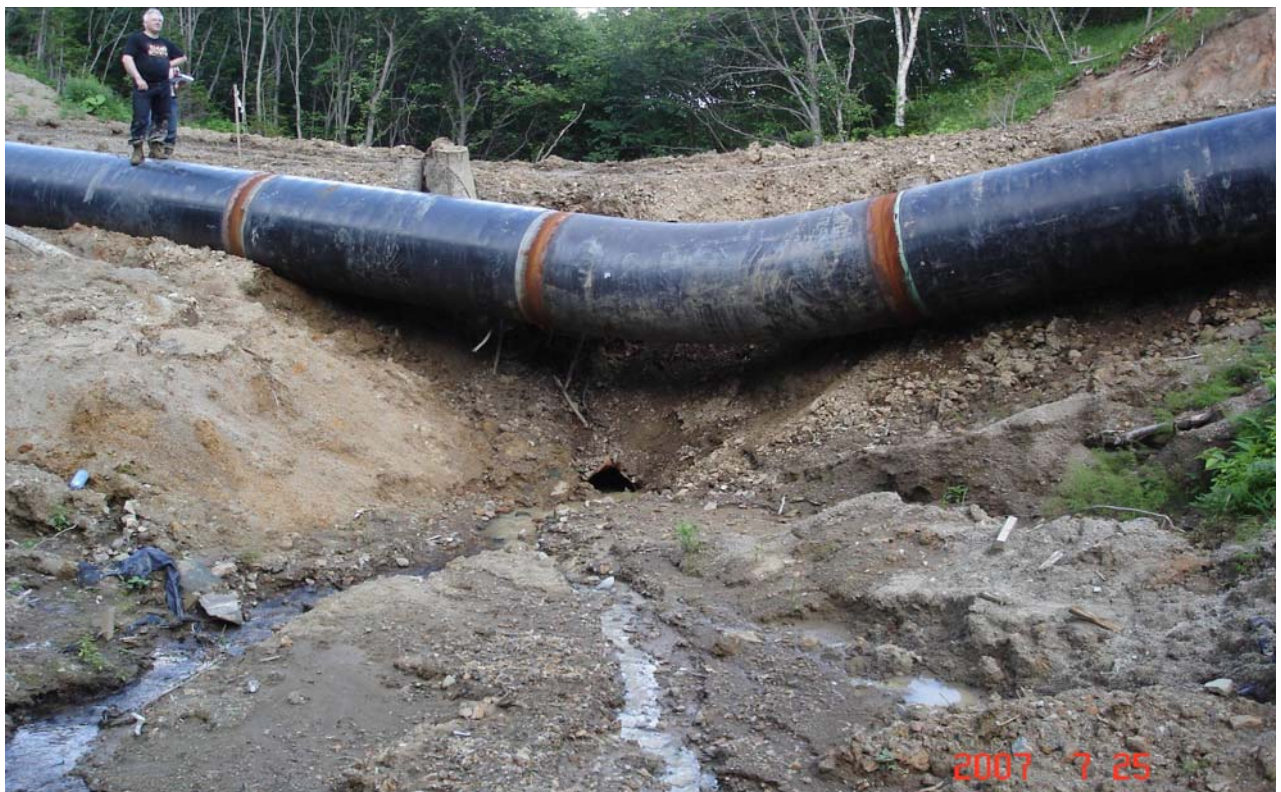
Un-numbered stream, tributary of Krinka River of the 2nd order. KP 350.0. The culvert does not correspond to design requirements and matching conditions. The hydrological process of the water flow has been disrupted. Waste construction soil is entering the streambed and contaminating the water.
