# Citizens Photo Monitoring Report

Prepared by Sakhalin Environment Watch  
&  
Pacific Environment

Sakhalin II Pipeline Route  
October & December 2007

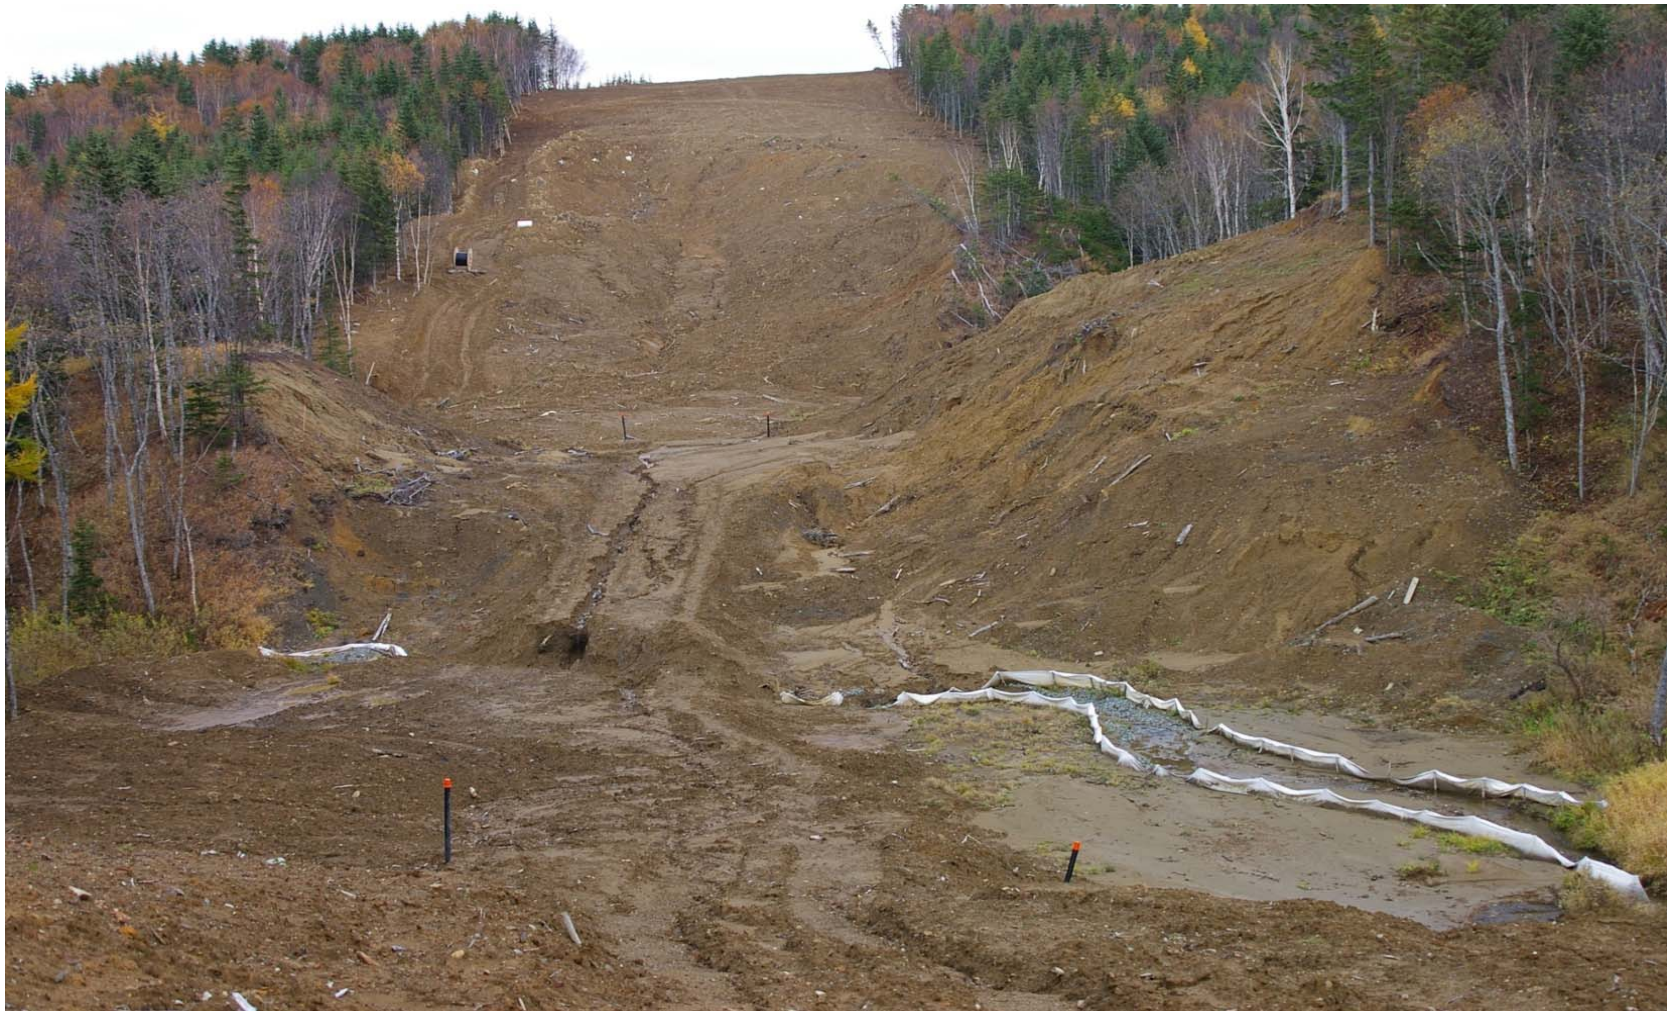
October 23, 2007: KP 493.6-493.9. General view from the northern bank of the stream to the south of Listvennitsa River and its right tributary. "Technical recultivation" work (replacement and smoothing of construction soil only) was carried out during the winter of 2006-2007 in the areas depicted in these photos. "Complete recultivation" (erosion control measures, replacement of top soil, replanting, slope reinforcement, and mulching) was not carried out, and erosion processes have developed throughout 2007. However, SEIC's Erosion Control Performance 2007: Dispatch No.2 ([www.sakhalinenergy.com/en/default.asp?p=channel&c=9&n=218](http://www.sakhalinenergy.com/en/default.asp?p=channel&c=9&n=218)) states: "as of 28 July 2007, 100% of the 81 activities in this section were completed." The Dispatch is specifically referring to the area where this and all following photos were taken. This photo depicts a situation where the pipeline right-of-way (RoW) alters the configuration of a natural network of waterways, which is a worst industry practice and strongly prohibited by Russian law.

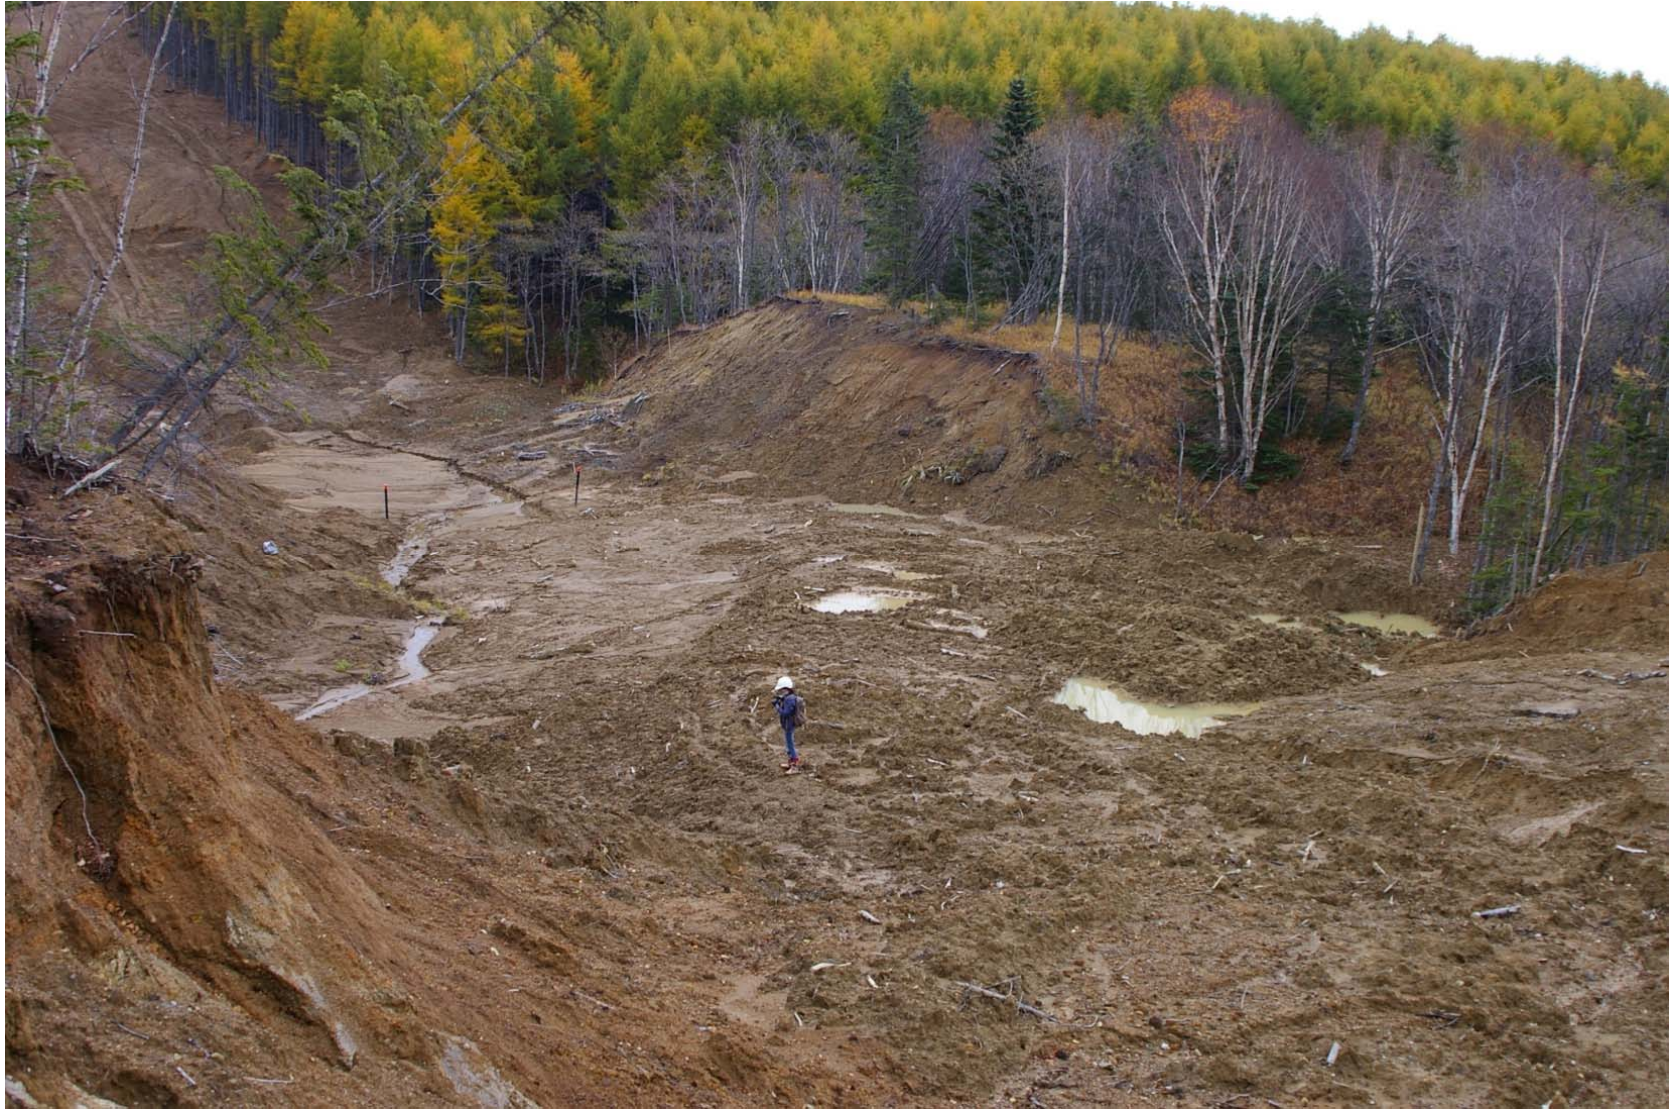
October 23, 2007: KP 493.9. A general view of erosion processes from the southern bank of the stream to the south of Listvennitsa River and its right tributary.

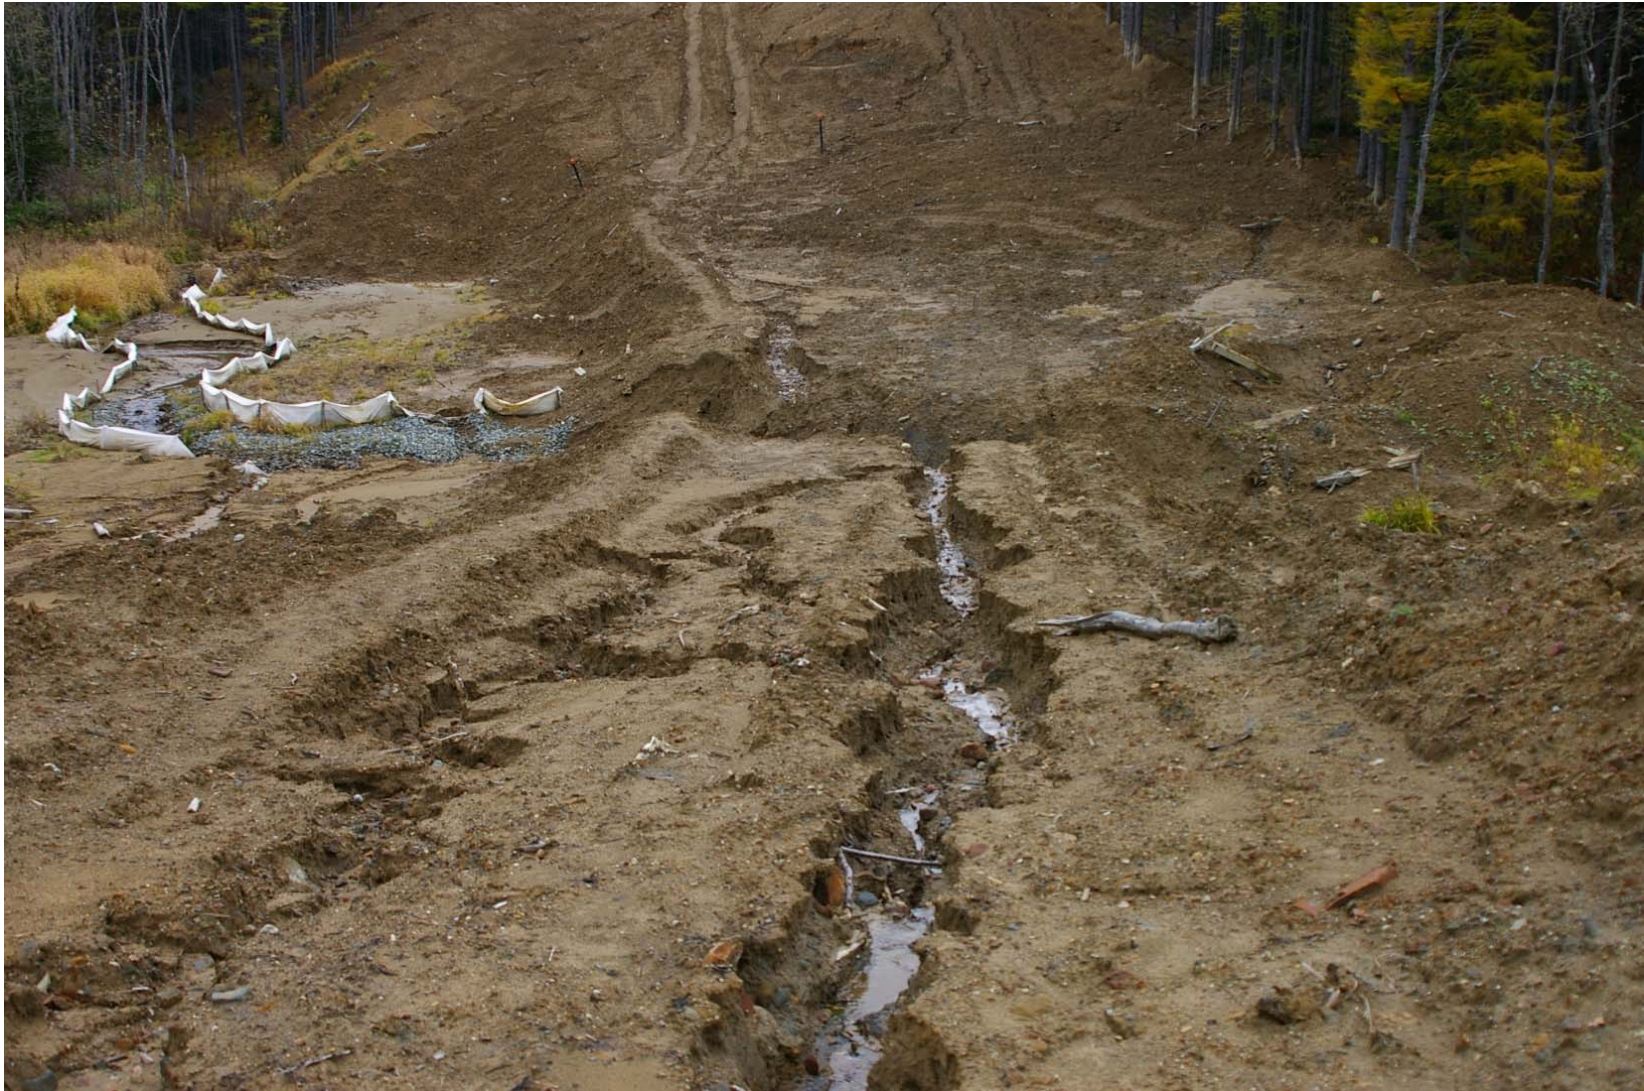
October 23, 2007: KP 493.8. The stream to the south of Listvennitsa River. Erosion ditch on the pipeline RoW.

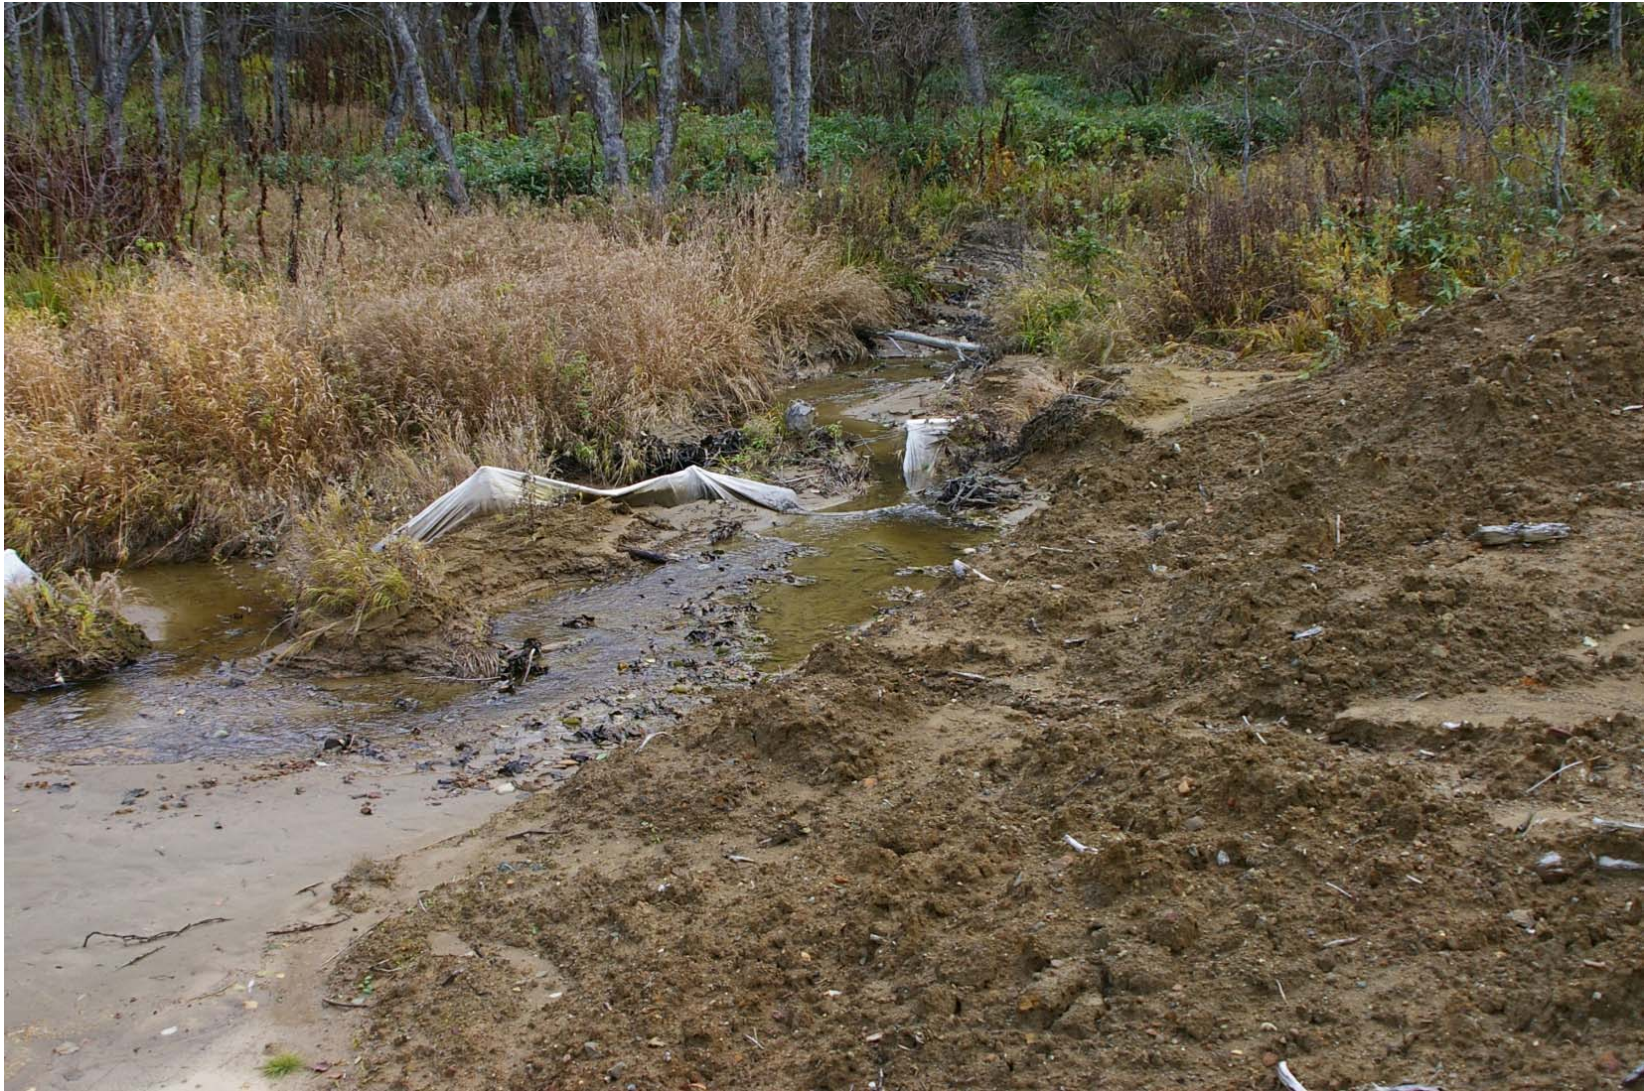
October 23, 2007: KP 493.7. The stream to the south of the Listvennitsa River. Mud enters the stream and anti-erosion silt fences have been abandoned since autumn 2006.

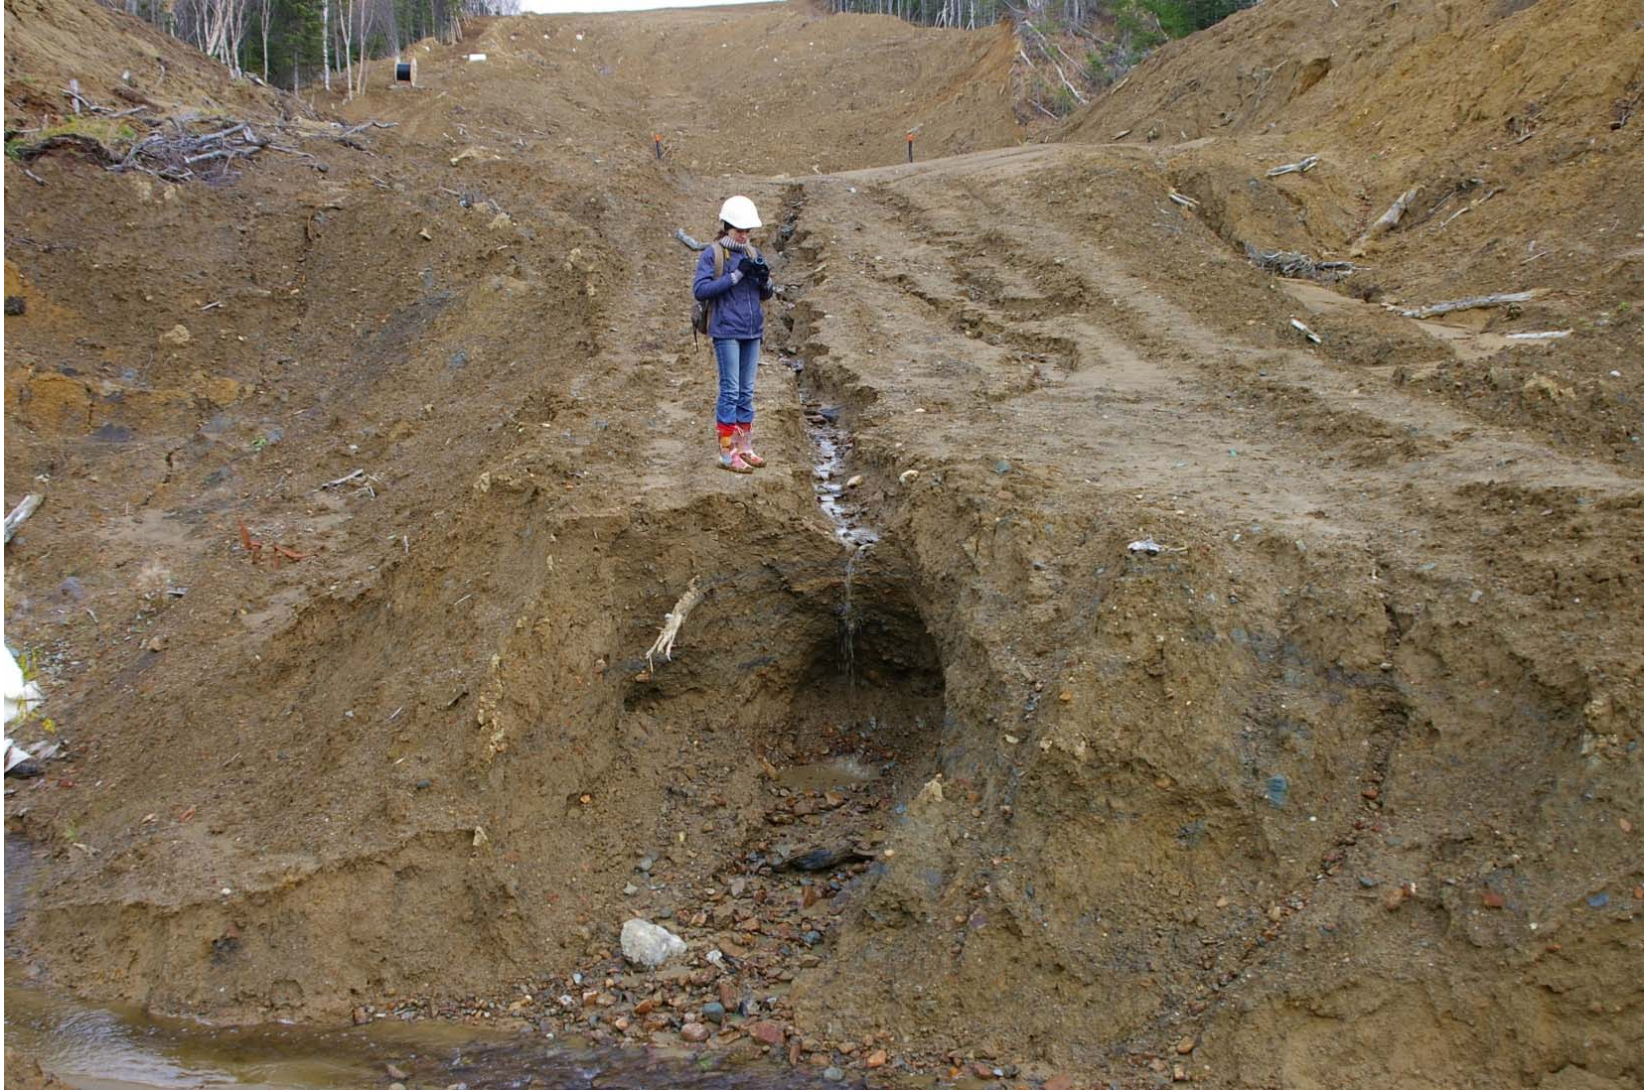
October 23, 2007: KP 493.7. The stream to the south of the Listvennitsa River. The re-directed stream tributary is making an erosion ditch and washing out a mound of earth that was placed here last winter as a "technical recultivation" measure.

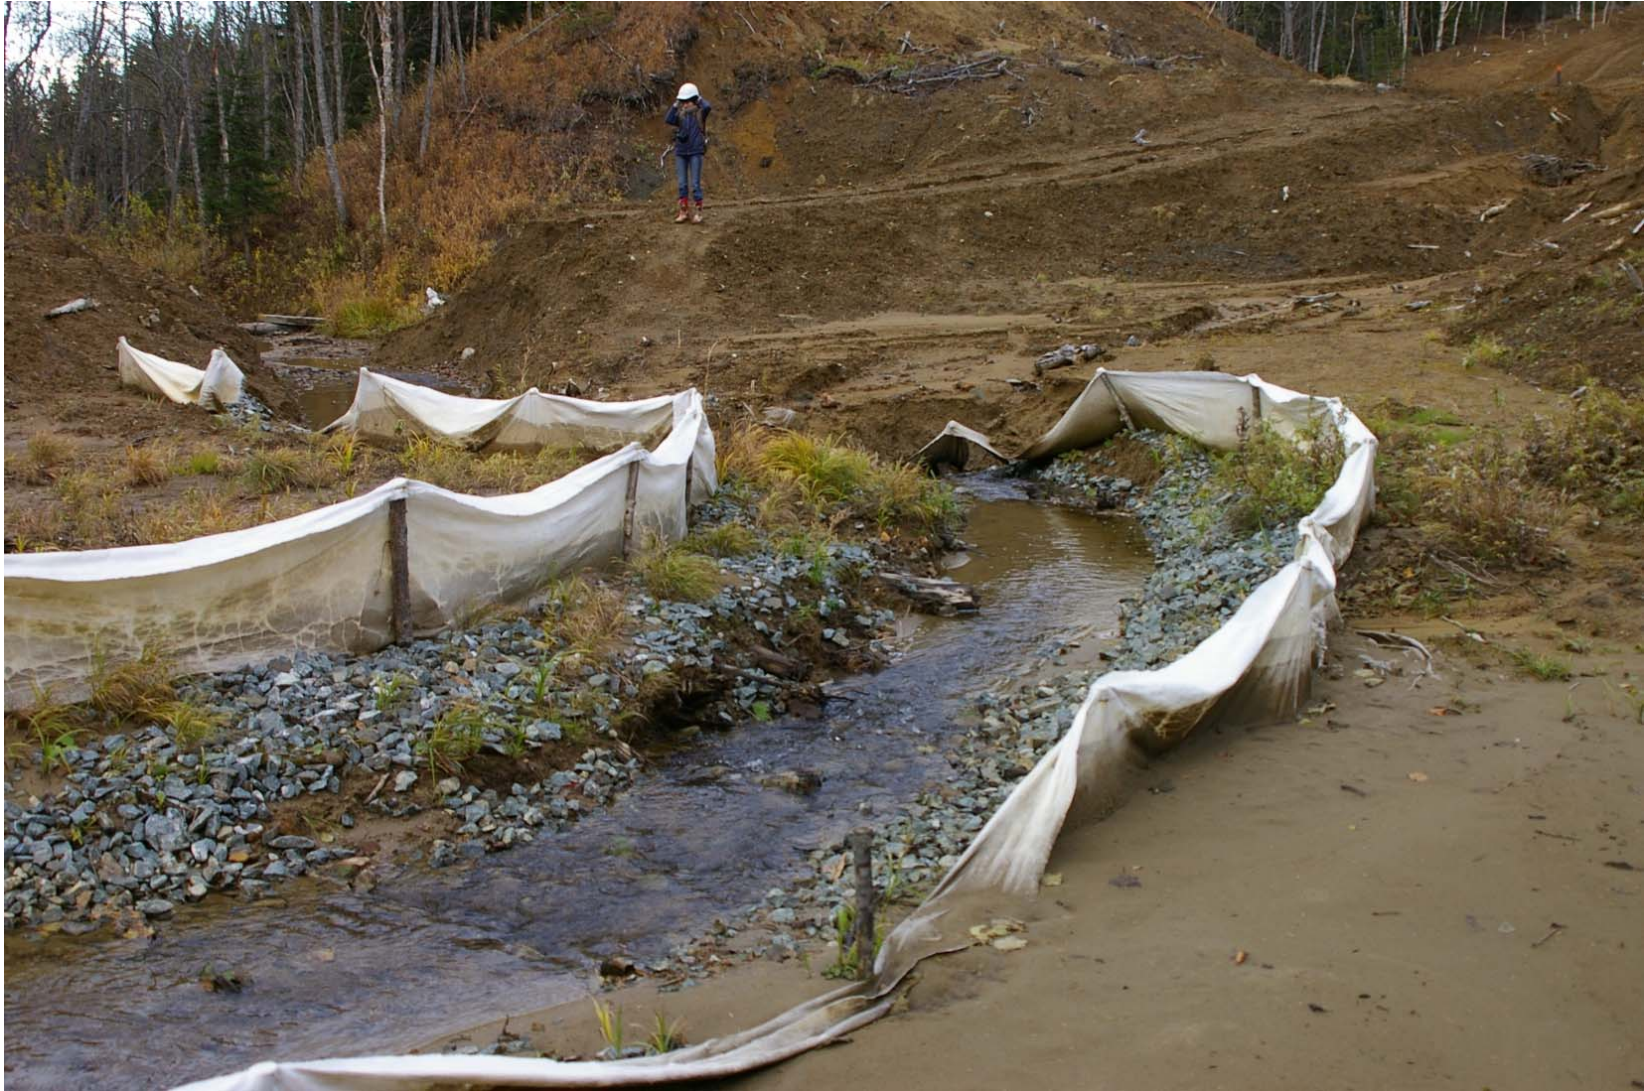
October 23, 2007: KP 493.7. The stream to the south of the Listvennitsa River. The stream has passed through an earth mound which was placed across the stream during "technical recultivation" last winter. The mound helped construction crews cross the stream during winter construction work. It's obvious that the mound in the background was placed after the silt fences were installed because the mound covers the silt fences. Since last winter nothing was done here to prevent or stop erosion or to maintain the stream and its tributaries.

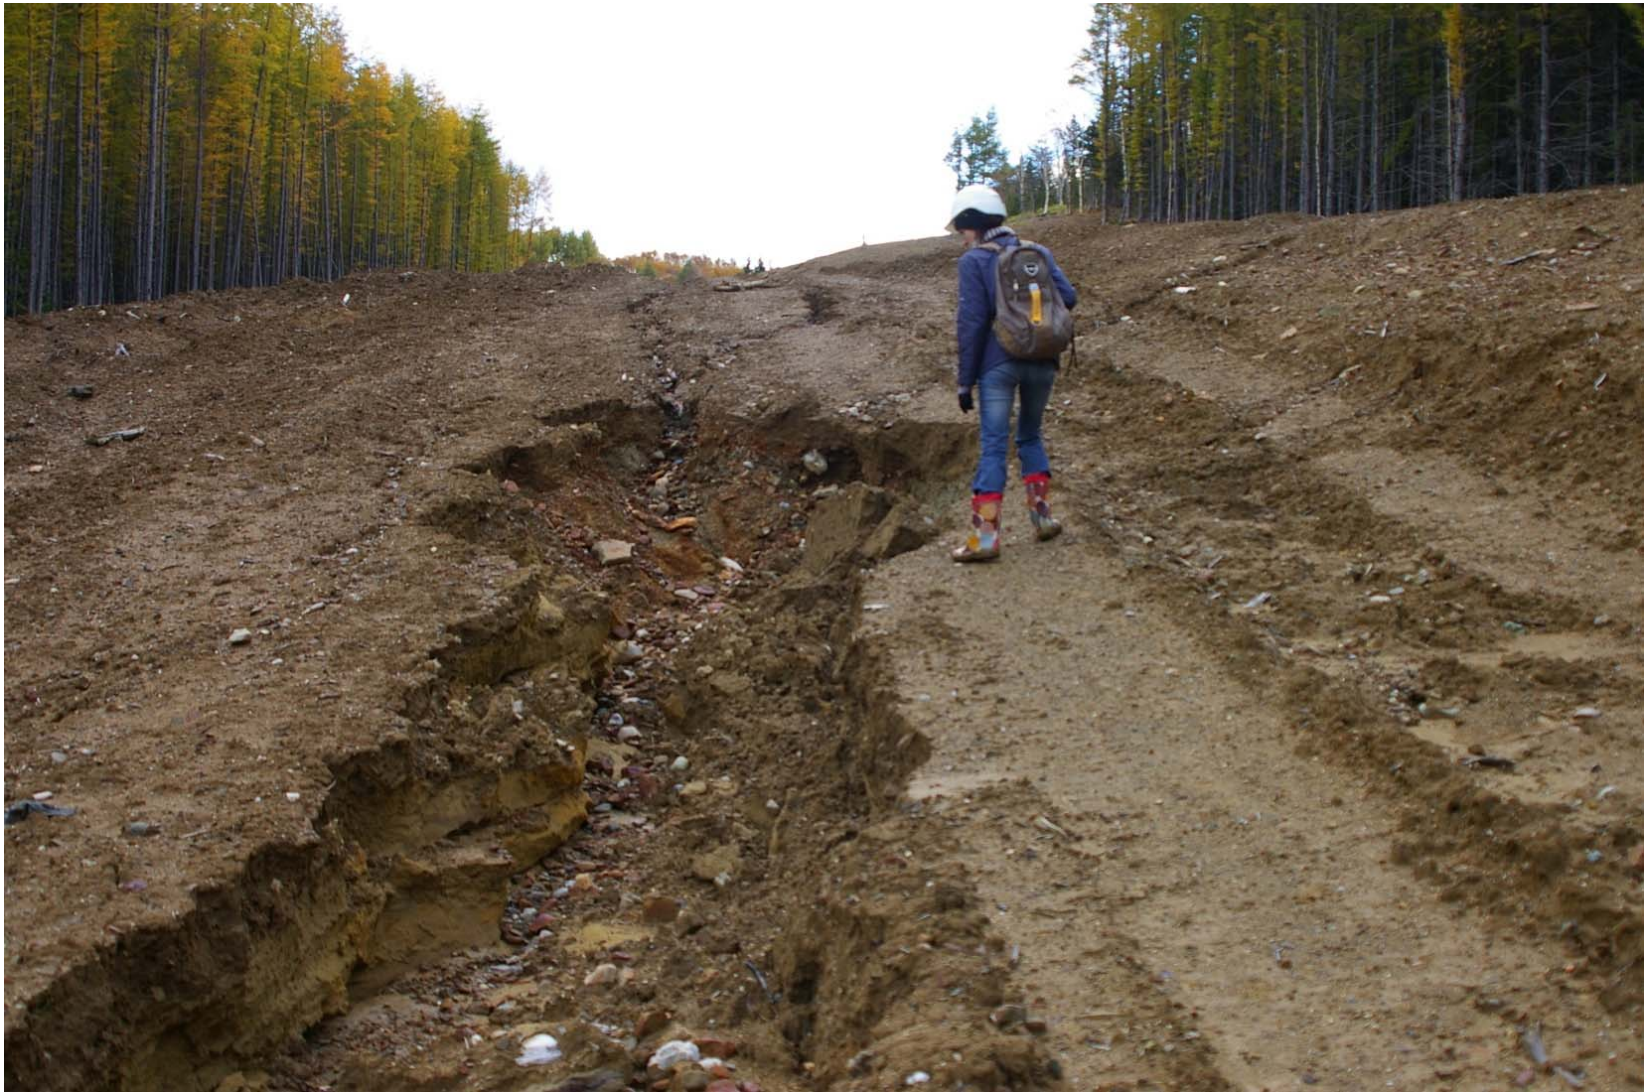
October 23, 2007: KP 493.6. Between the stream to the south of the Listvennitsa River and the Listvennitsa River, Dolinsk Dstrict. Erosion ditch on the pipeline RoW.

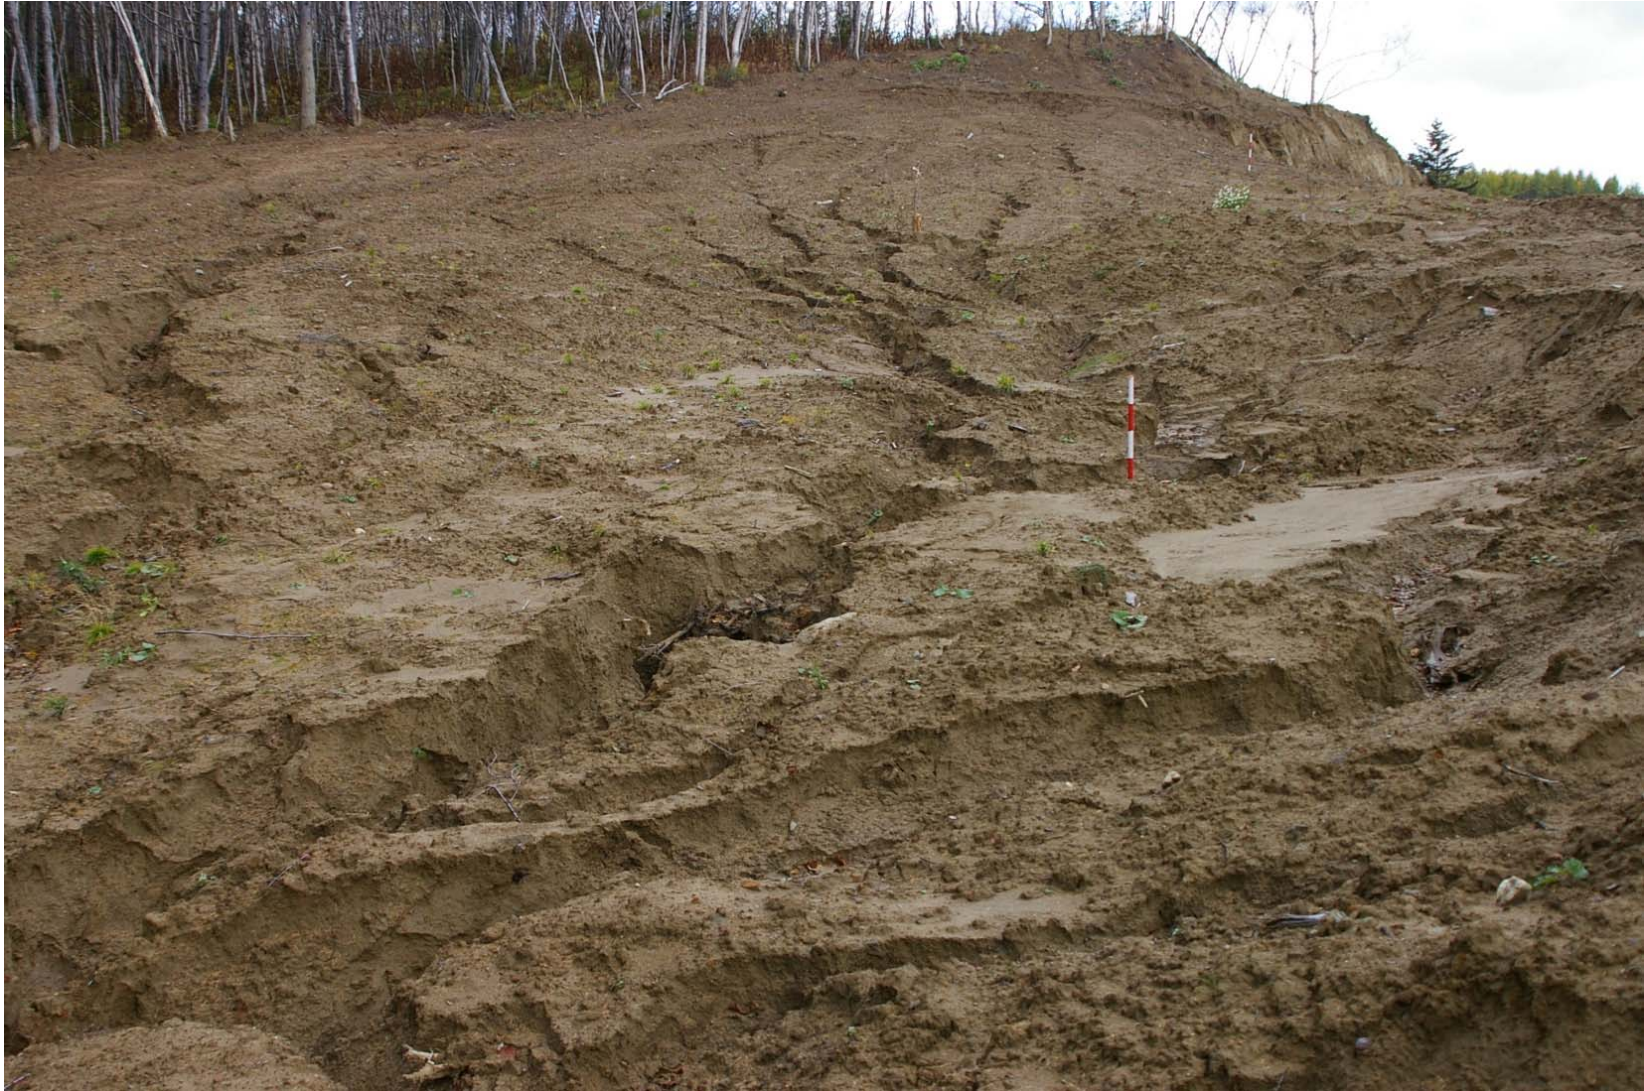
October 23, 2007: KP 493.2. 300 meters to the south of the Listvennitsa River. Erosion ditches on the pipeline RoW.

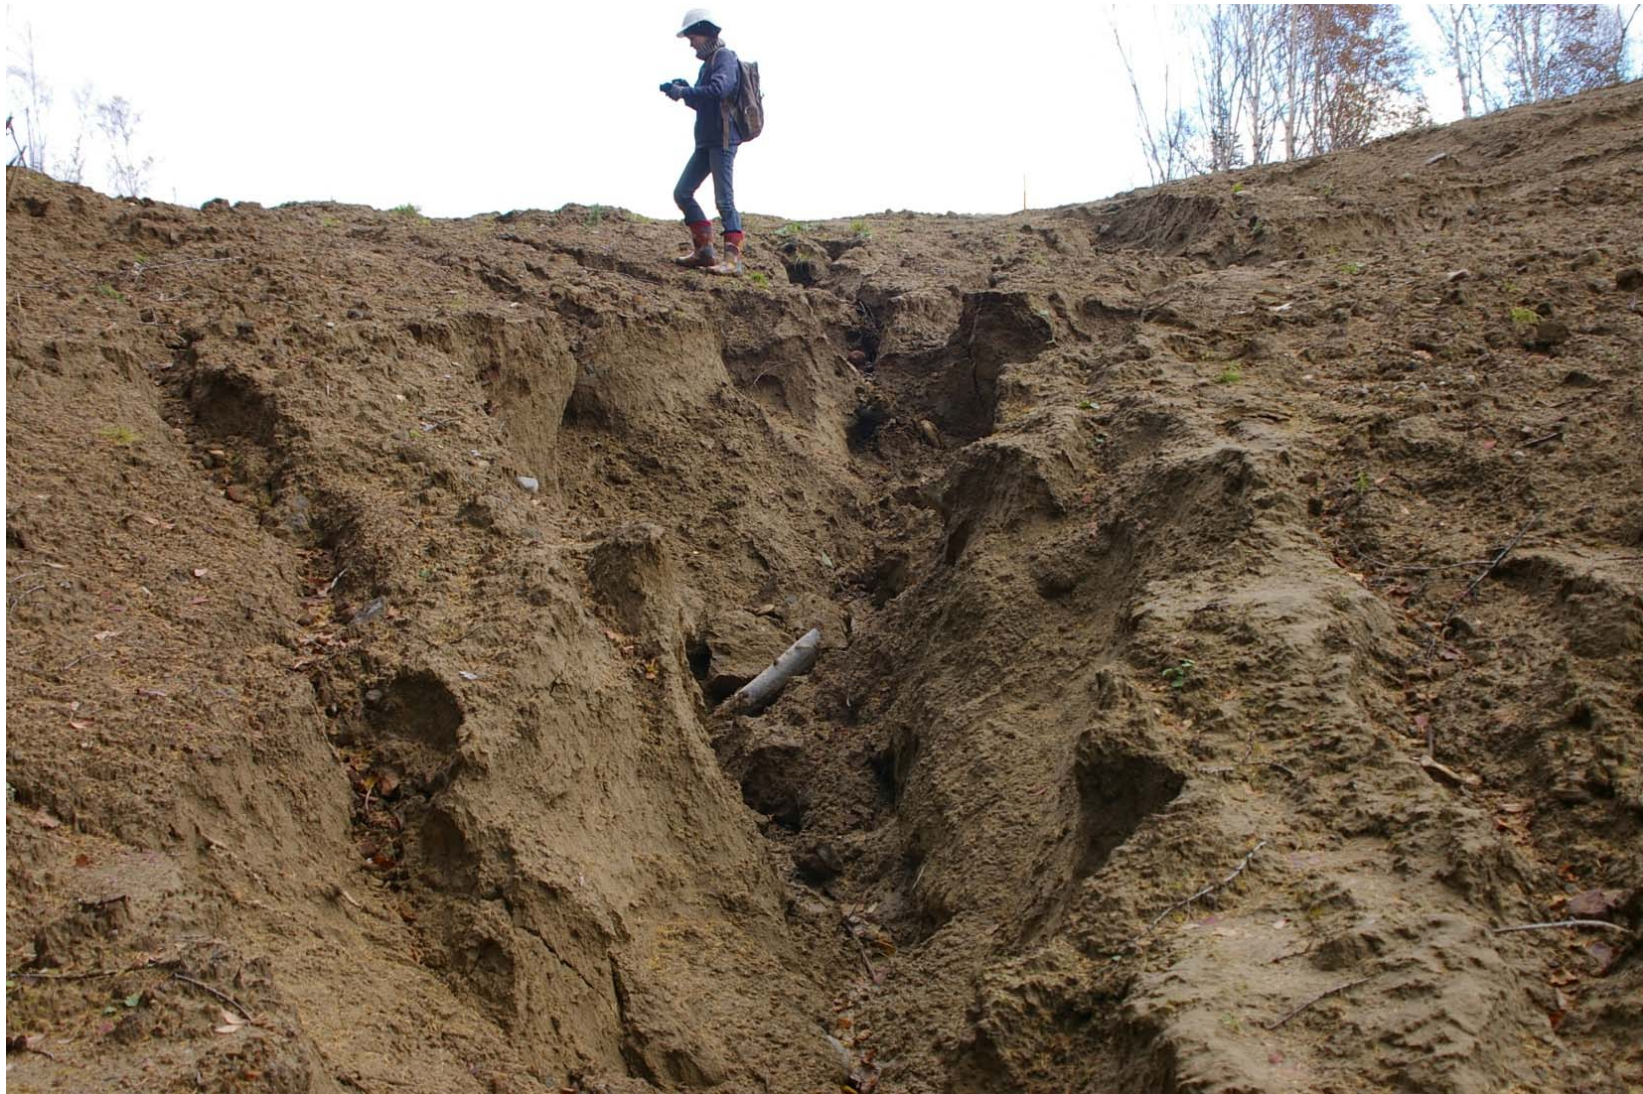
October 23, 2007: KP 493.2. 300 meters to the south of the Listvennitsa River. Very deep erosion ditch on the pipeline RoW.

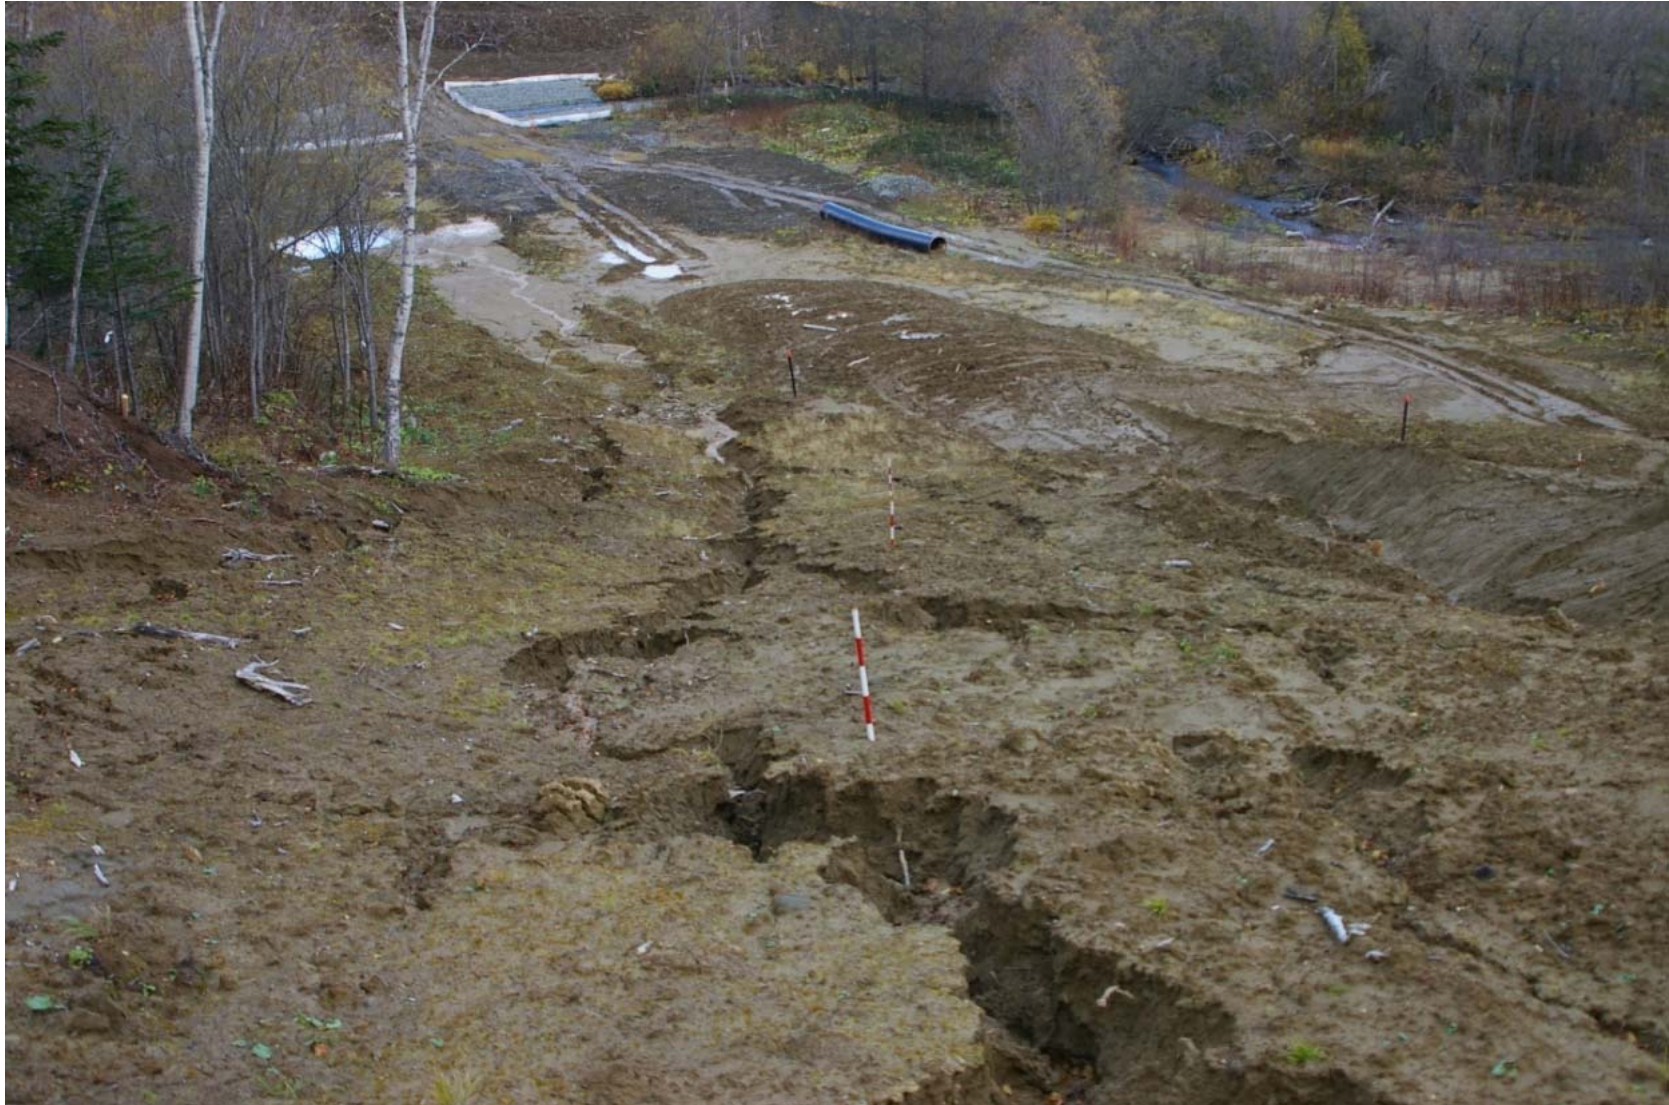
October 23, 2007: KP 492.9. Right bank of the Listvennitsa River. Erosion ditches on the pipeline RoW.

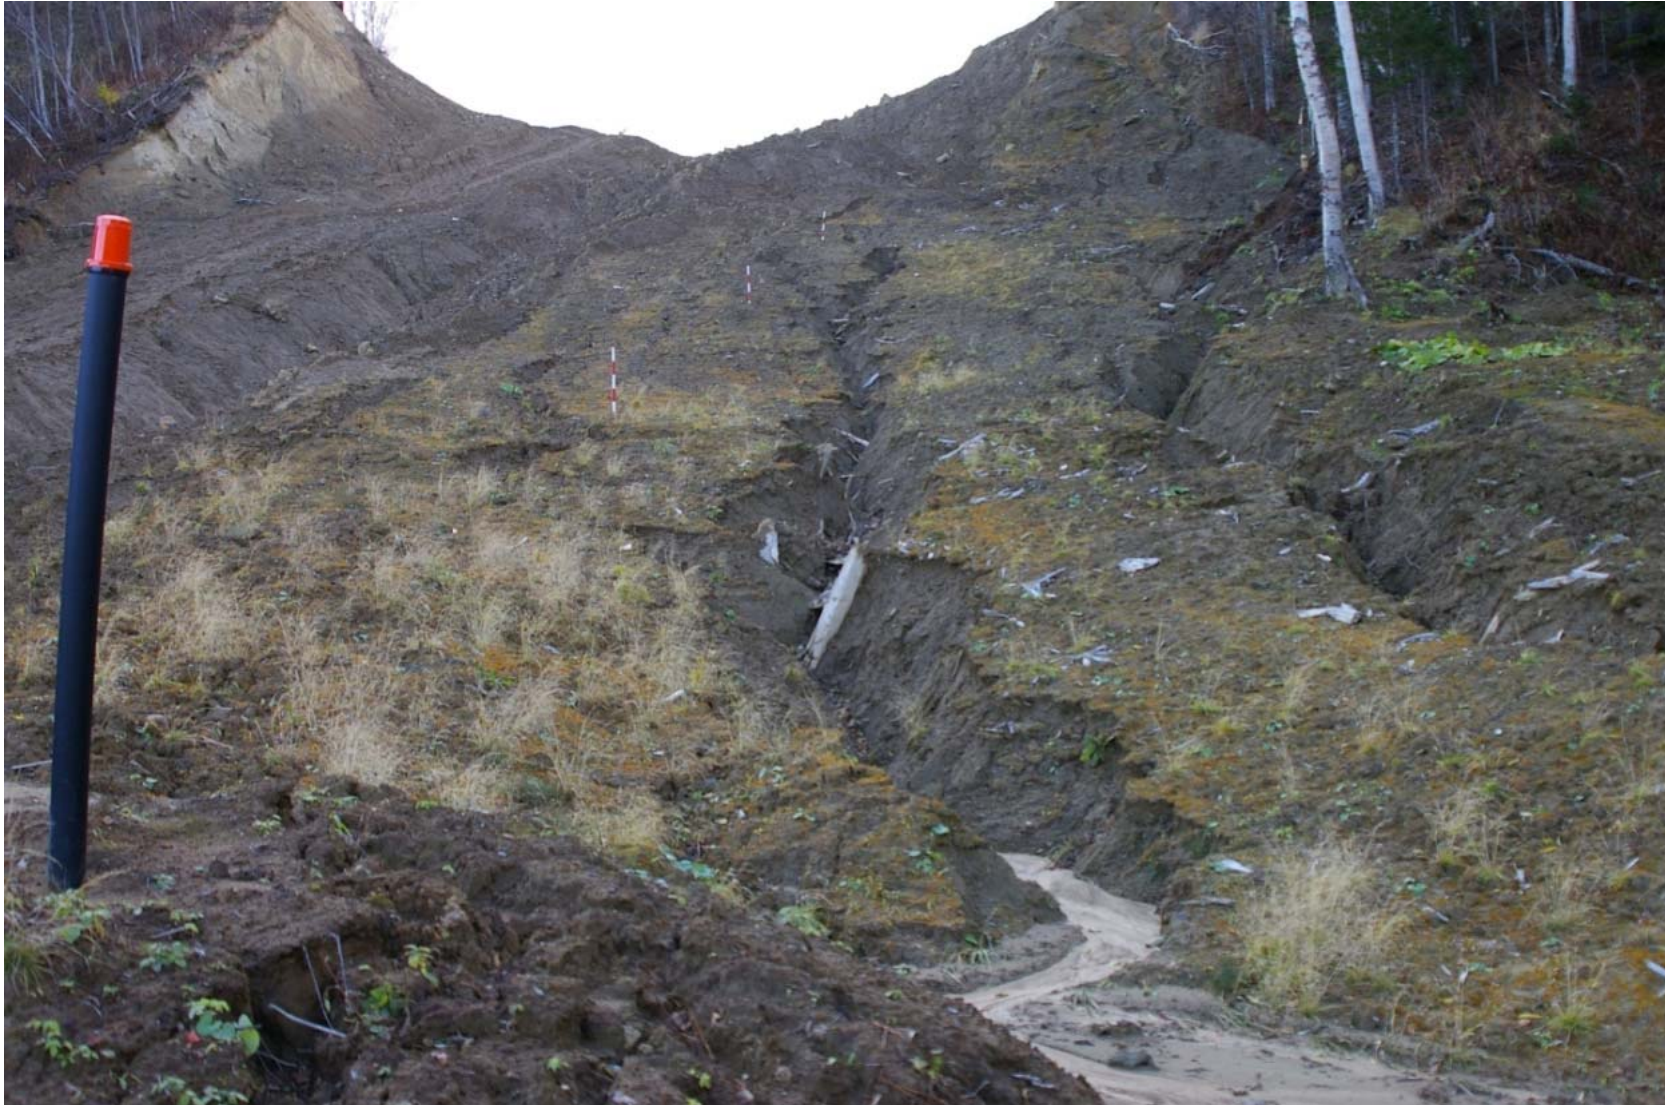
October 23, 2007: KP 492.9. Right bank of the Listvennitsa River. Erosion ditches on the pipeline RoW. This stream is muddy brown from erosion runoff.

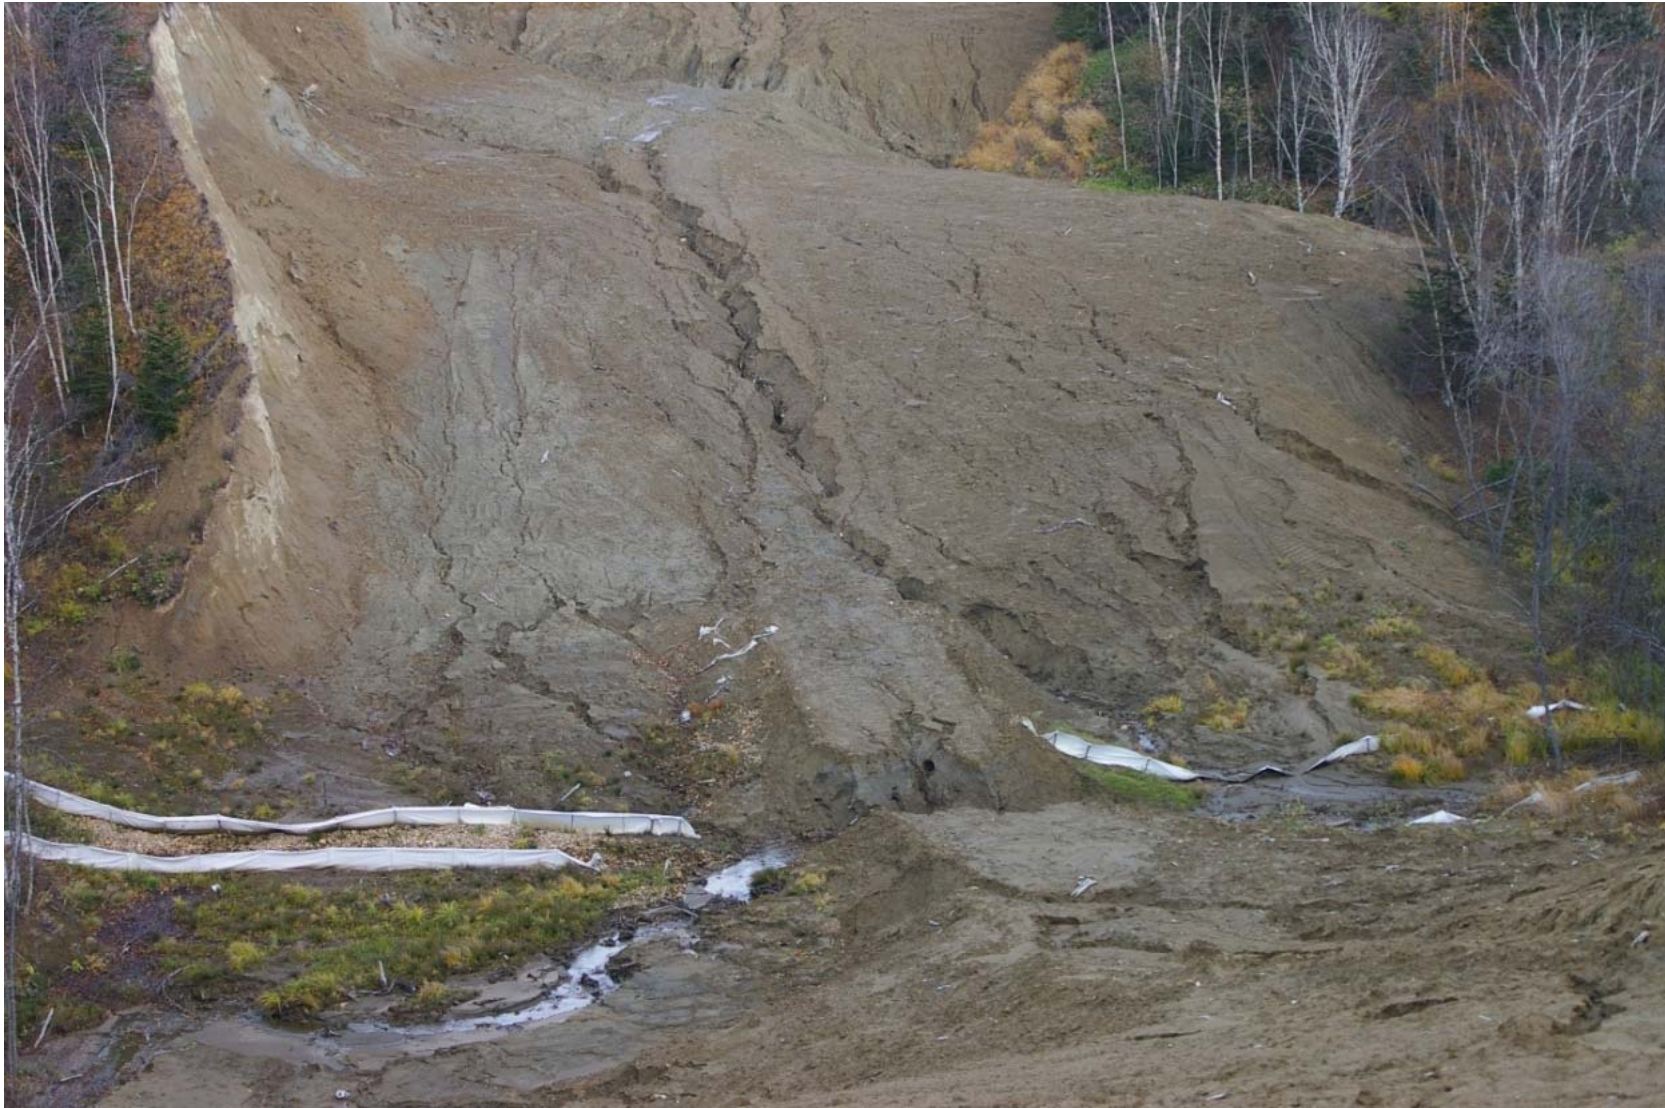
October 23, 2007: KP 492.5. Stream to the north of the Listvennitsa River (left bank). Erosion ditches on the pipeline RoW. The stream has made a channel through the earth mound placed across the stream last winter. The earth mound (here and in other locations) was made for vehicles which were doing "technical recultivation" last winter. The main purpose of the mound was to simplify stream crossings for vehicles during winter operations, yet this "technical recultivation" is now a source of erosion into the stream.
