# Citizens Photo Monitoring Report

Prepared by Sakhalin Environment Watch  
&  
Pacific Environment

Sakhalin II Pipeline Route  
October & December 2007

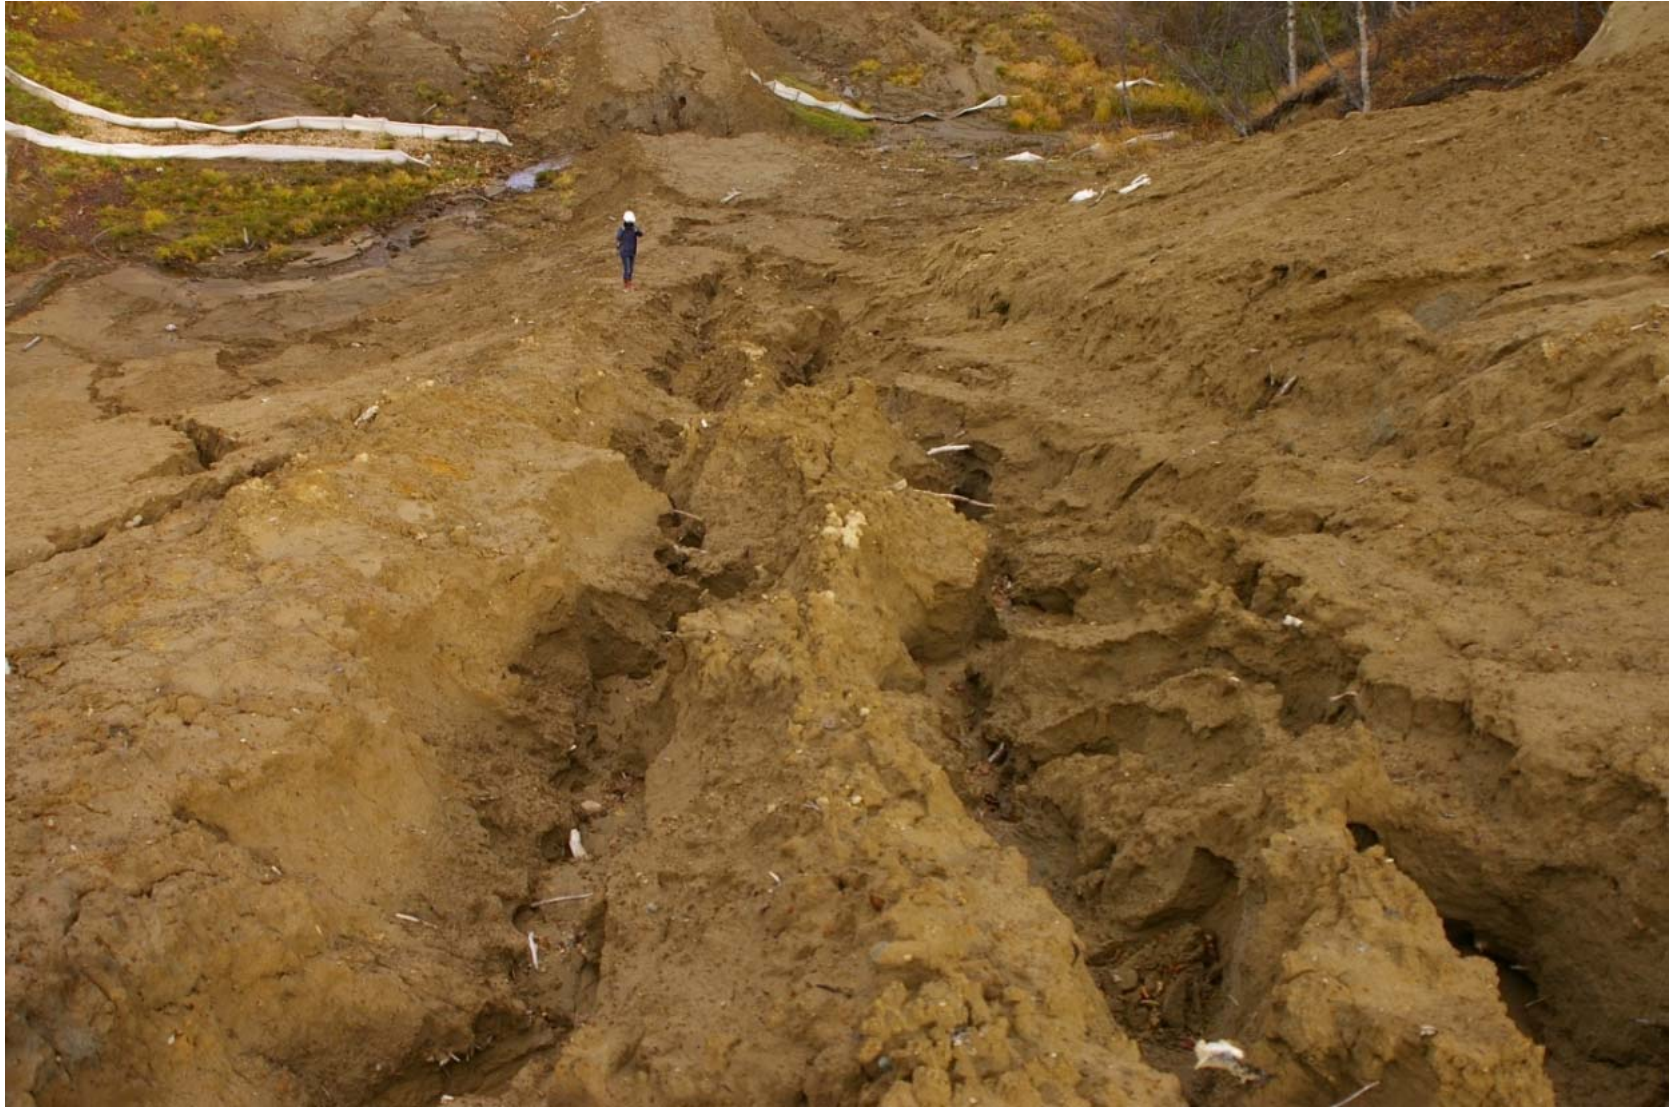
October 23, 2007: KP 492.5. Stream to the north of the Listvennitsa River (right bank). Severe erosion ditches on the pipeline RoW.

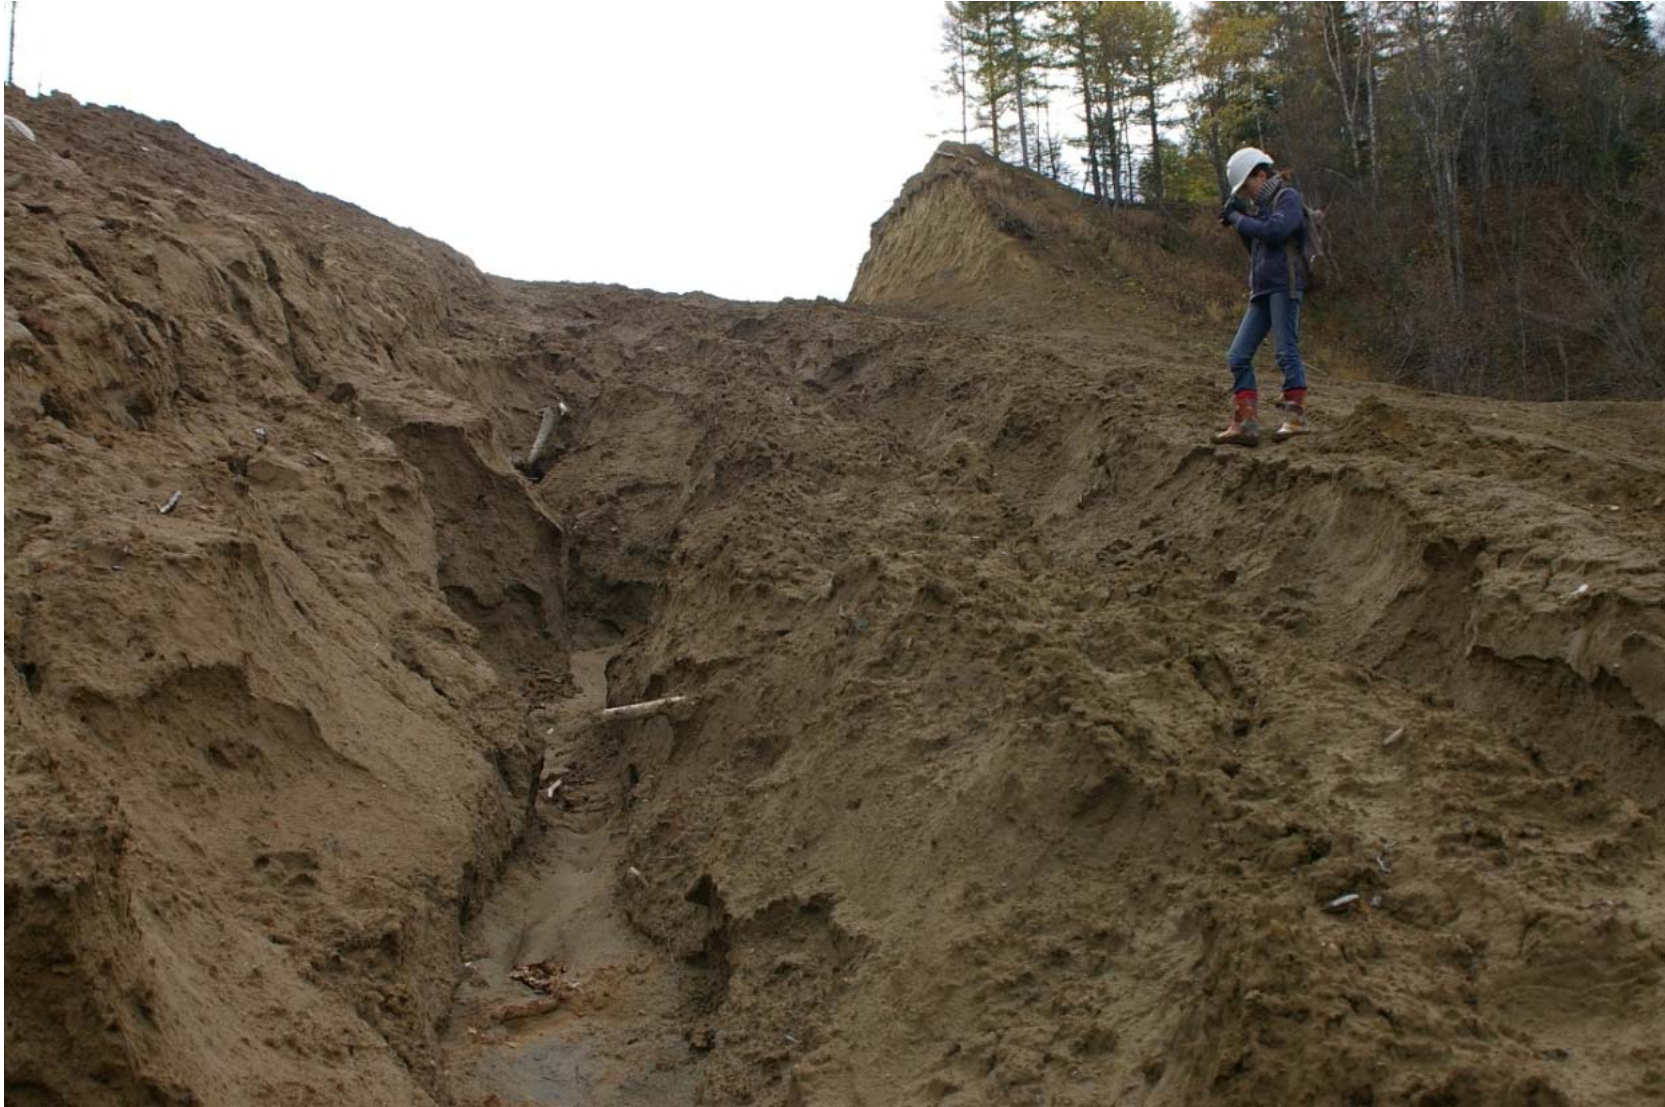
October 23, 2007: KP 492.5. Stream to the north of the Listvennitsa River (right bank). Very deep erosion ditch on the pipeline RoW.

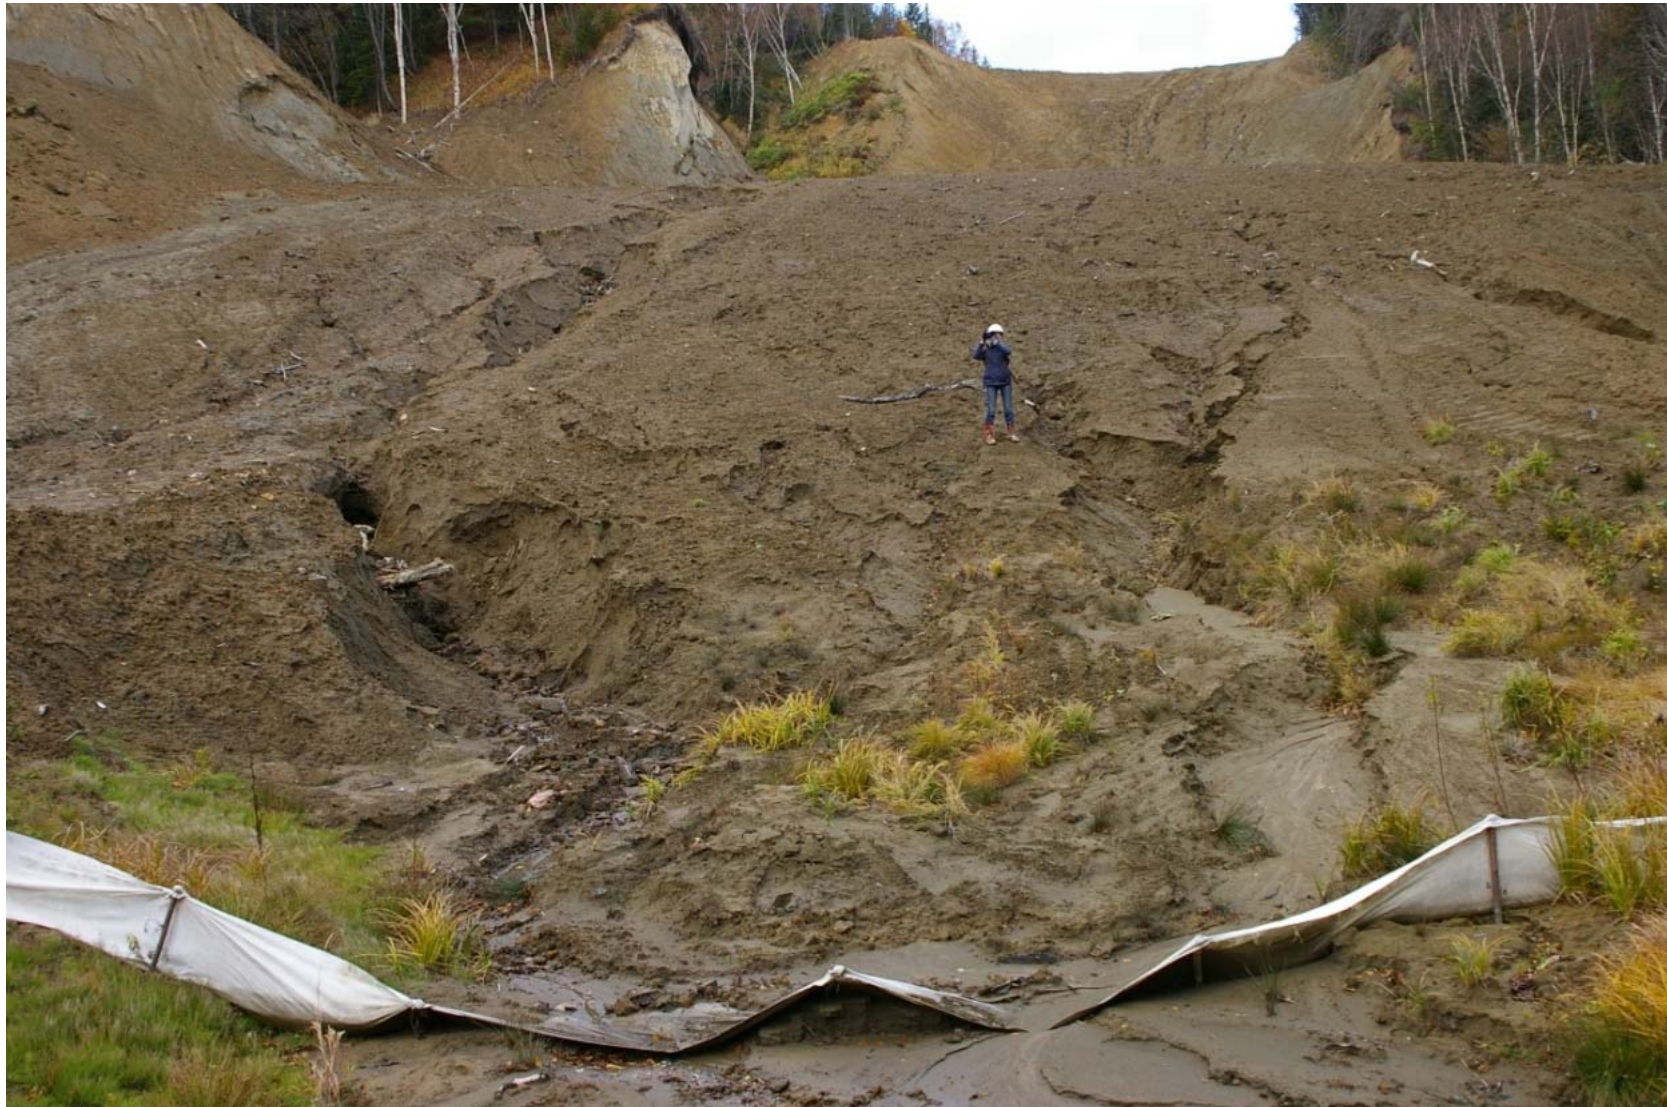
October 23, 2007: KP 492.5. Stream to the north of the Listvennitsa River (right bank). Massive, long term washout of earth into the stream is obvious.

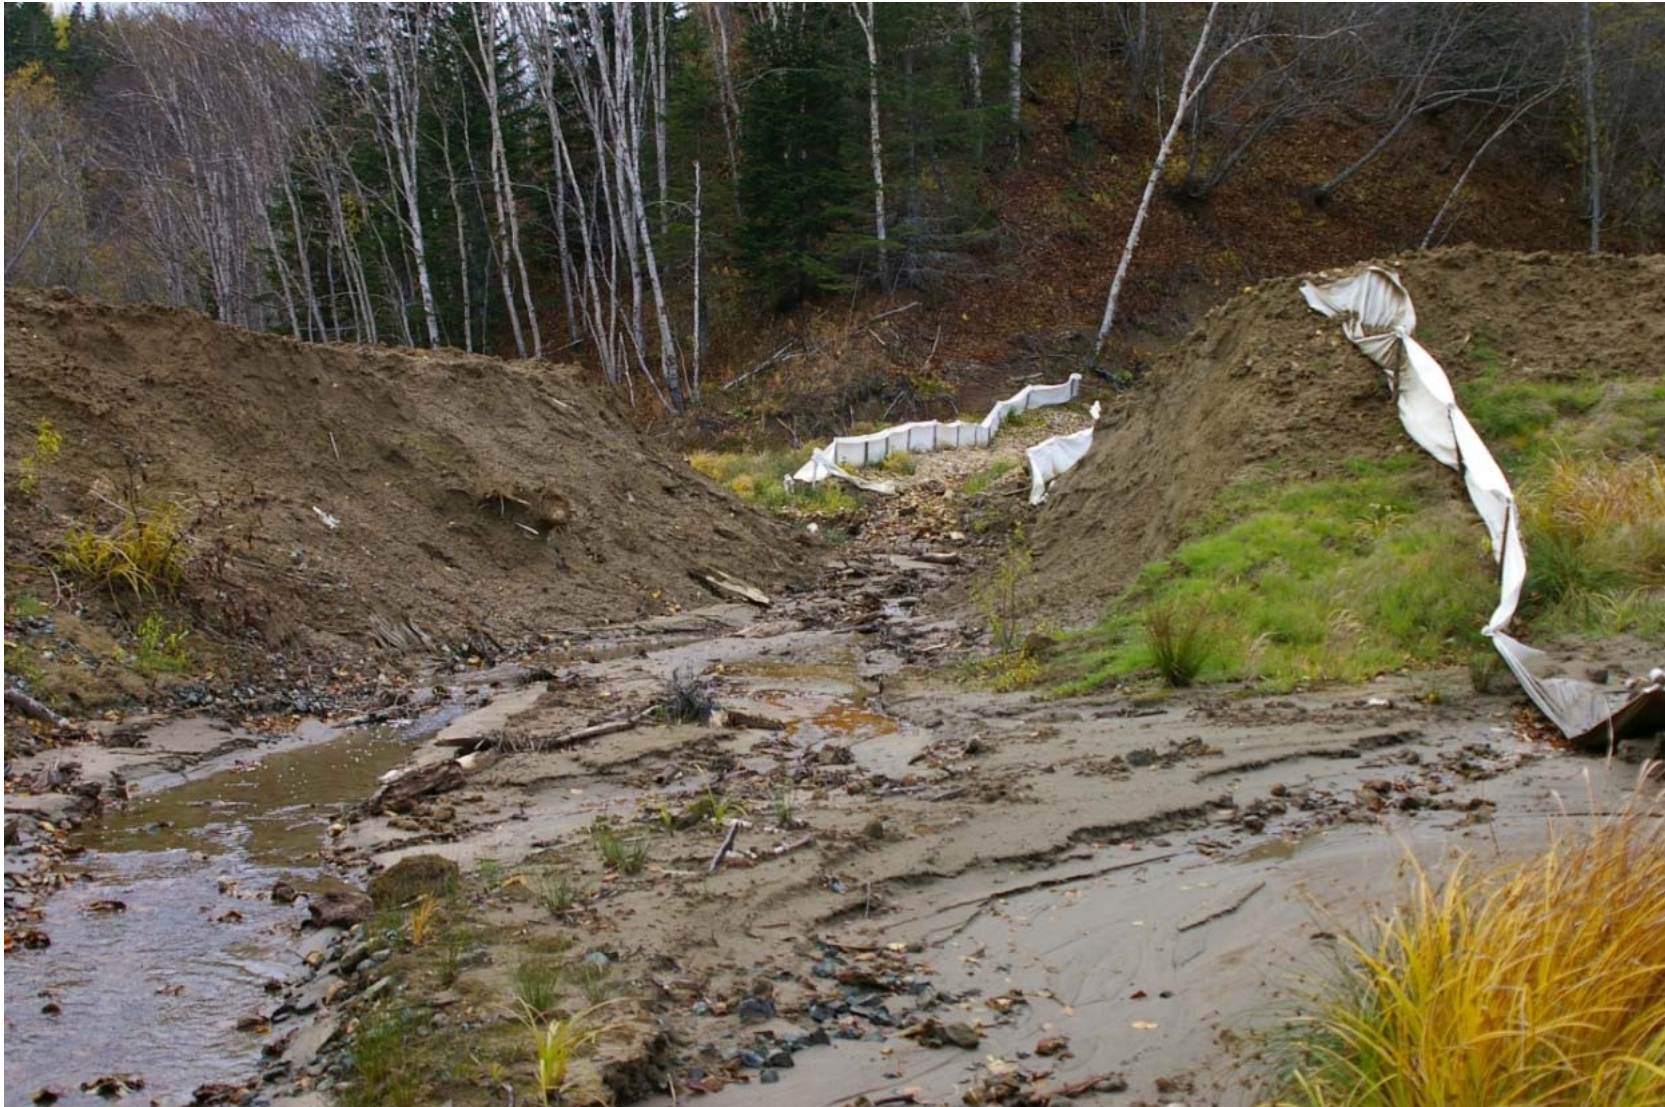
October 23, 2007: KP 492.5. Stream to the north of the Listvennitsa River. Again, the stream has passed through an earth mound which was placed across the stream during winter "technical recultivation," creating a source of erosion into the stream. Tens of tons of earth were washed into the stream.

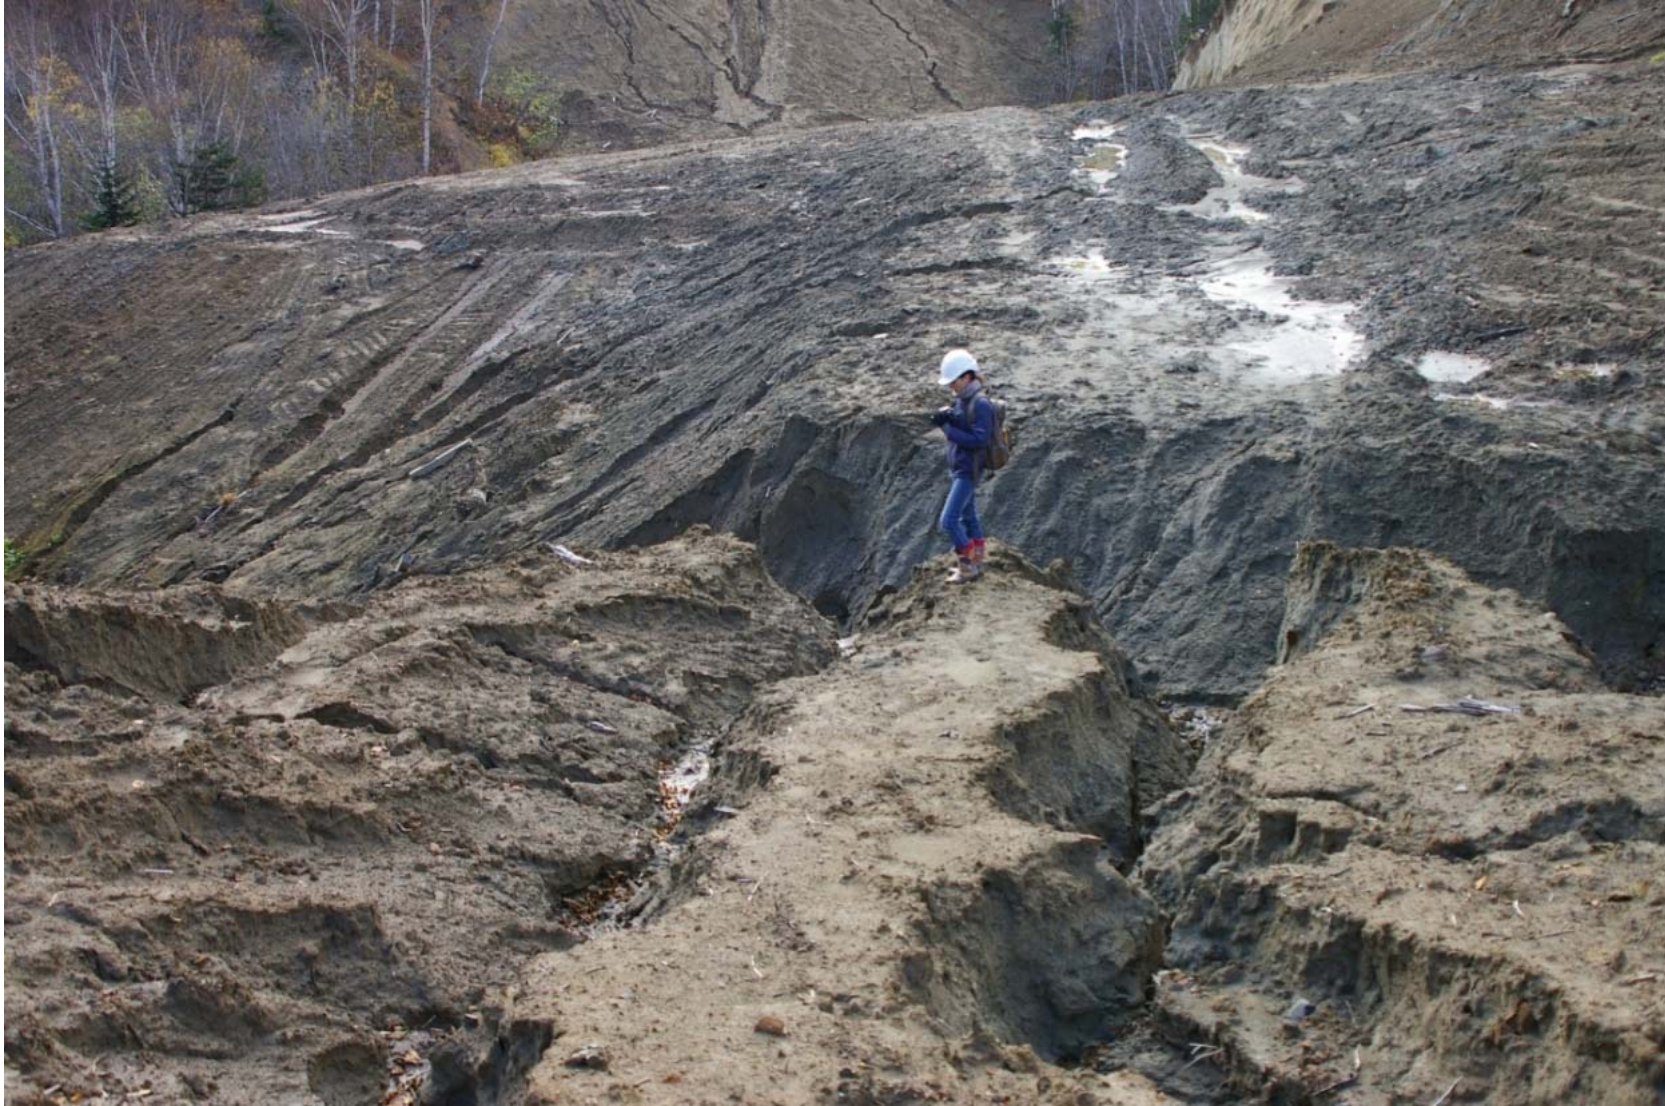
October 23, 2007: KP 492.4. Left tributary of the previous stream (to the north of the Listvennitsa River). This small stream was also blocked by an earth mound in the winter and has since passed through the mound, causing serious erosion processes.

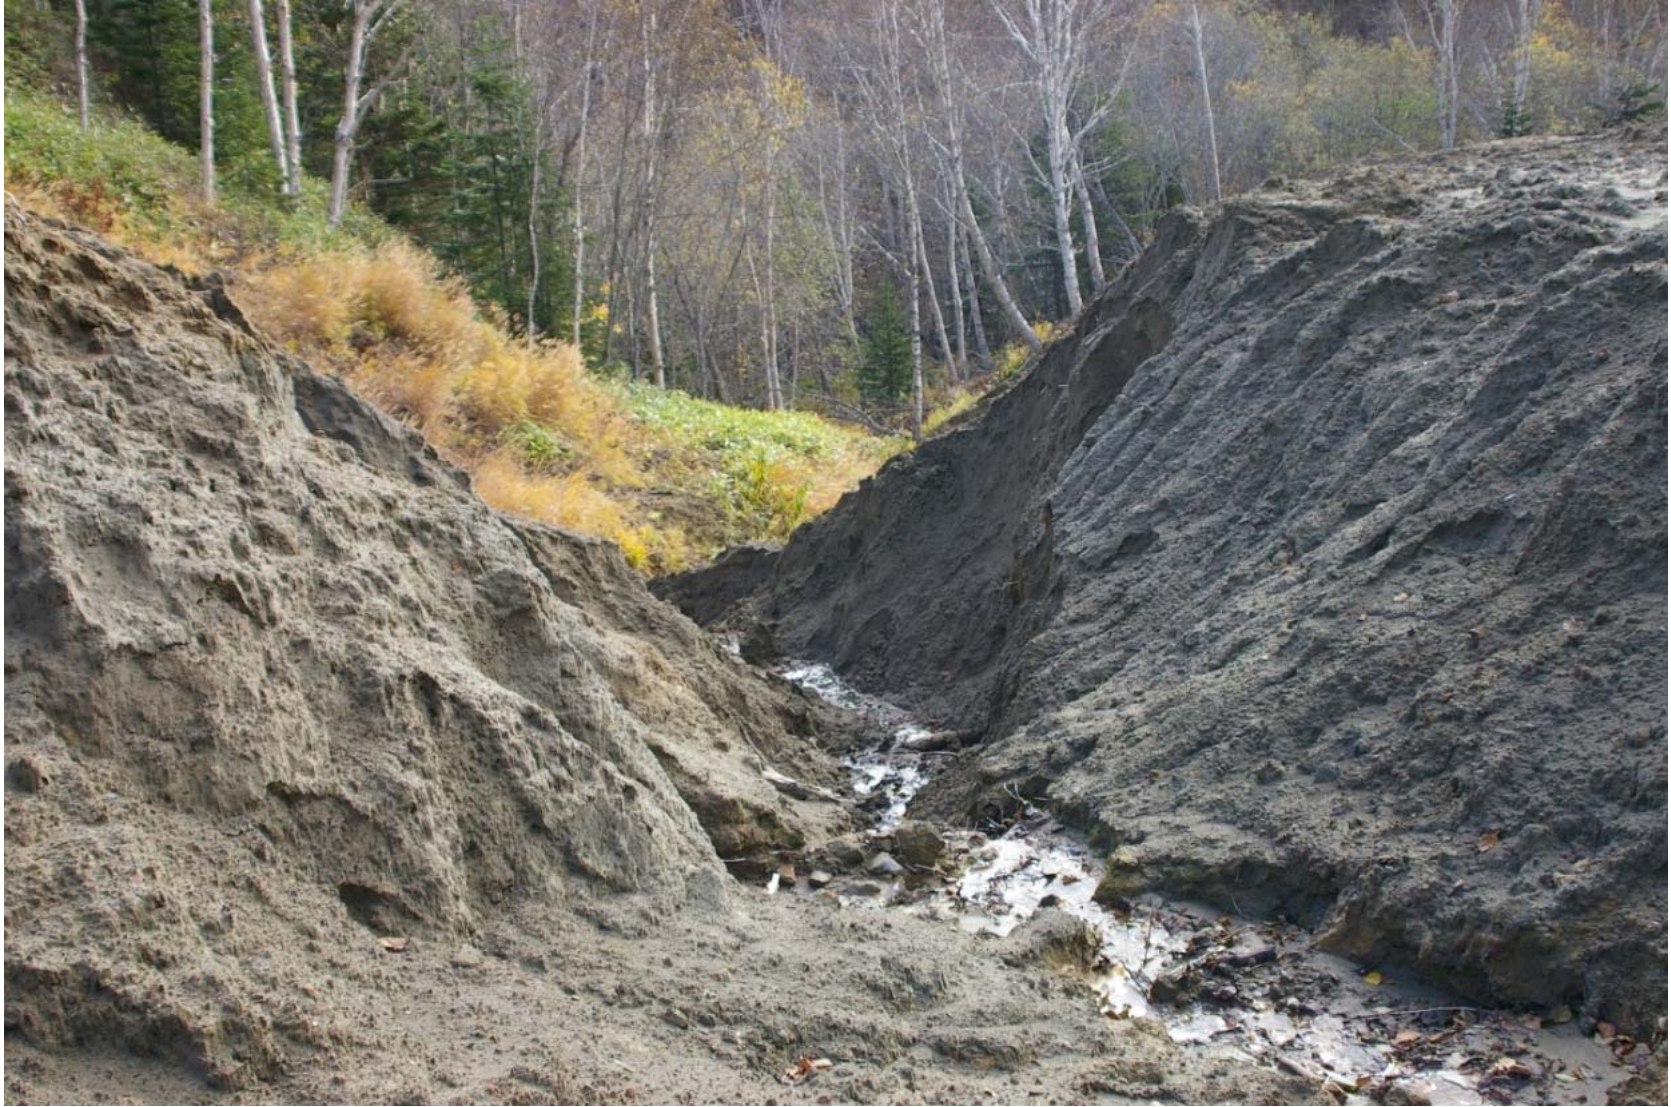
October 23, 2007: KP 492.4. An earth mound which was washed out by the stream.

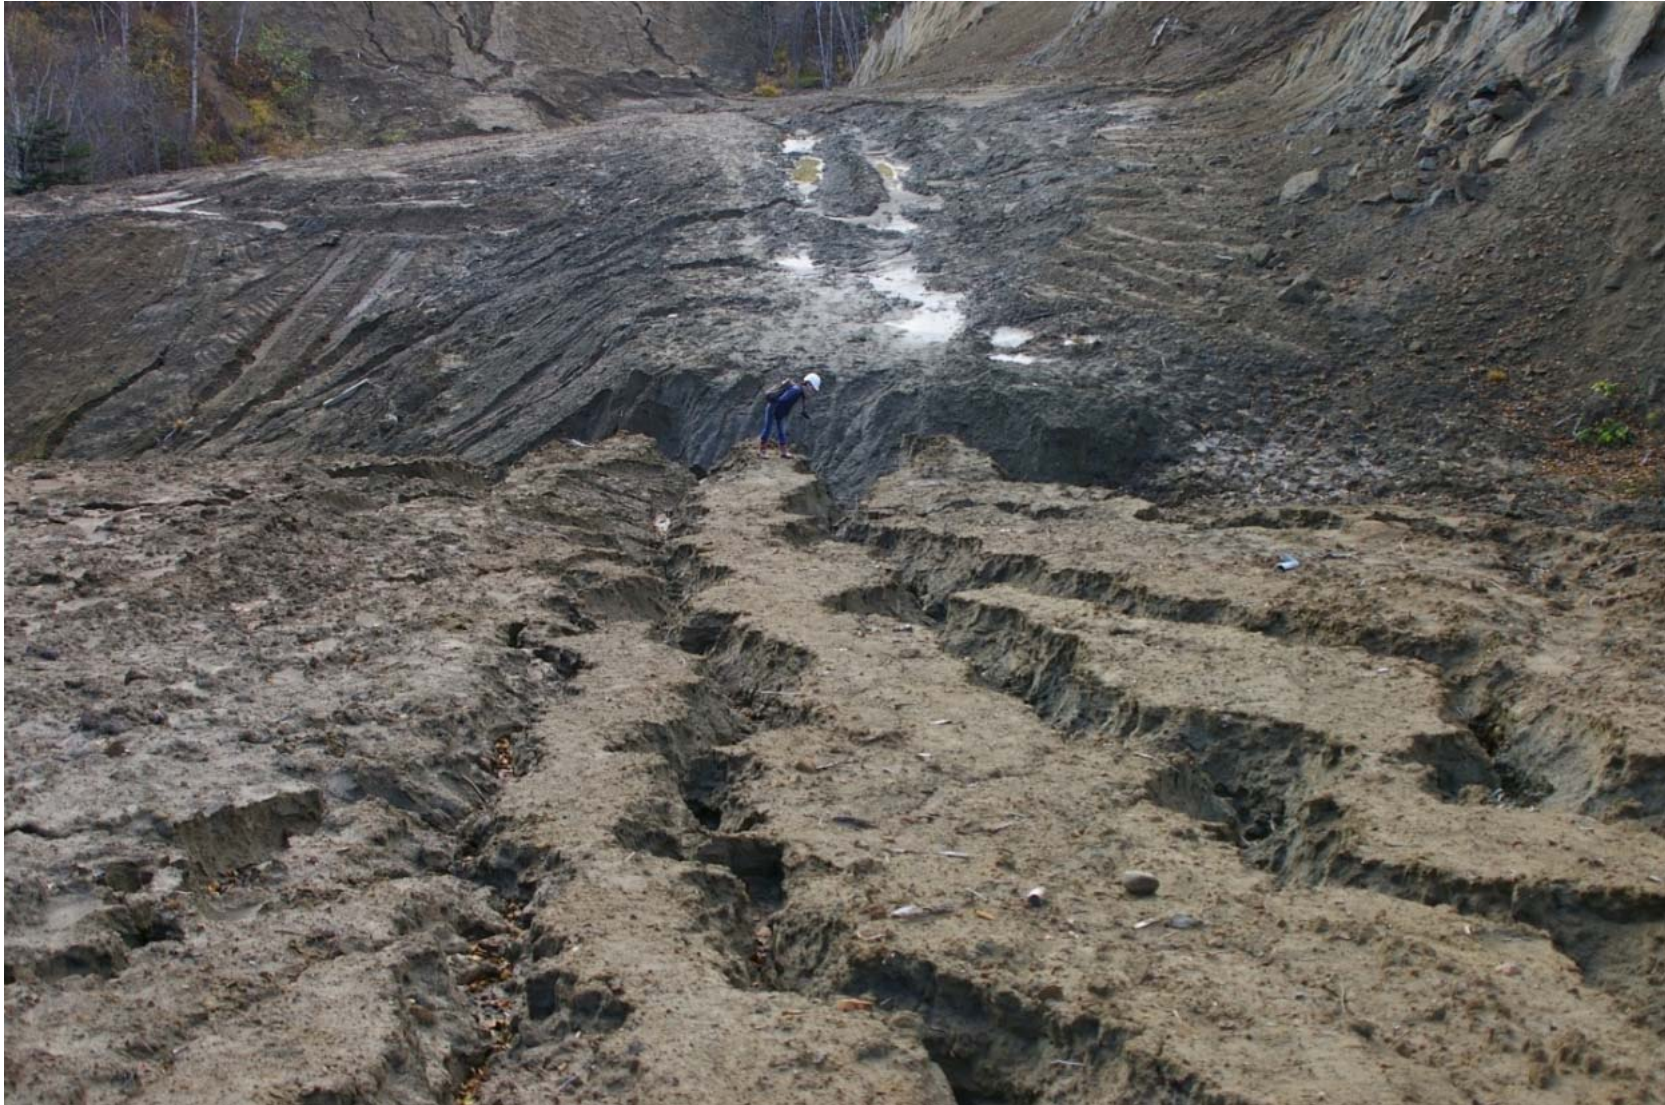
October 23, 2007: KP 492.4. Deep erosion ditches on the left bank of the left tributary of the stream, located to the north of the Listvennitsa River.

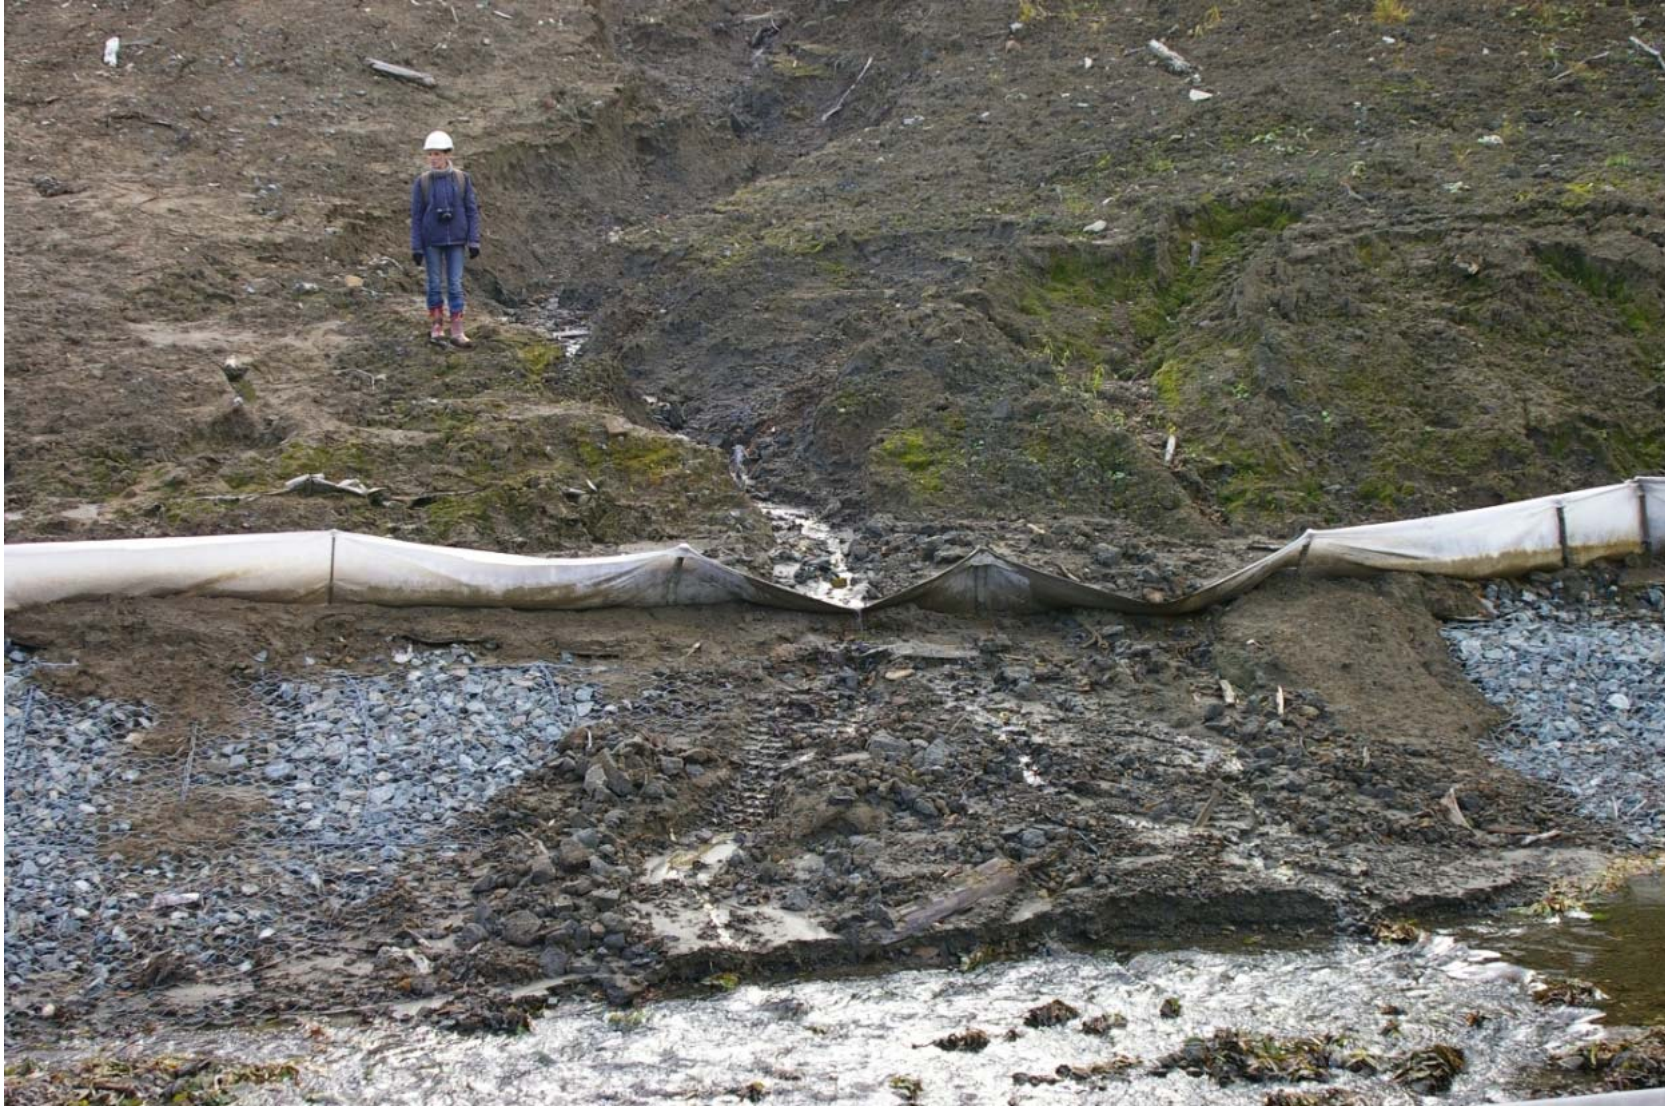
October 23, 2007: KP 491.4. Right bank of the Krutoyarka River. The silt fences don't work and erosion runoff enters the stream.

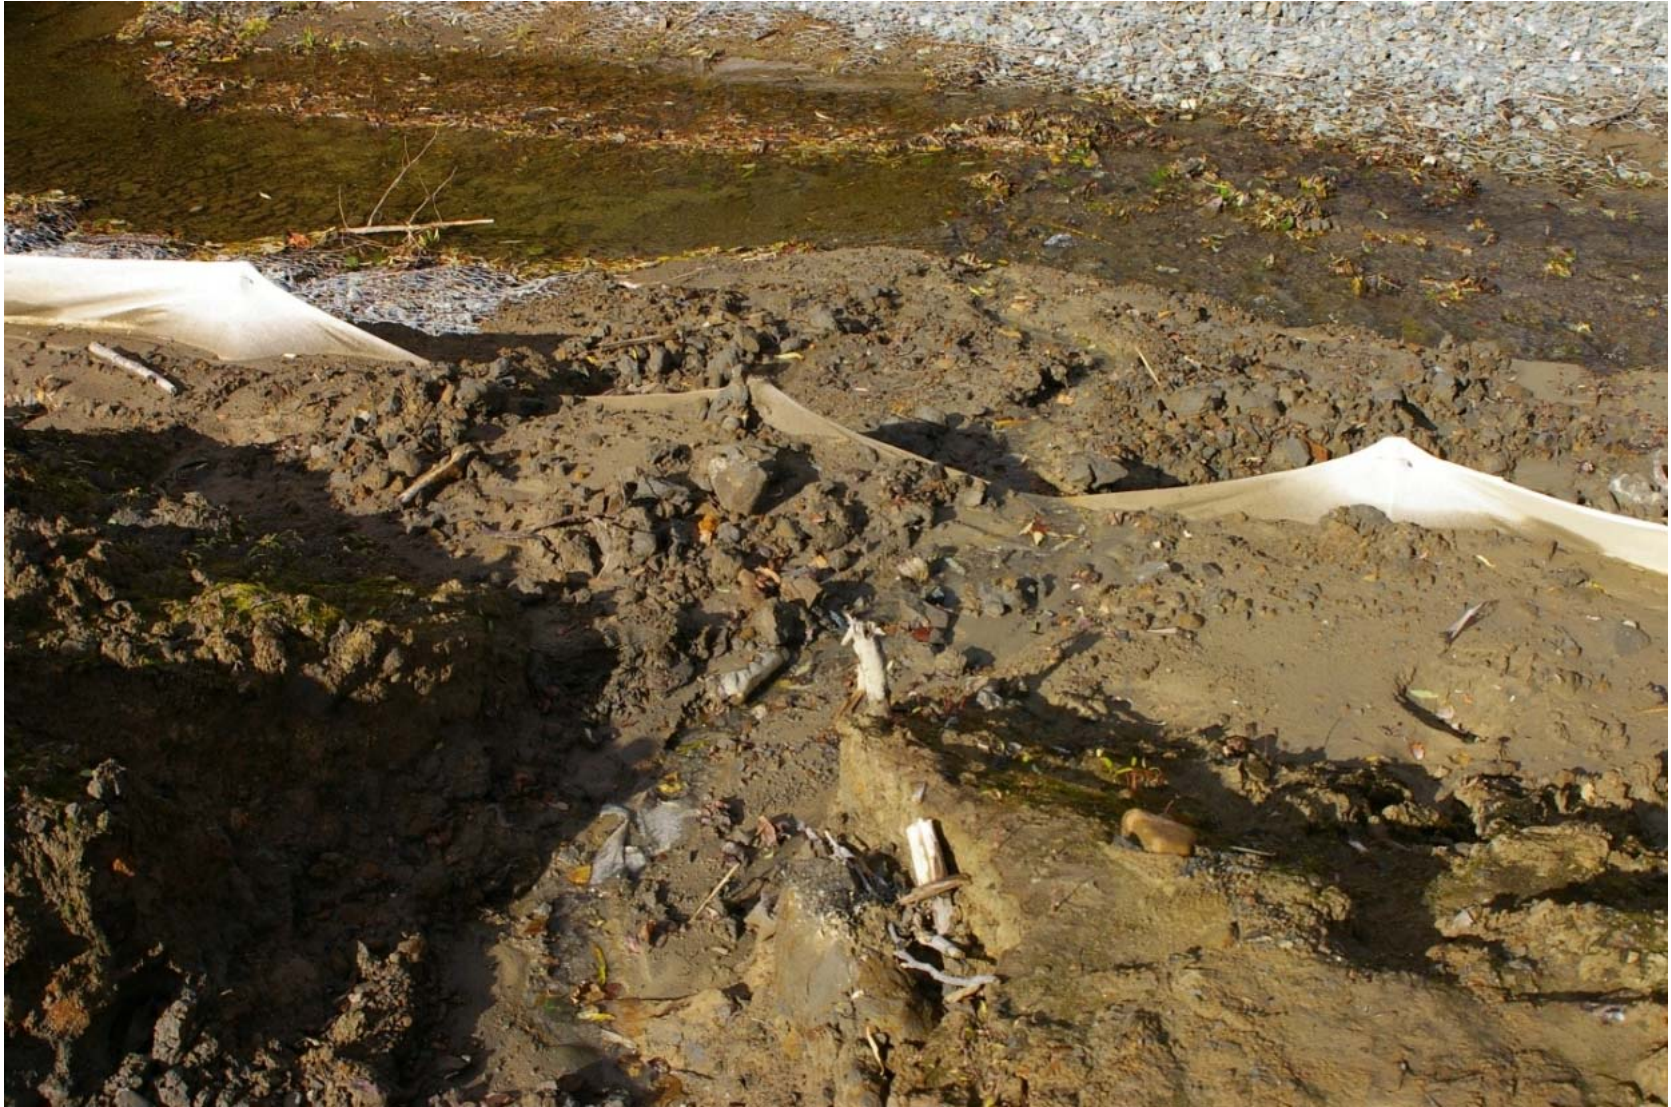
October 23, 2007: KP 491.4. Right bank of the Krutoyarka River. More failed silt fences.

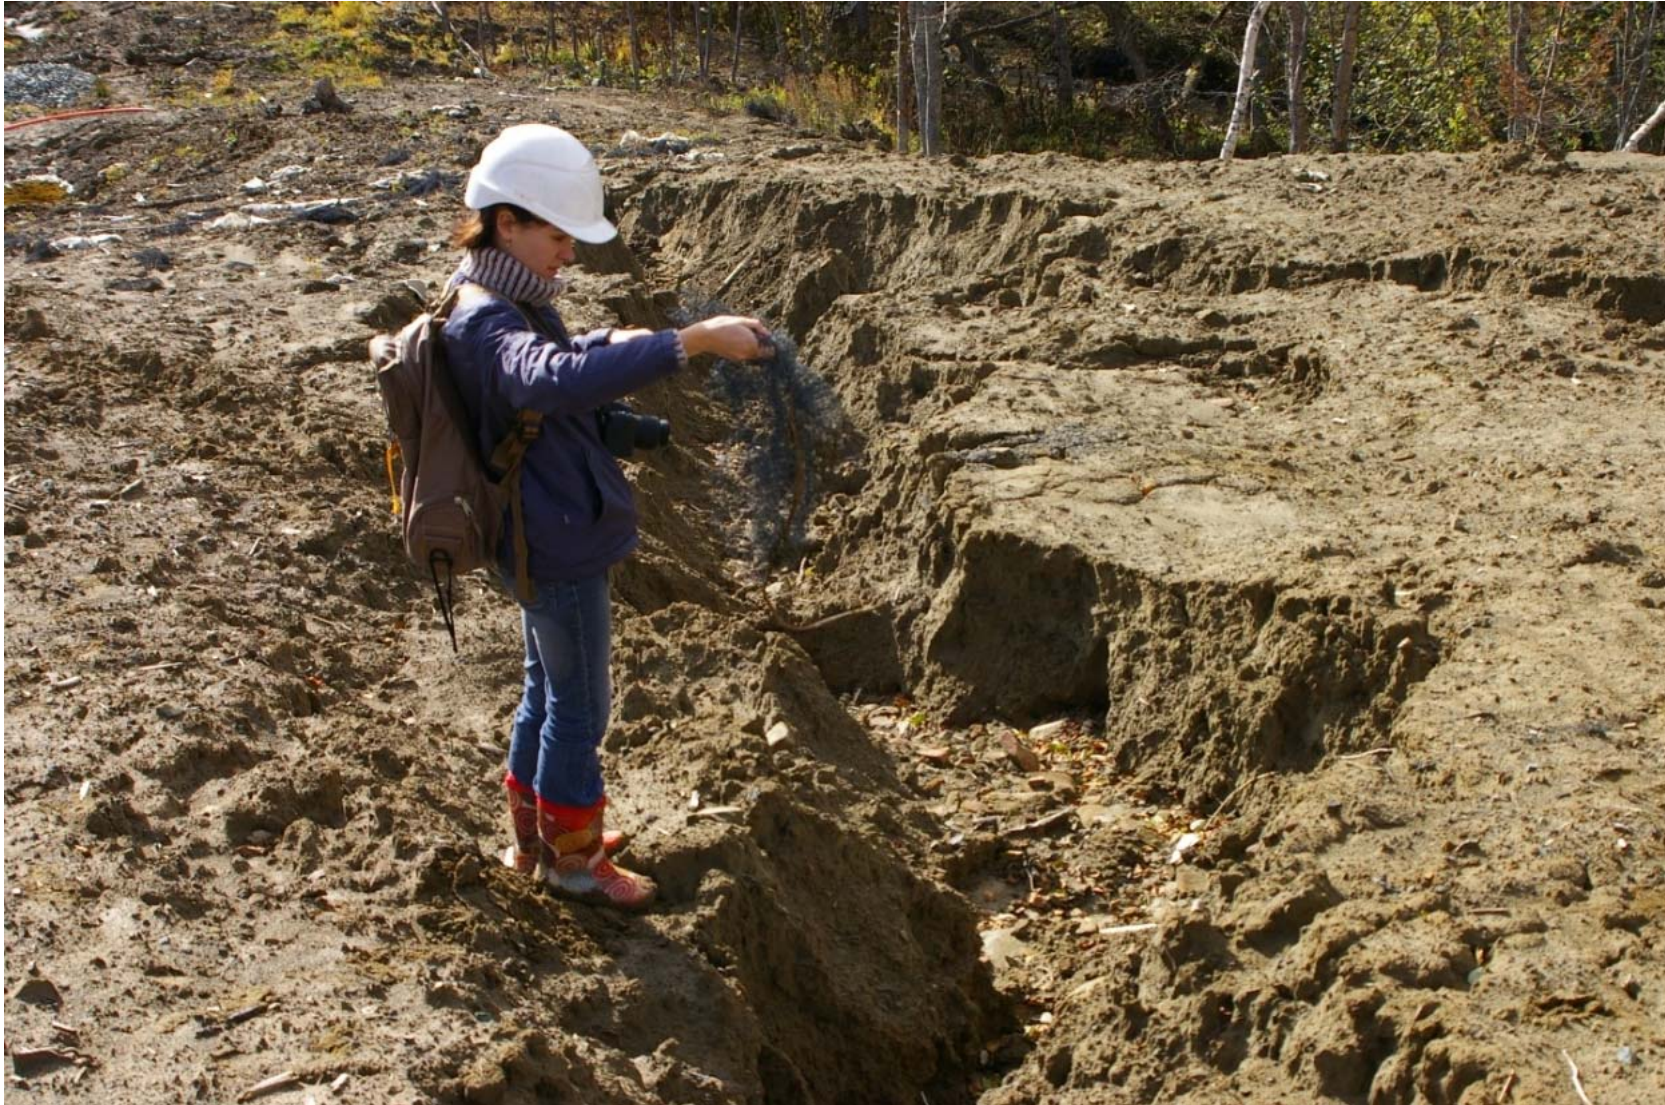
October 23, 2007: KP 491.3. Left bank of the Krutoyarka River. Galya is holding the remains of failed enkamats. Though a very few anti-erosion measures such as this were observed, they absolutely failed to achieve their intended purpose.

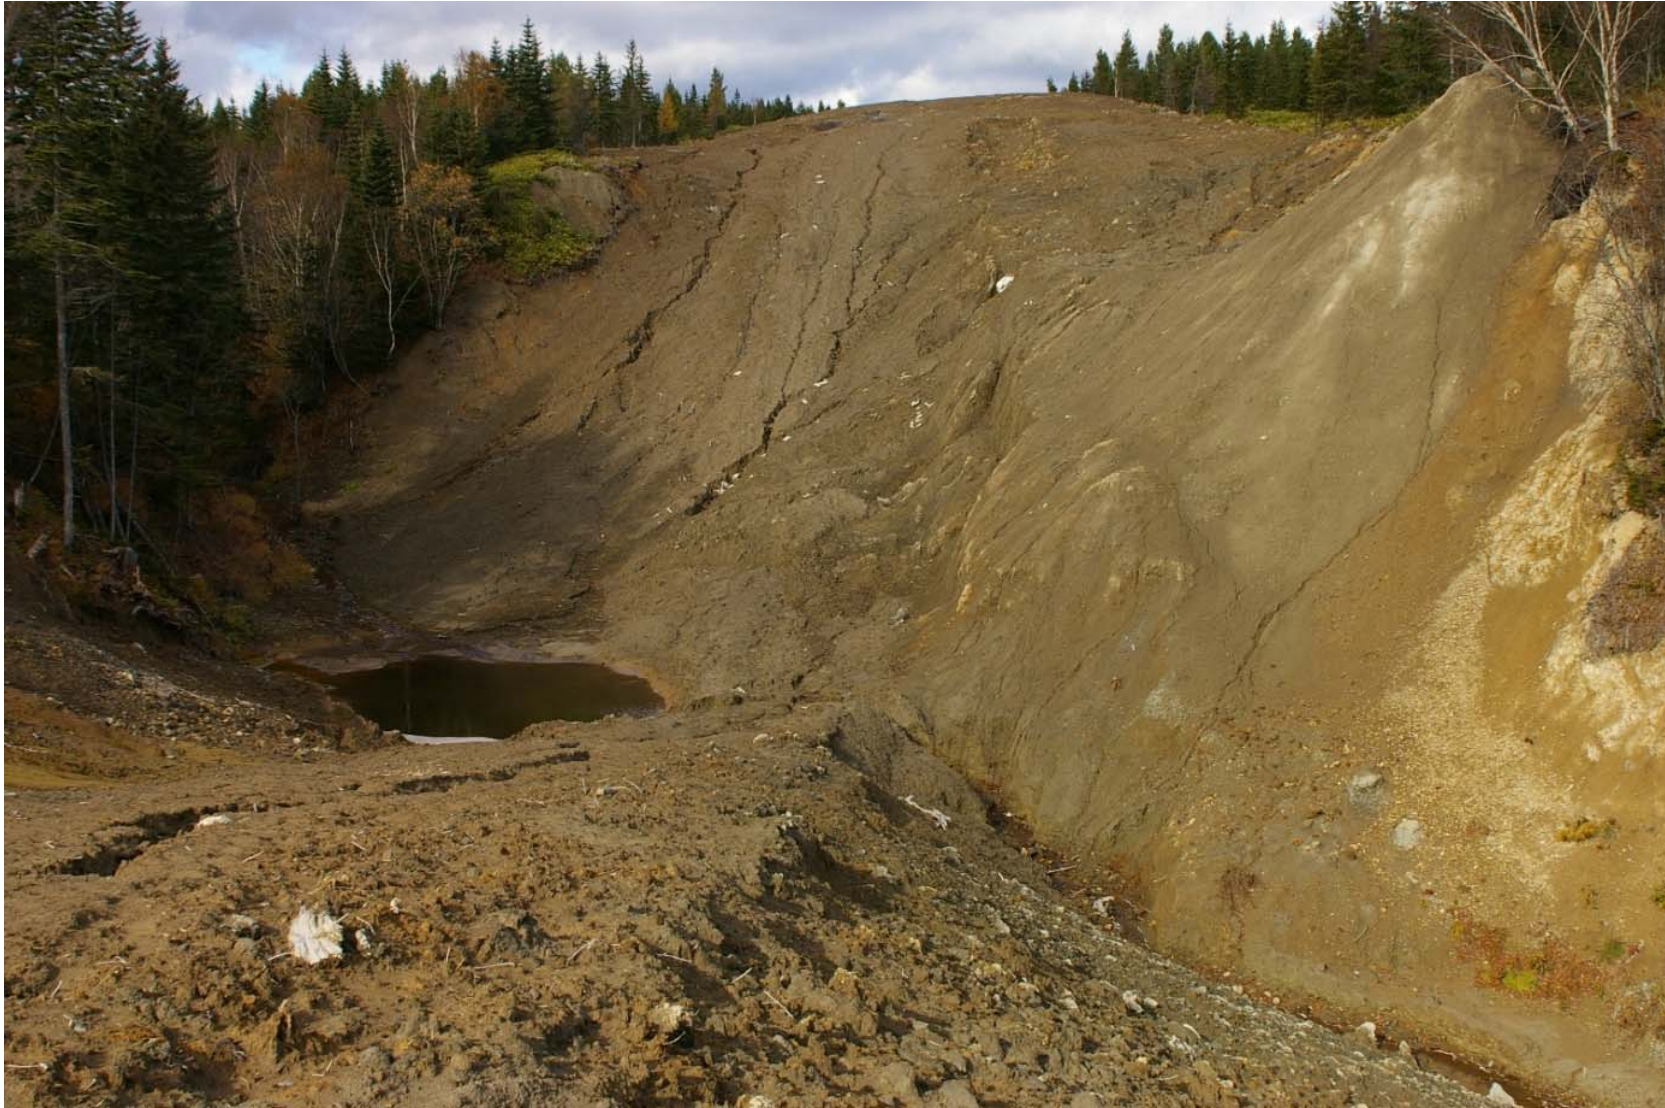
October 23, 2007: KP 490.6. Stream to the north of the Krutoyarka River. The pond formed as a result of the stream flow being blocked by an earth mound.

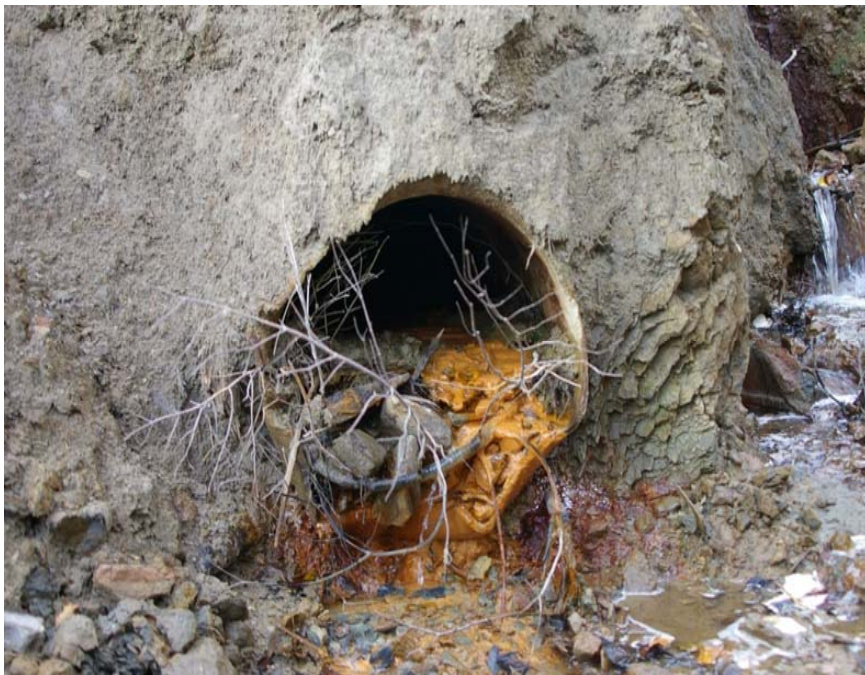
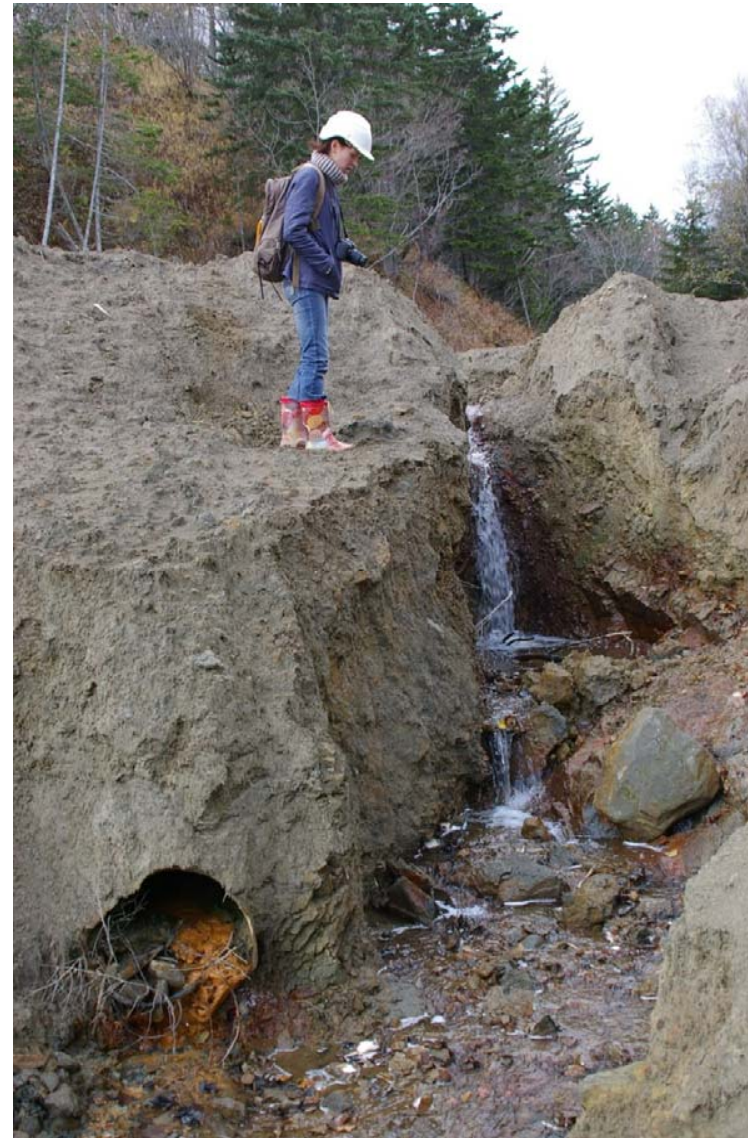
October 23, 2007: KP 490.6. Stream to the north of the Krutoyarka River.

The stream is passing through an earth mound.

The culvert (below) is blocked by earth and debris.
