# Citizens Photo Monitoring Report

Prepared by Sakhalin Environment Watch  
&  
Pacific Environment

Sakhalin II Pipeline Route  
October & December 2007

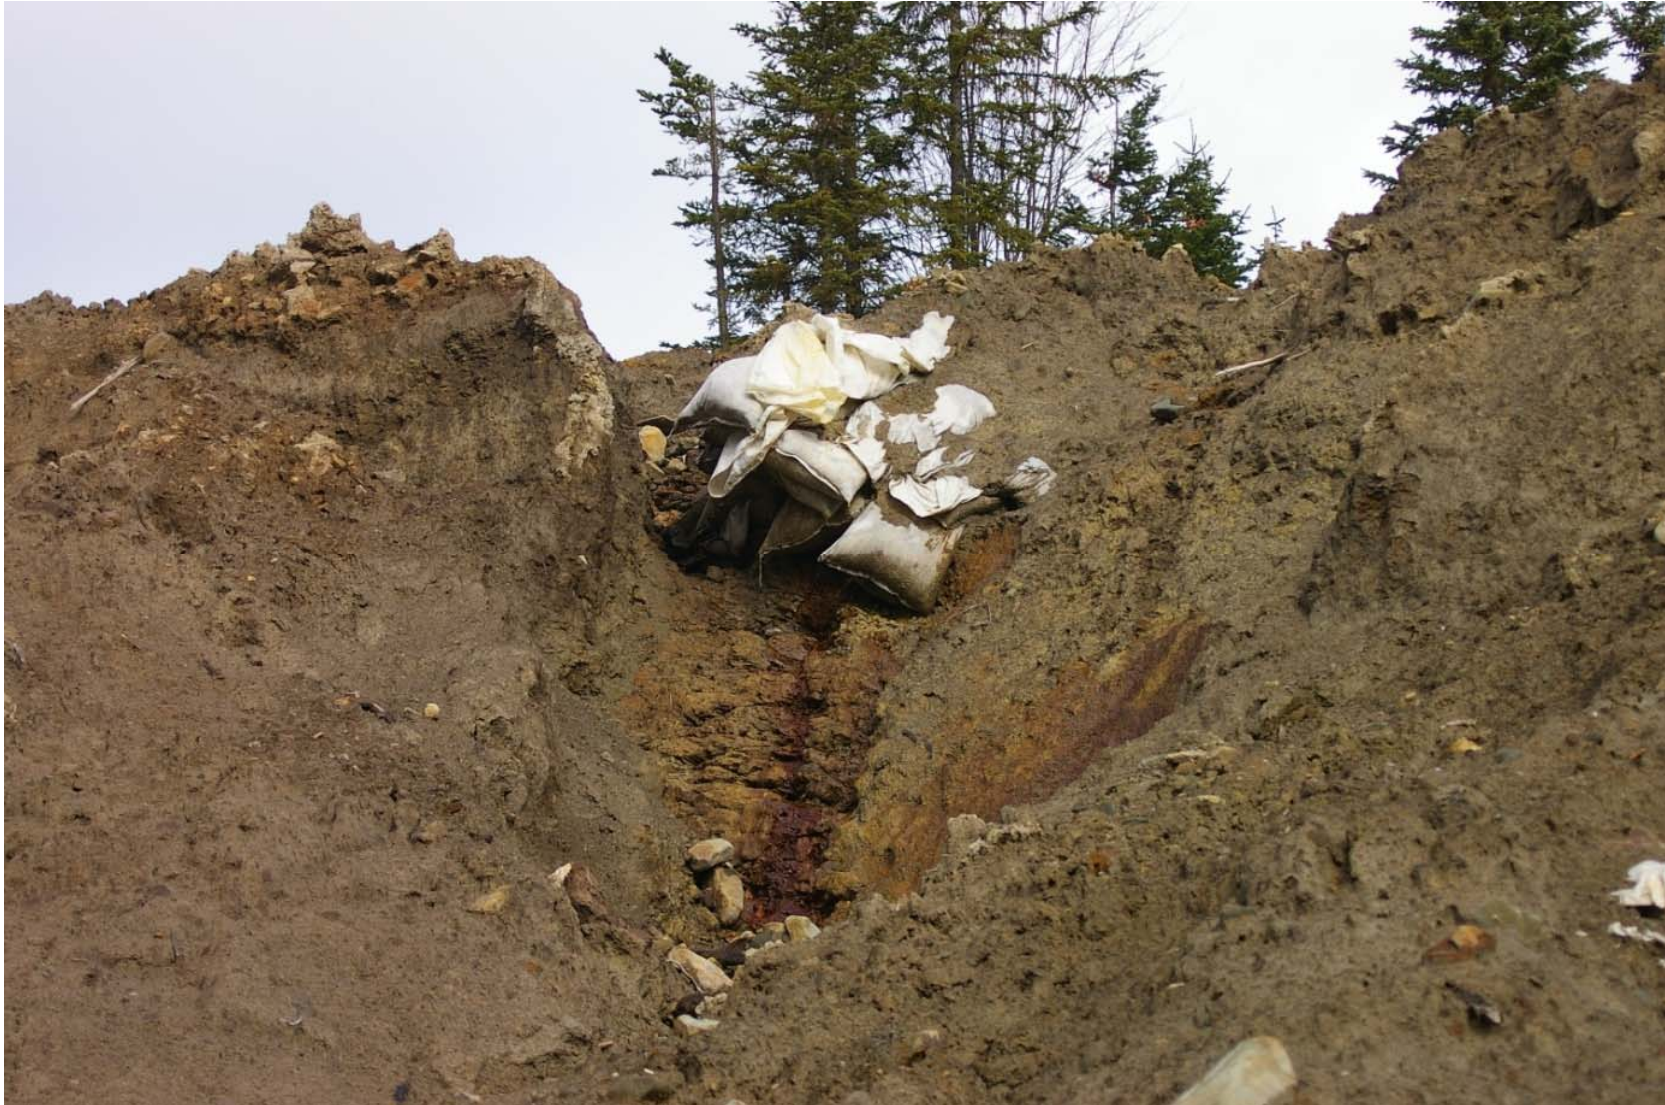
October 23, 2007: KP 490.5. Left bank of the stream to the north of the Krutoyarka River. Failed anti-erosion and anti-land slide measures. Though a very few anti-erosion measures such as this were observed, they absolutely failed to achieve their intended purpose.

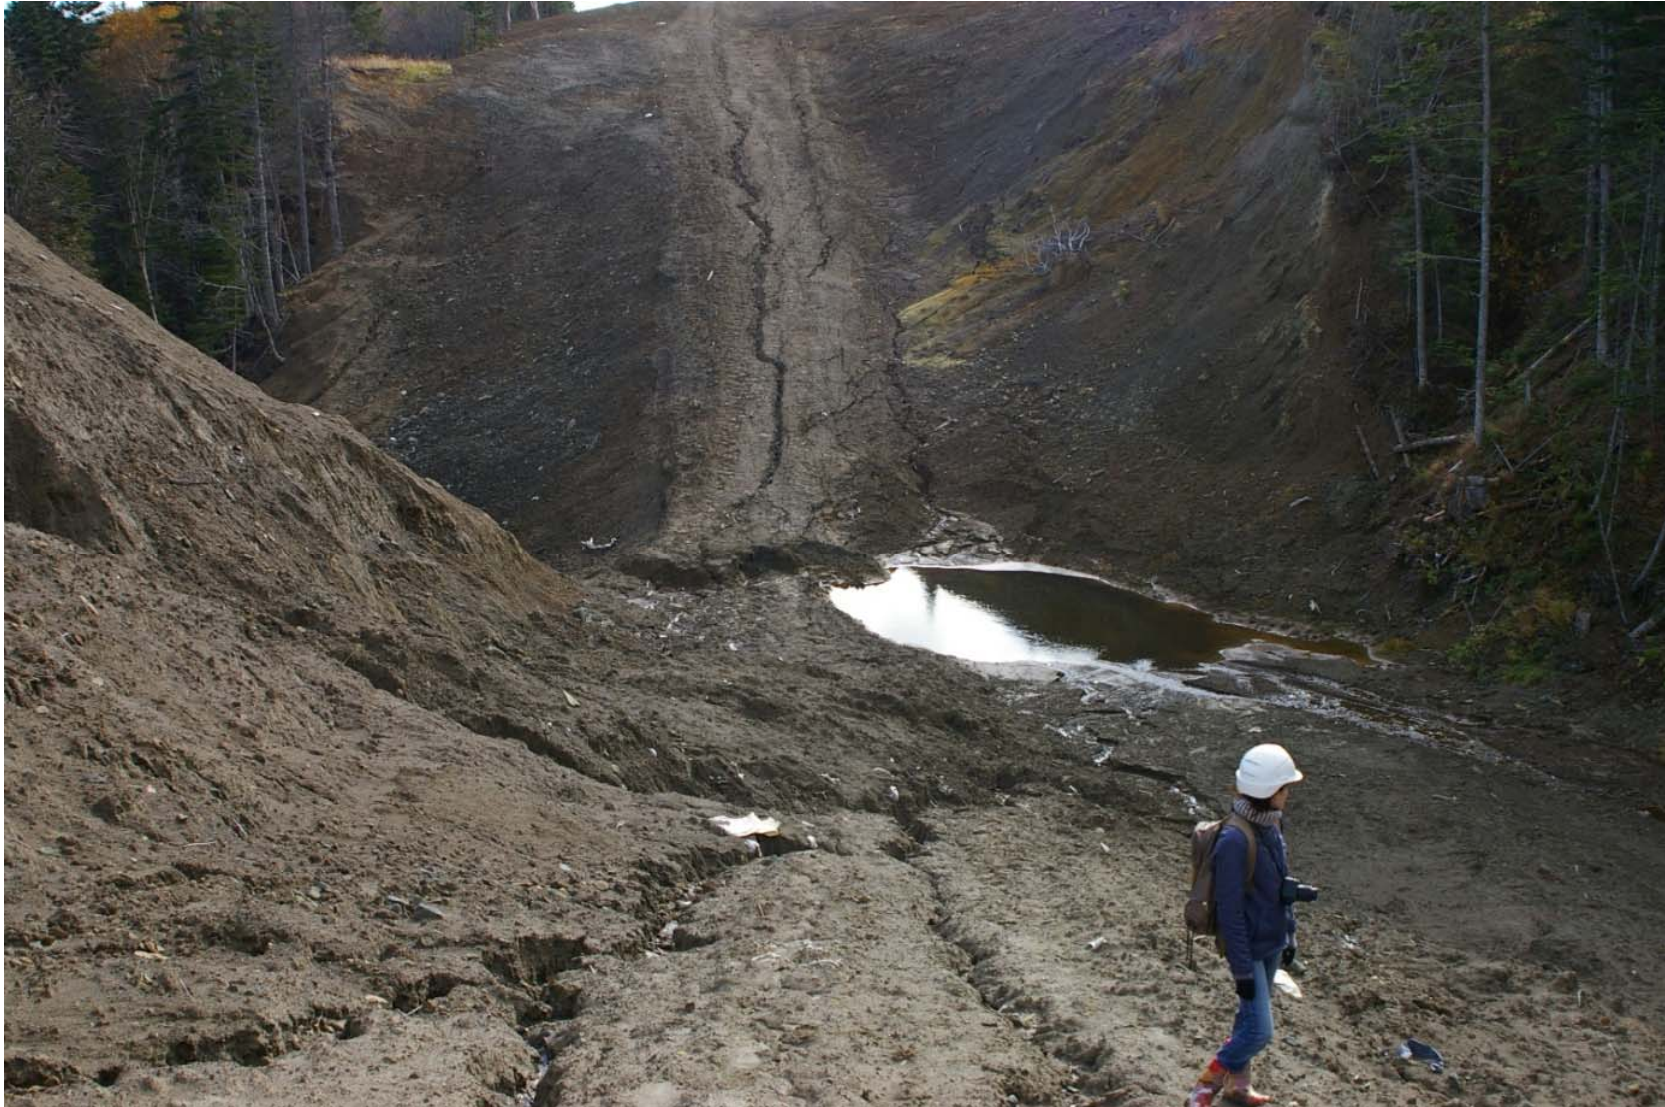
October 23, 2007: KP 490.6. Erosion runoff enters the stream to the north of the Krutoyarka River.

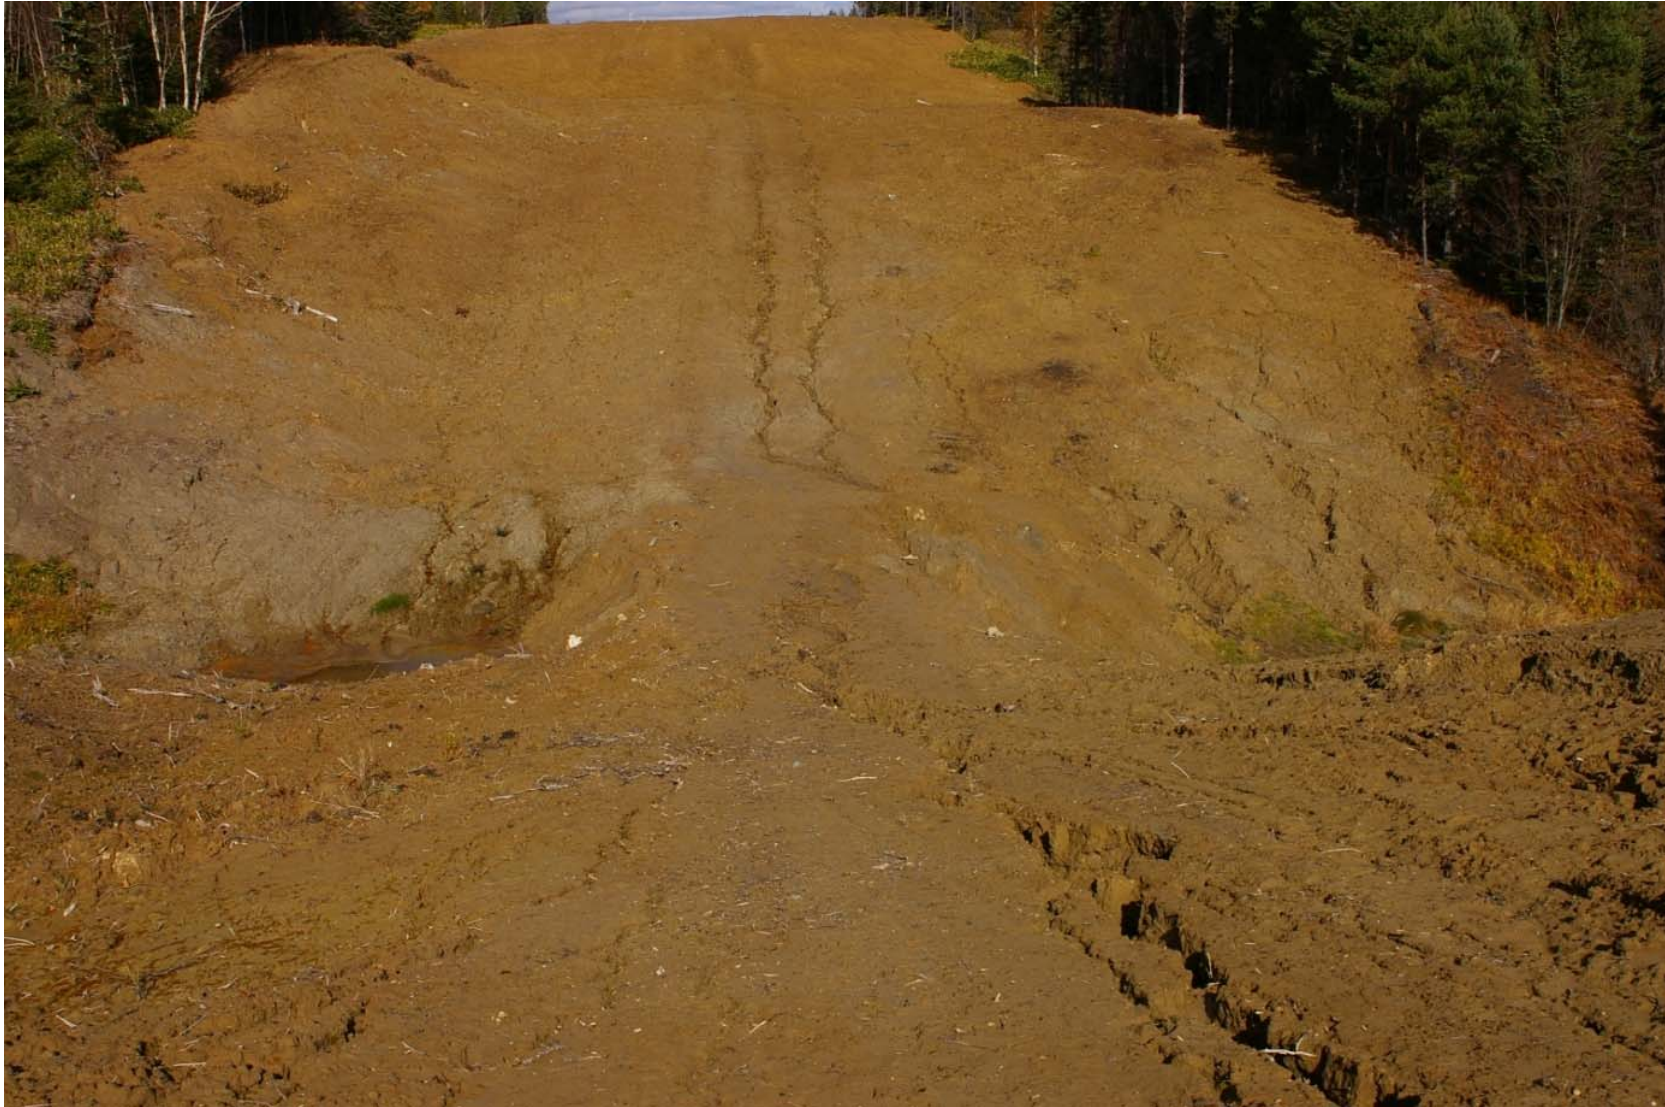
October 23, 2007: KP 490.2 Another stream to the north of the Krutoyarka River. This stream is also blocked by an earth mound which has been in place since last winter.

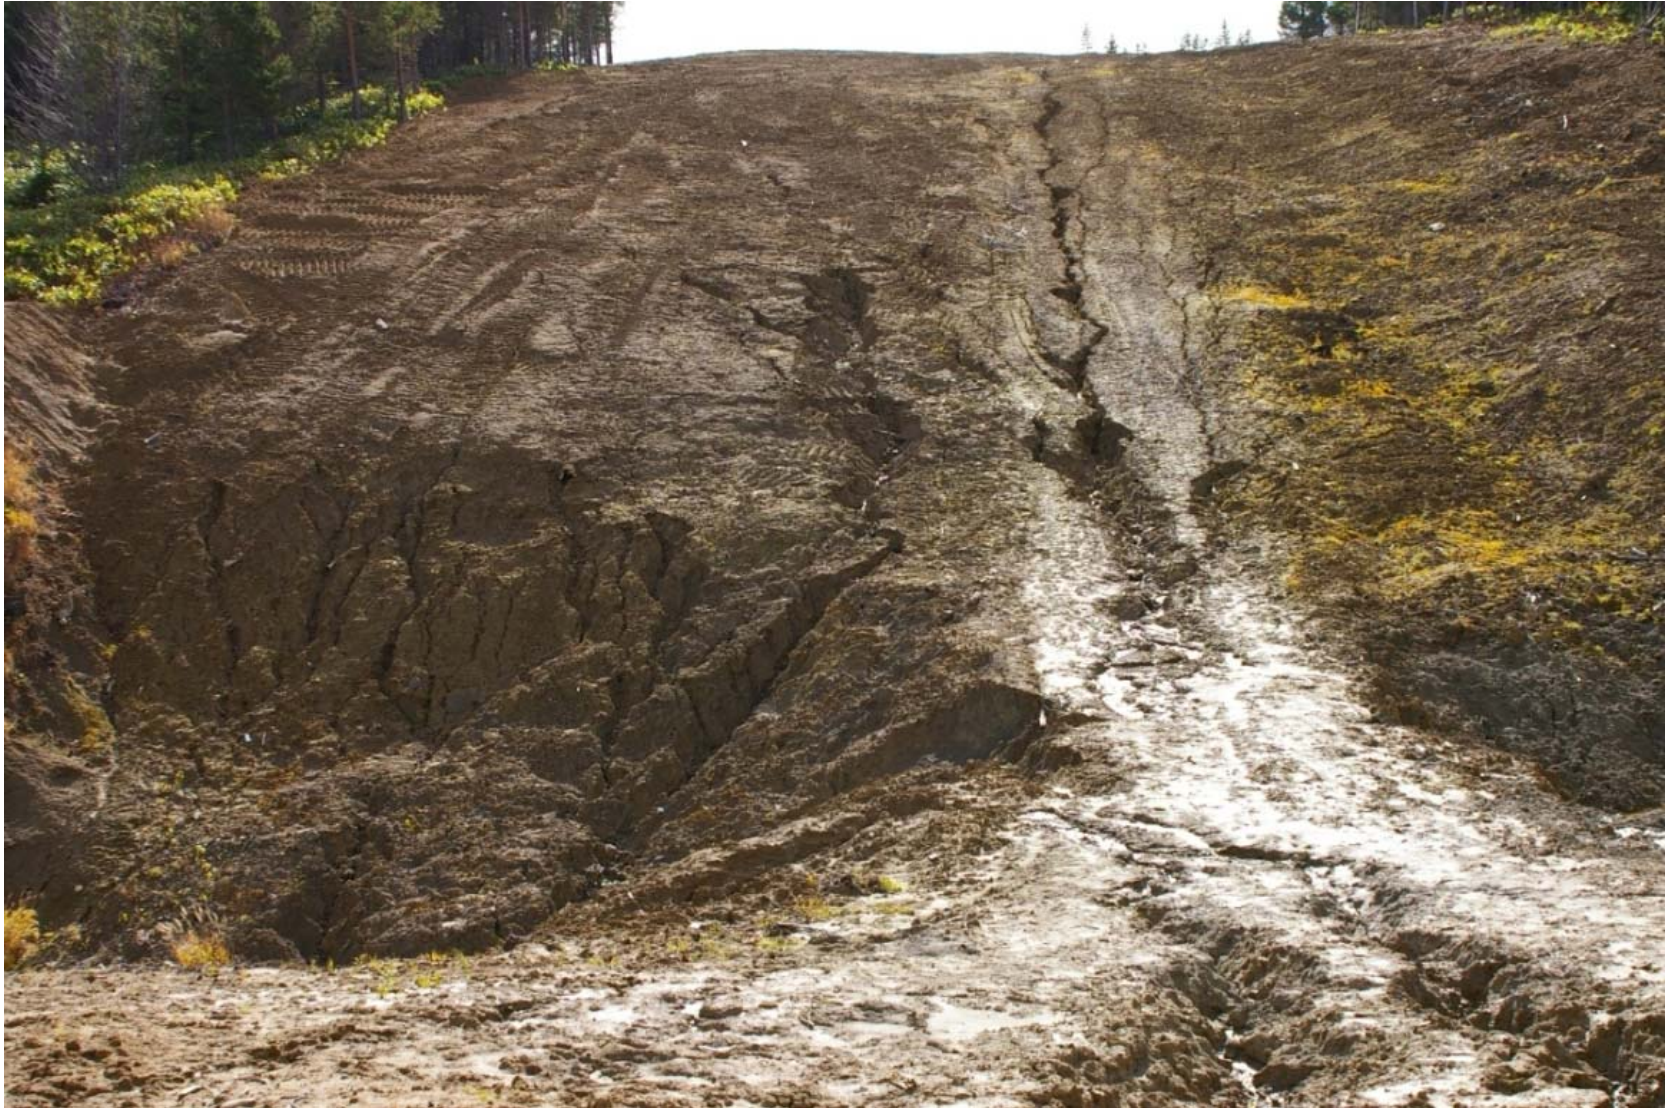
October 23, 2007: KP 490.2. Another view of the second stream to the north of the Krutoyarka River which has been blocked by an earth mound since last winter.

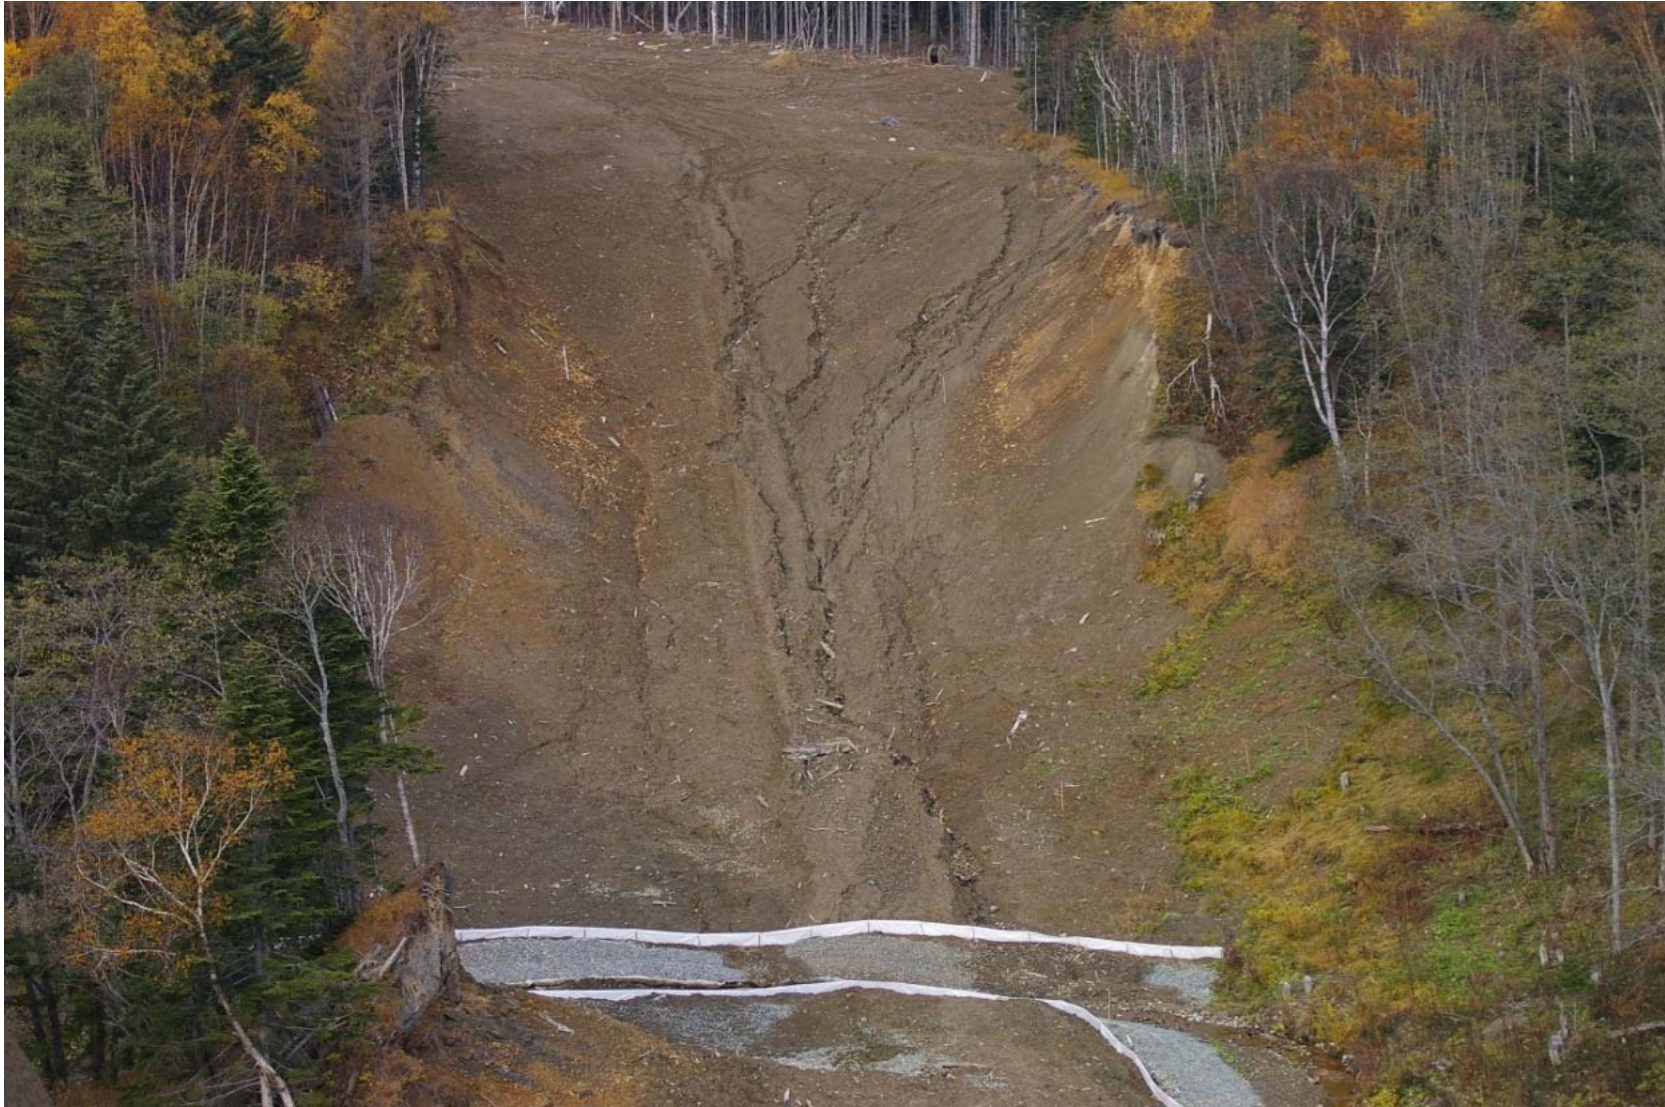
October 23, 2007: KP 489.5. The Rybnaya River and its left bank. Erosion trails over the Reno mat. The silt fences were installed just recently, over the erosion trails.

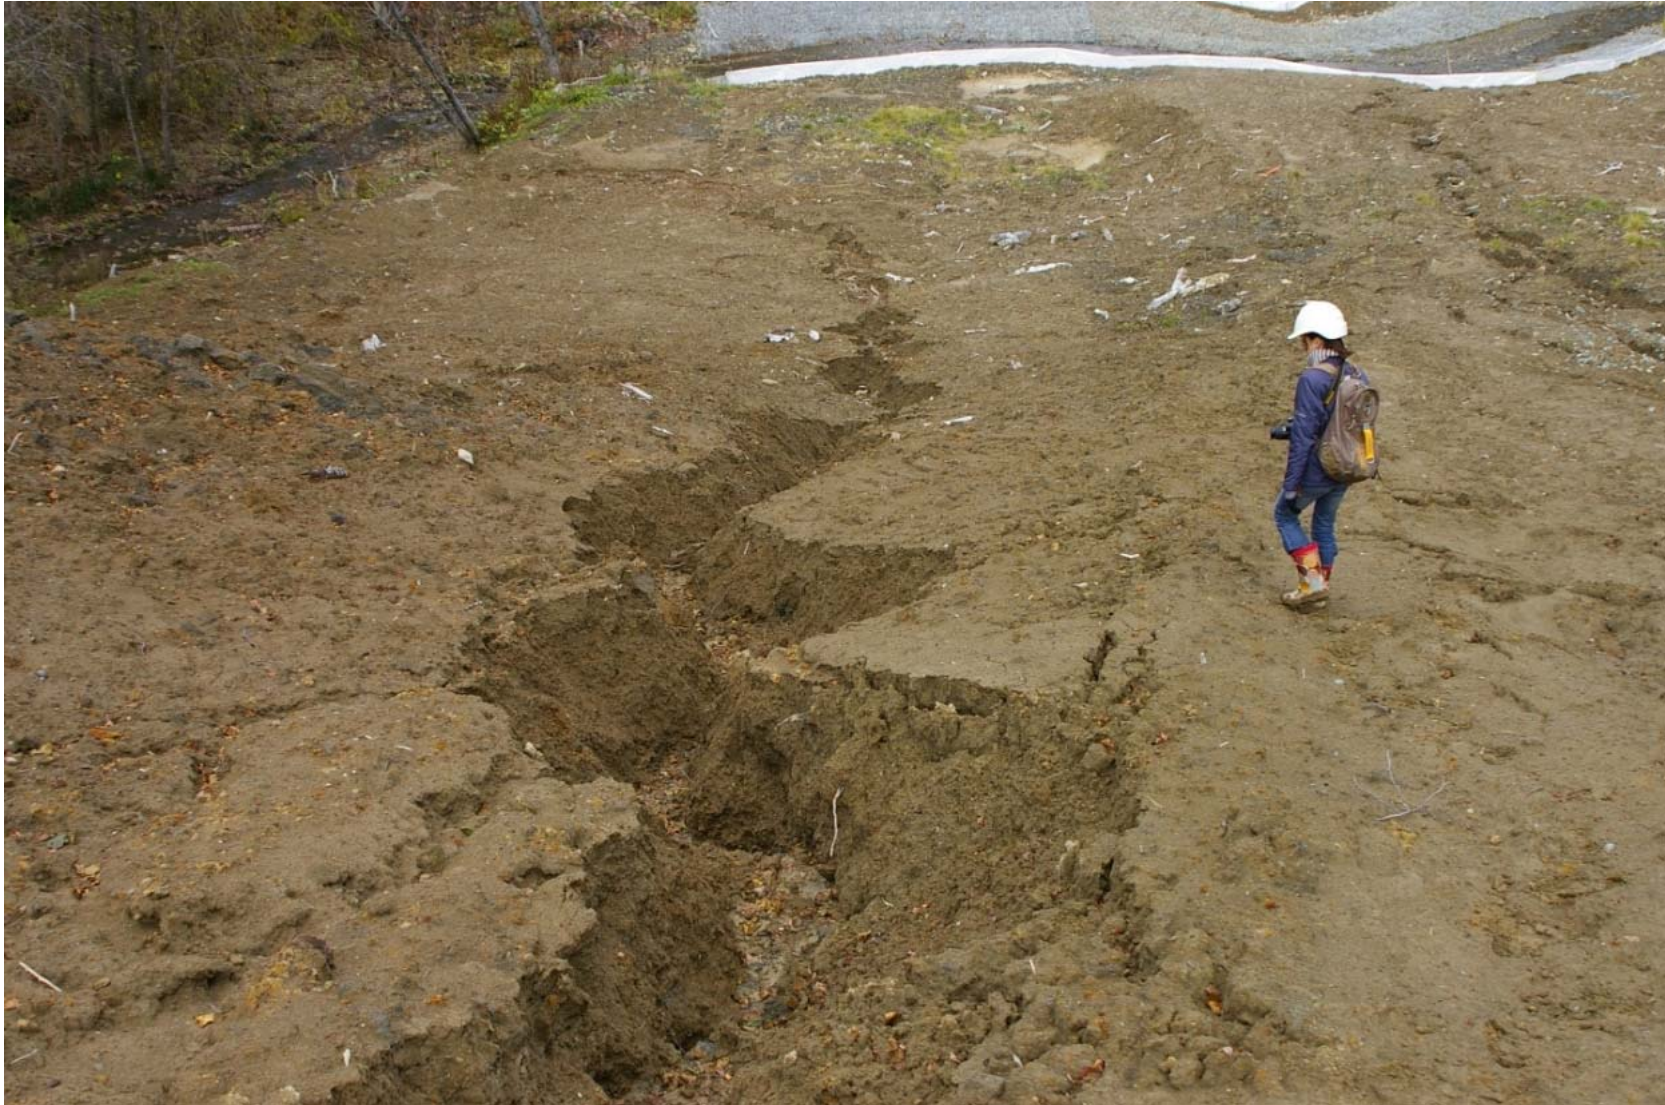
October 23, 2007: KP 489.5. Erosion trench flows down the right bank of the Rybnaya River unabated by erosion control measures.

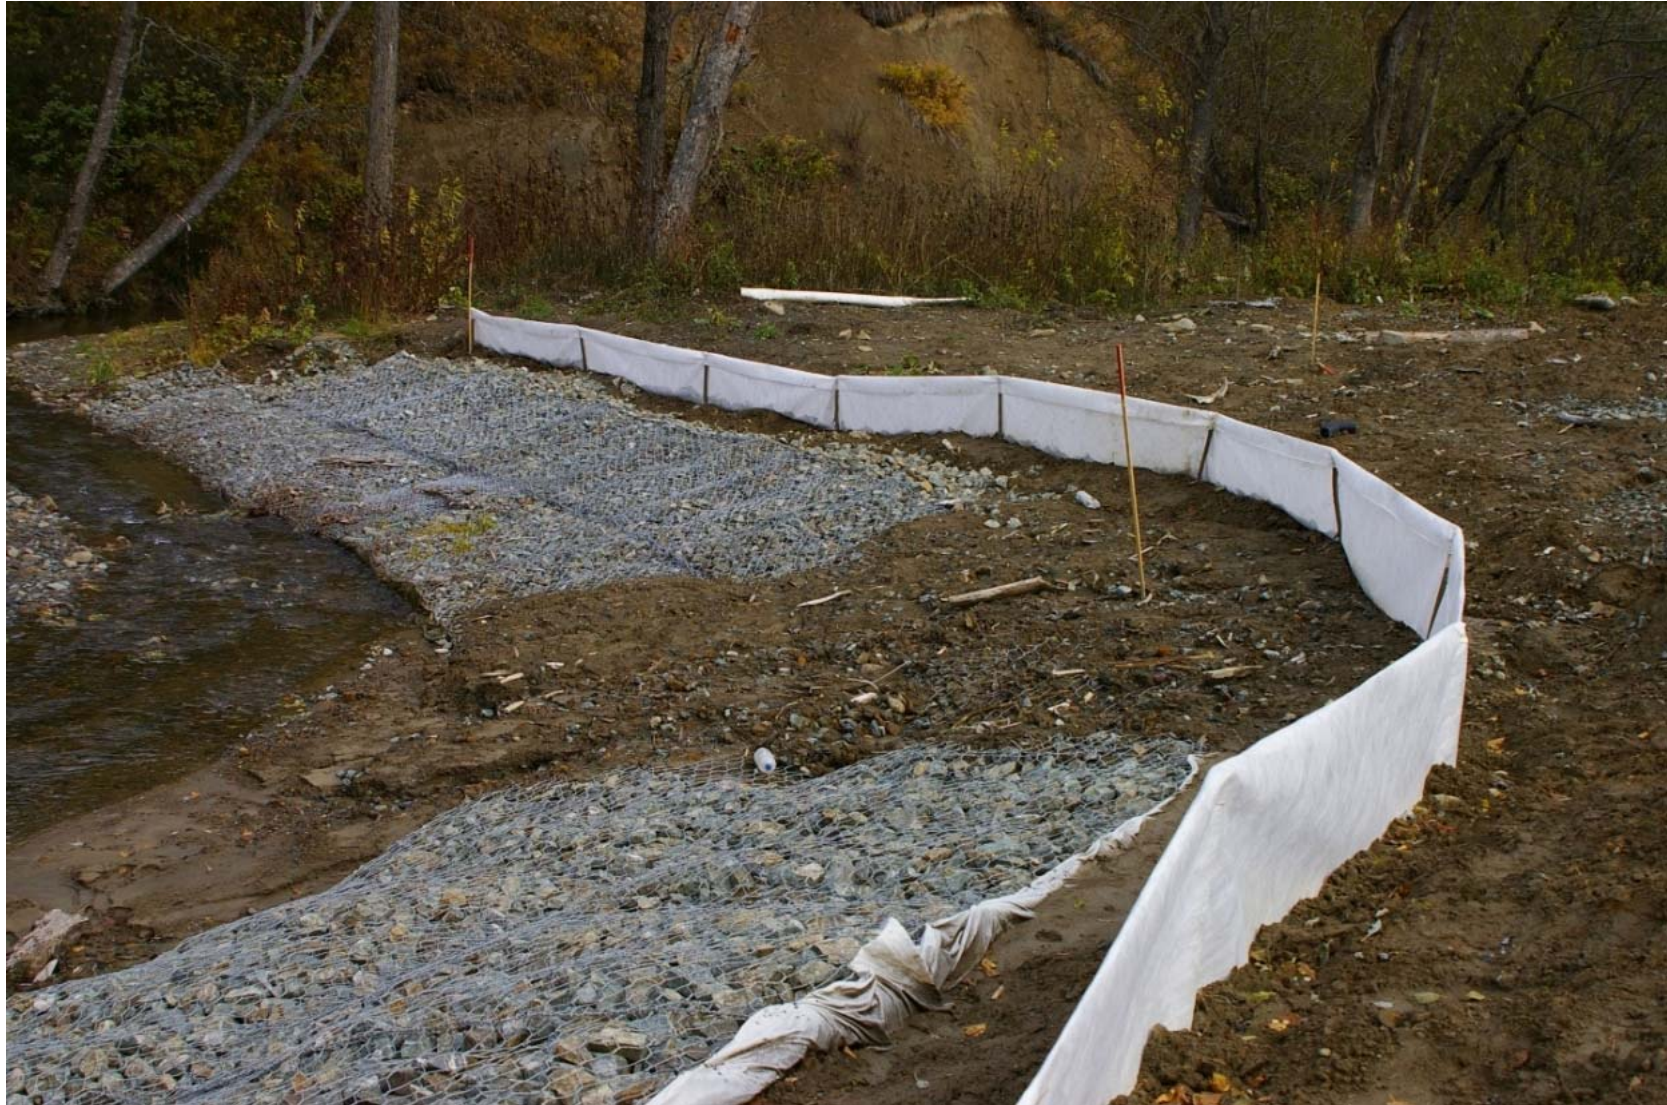
October 23, 2007: KP 489.5. The right bank of the Rybnaya River. Erosion trails over the Reno mat and into the river. A new silt fence was installed just recently over the erosion trail.

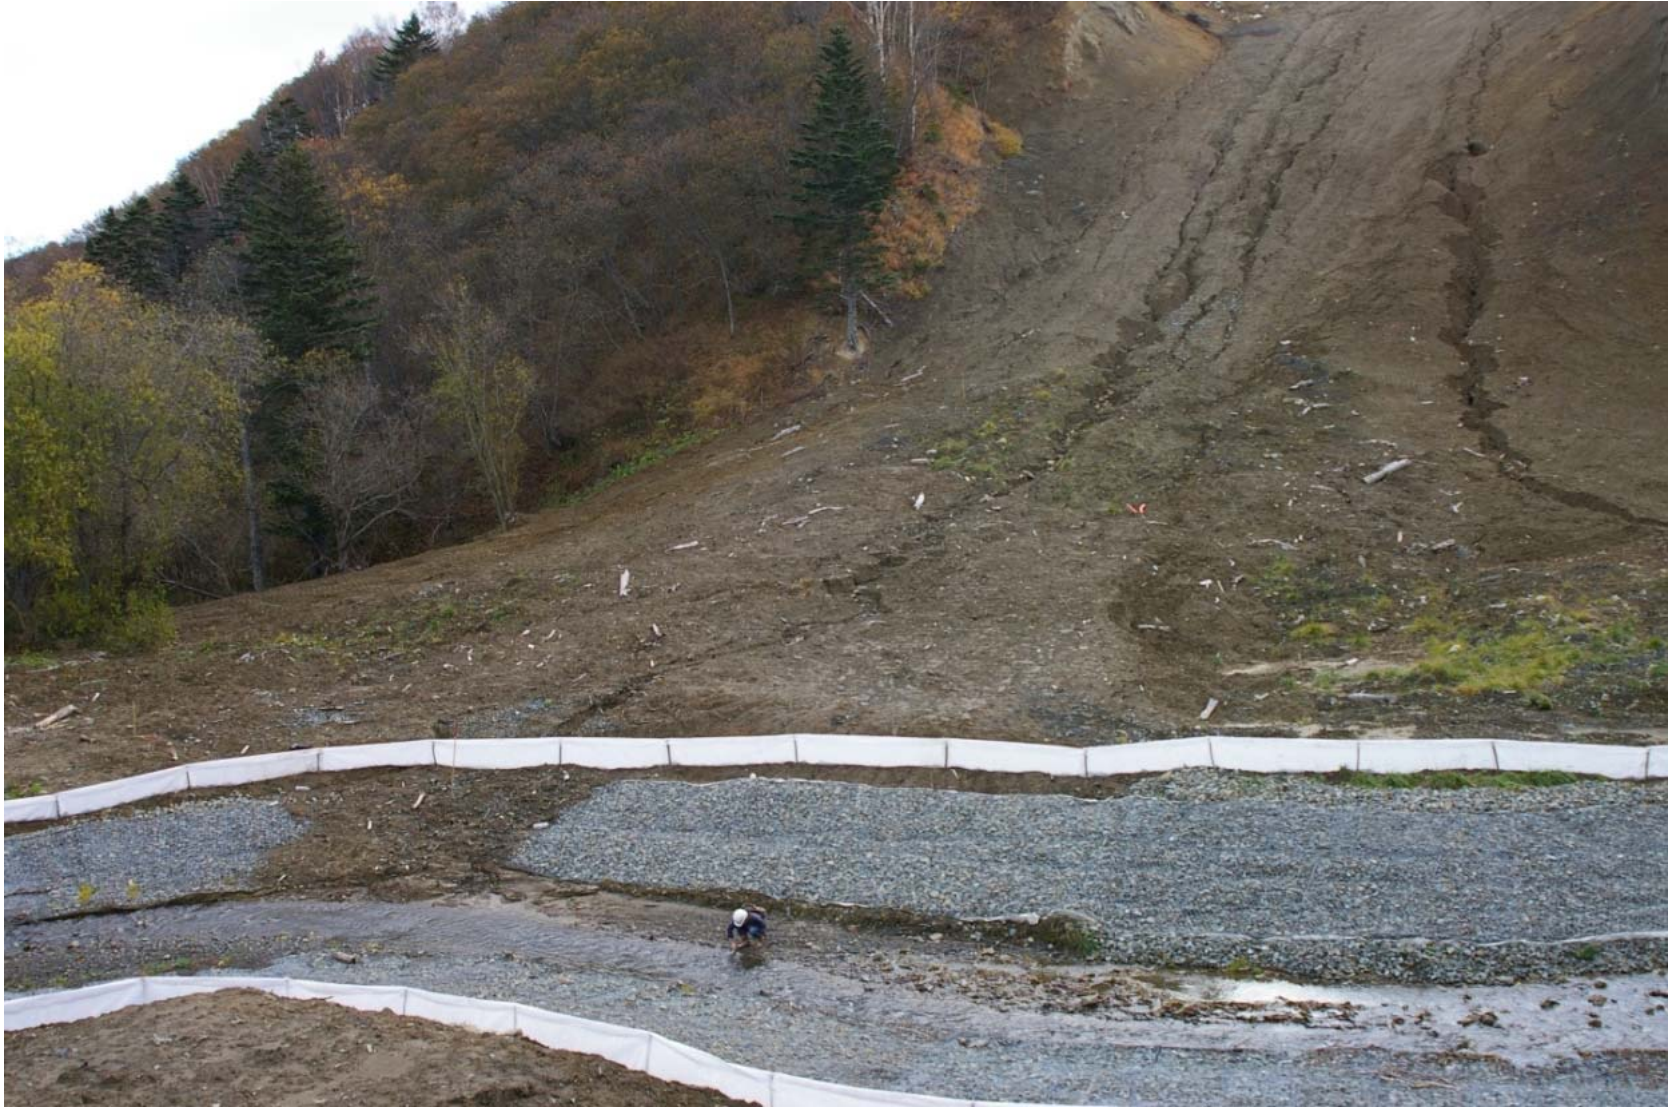
October 23, 2007: KP 489.5. The right bank of the Rybnaya River where mudflows crossed Reno mats into the river.

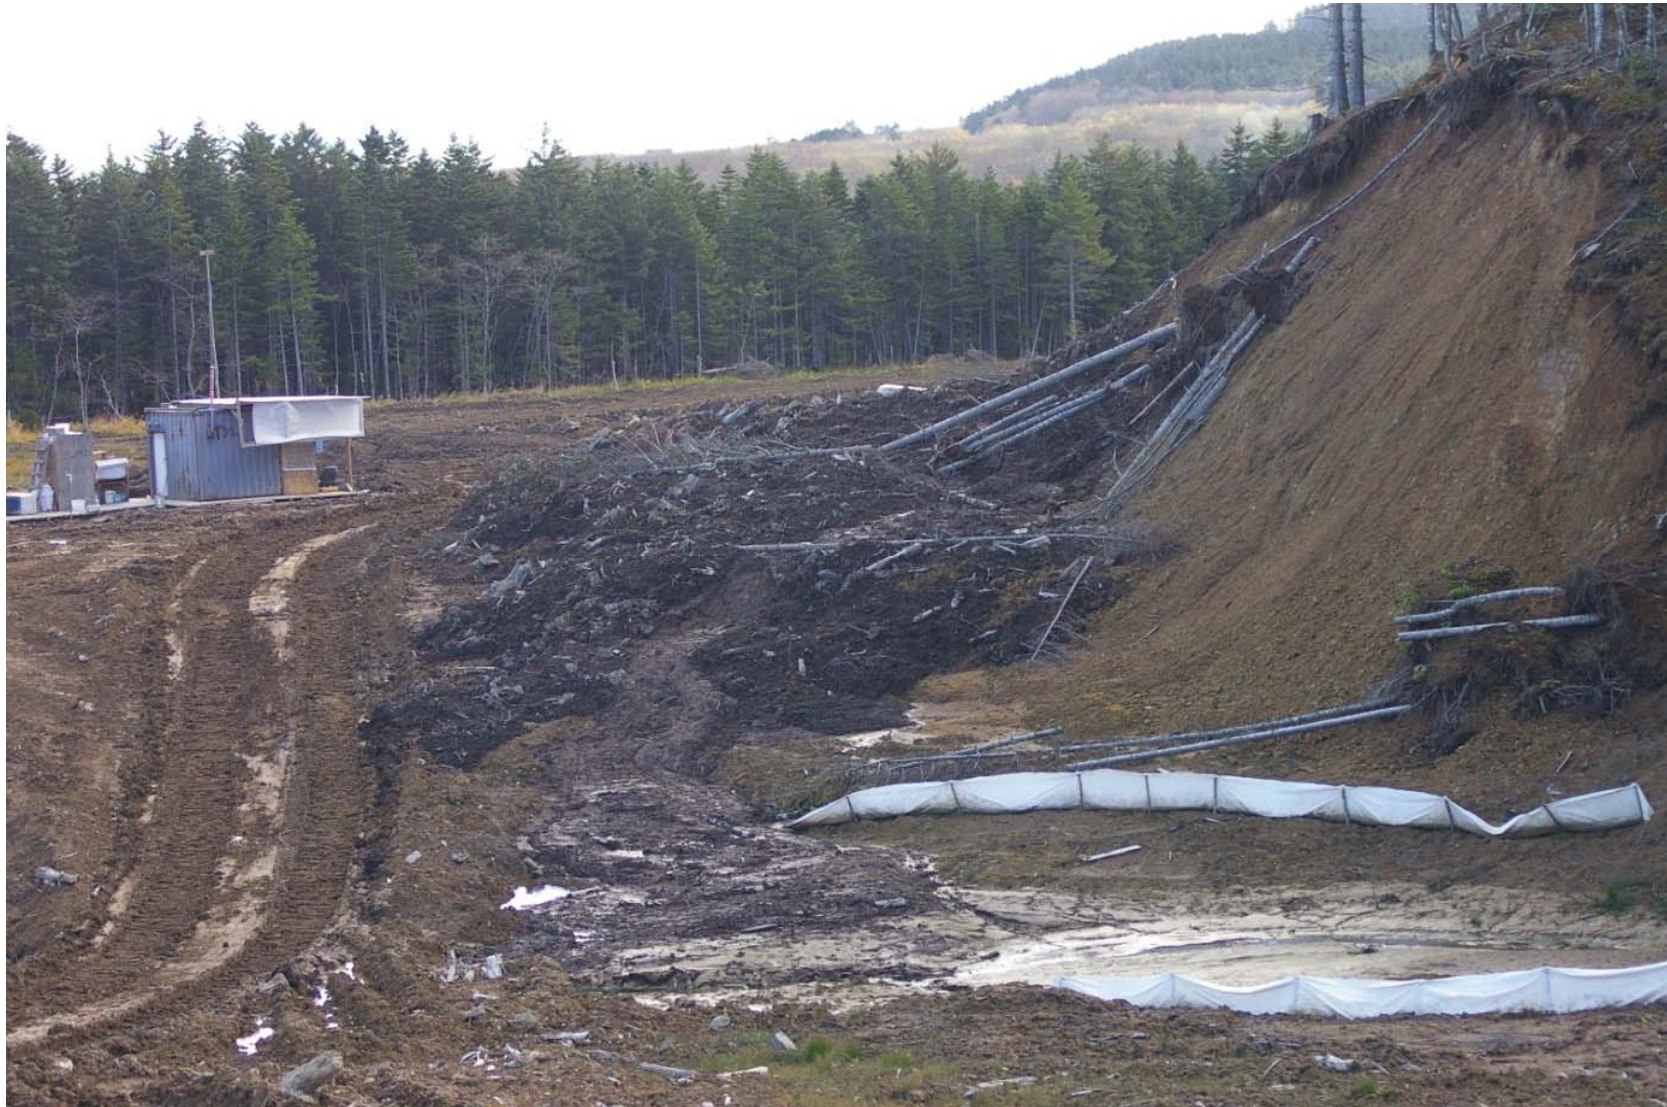
October 23, 2007: KP 483.7. Trees and soil have covered the RoW next to a stream to the north of Firsovo Village.

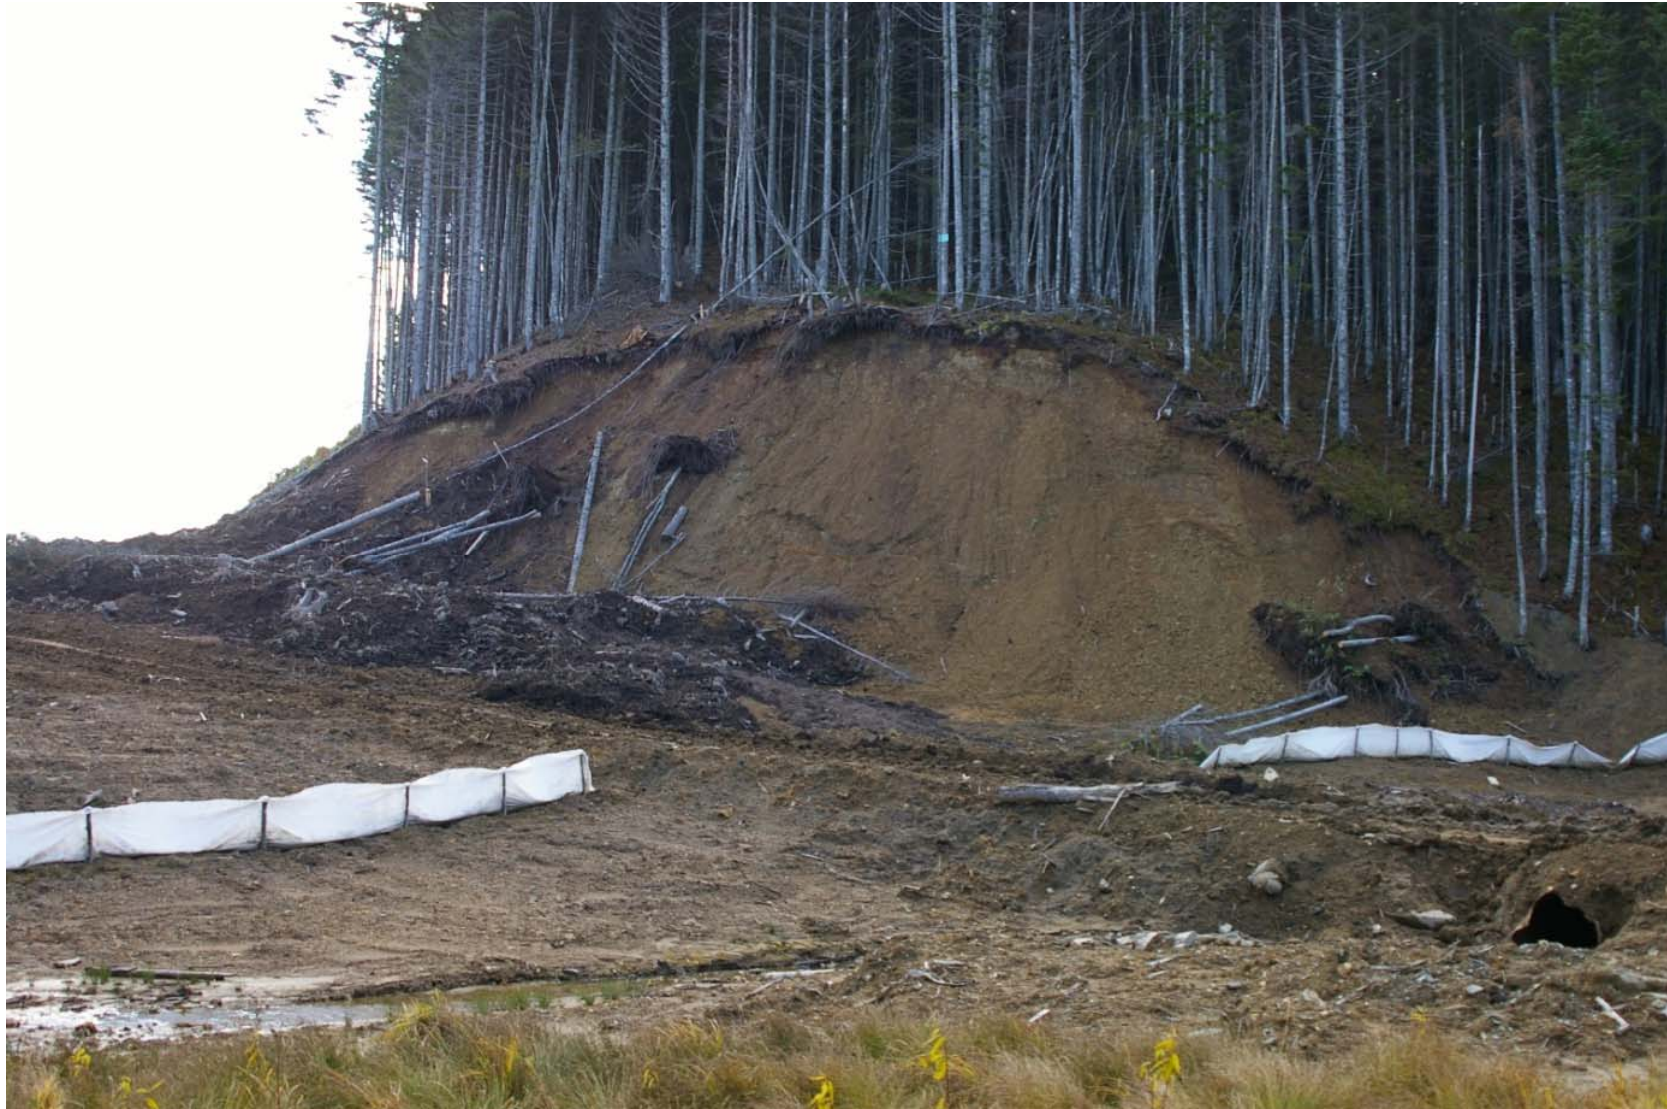
October 23, 2007: KP 483.7. Trees and soil have covered the RoW next to a stream to the north of Firsovo Village. There are no reinstatement measures.

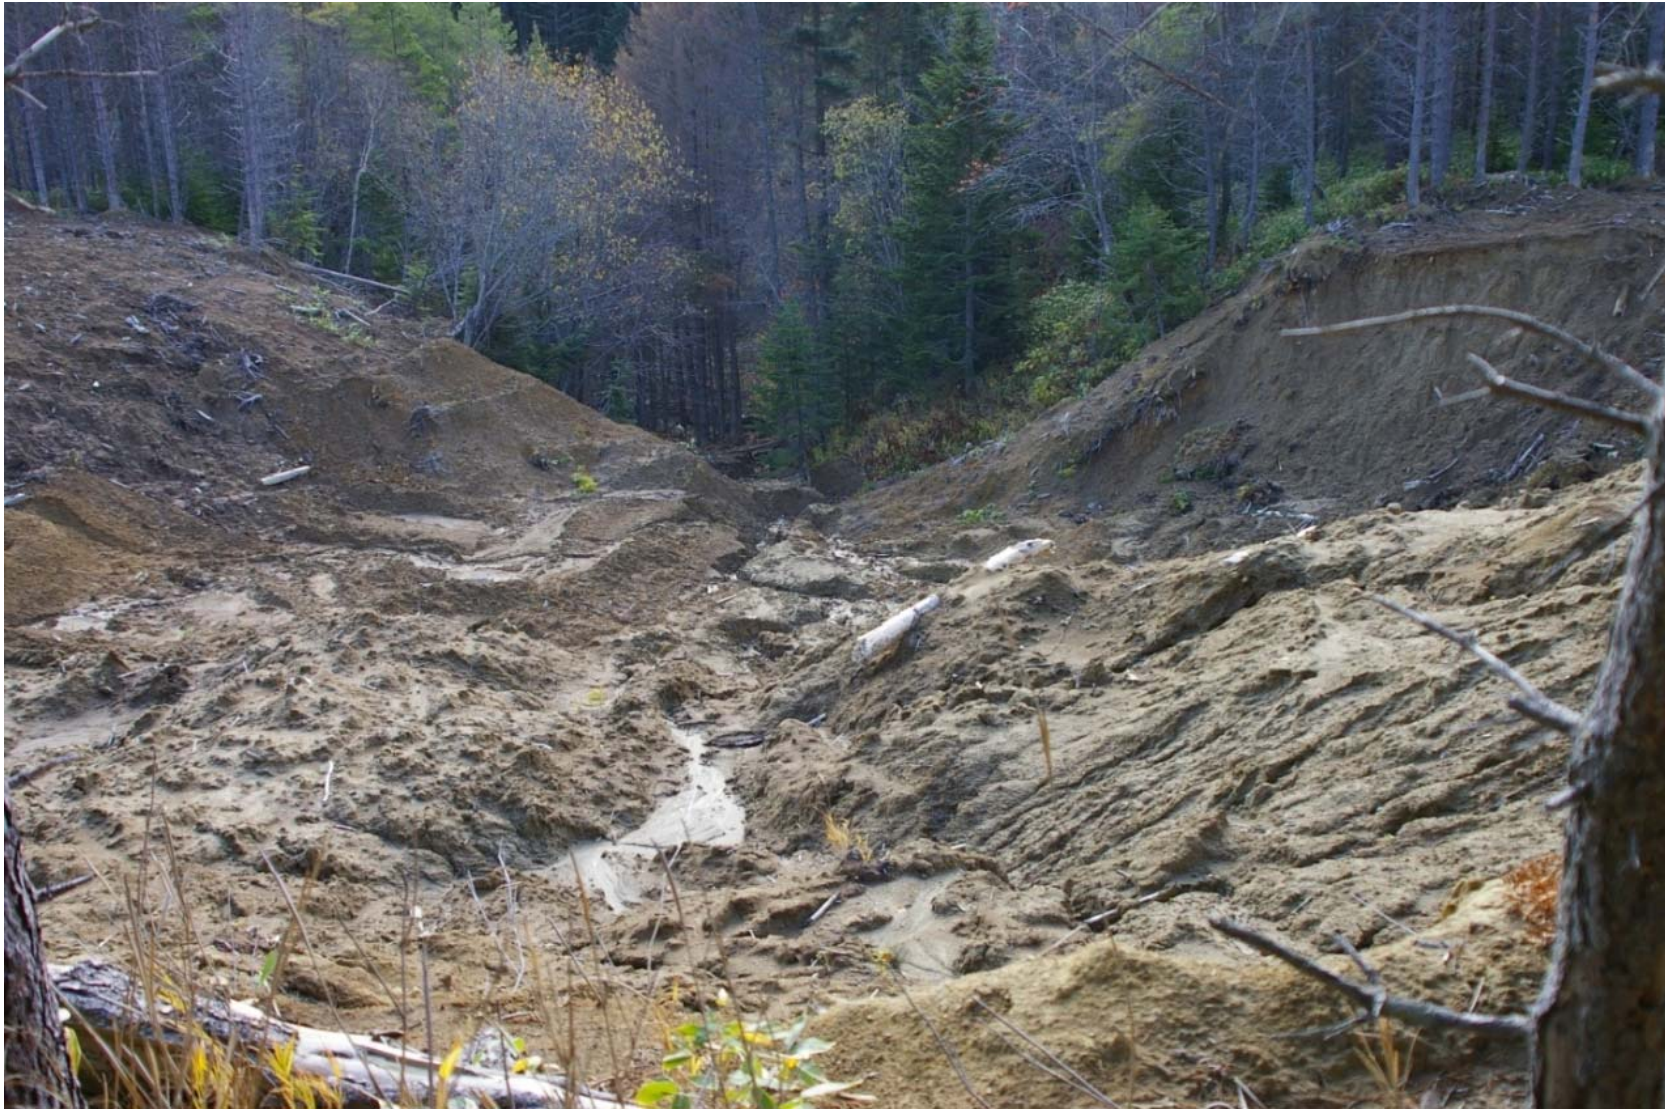
October 23, 2007: KP 483.3. To the north of Firsovo Village. A deep erosion canyon across the pipeline RoW.

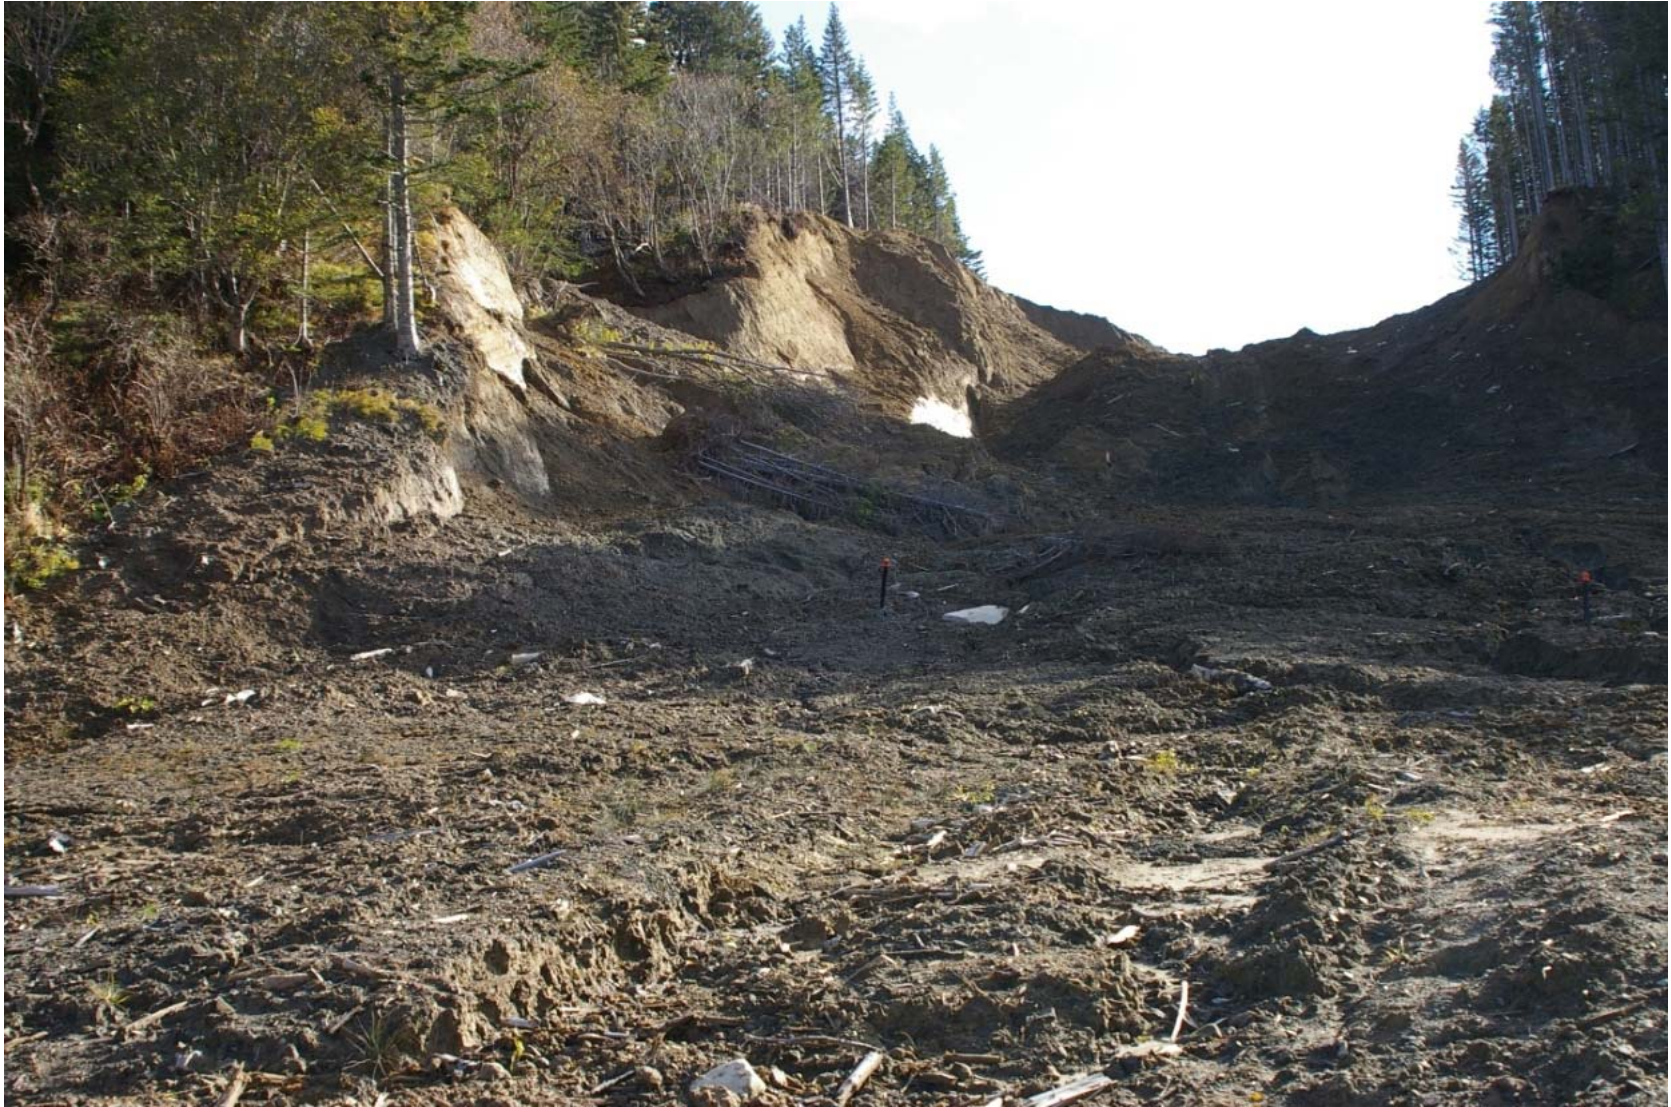
October 23, 2007: KP 482.5. The right bank of the Primorskaya River. A significant land slide.
