# Citizens Photo Monitoring Report

Prepared by Sakhalin Environment Watch  
&  
Pacific Environment

Sakhalin II Pipeline Route  
October & December 2007

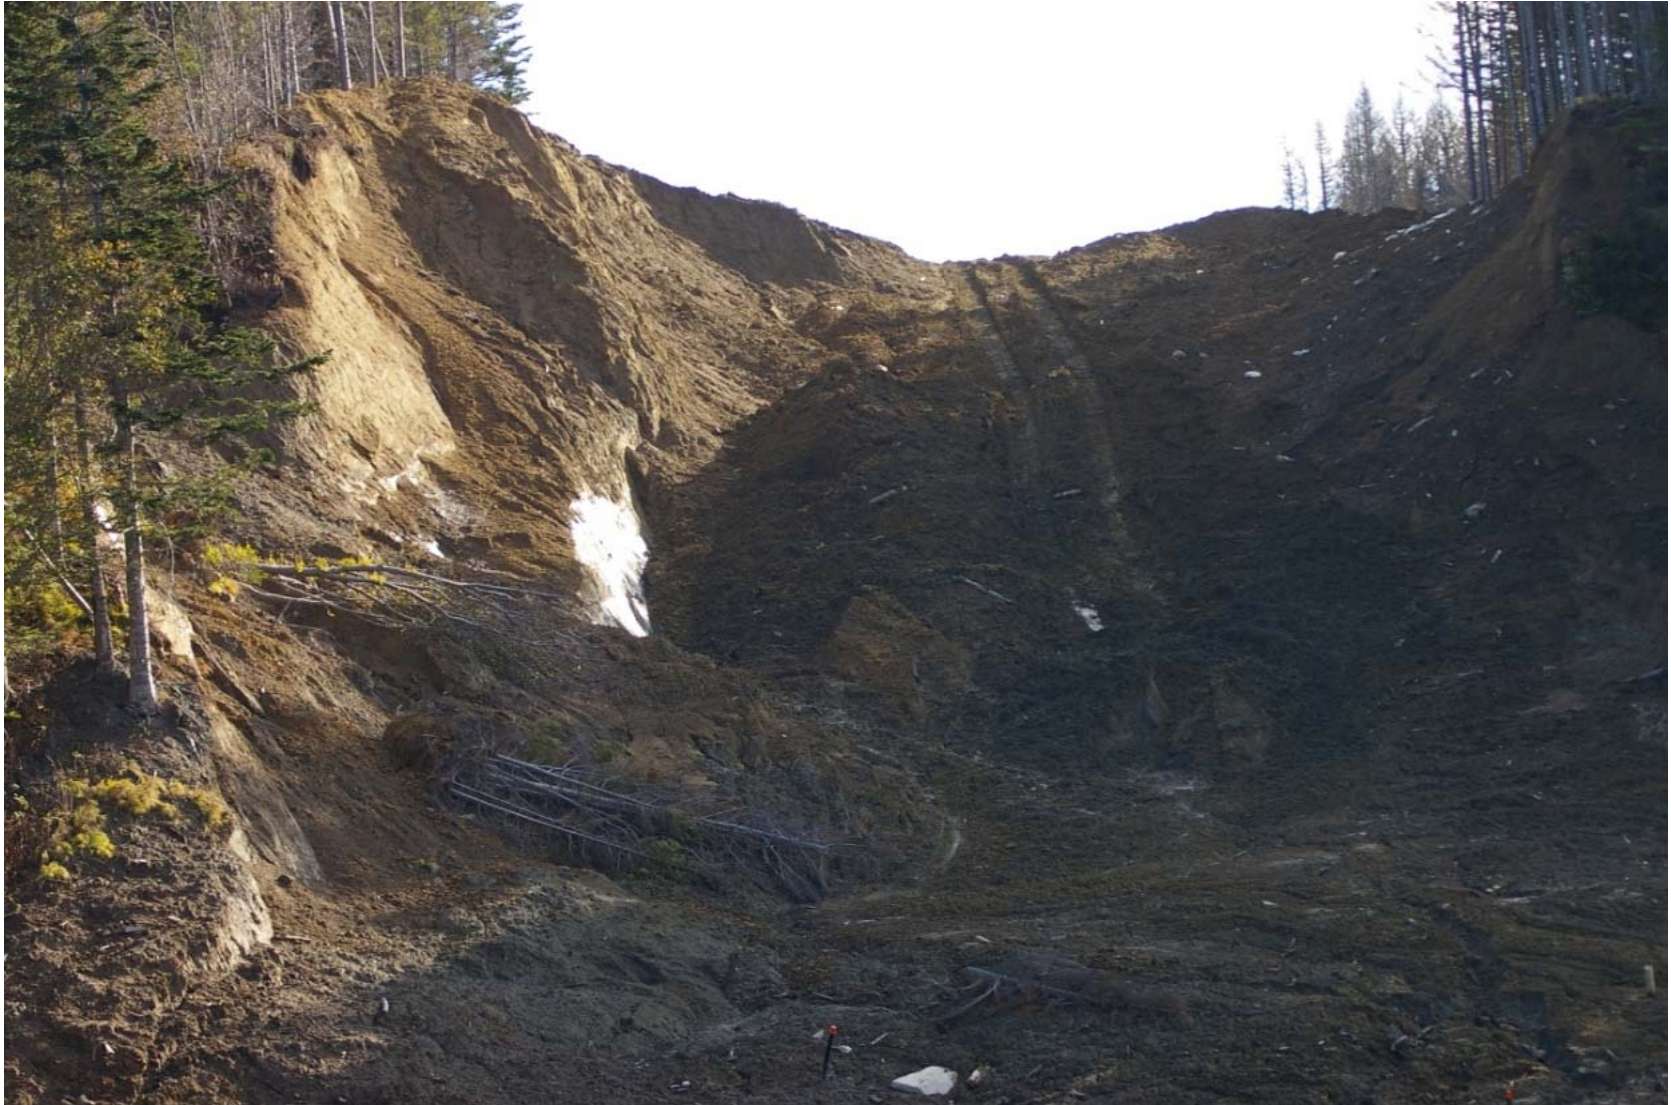
October 23, 2007: KP 482.5. The right bank of the Primorskaya River. A significant land slide.

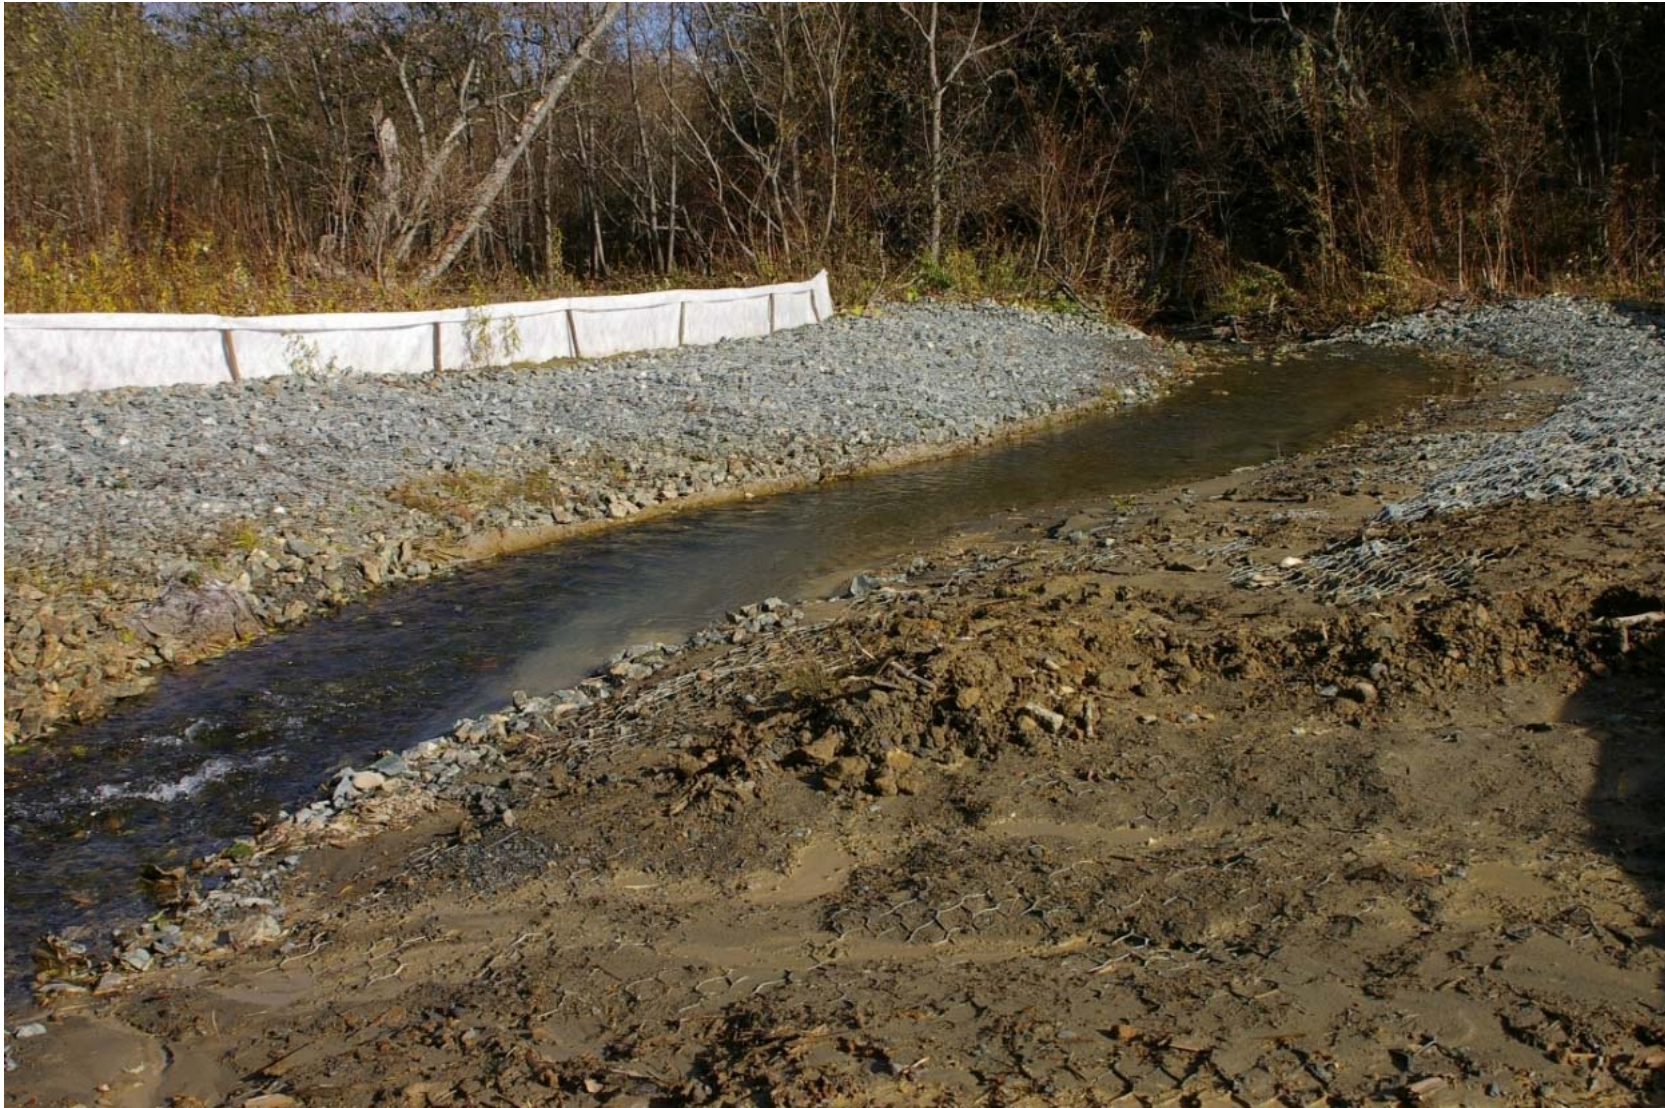
October 23, 2007: KP 482.5. The right bank of the Primorskaya River. SEIC doesn't maintain the Reno mats properly and doesn't have any land slide or erosion control measures in place on the adjacent slopes. As a result, sediments enter the river even during dry weather without the added effect of rainfall.

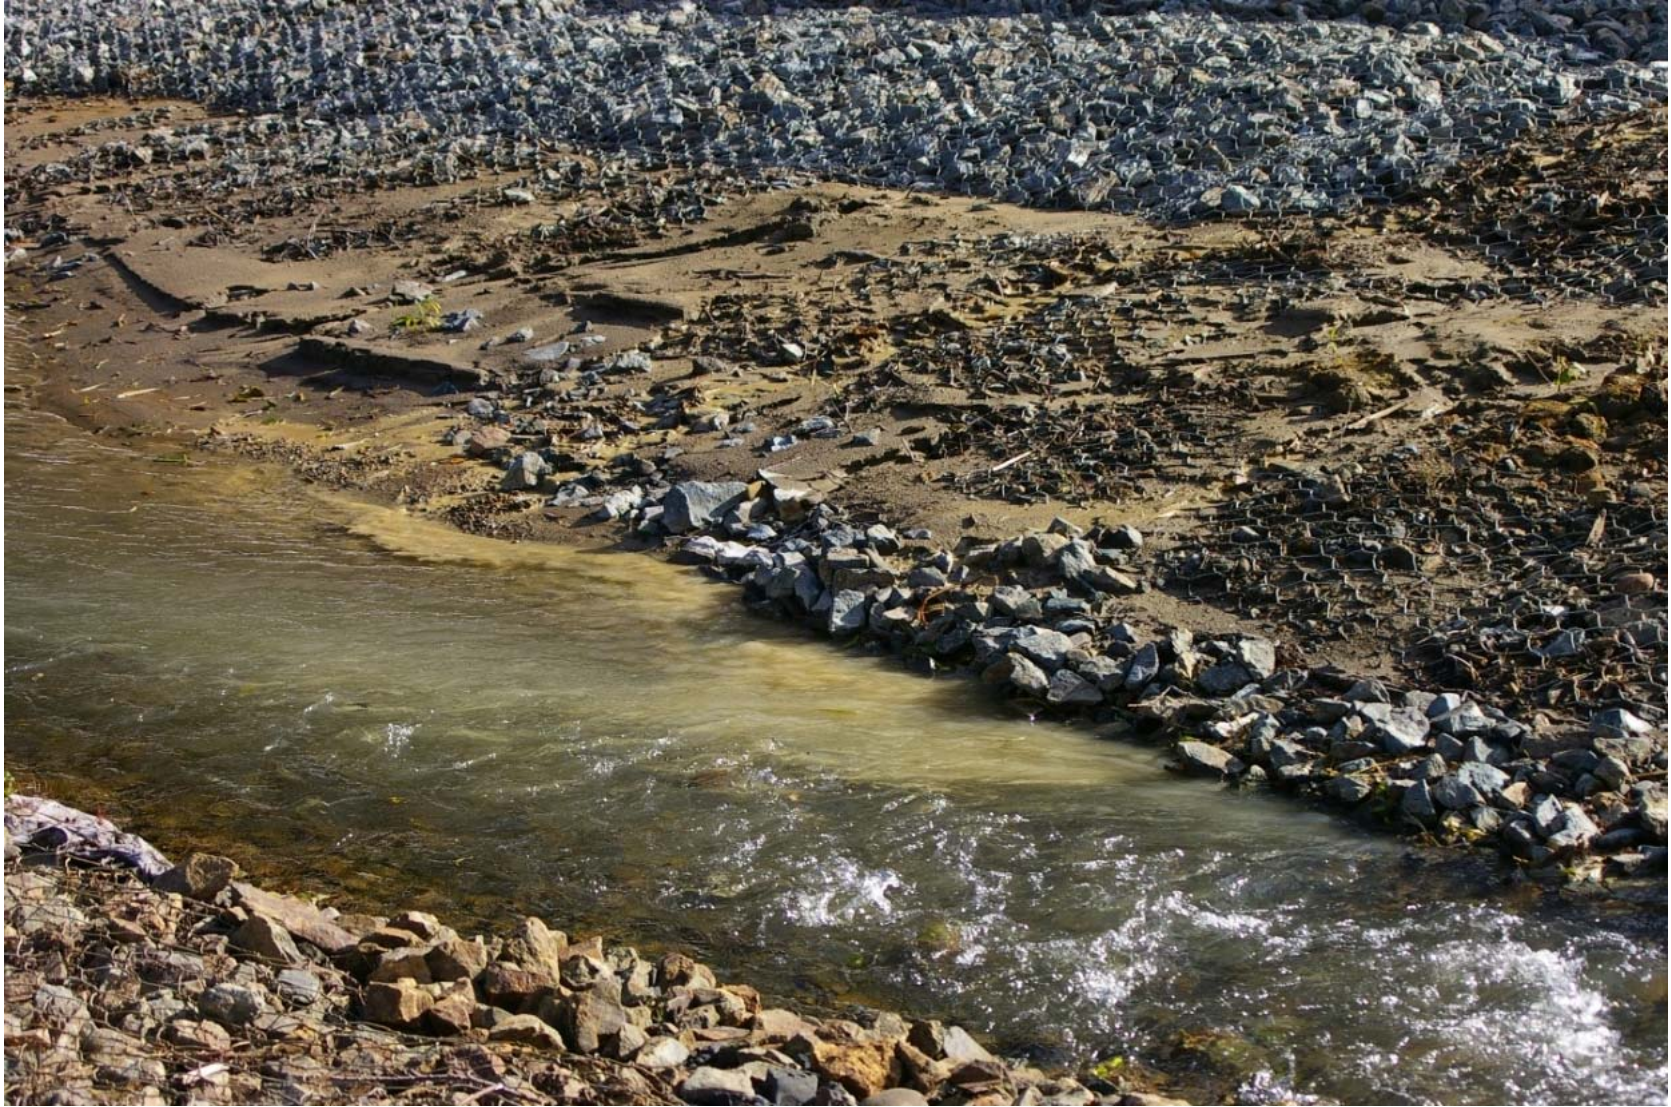
October 23, 2007: KP 482.5. The right bank of the Primorskaya River. Contamination of the river with soil runoff.

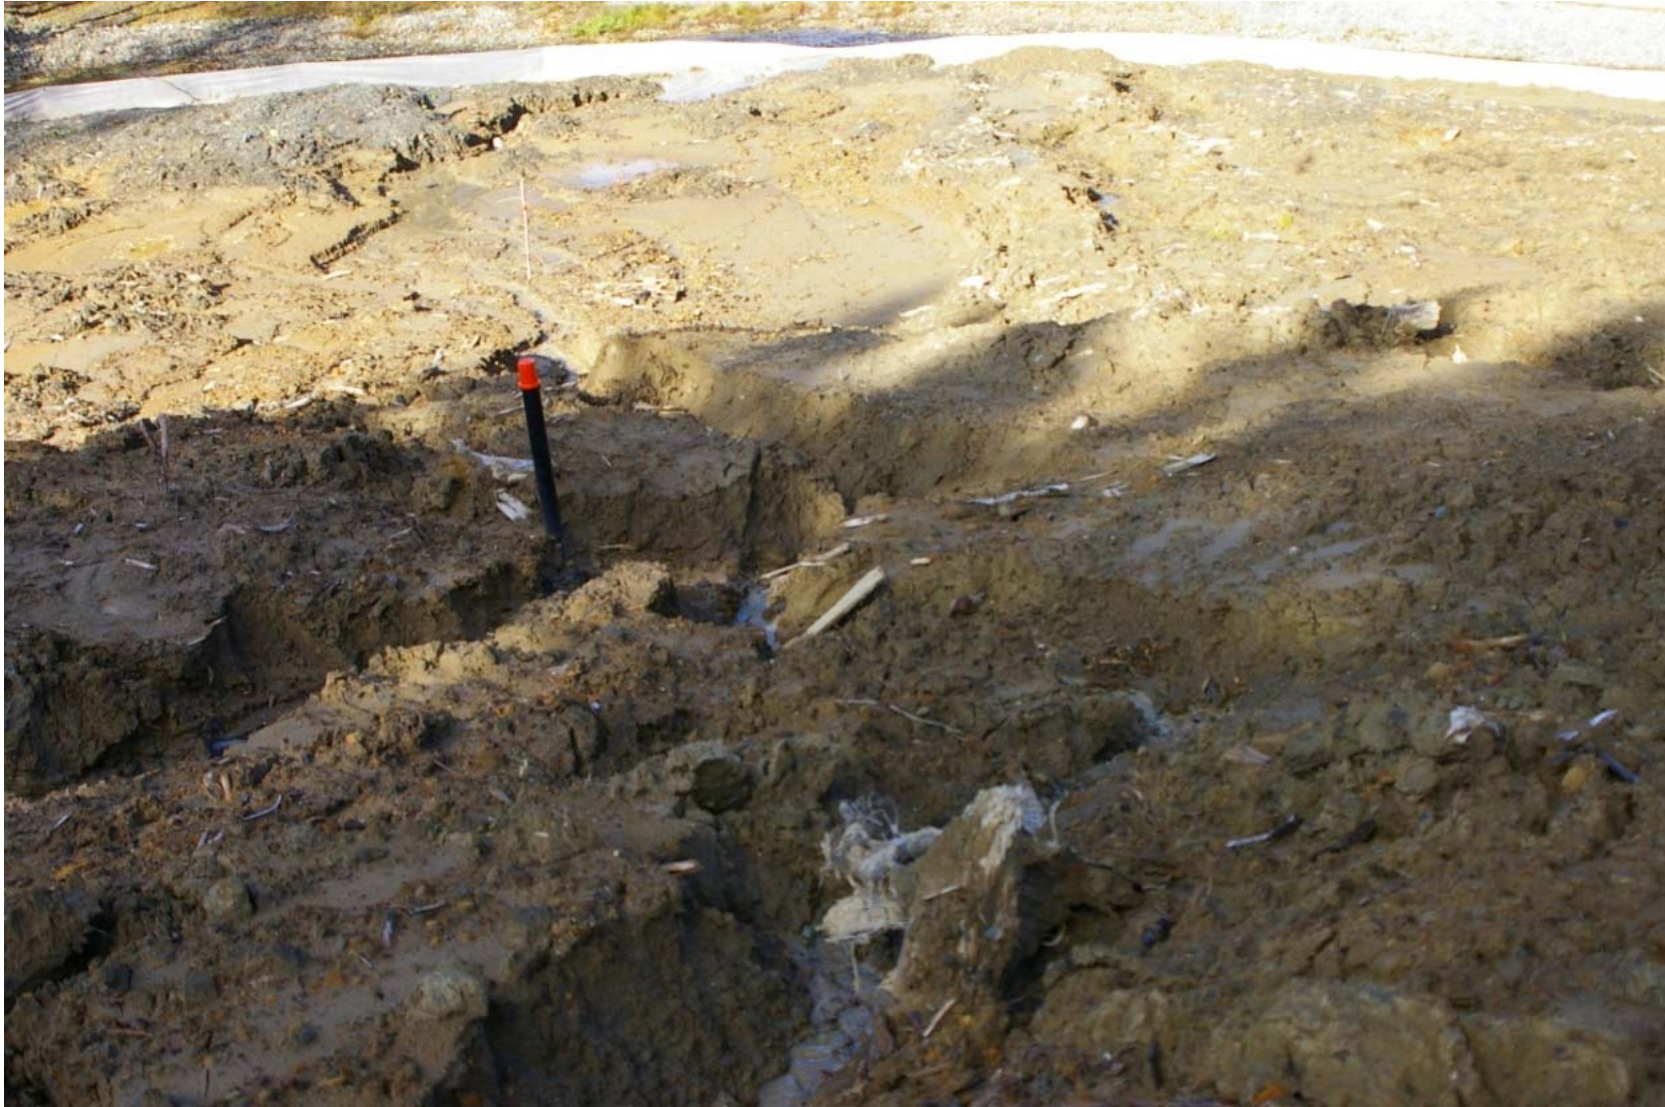
October 23, 2007: KP 482.5. The right bank of the Primorskaya River. Erosion is taking place directly above the gas line. The black stick with the orange cap is a cathode protection check point.

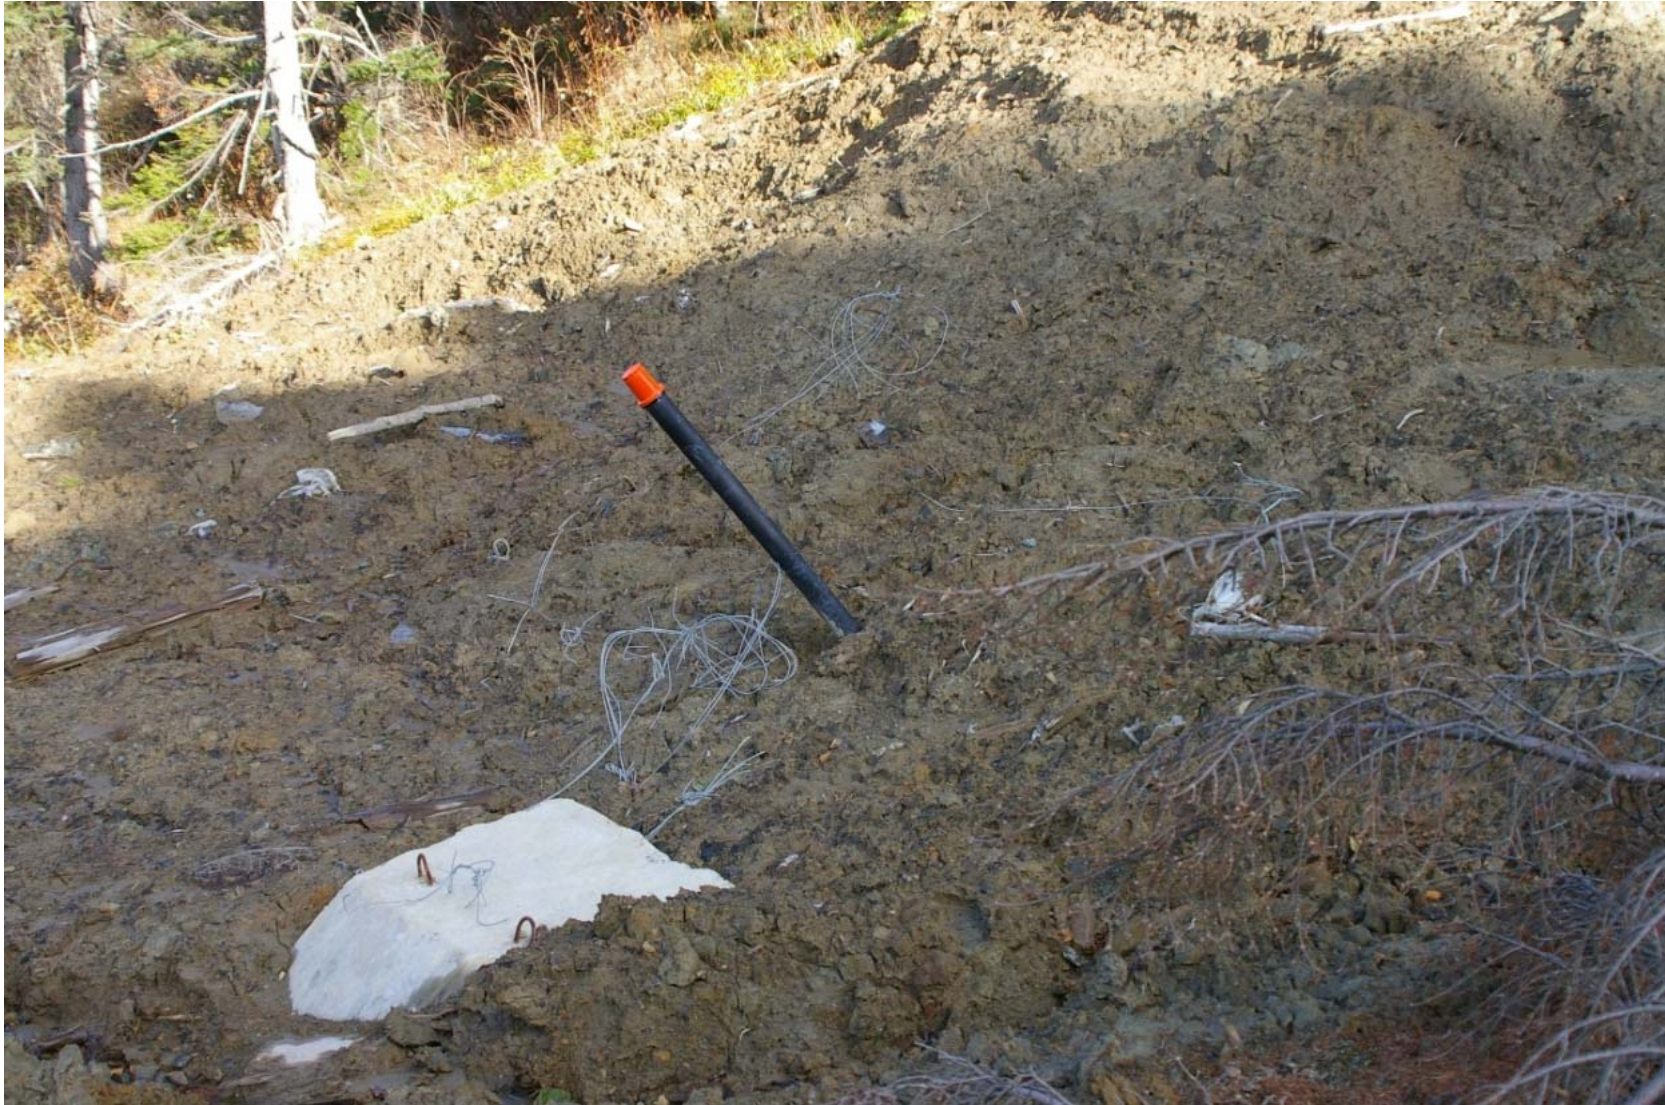
October 23, 2007: KP 482.5. The right bank of the Primorskaya River. The cathode protection check point for the oil line has been broken by the creeping land slide.

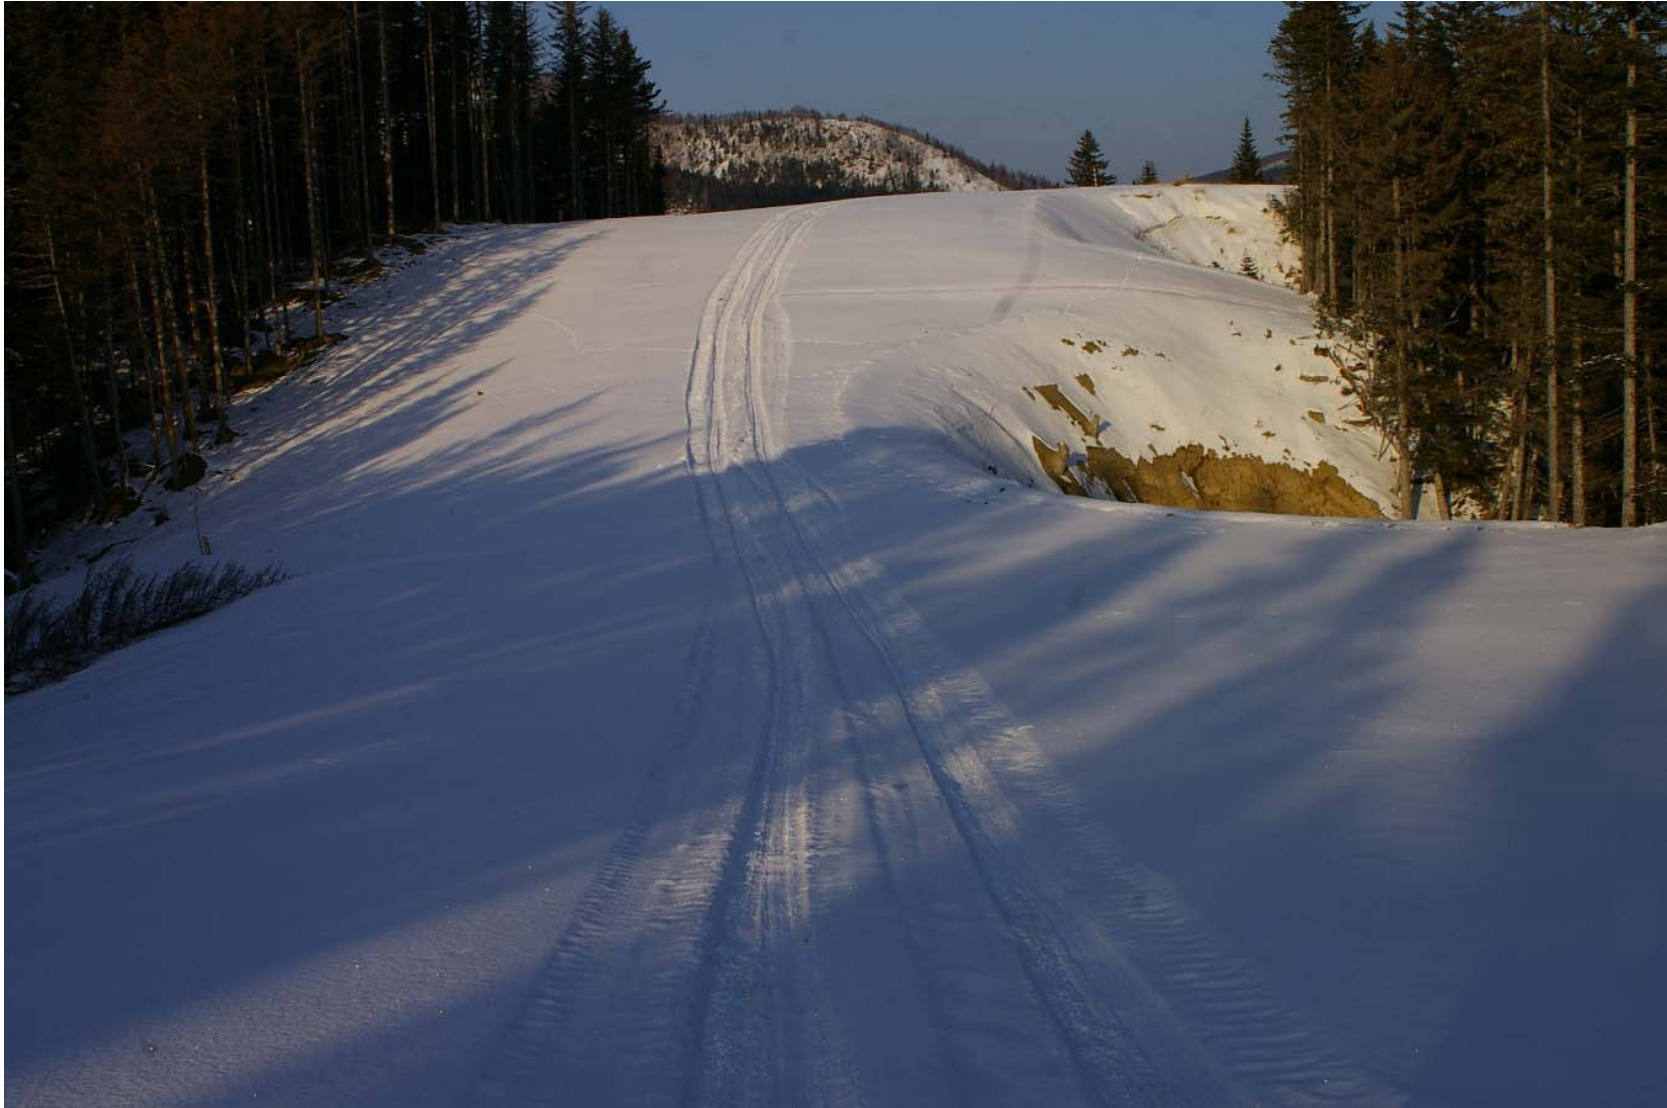
December 22, 2007: KP 365.1. A section of the pipeline to the north of the Pegas River crossing in Makarov District. The two washouts on the right appeared as a result of landslides. As spring approaches the threat of landslides will increase and erosion processes will undermine the oil pipeline here.

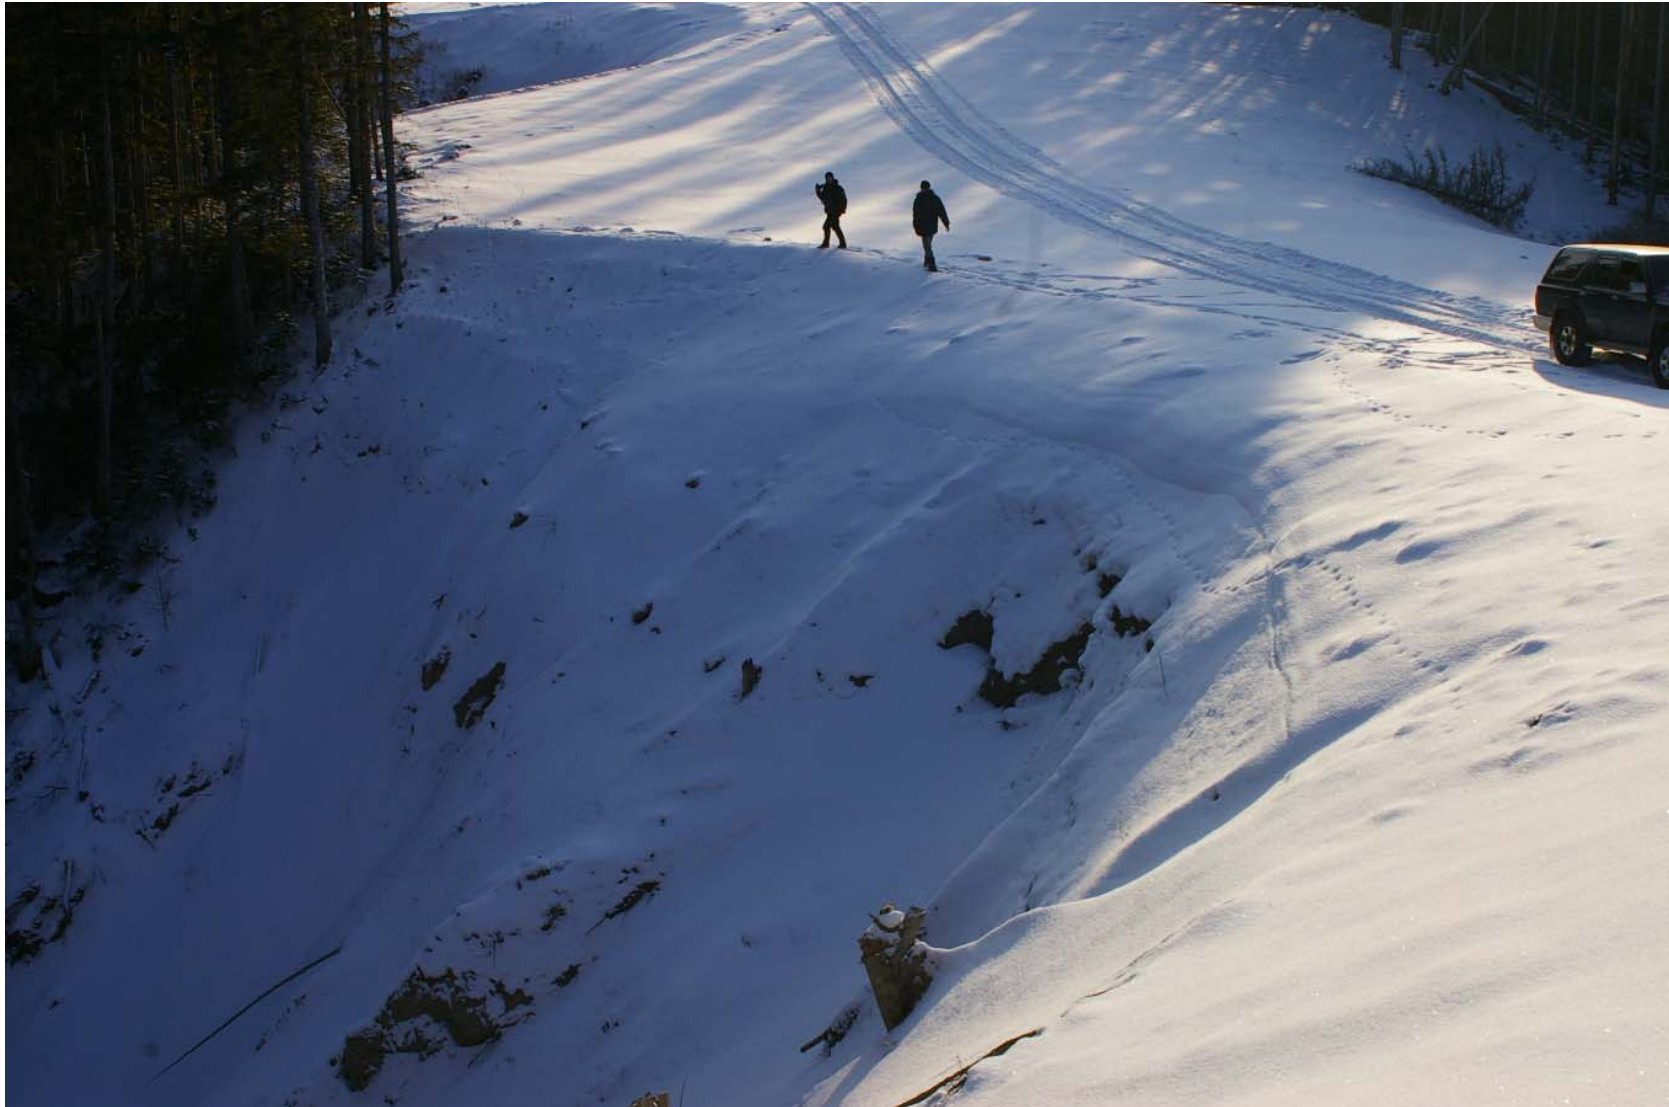
December 22, 2007: KP 365.1. A section of the pipeline to the north of the Pegas River crossing in Makarov District. A landslide zone which undermines the pipeline is pictured.

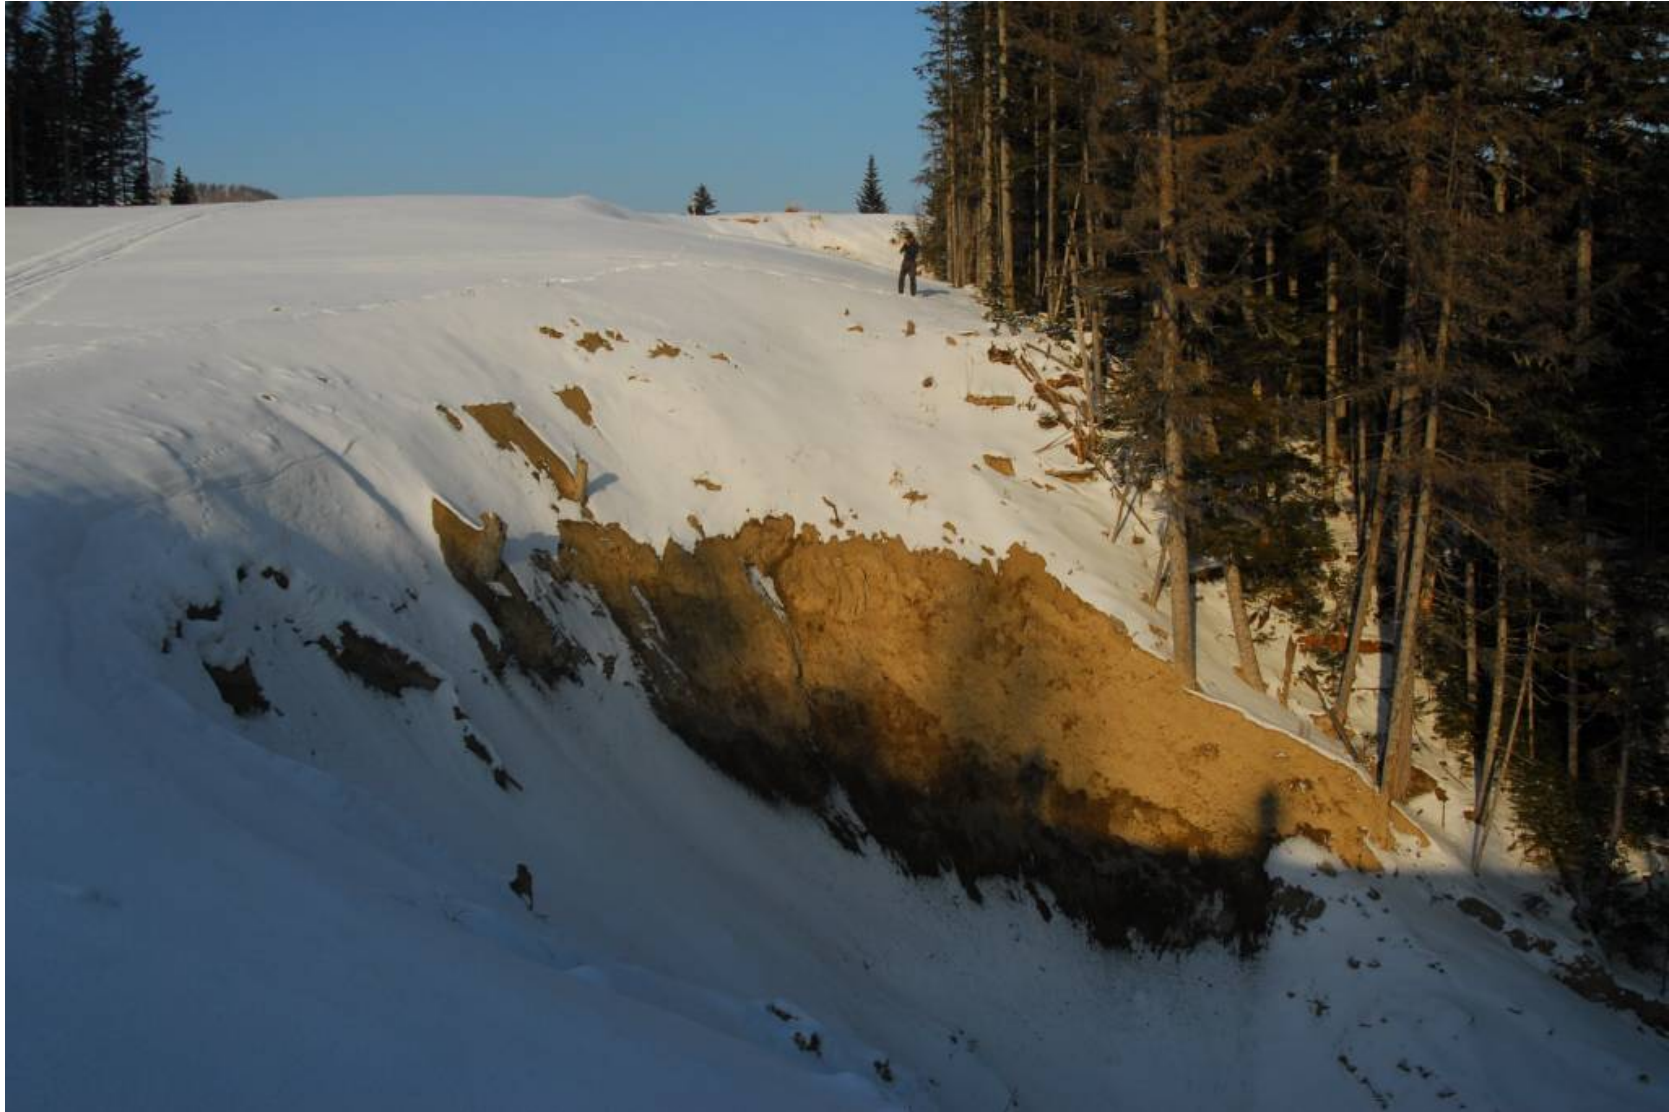
December 22, 2007: KP 365.1. A section of the pipeline to the north of the Pegas River crossing in Makarov District. A landslide zone which undermines the pipeline is pictured.

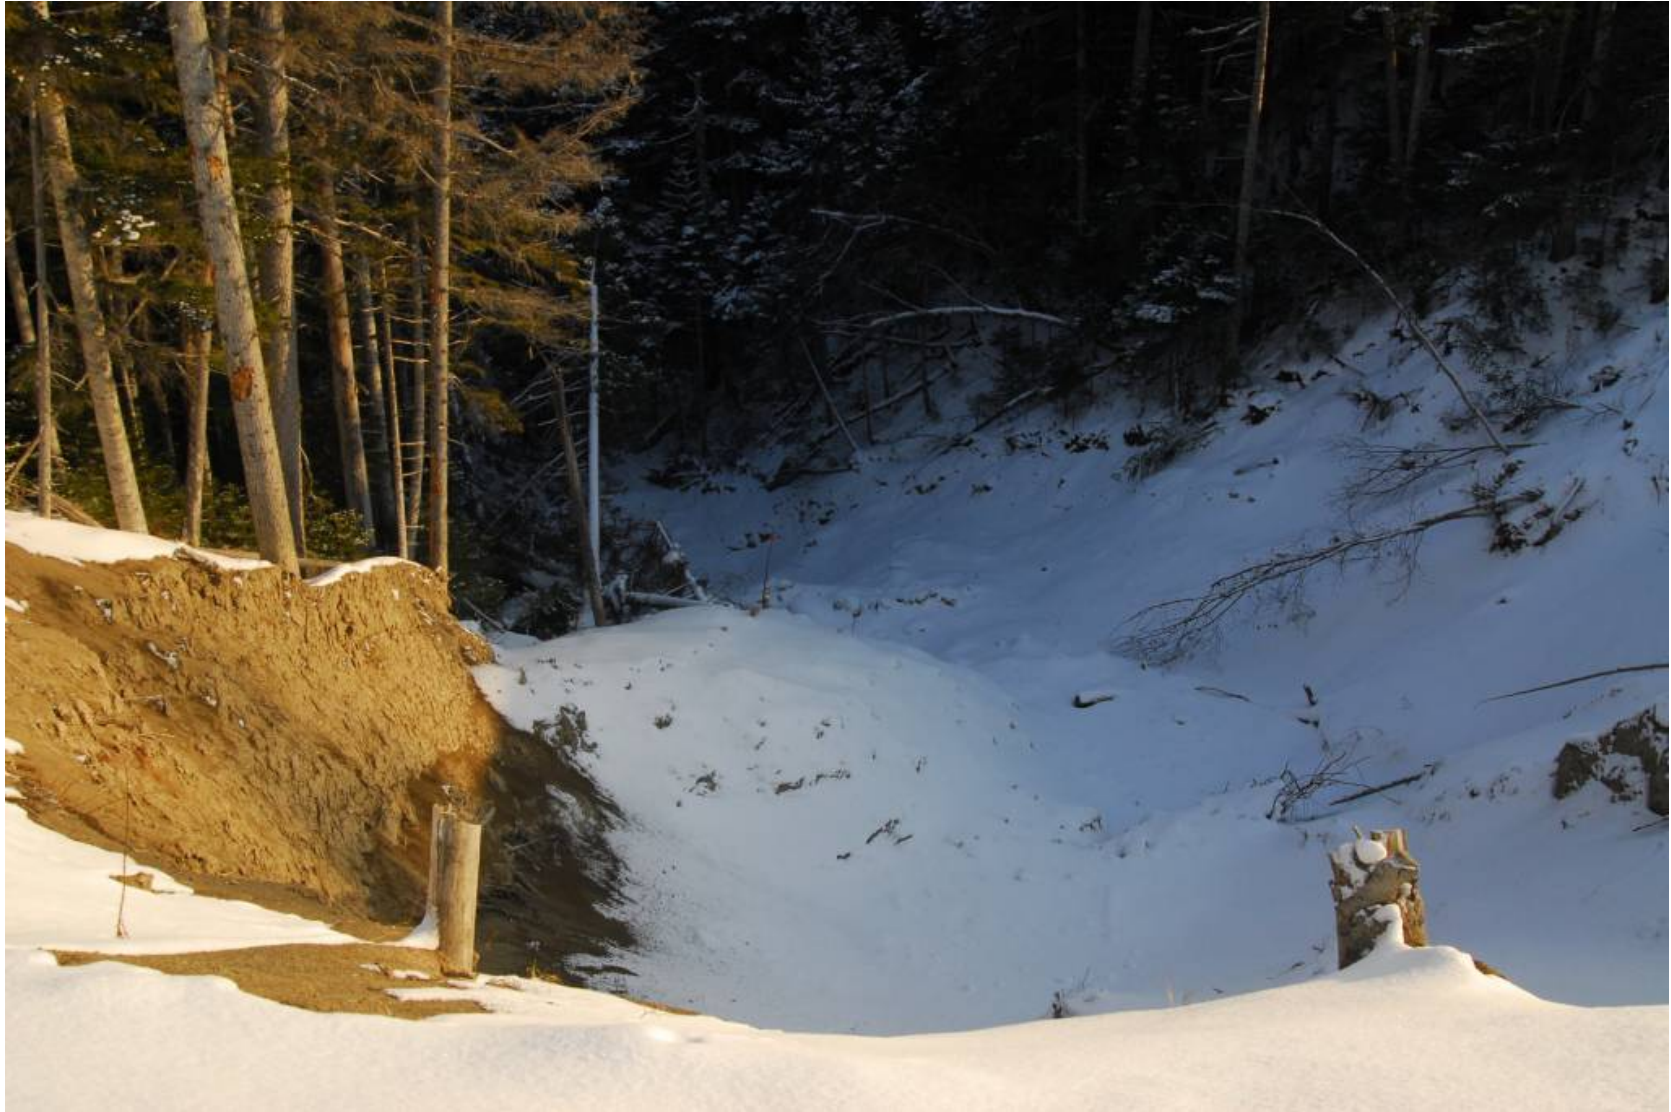
December 22, 2007: KP 365.1. A section of the pipeline to the north of the Pegas River crossing in Makarov District. A landslide down the hill from the pipeline RoW.
