Sakhalin Environment Watch

Photo report for inspection of construction on the main pipeline for Sakhalin II project in Dolinsky District of Sakhalin Region

Inspection conducted on April 3, 2008 as part of public environmental monitoring
in accordance with Article 68 of Federal Law "On Environmental Protection"

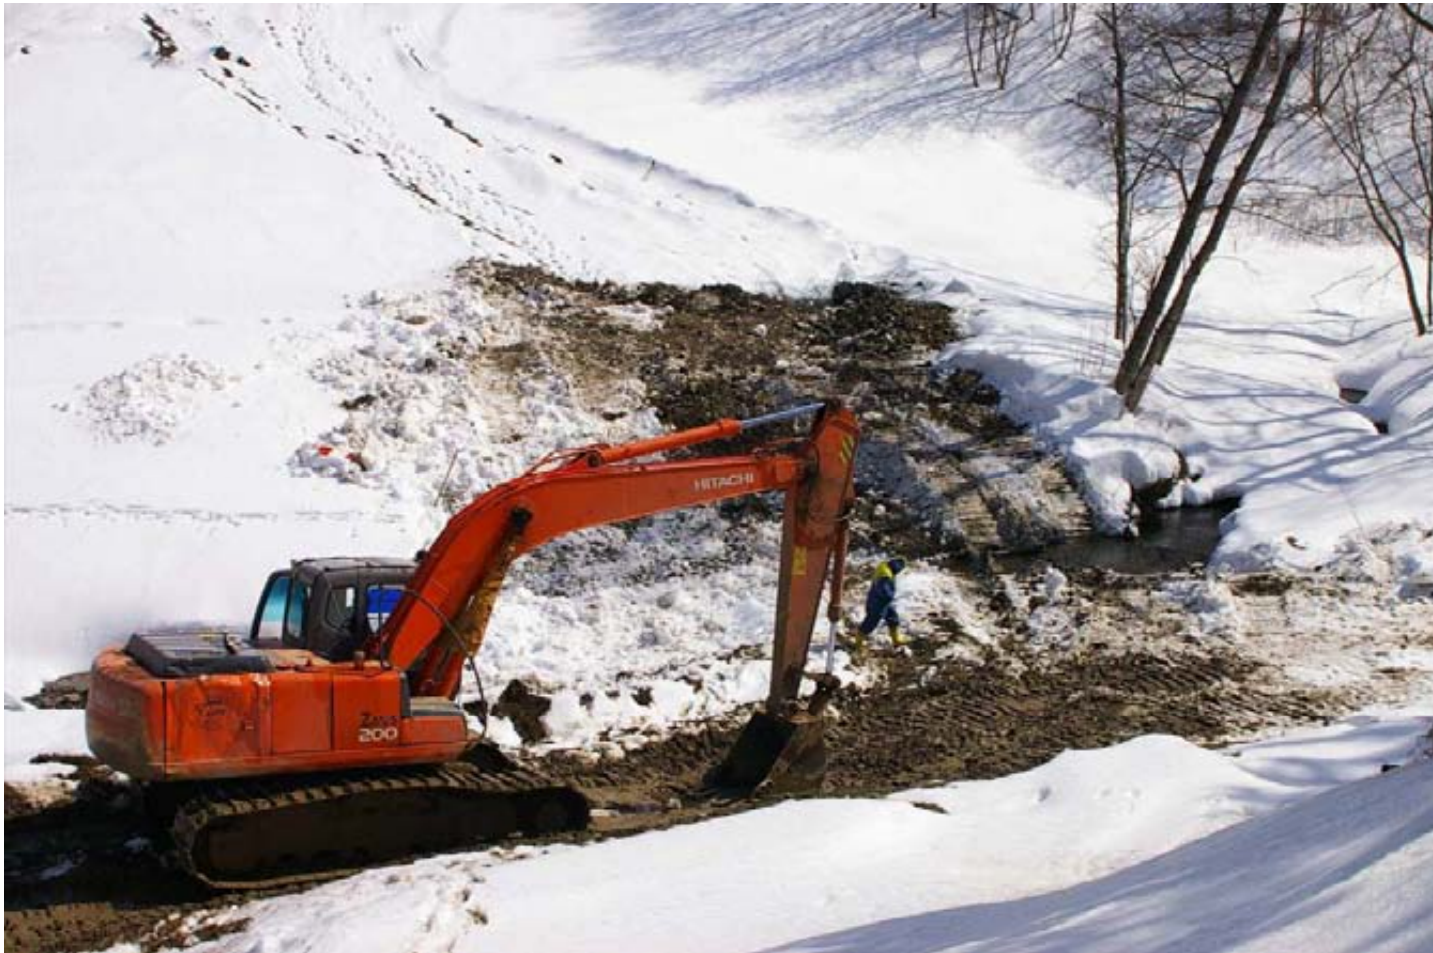
General view of the location where the pipeline crosses the Rybnaia River. On the right side of the photo one can see the tracks of caterpillar equipment through the riverbed.

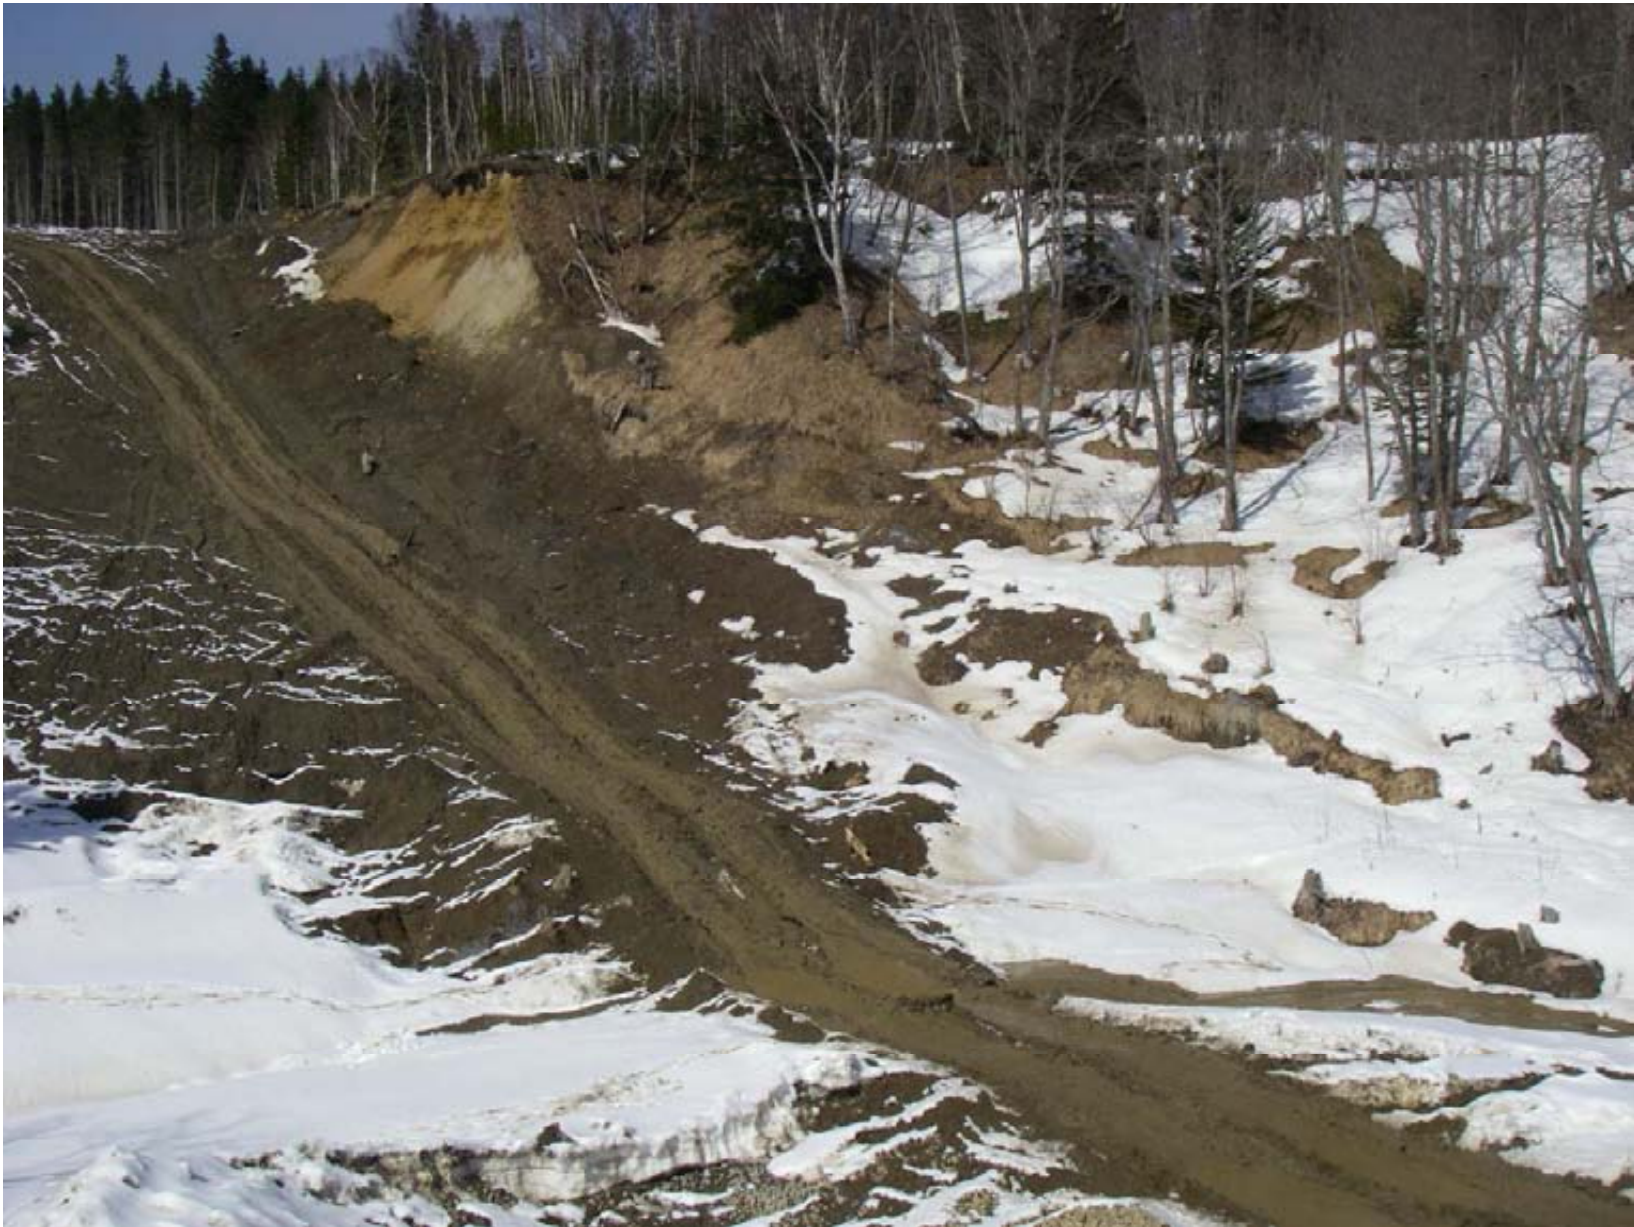
PK 488.4. General view of a slope in the Rybnaia River valley (left shore). A road was recently built along this slope. From the southern side, this slope receives strong direct sunlight, so snow melts faster here. The movement of caterpillar equipment accelerates the snow melting process even more, concentrating melt waters in the road tracks.

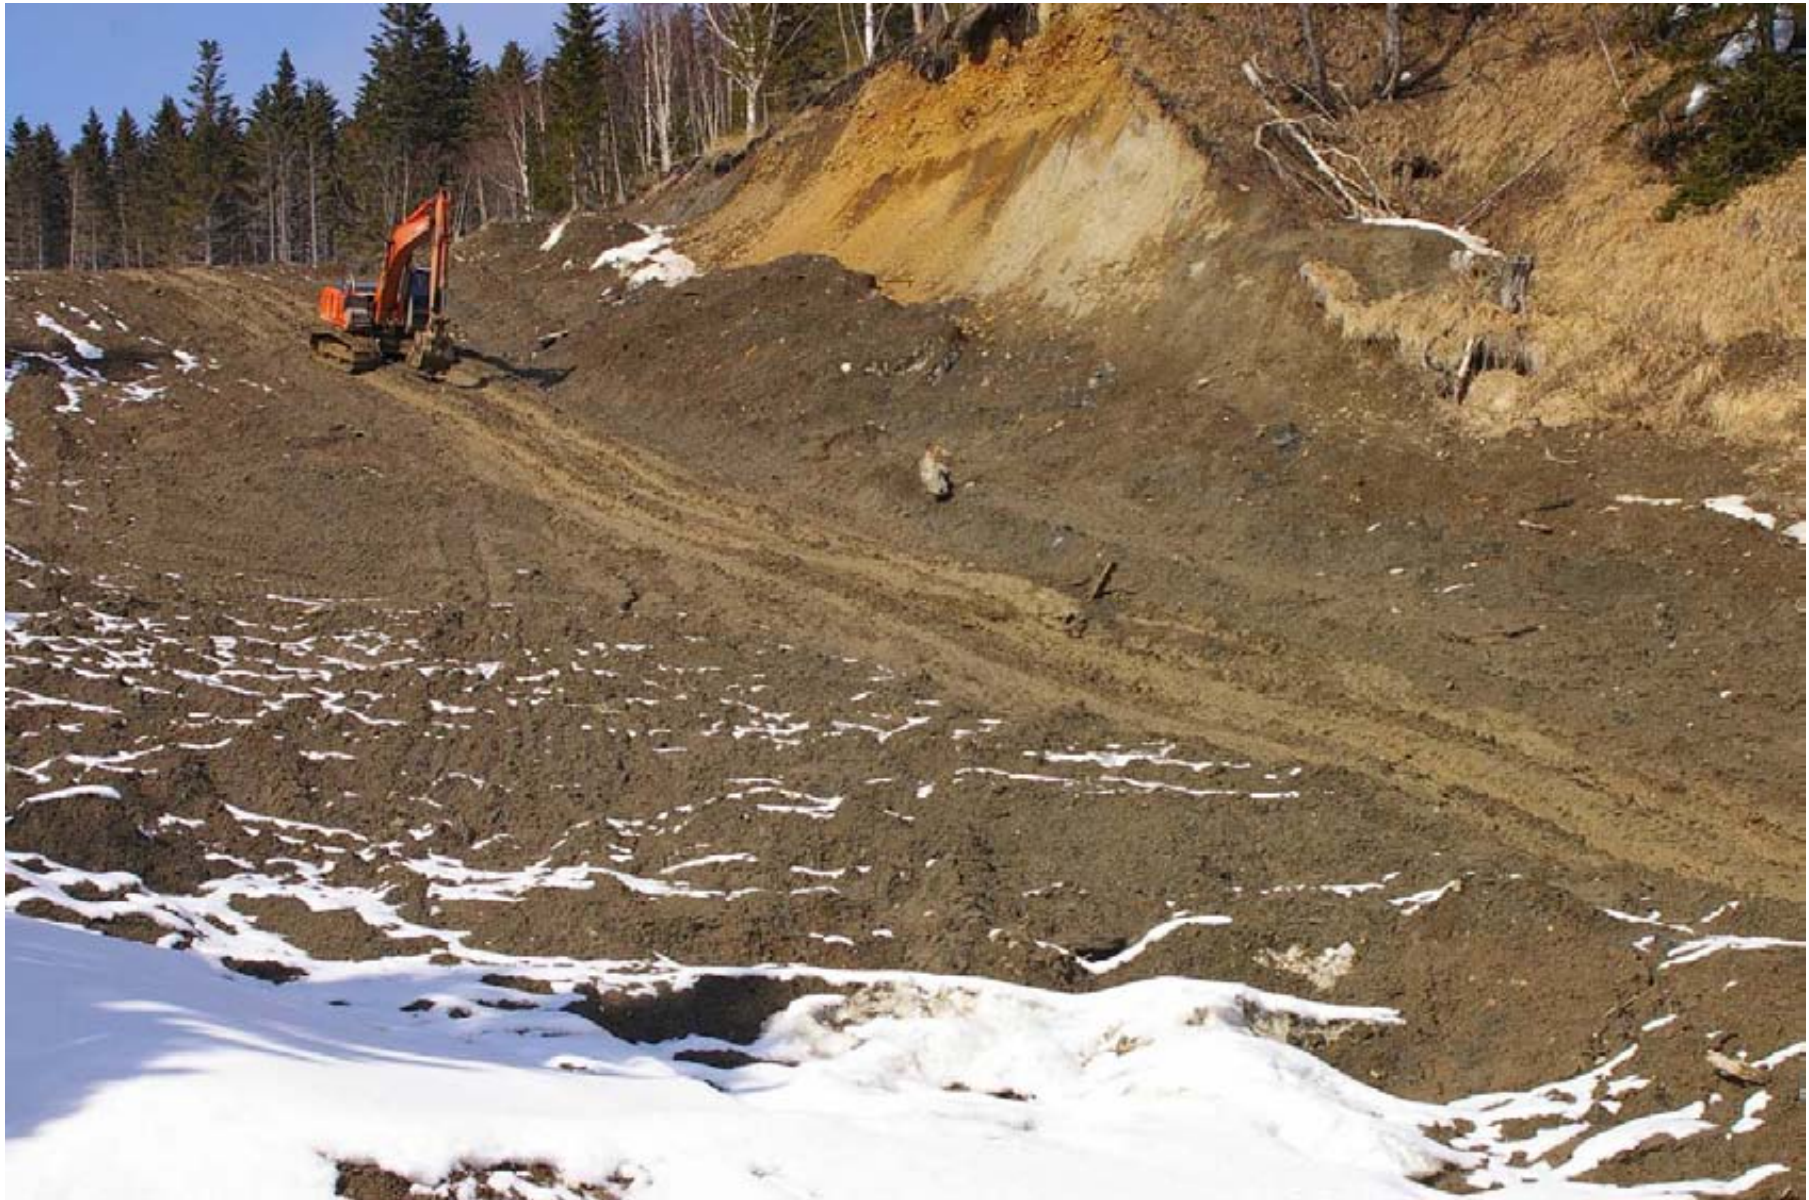
PK 488.4. The presence of the road and activity on it substantially activates erosion of the soil on the slope from melt waters.

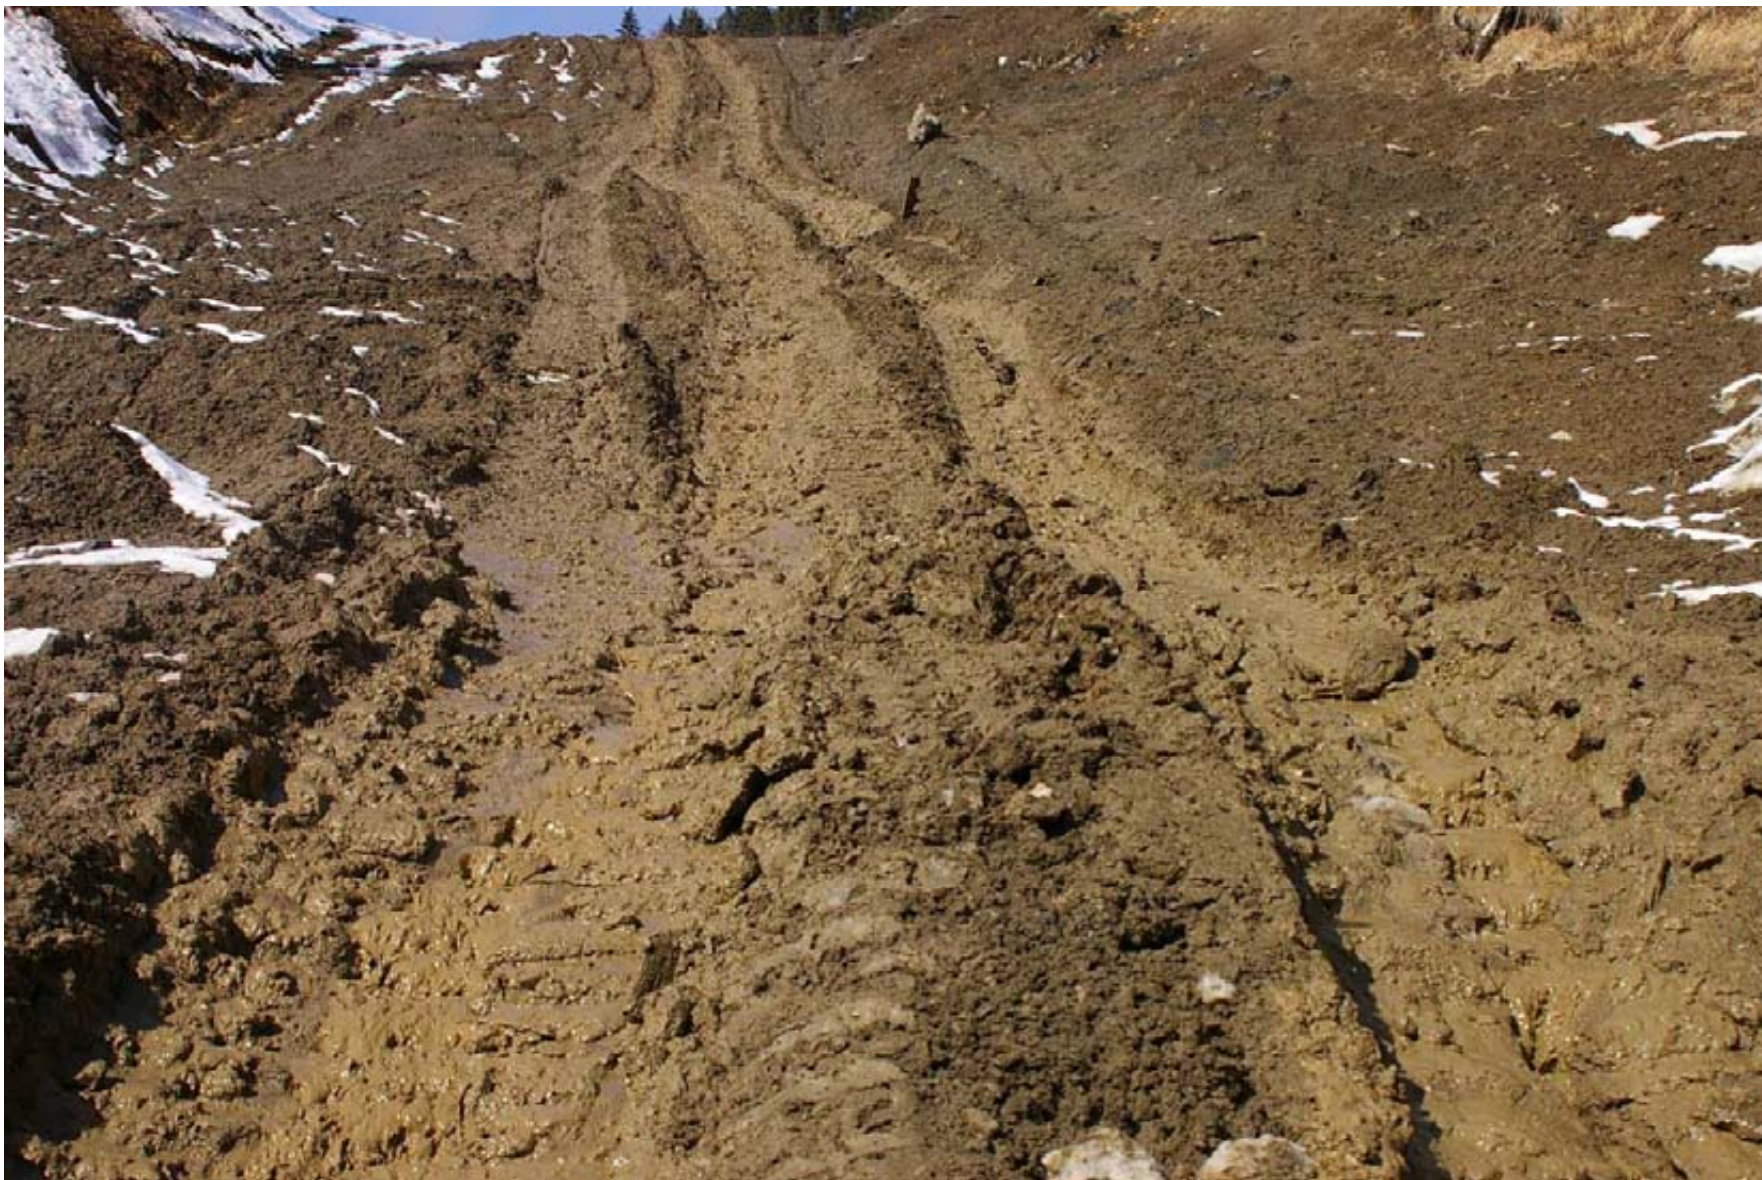
PK 488.4. As a result of active erosion, mud flows rush down into the Rybnaia River, and the volume of the mud flows is sharply increased after the passing of heavy equipment.

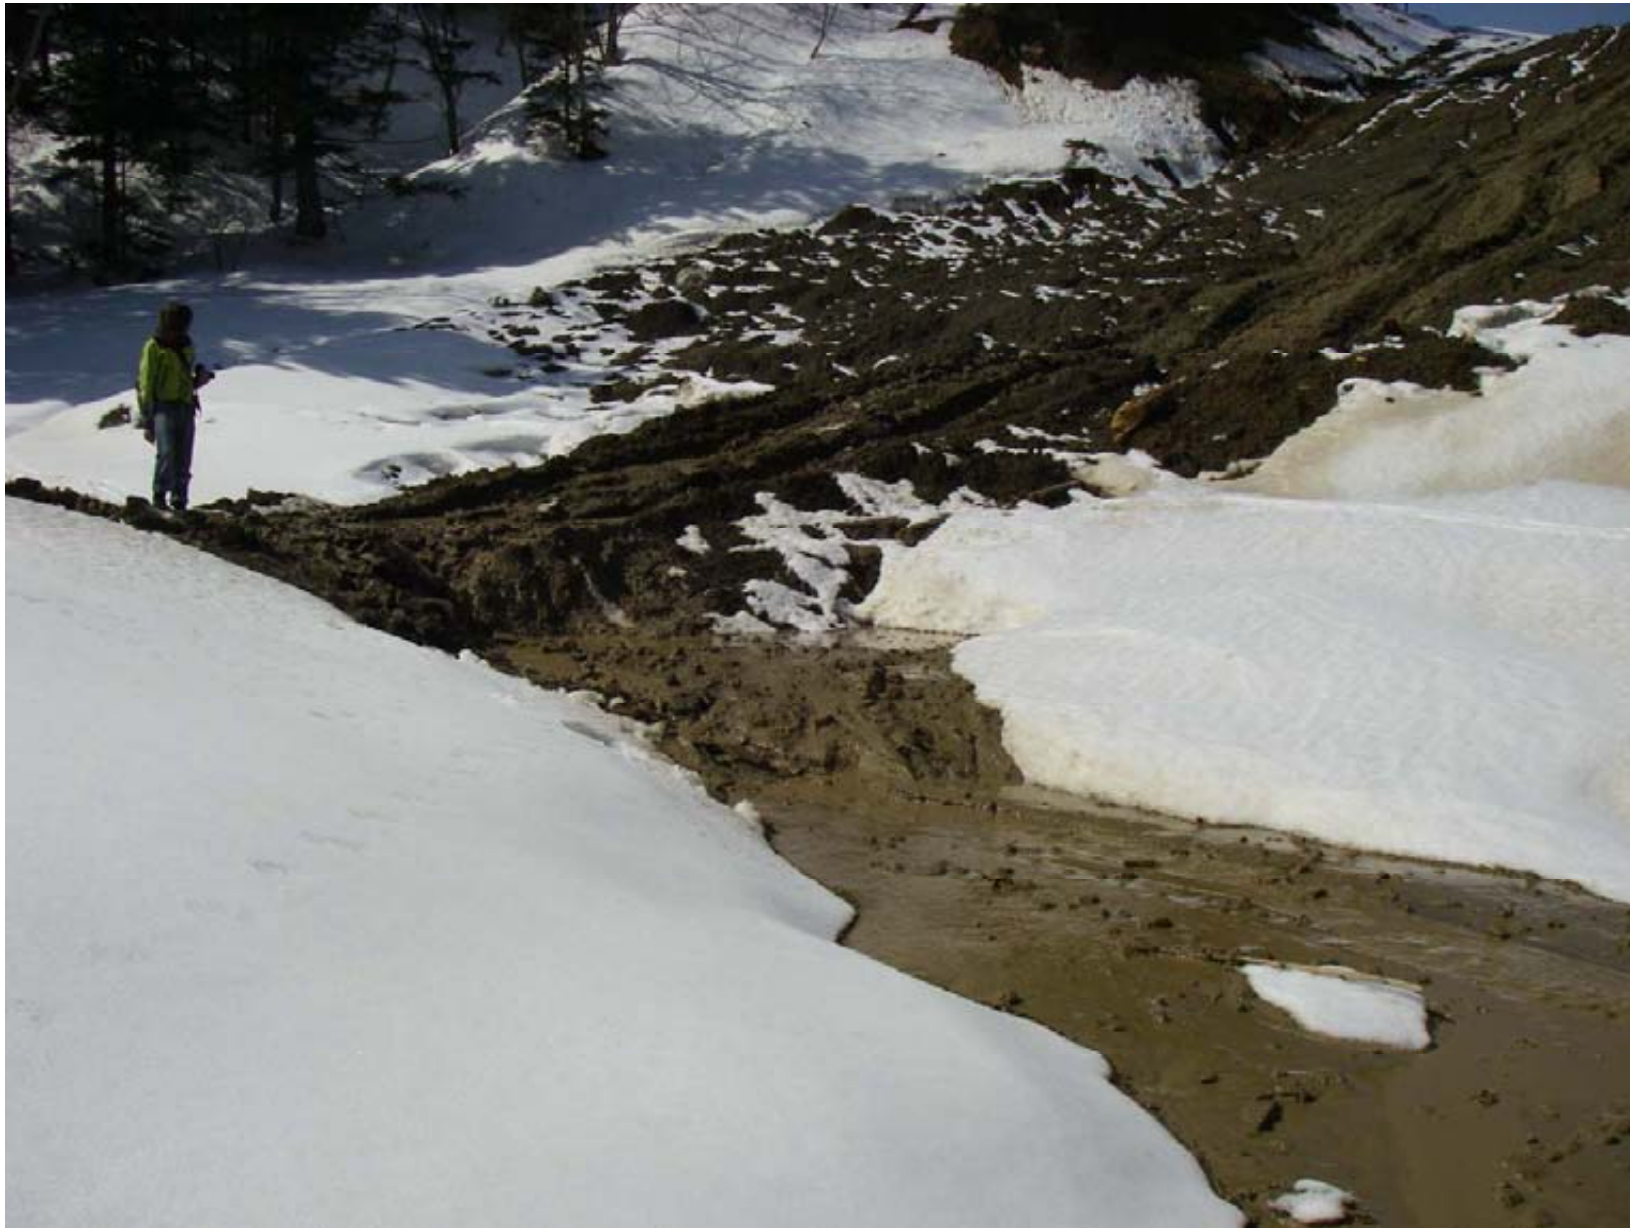
PK 488.4. In fact, it is not dirty water that flows from the road in the pipeline right-of-way to the Rybnaia River, but rather liquid mud. In normal, natural conditions during this time of year the water in the river should be clean. Such is the case upstream from the crossing of the pipeline route on the Rybnaia River, as well as on all other rivers in Dolinsky Region which are not suffering from erosion processes as a result of the pipeline route.

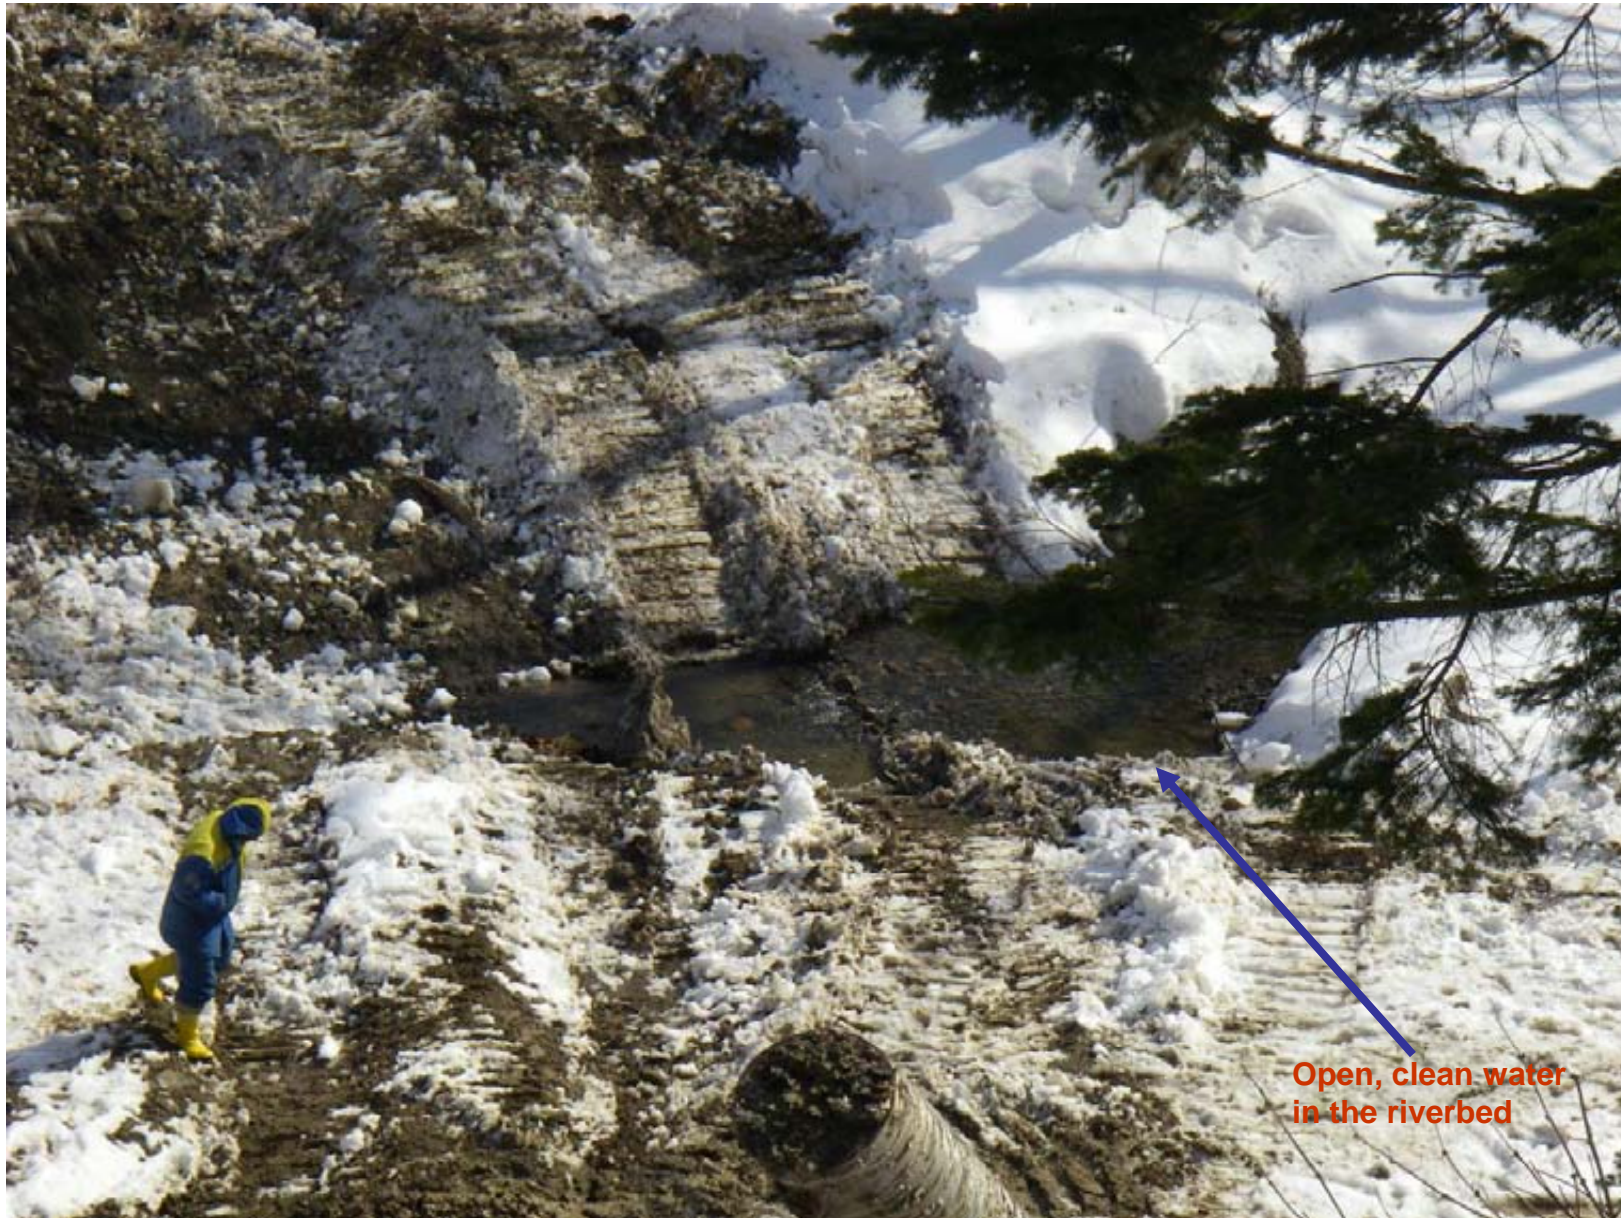
PK 488.4. A location where caterpillar equipment crosses the Rybnaia riverbed upstream from where mud from the road enters the river from the left shore. It is easy to see that here the water in the river is clean (until it mixes with the mud from the road).

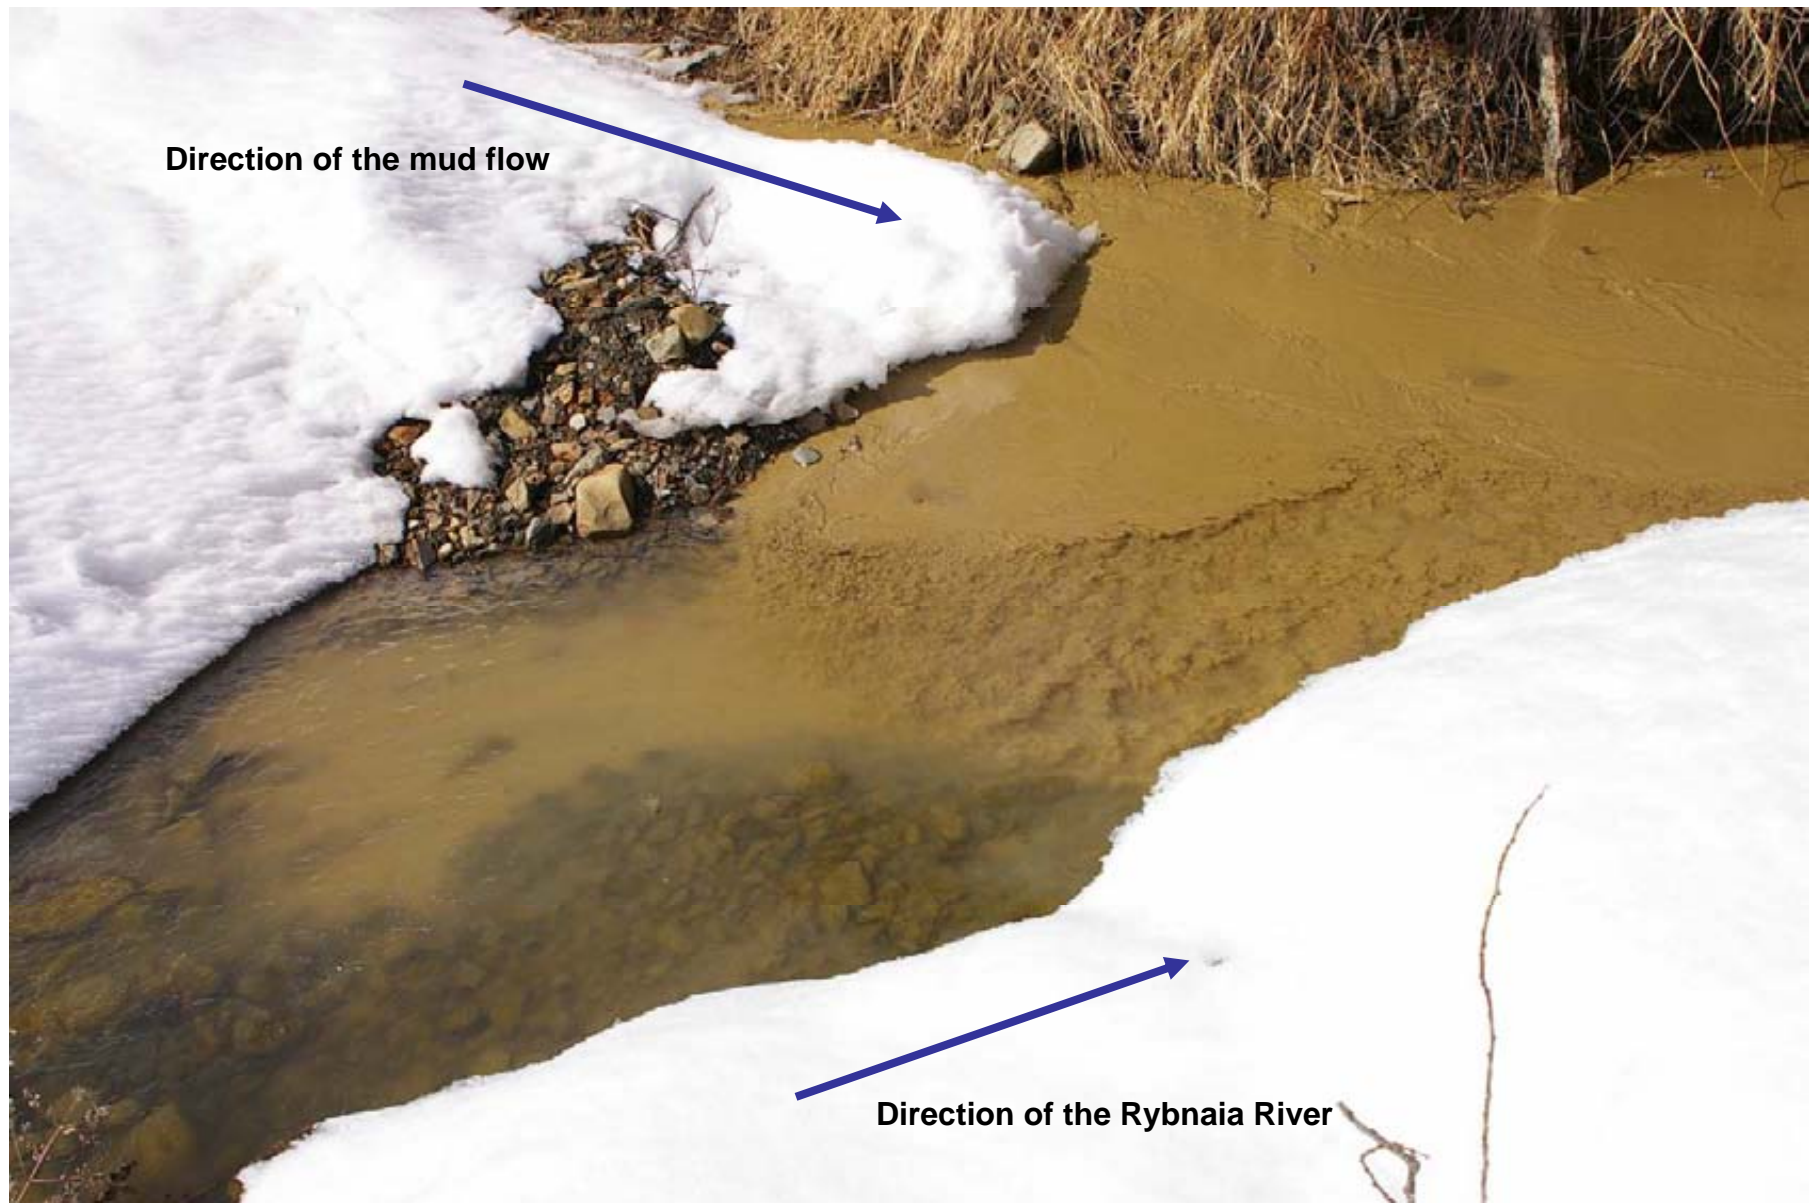
PK 488.4. The point where mud from the road enters the Rybnaia River.

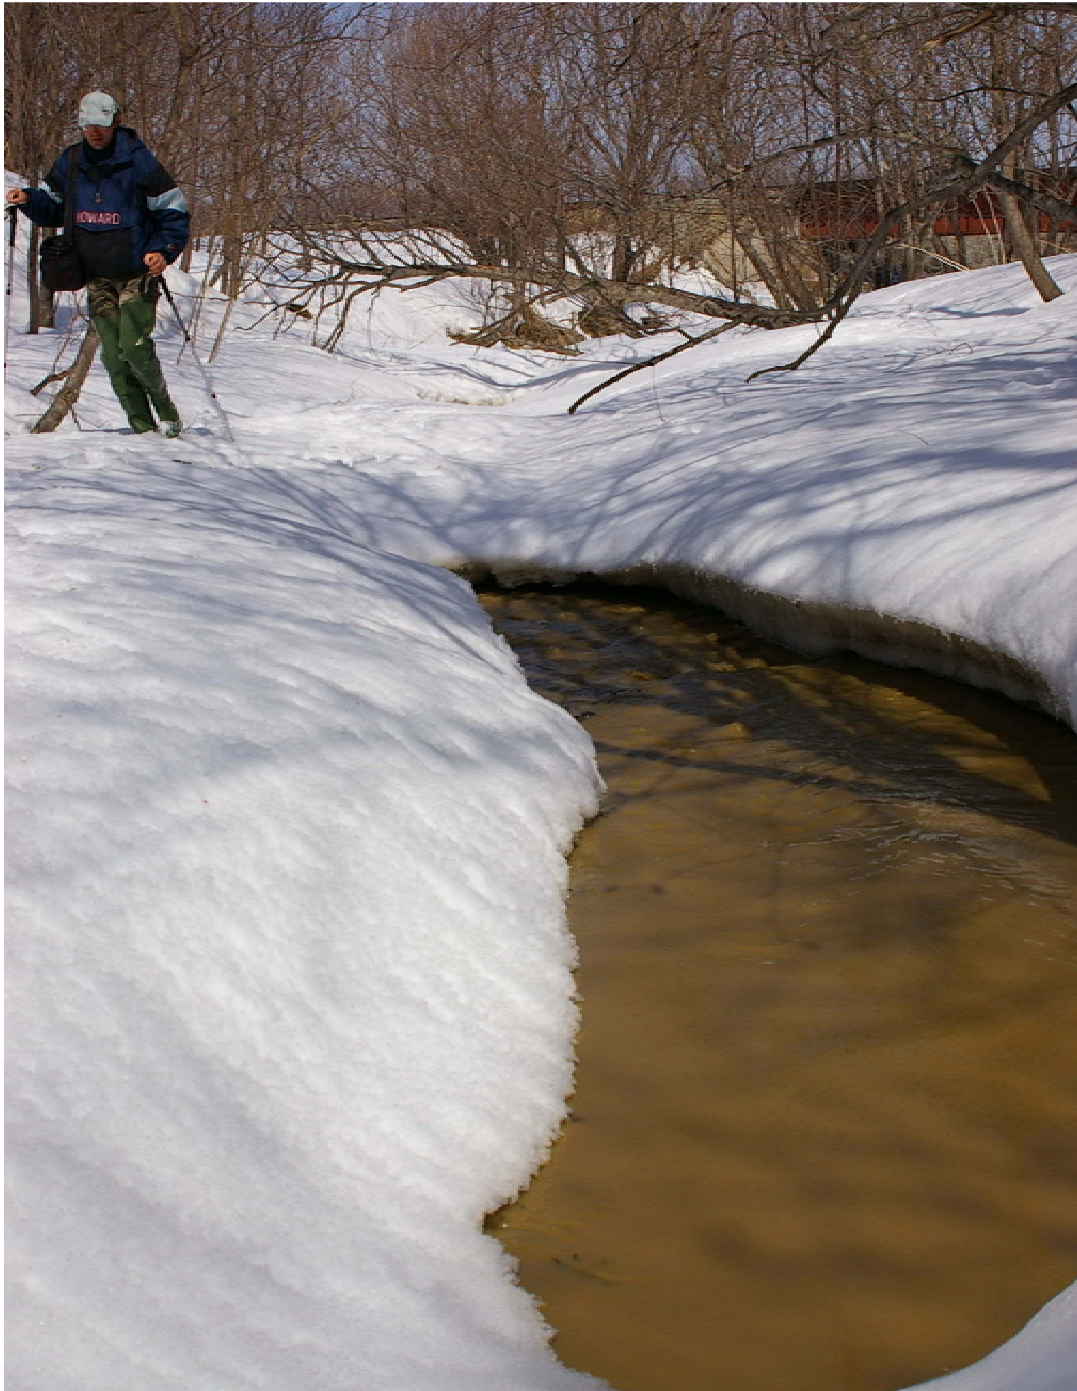
The Rybnaia River about 300 meters downstream from the crossing of the Sakhalin II pipelines. The water in the river is absolutely dirty.

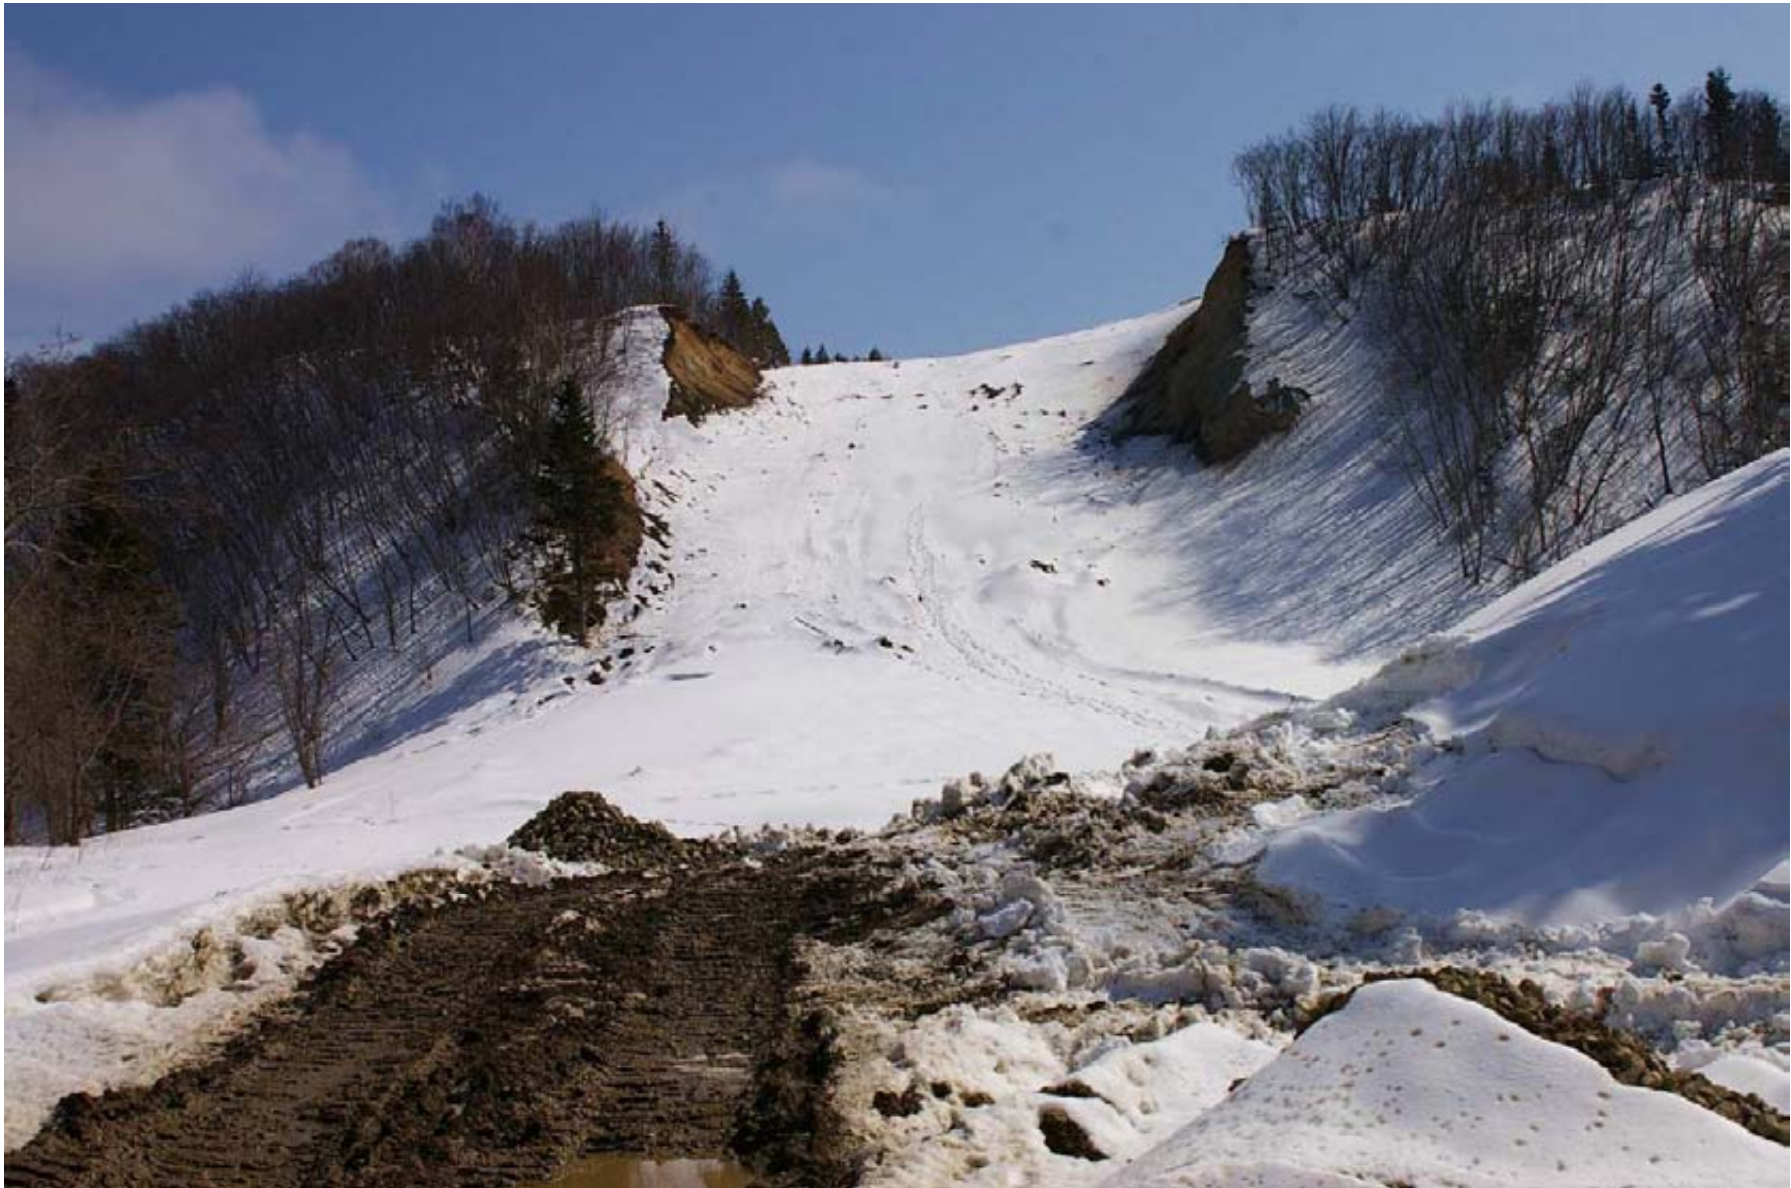
PK 488.4. A general view of the Rybnaia River valley slope (right shore). Here the integrity of the snow cover is preserved, there is no recently-constructed road, and there is no activity by heavy equipment. Accordingly, erosion processes are not observed and pollution of the river from this slope has not taken place so far.

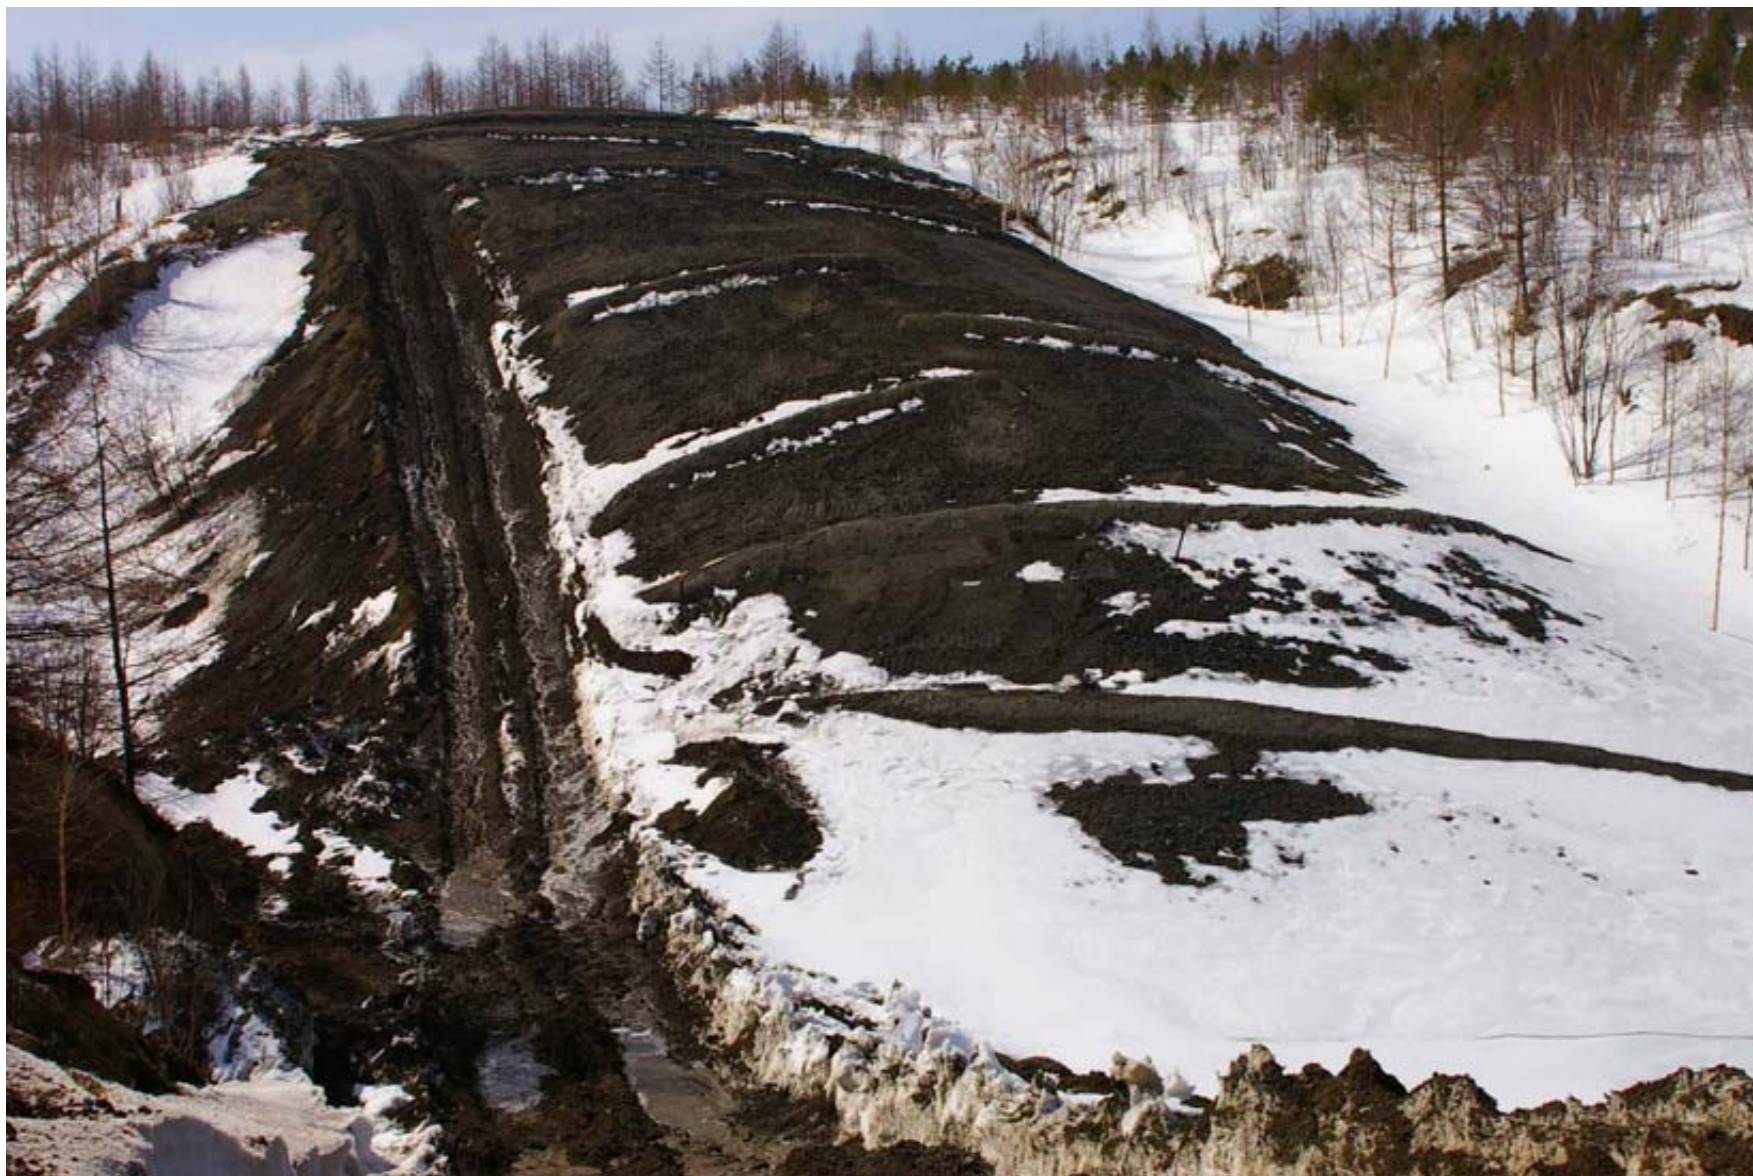
PK 461.0. General view of the slope above a stream which flows into the Krasnaia River. A section of the pipeline with completed anti-erosion barriers that were disrupted by the recently constructed road is visible.

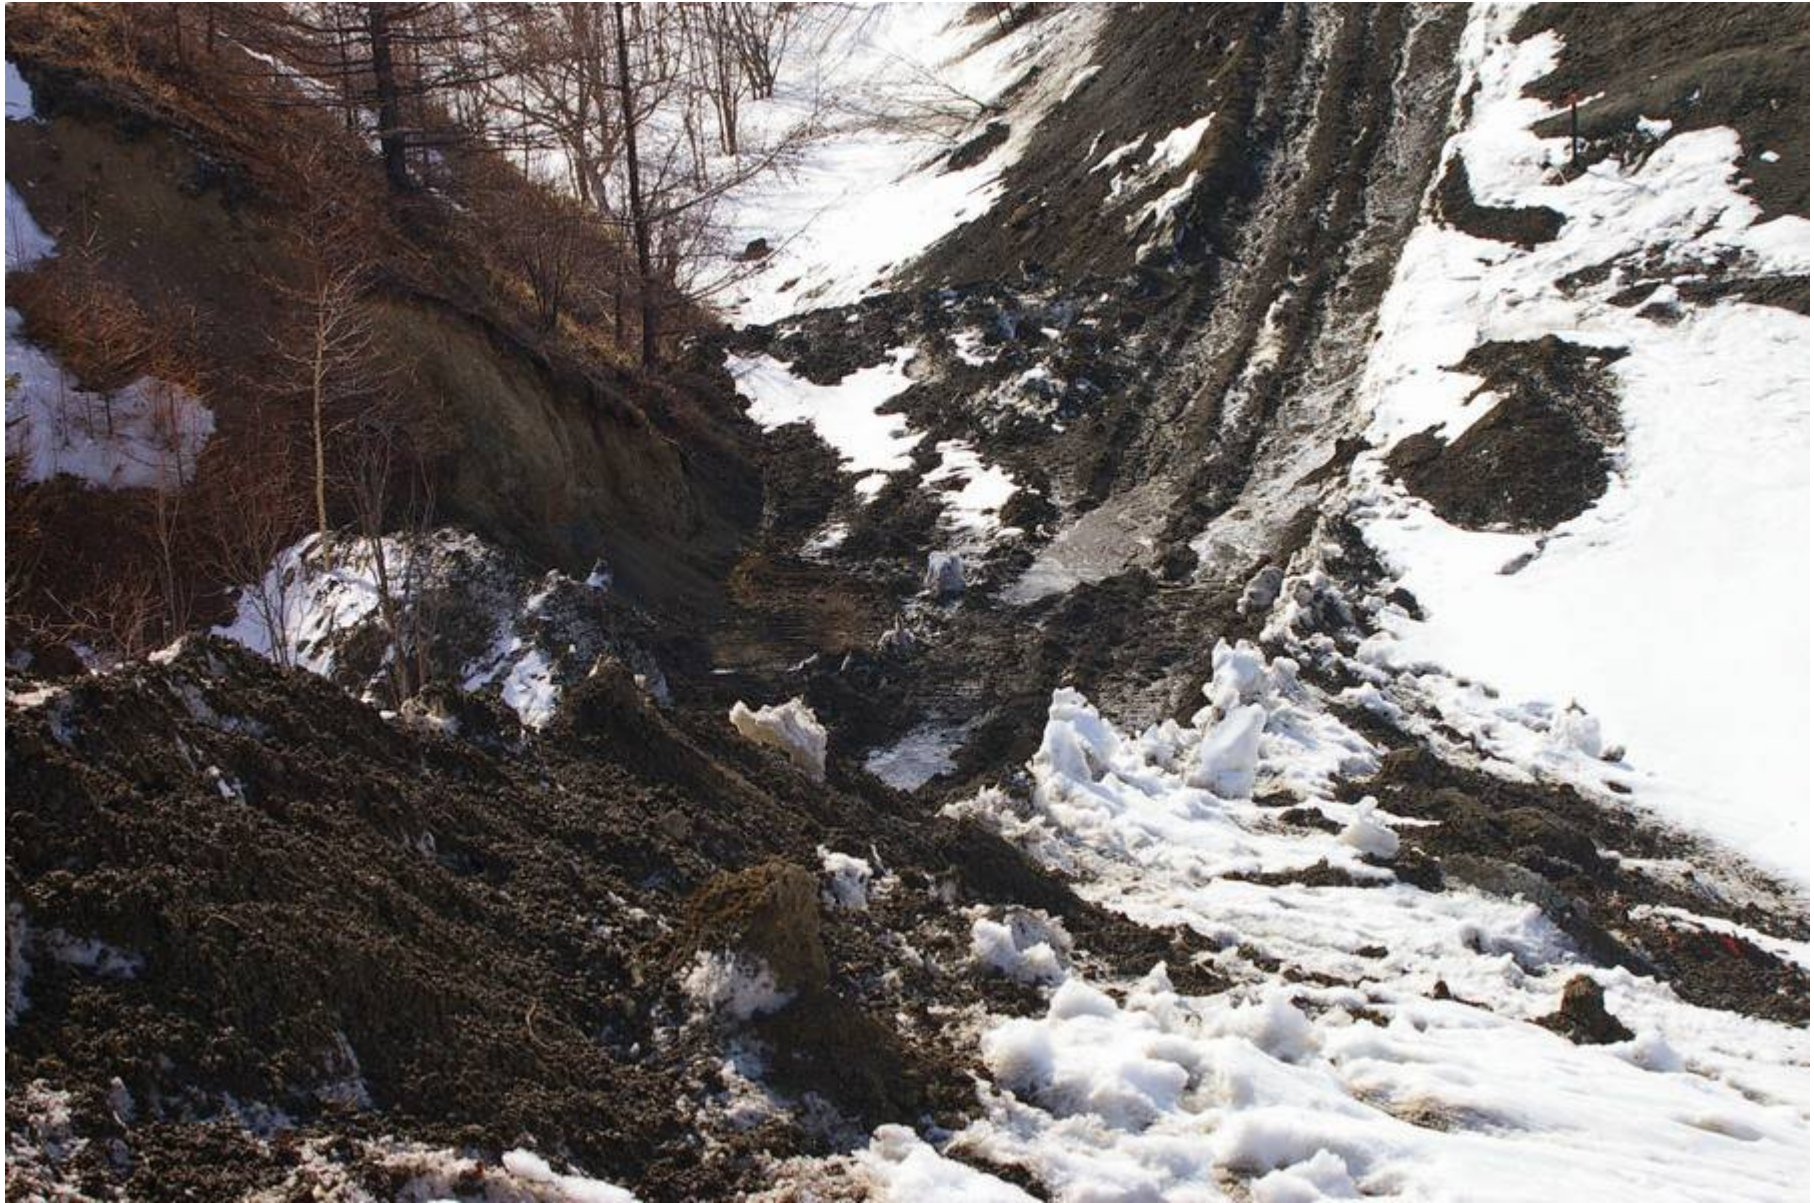
PK 461.0. A streambed, covered with soil for the construction of a road crossing. Water-passage equipment is absent, and the soil is piled on top of the snow and ice.
