Sakhalin Environment Watch

Photo report for inspection of construction on the main pipeline for Sakhalin II project in Dolinsky District of Sakhalin Region

Inspection conducted on April 3, 2008 as part of public environmental monitoring
in accordance with Article 68 of Federal Law "On Environmental Protection"

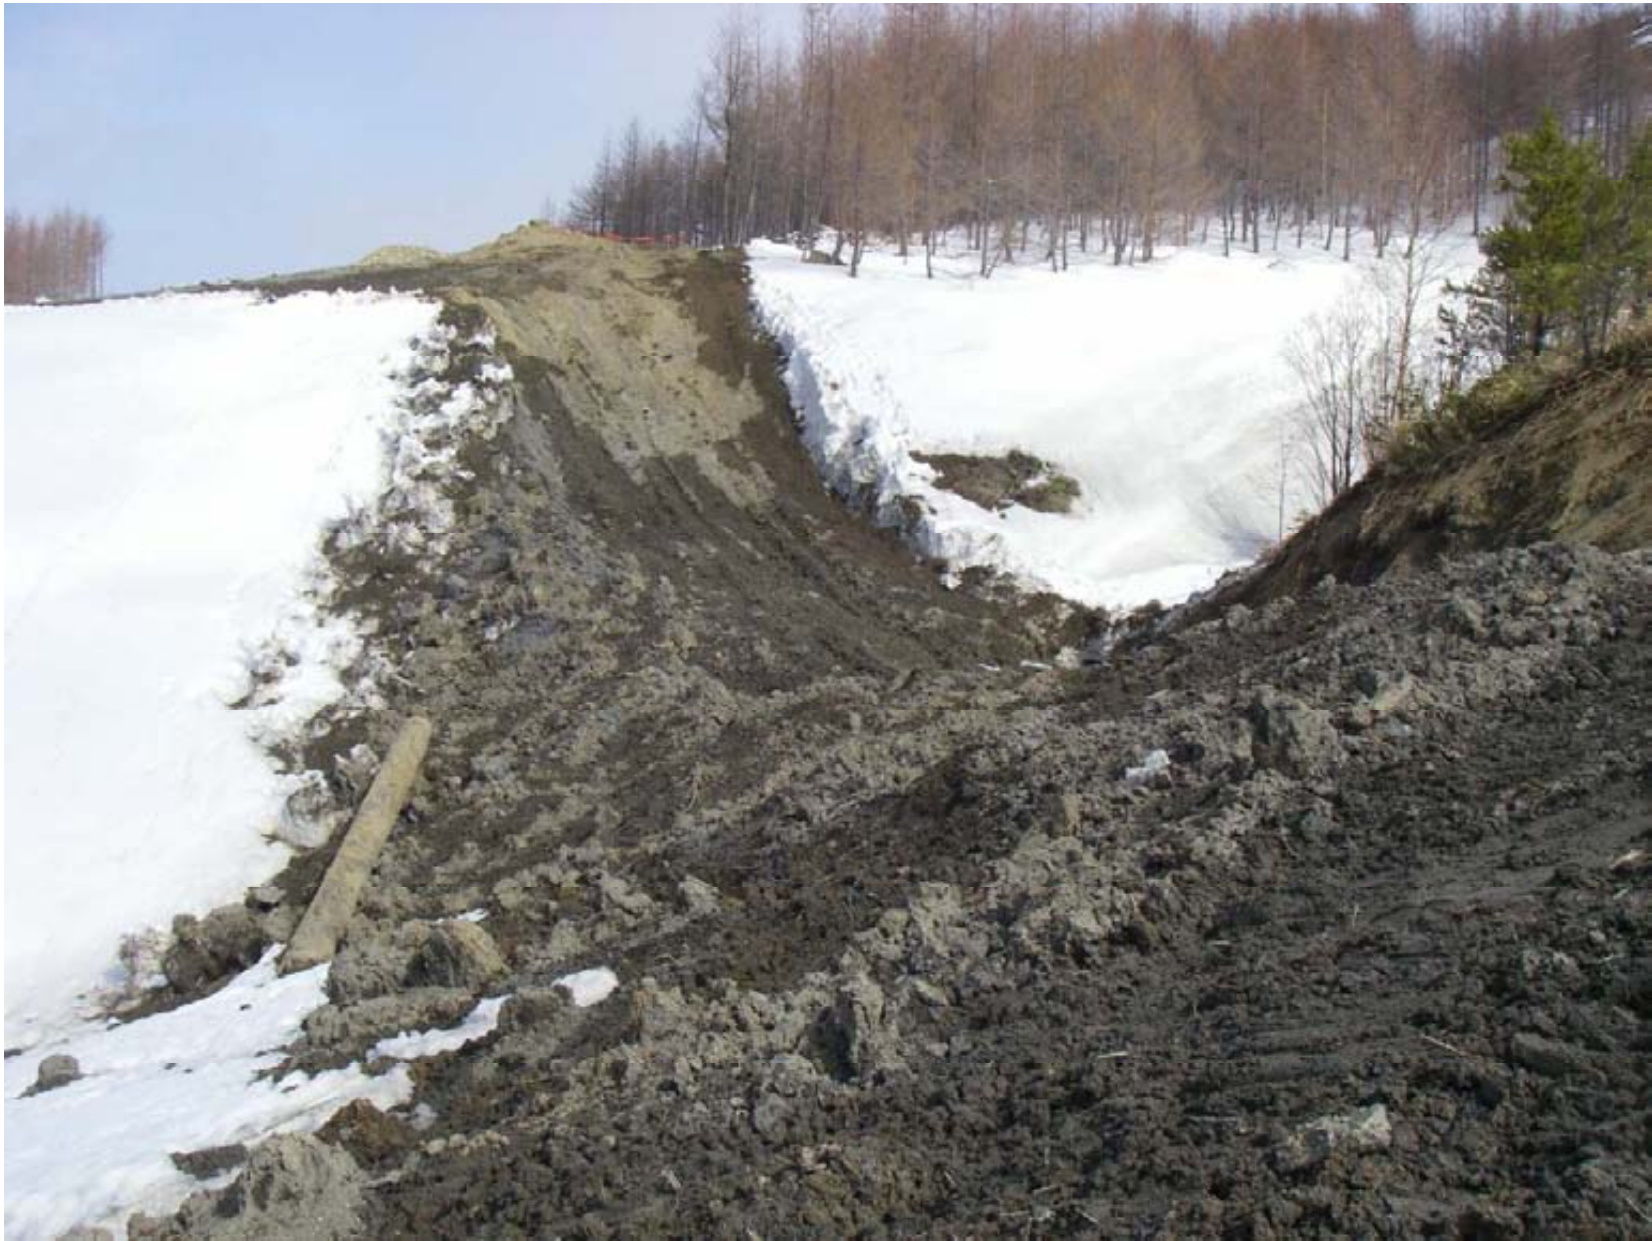
PK 461.7. The bed of another stream, filled with soil for the construction of a road crossing over the stream. Water-passage equipment is absent, the soil is piled on top of the snow and ice. On the left an abandoned culvert lies on the ground.

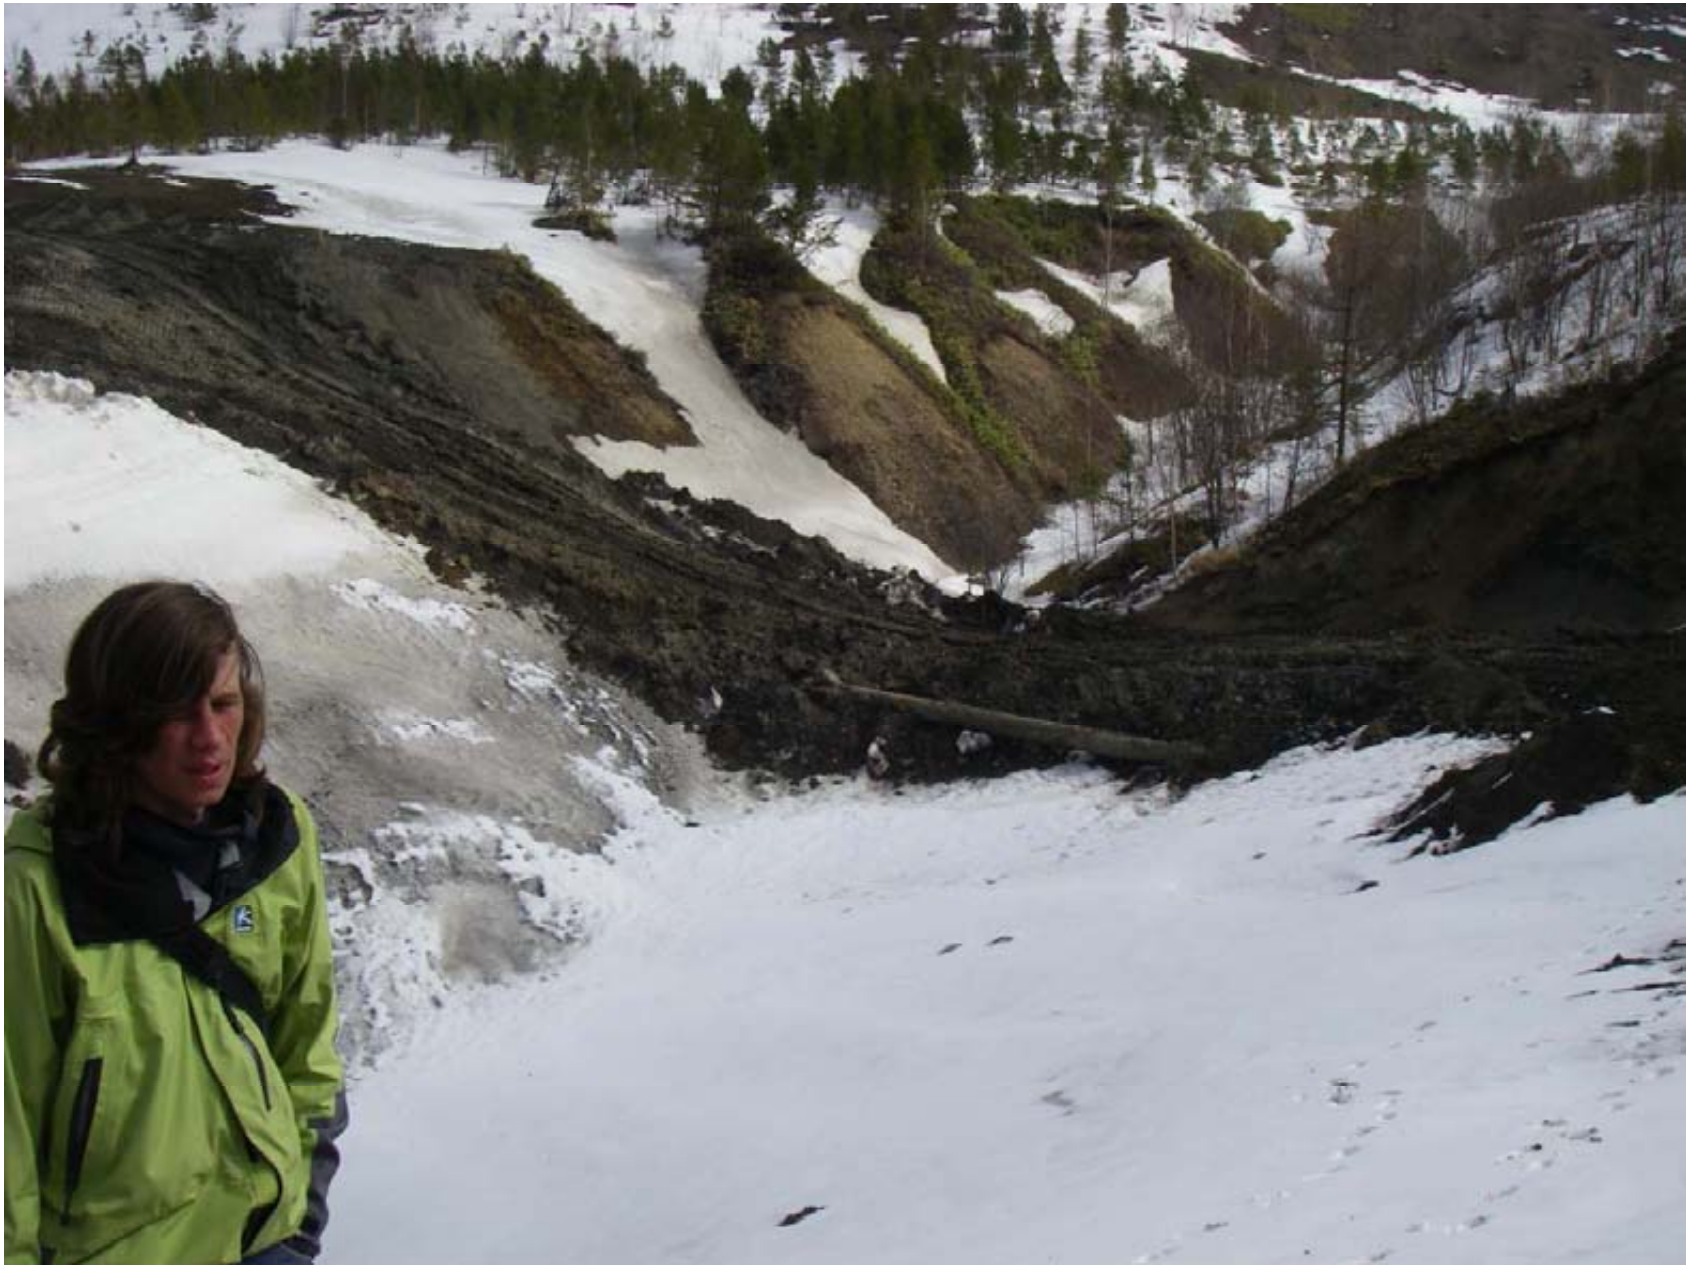
PK 461.7. The same location as in the previous photo. The pile of earth blocks the streambed, and a culvert lies on the ground.

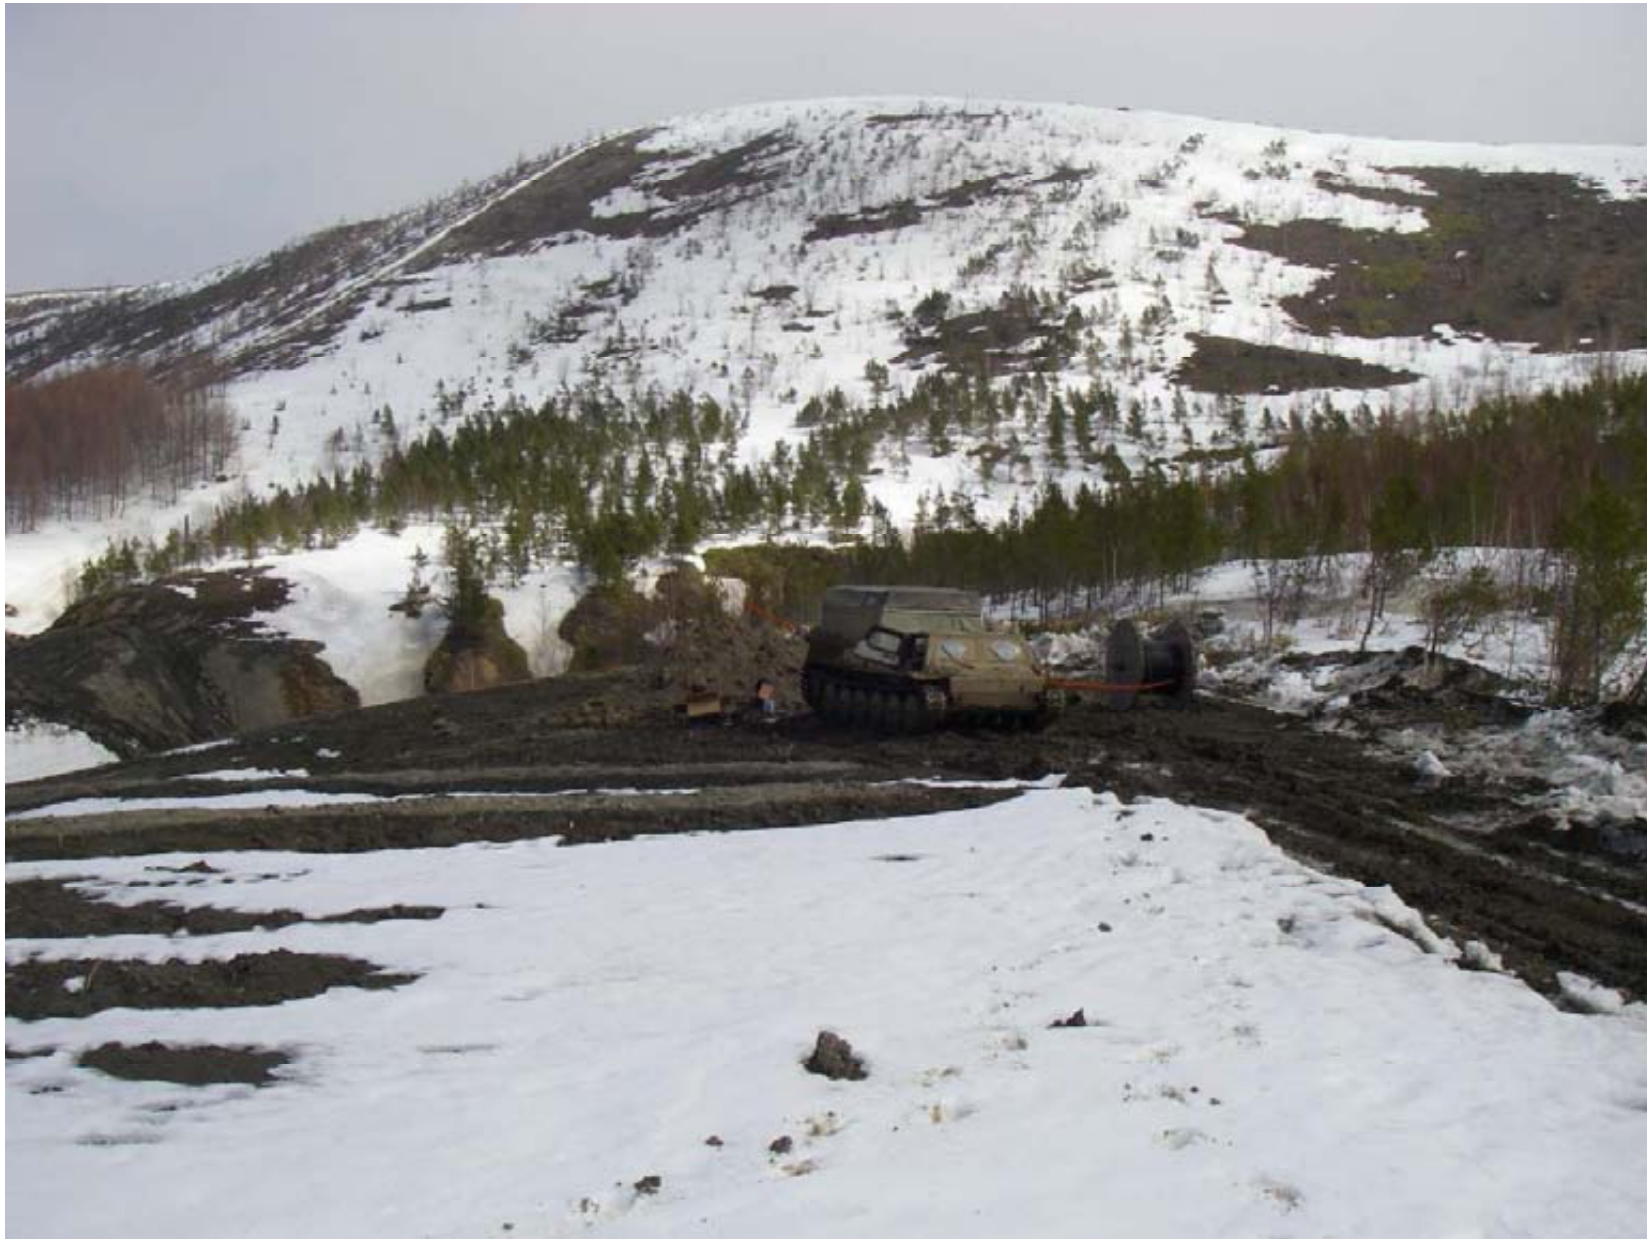
PK 462.0. Repair work on the fiber optic cable with the use of a cross-country vehicle.

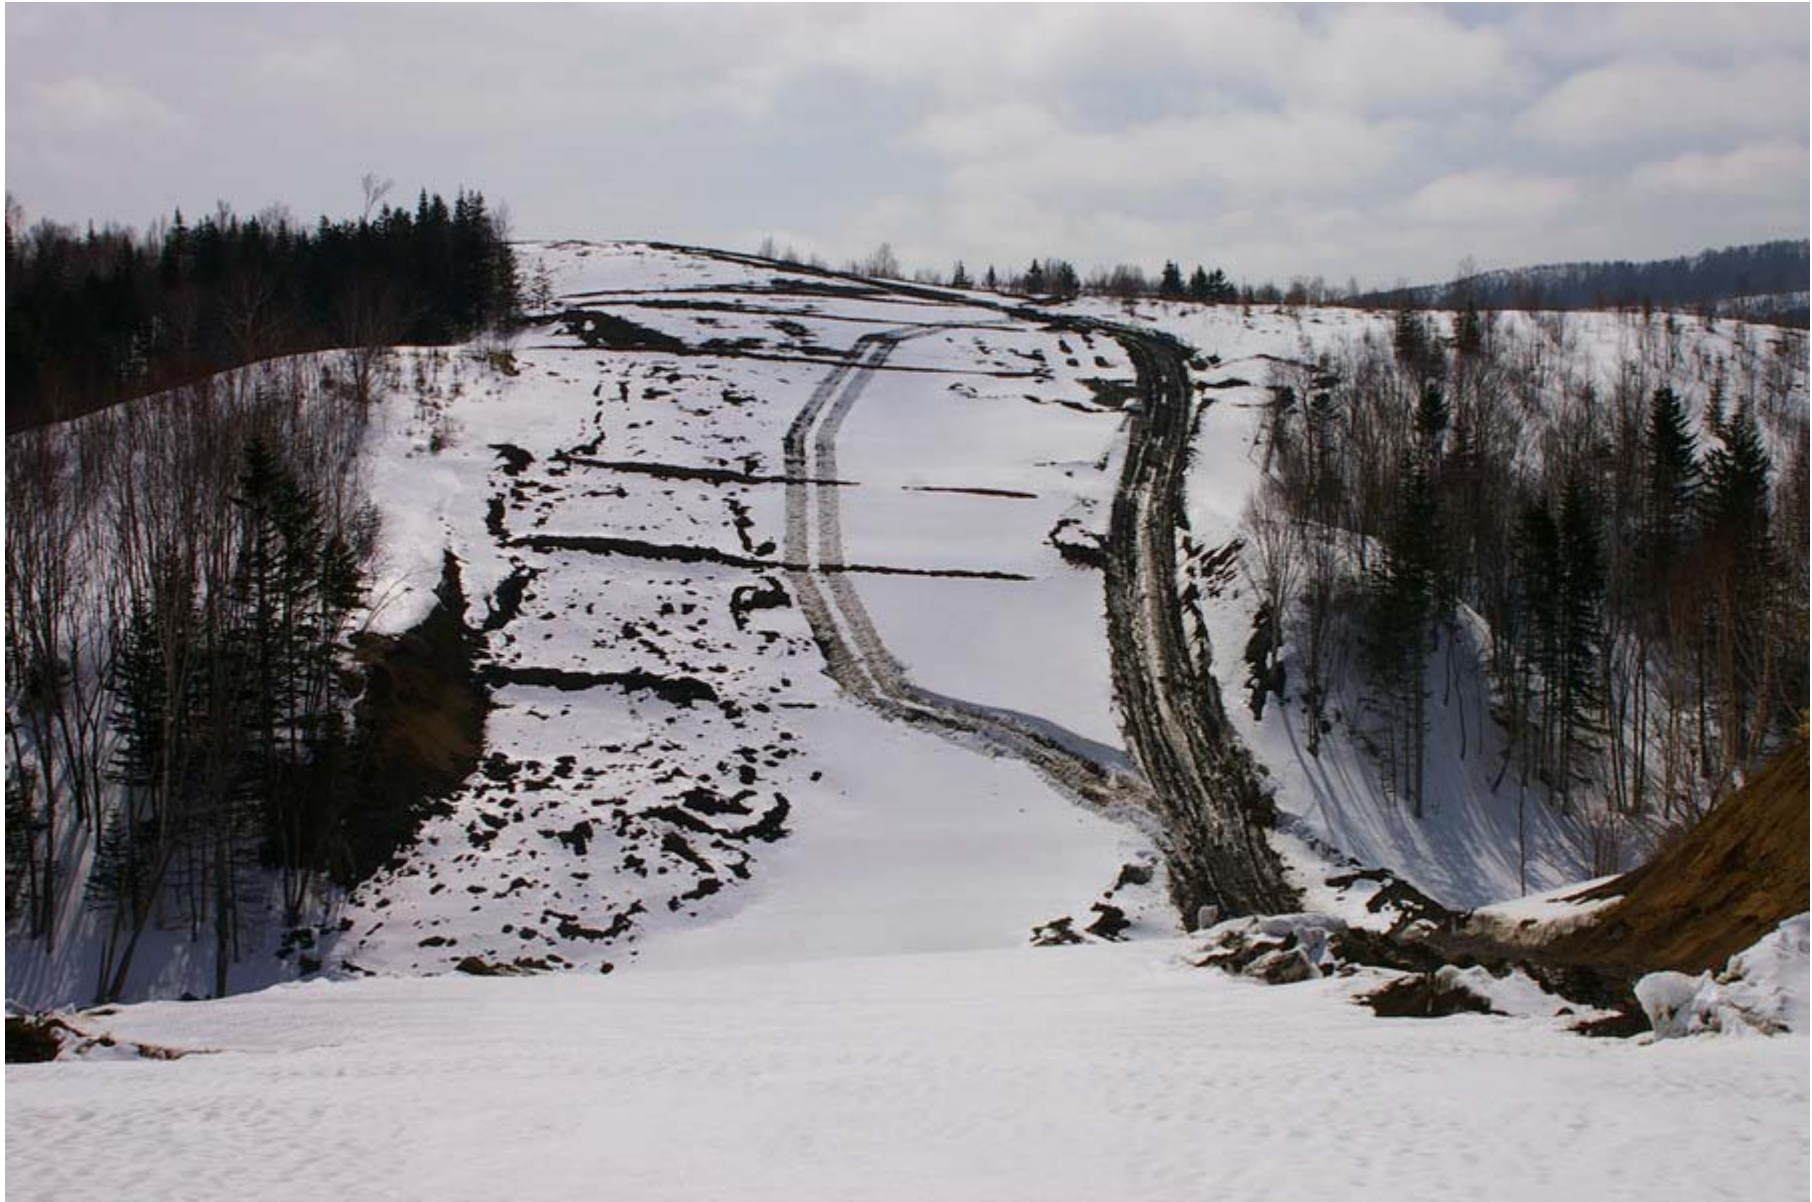
PK 462.6. Another example of a slope that has been damaged from a recently constructed road.

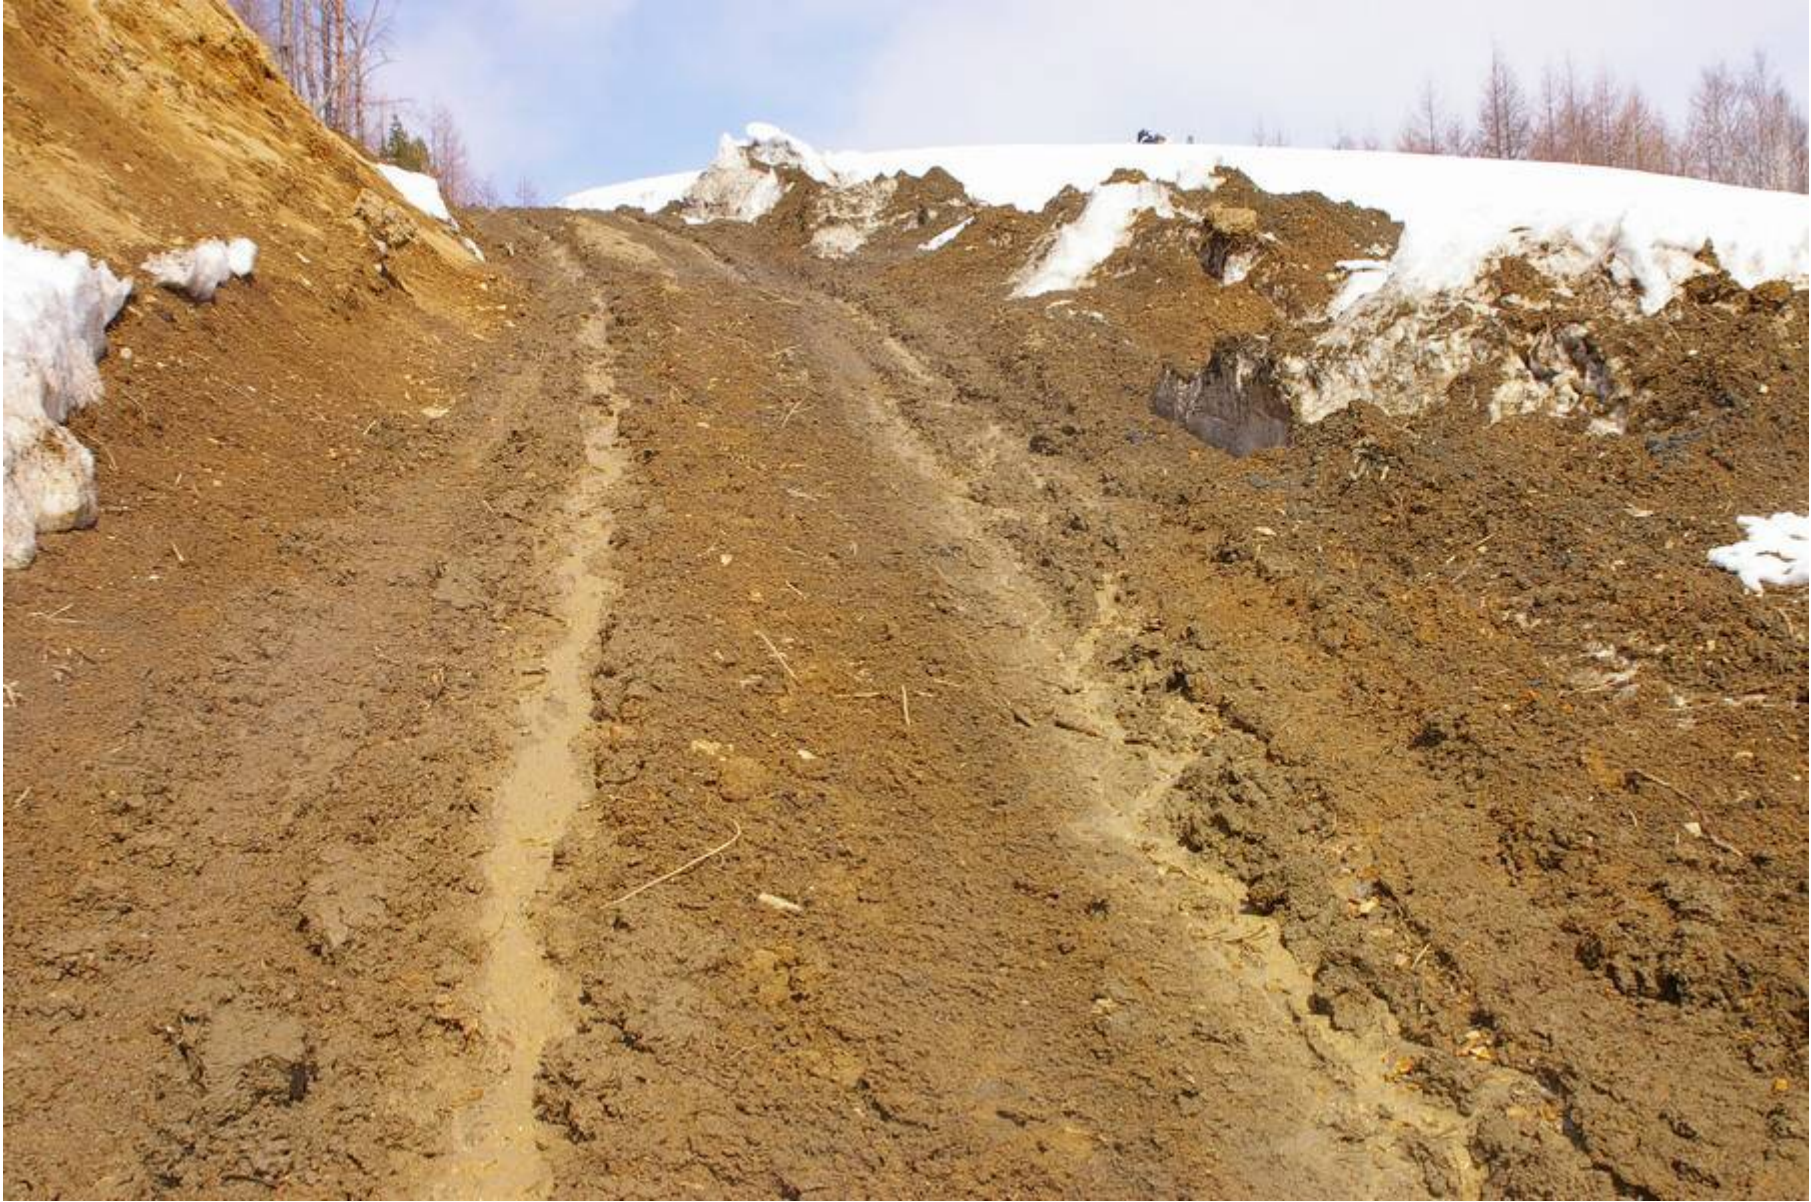
PK 462.6. Linear erosion is occurring on the tracks of this road, despite the fact that no soil wash-out was observed on other sections of the slope.

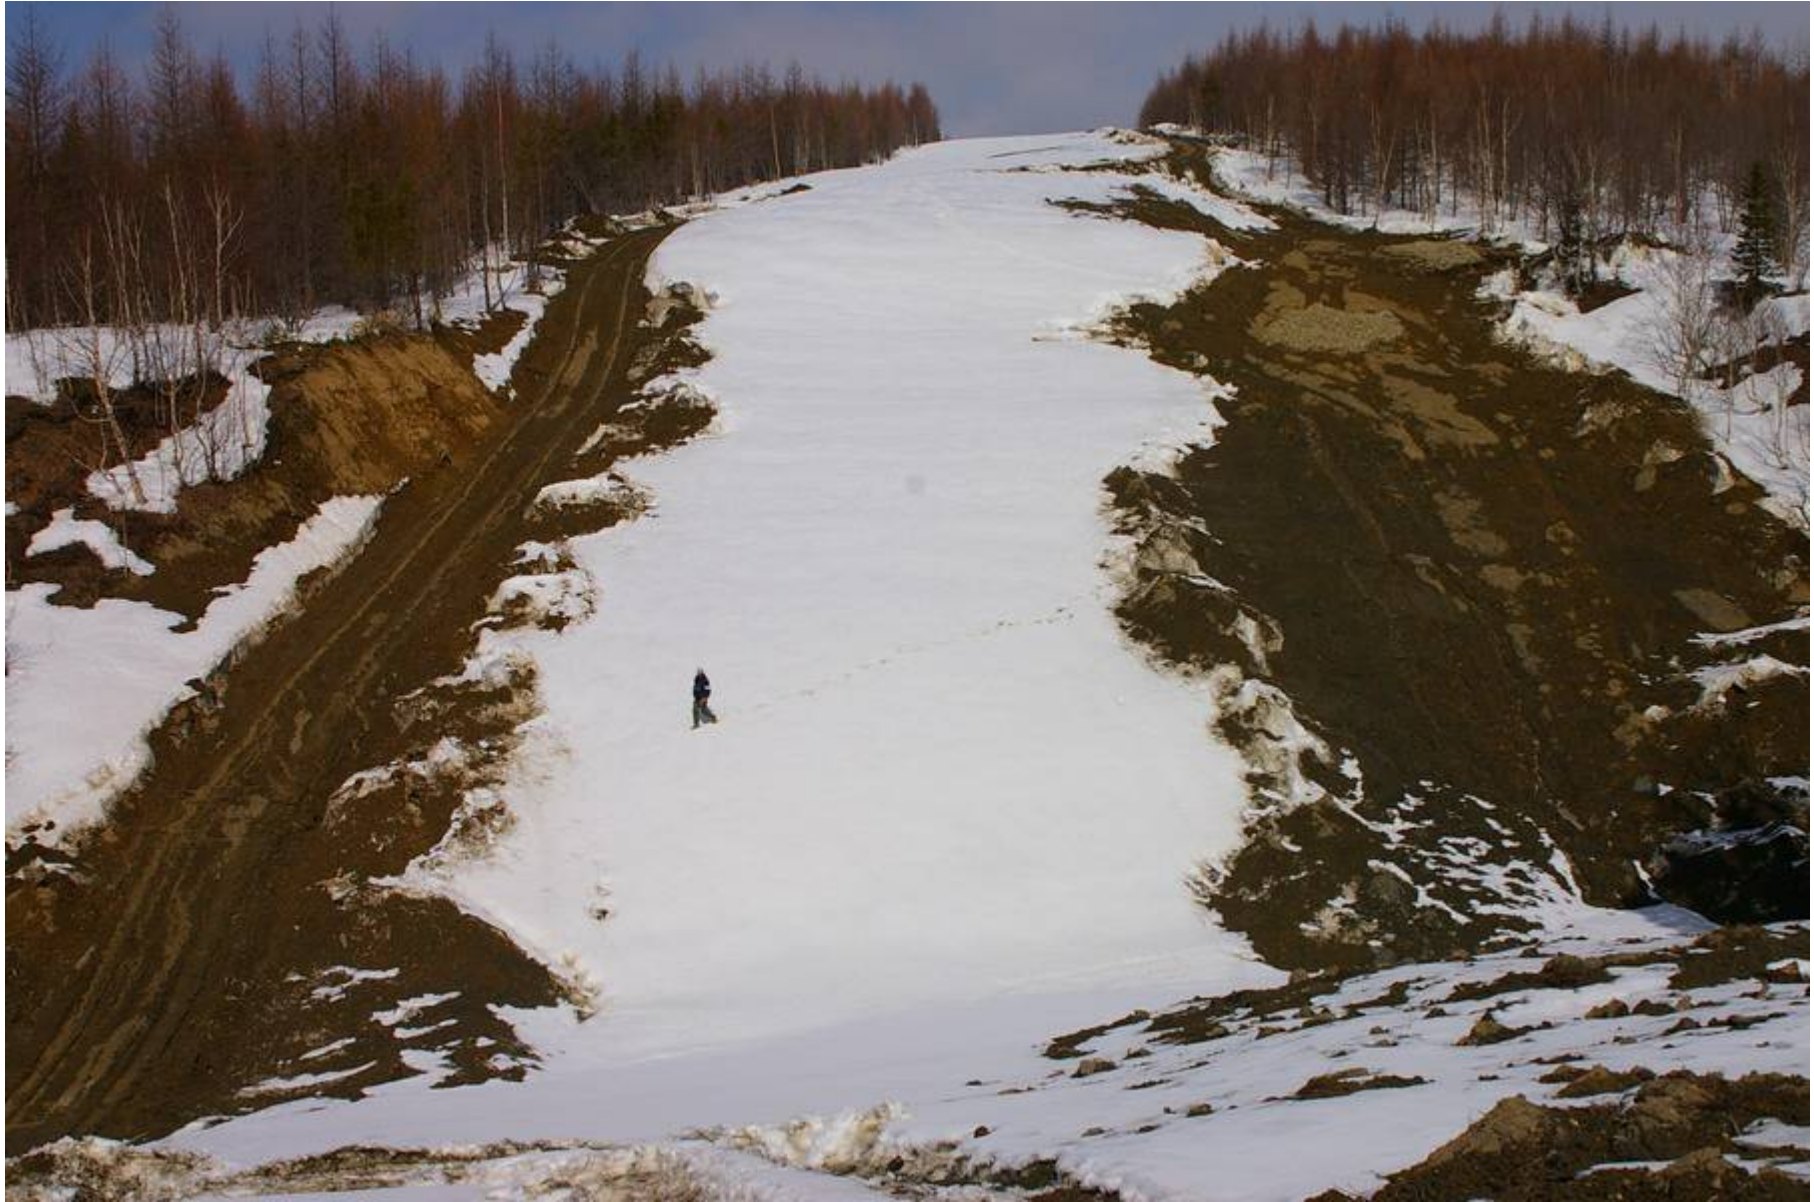
PK 462.6. To the right is a damaged section where repair excavation was recently carried out (repair of a fiber optic cable). To the left is a road that is currently in active use.

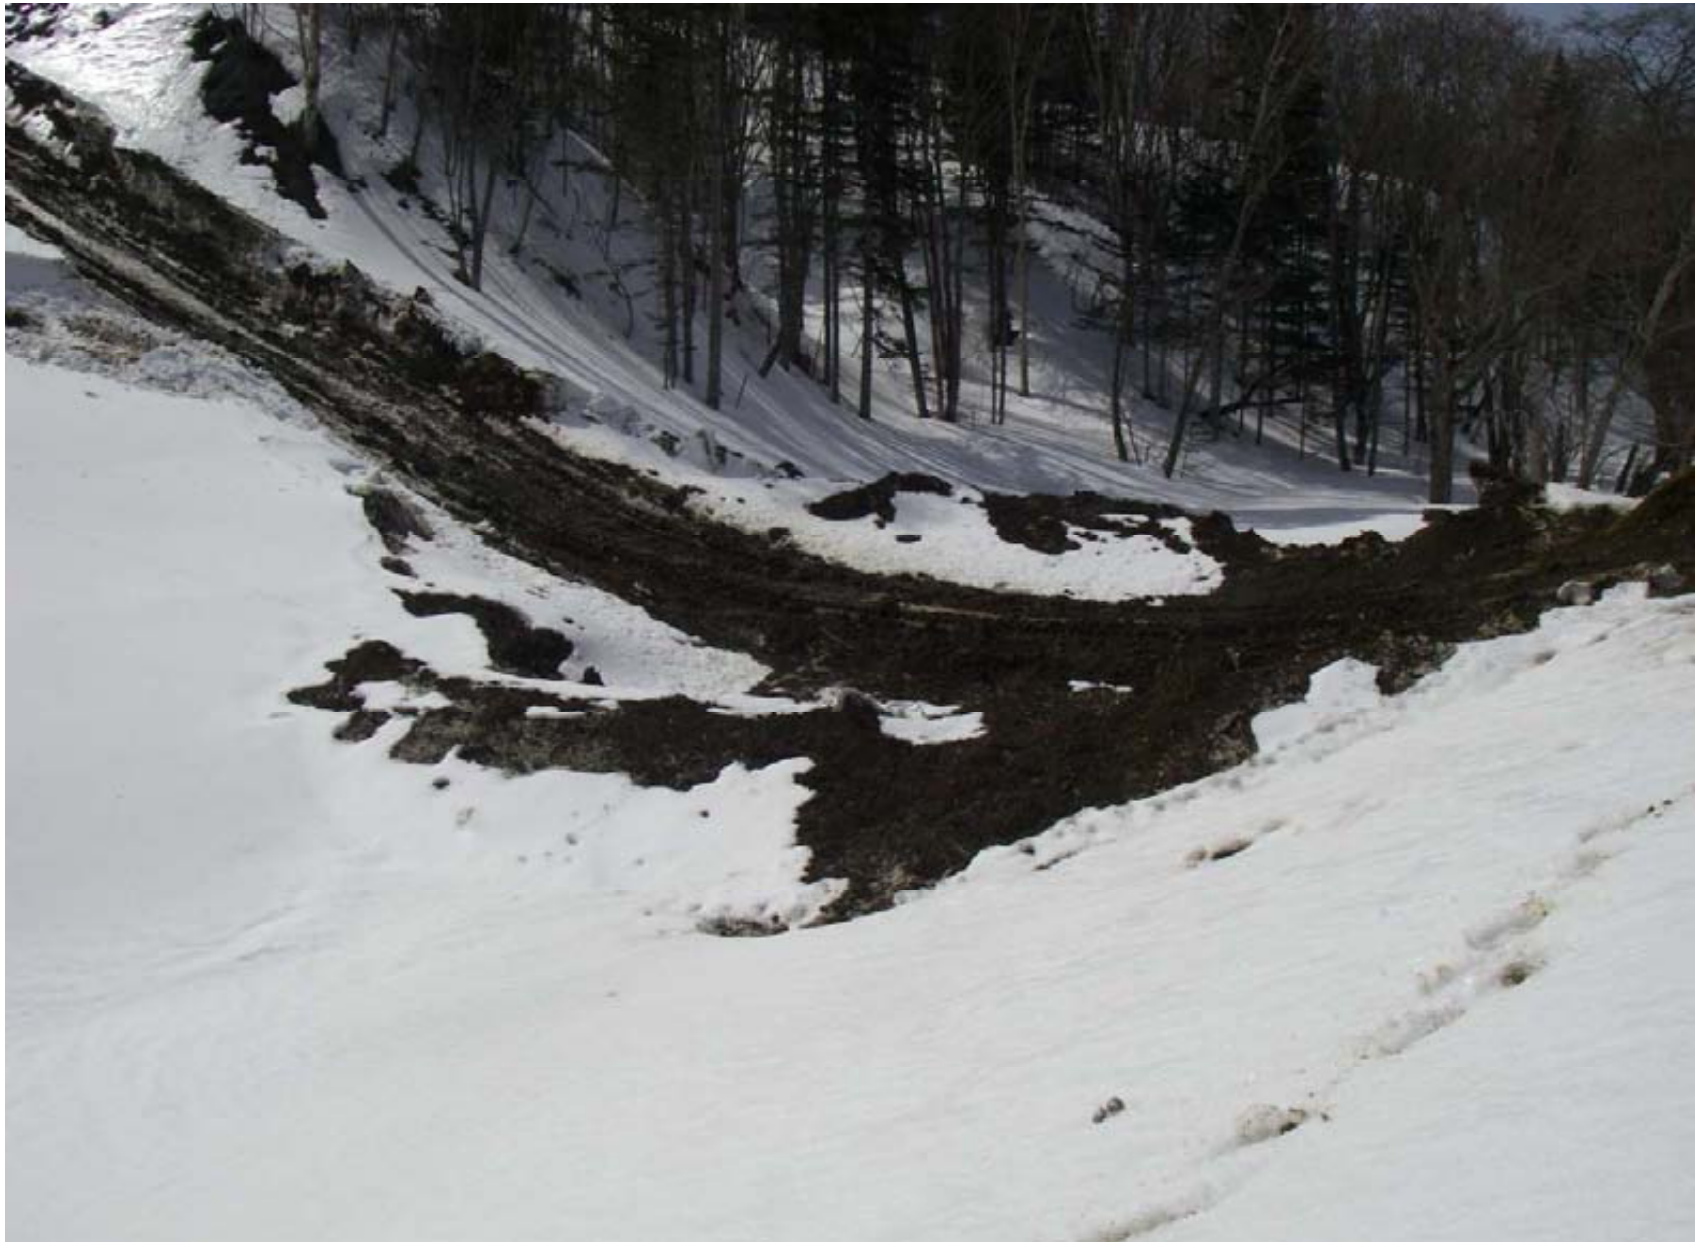
PK 462.6. Another example of a stream that has been covered with earth on top of snow and ice to create a crossing for equipment. When the ice begins to melt this entire mound of earth will run into the stream as well as into Baklanovka River, to which this stream flows.
