*Pacific Environment
Friends of the Earth Japan
Sakhalin Environment Watch*

Sakhalin II Project Oil and Gas Pipeline Project Dolinsky, Makarovsky and Nogliksky Districts of Sakhalin Region Photo Report from a Fact-Finding Mission May 30 – June 1, 2008

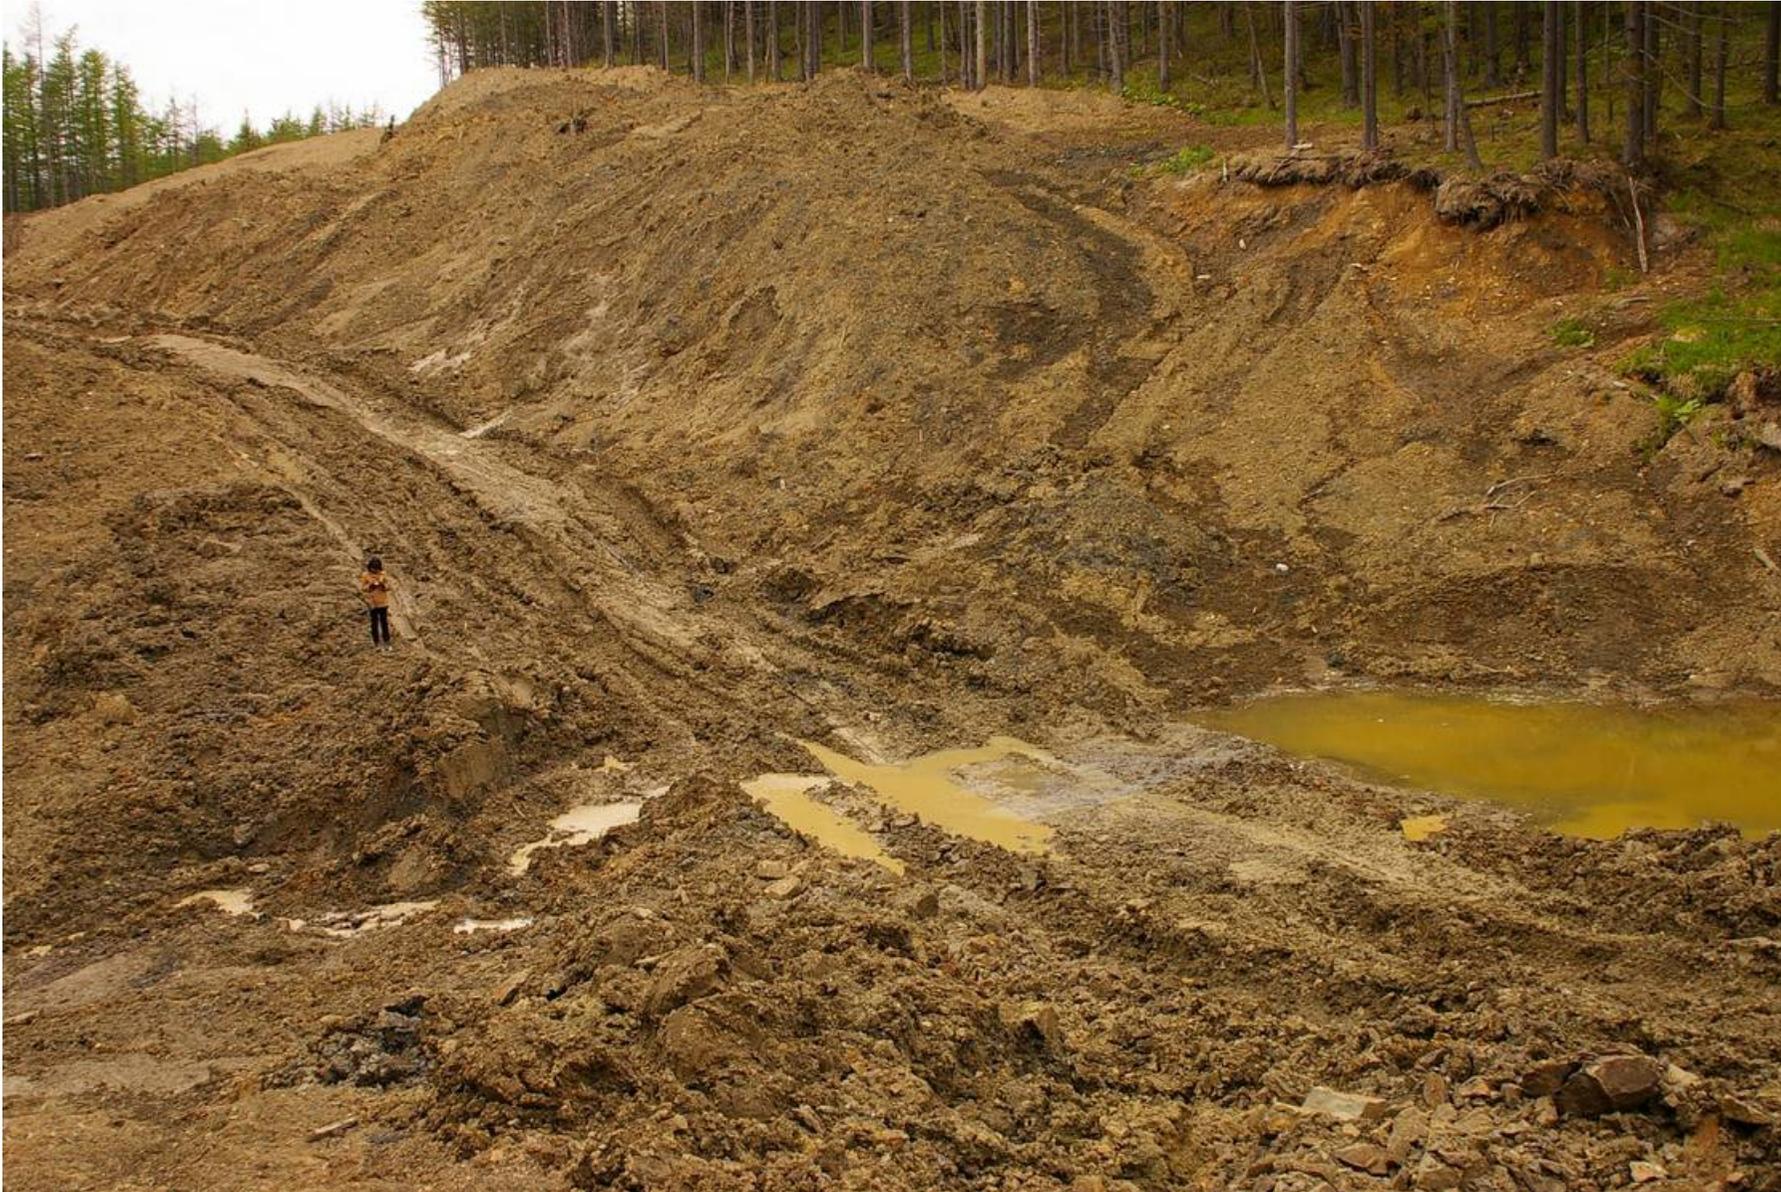
KP 445.6, Spread 4. Area on the pipeline corridor where a mud flow enters the stream (tributary of the Duet River). There is no culvert and vehicles move directly across the stream channel.

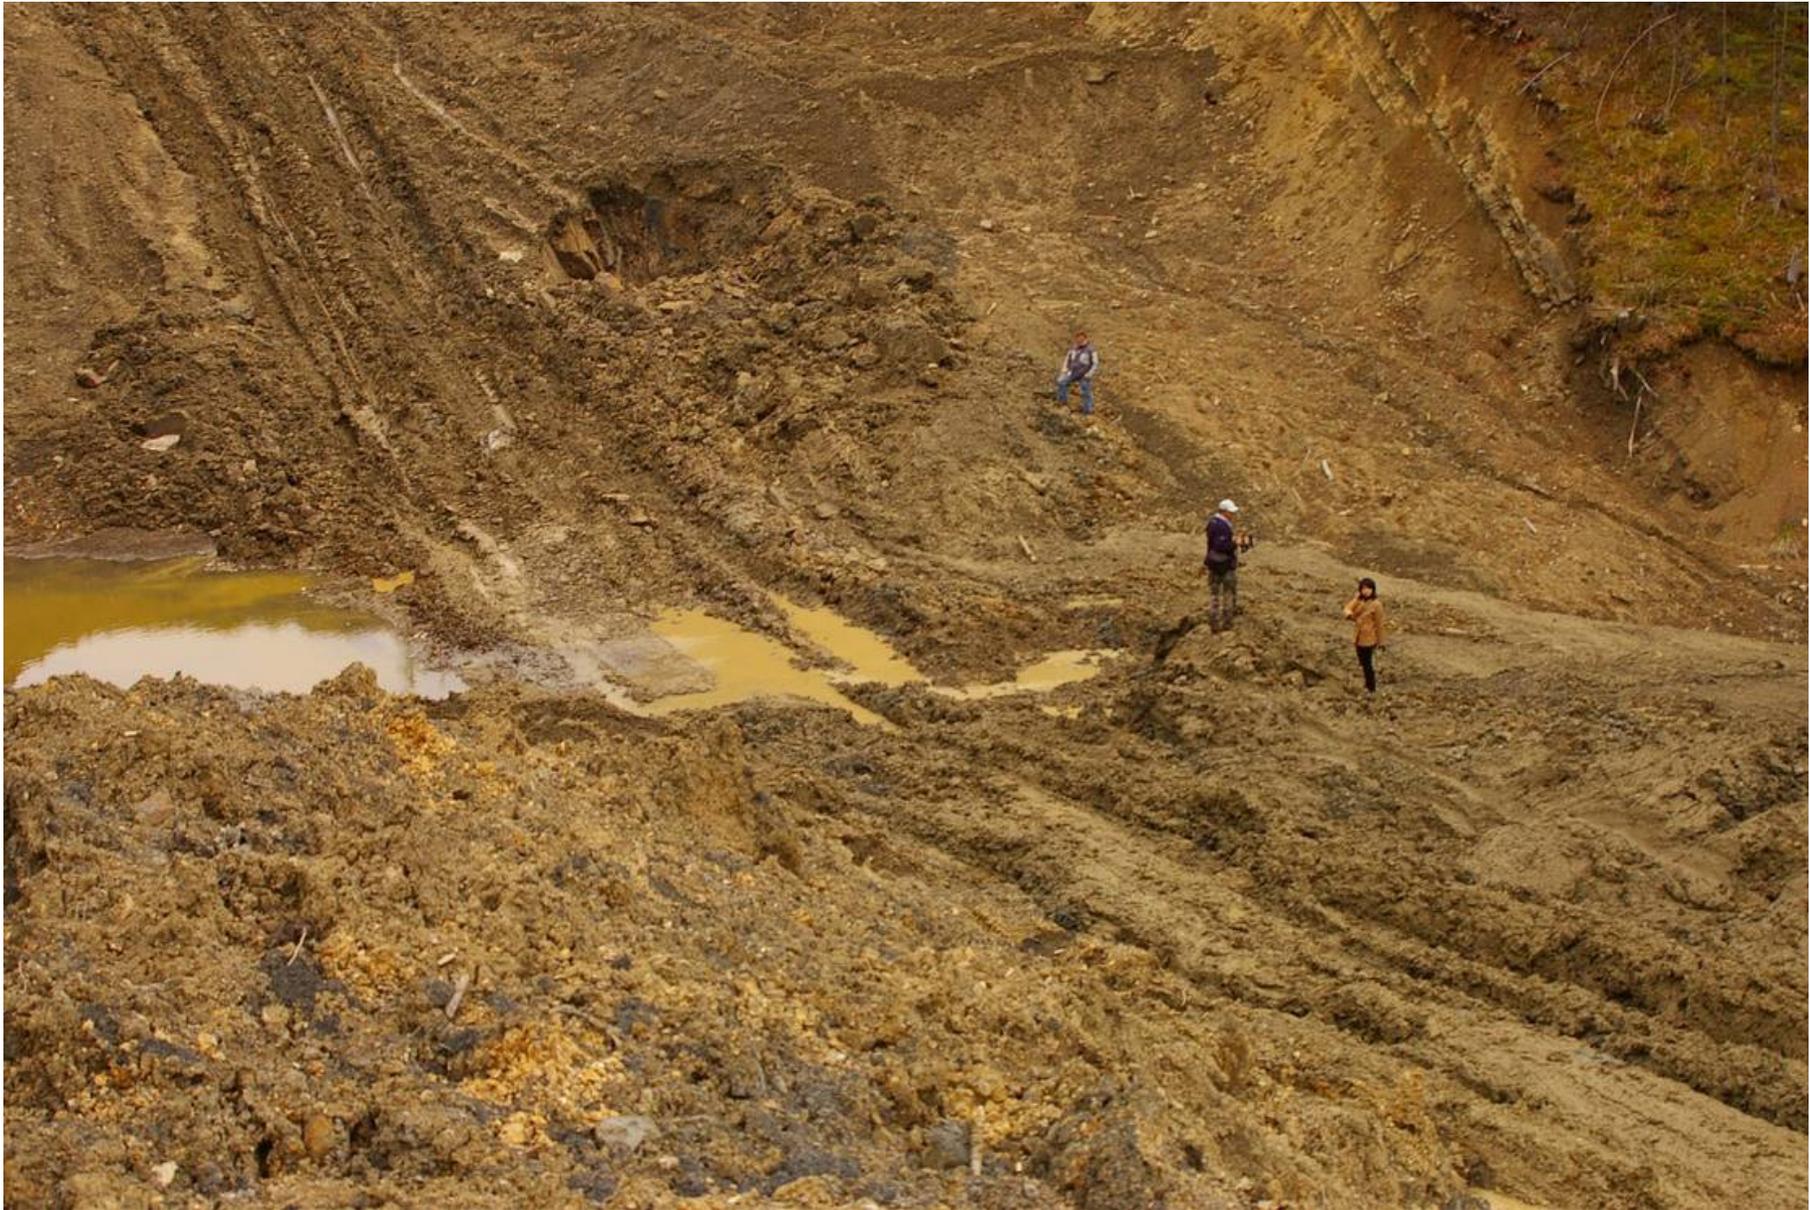
KP 445.6, Spread 4. A landslide on the left bank of the stream has reached the stream channel.

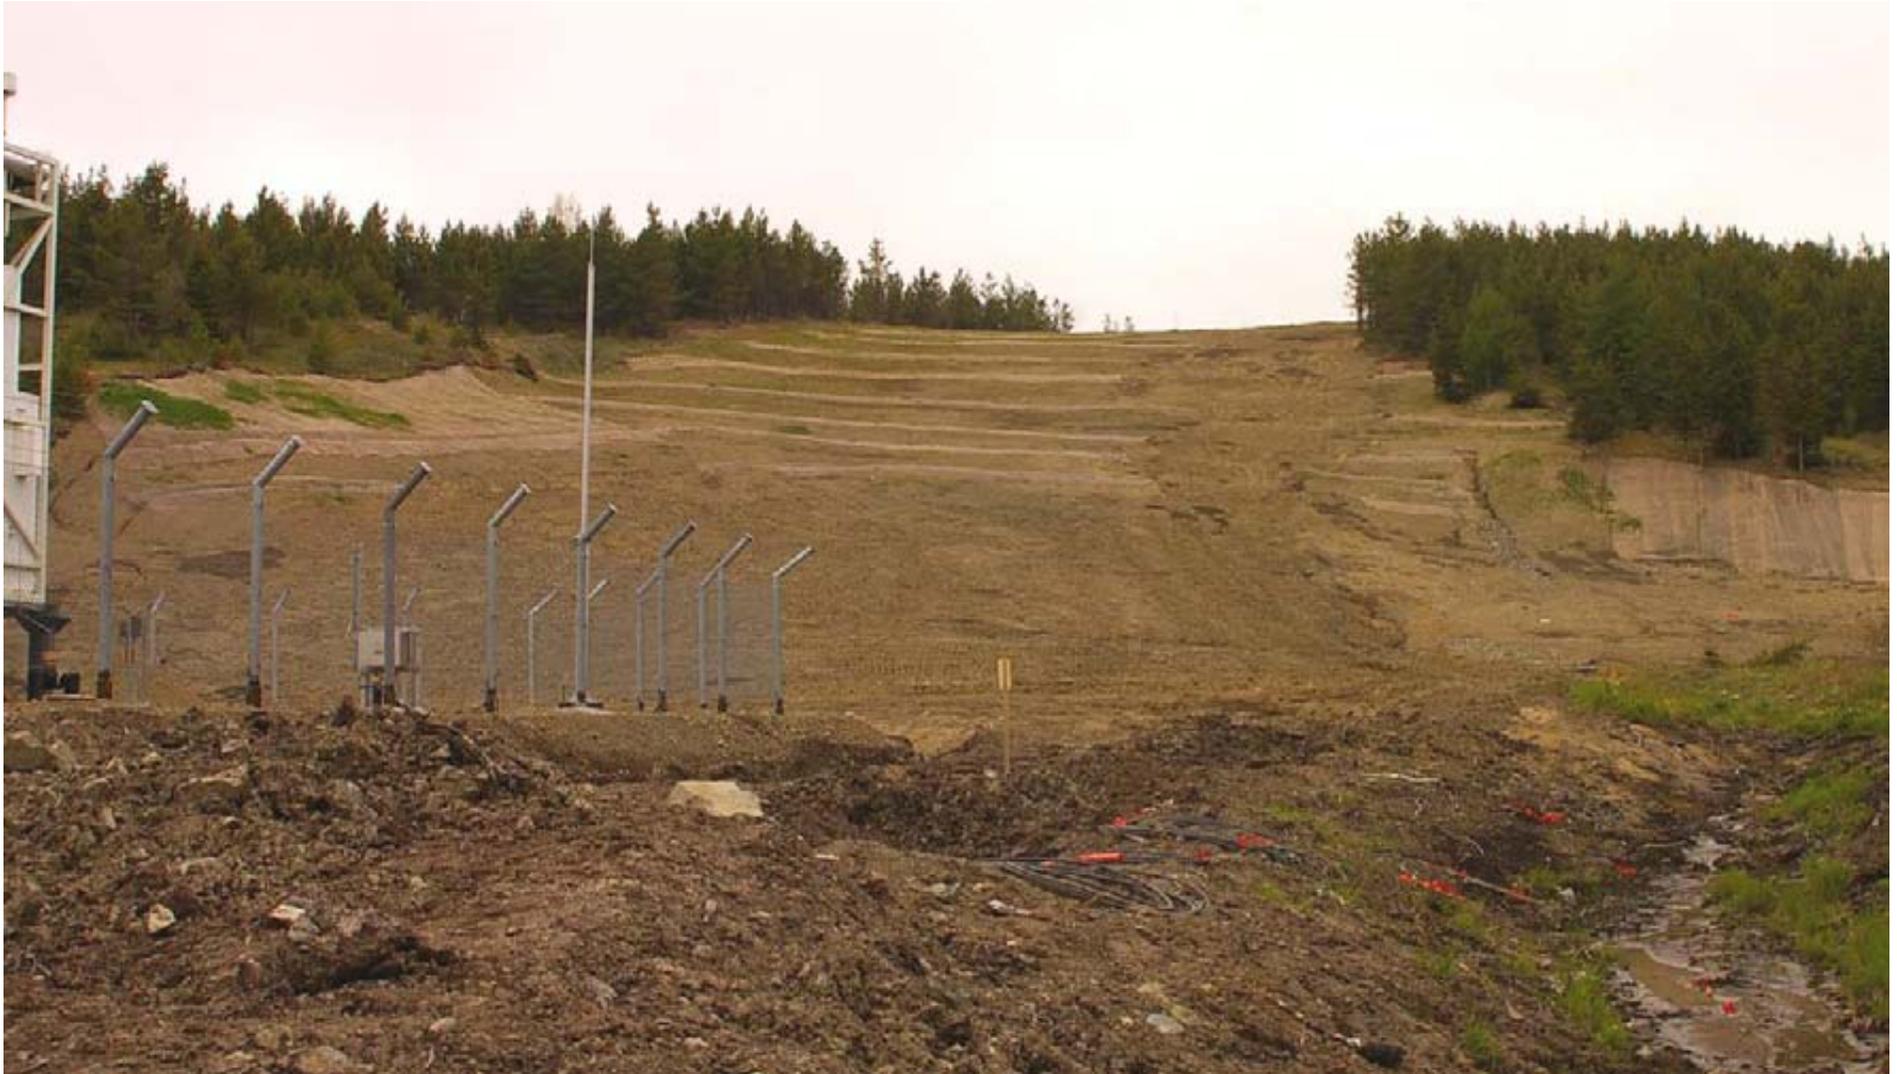
KP 418.7, Spread 4. A downstream slope on the Travyanaya River, north of a block valve (on the left). Pipeline construction was completed more than two years ago and recultivation measures were undertaken (stabilization of slopes, slope breakers, grass planting). Despite all those efforts, erosion continues along the slope on the pipeline corridor (on the right side of the pipeline right of way).

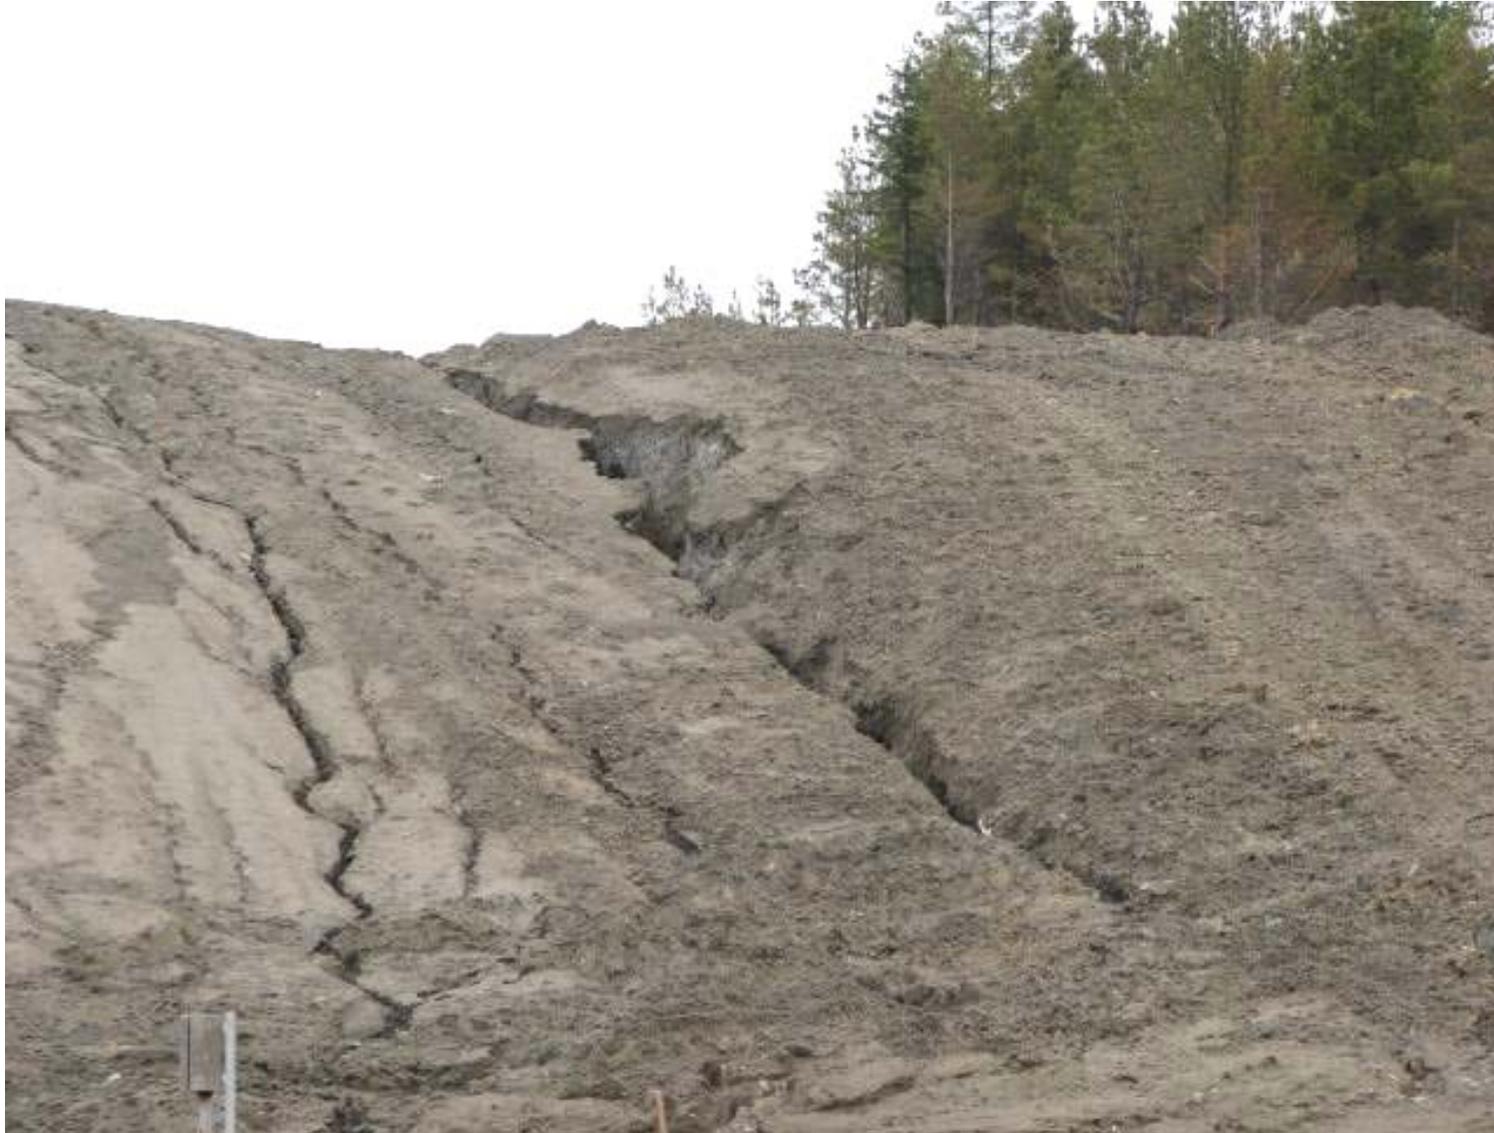
KP 418.7, Spread 4. A down stream slope near Travyanaya River. Erosion at the top of the slope where recultivation measures have failed. There are no traces of planted grass and topsoil was not replaced along the pipeline corridor. The absence of topsoil prevents the recovery of grass on the such steep slopes.

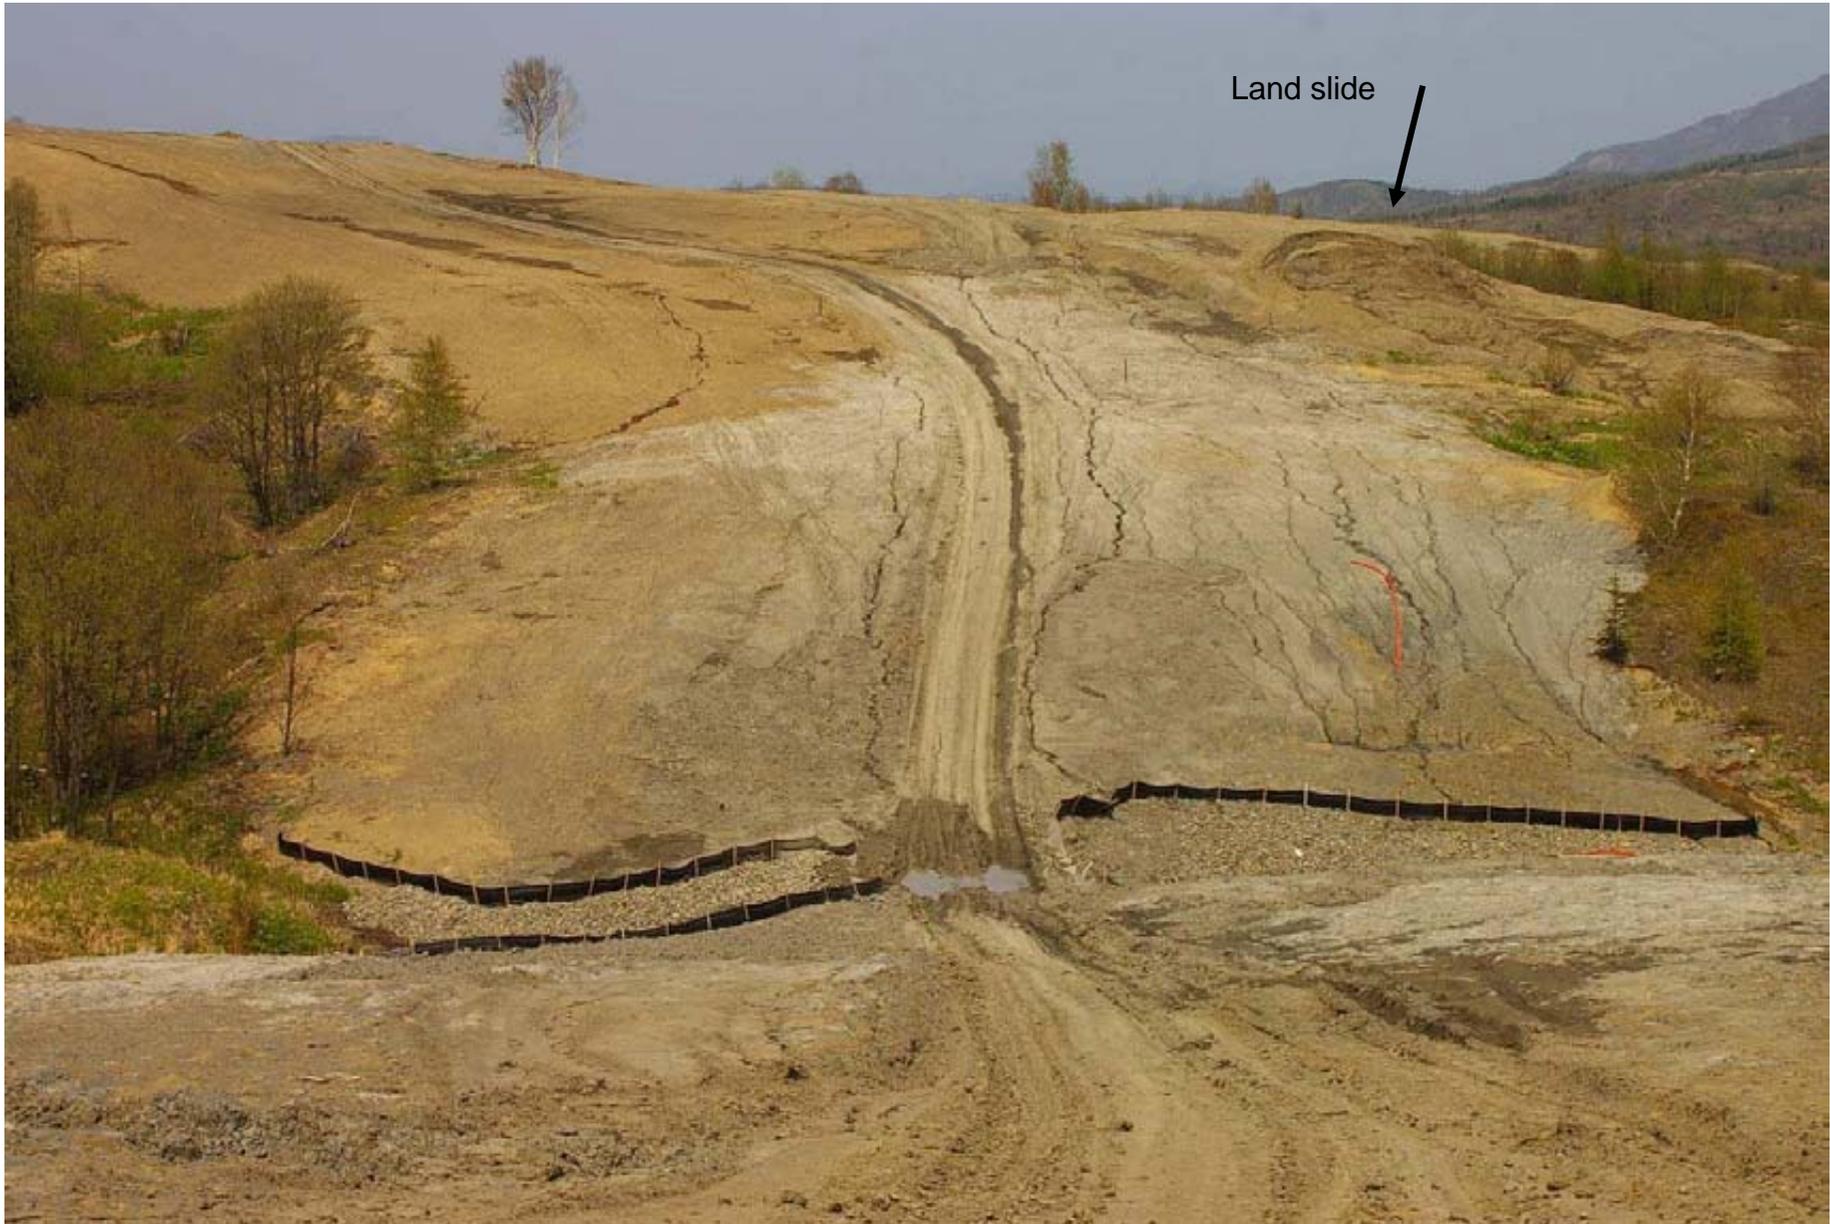
KP 403.1, Spread 3. Stream - right tributary of the Rudnaya River. There is active erosion on the slope, with a landslide at the top (to the right) that has affected forest lands beyond the pipeline right of way. There is no topsoil, slope breakers have not been installed and planted grass is absent.

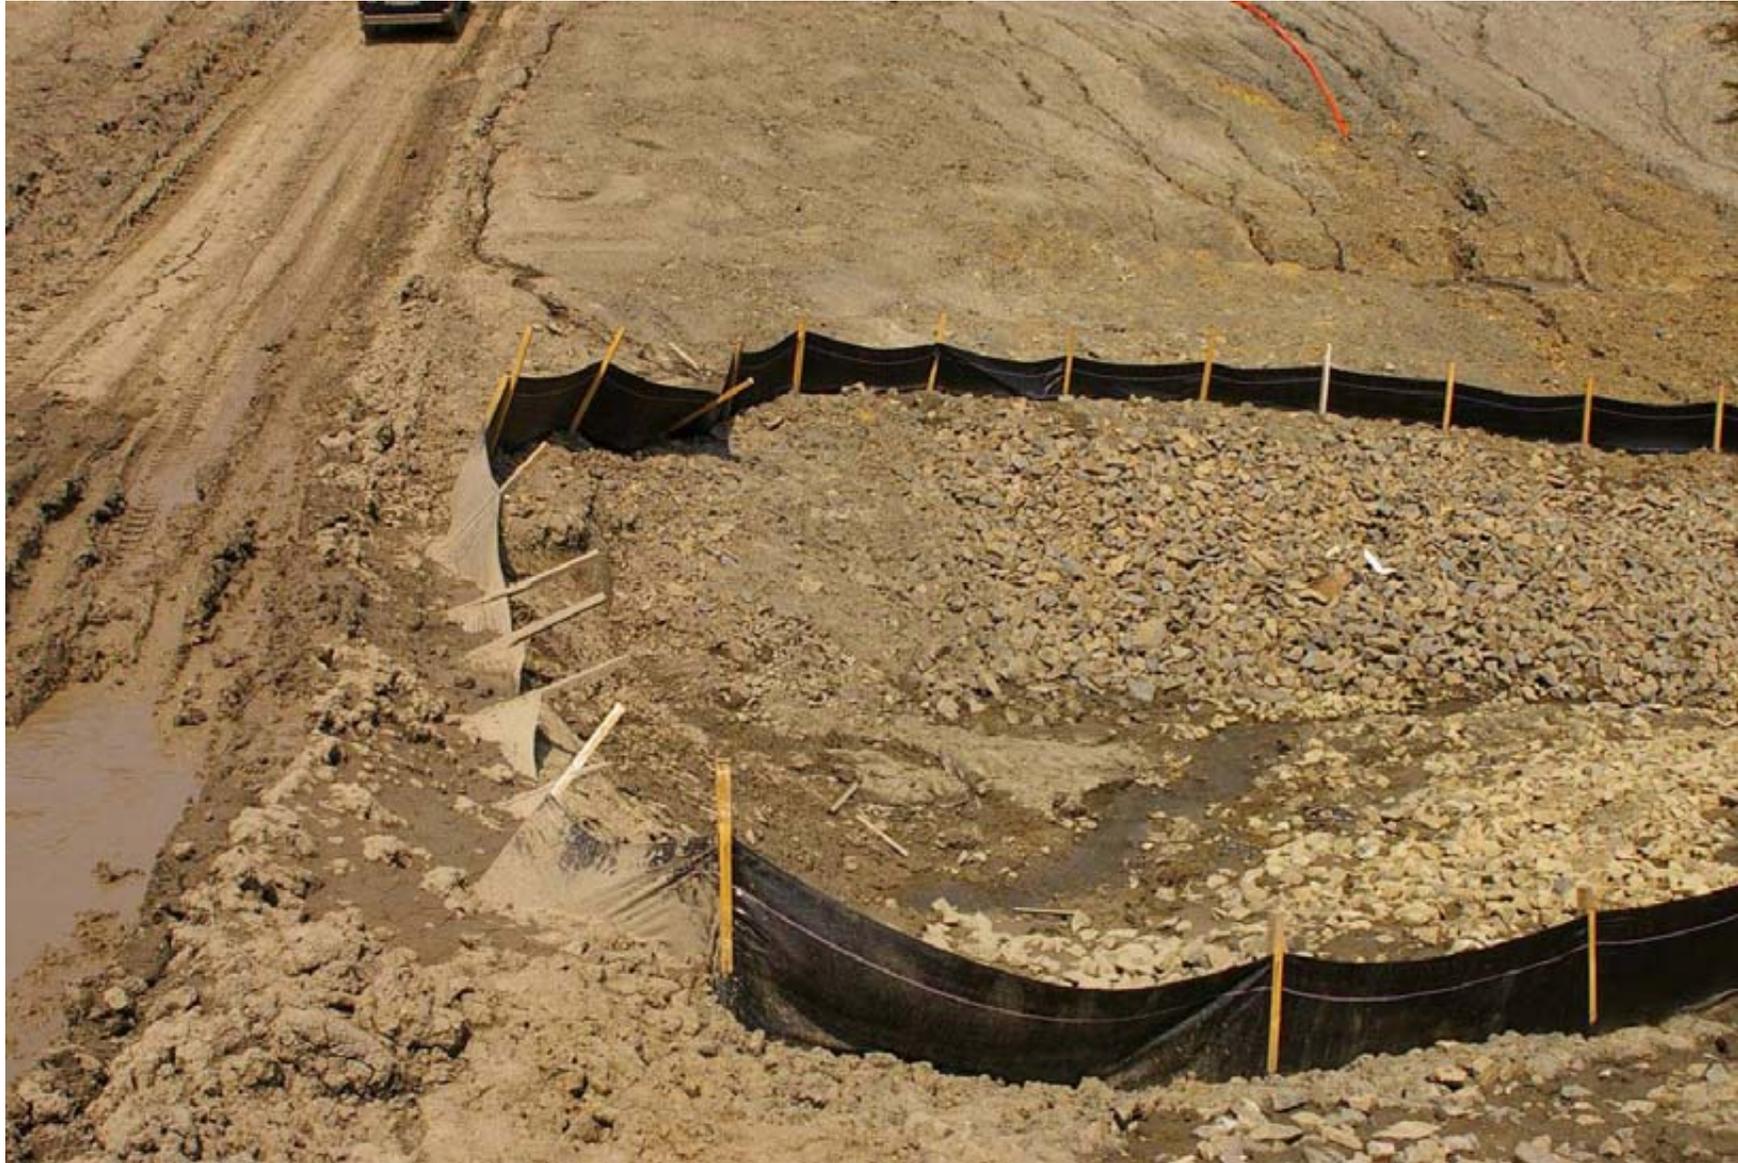
KP 403.1, Spread 3. Stream - right tributary of the Rudnaya River. Silt fences do not work. Mud enters the water body.

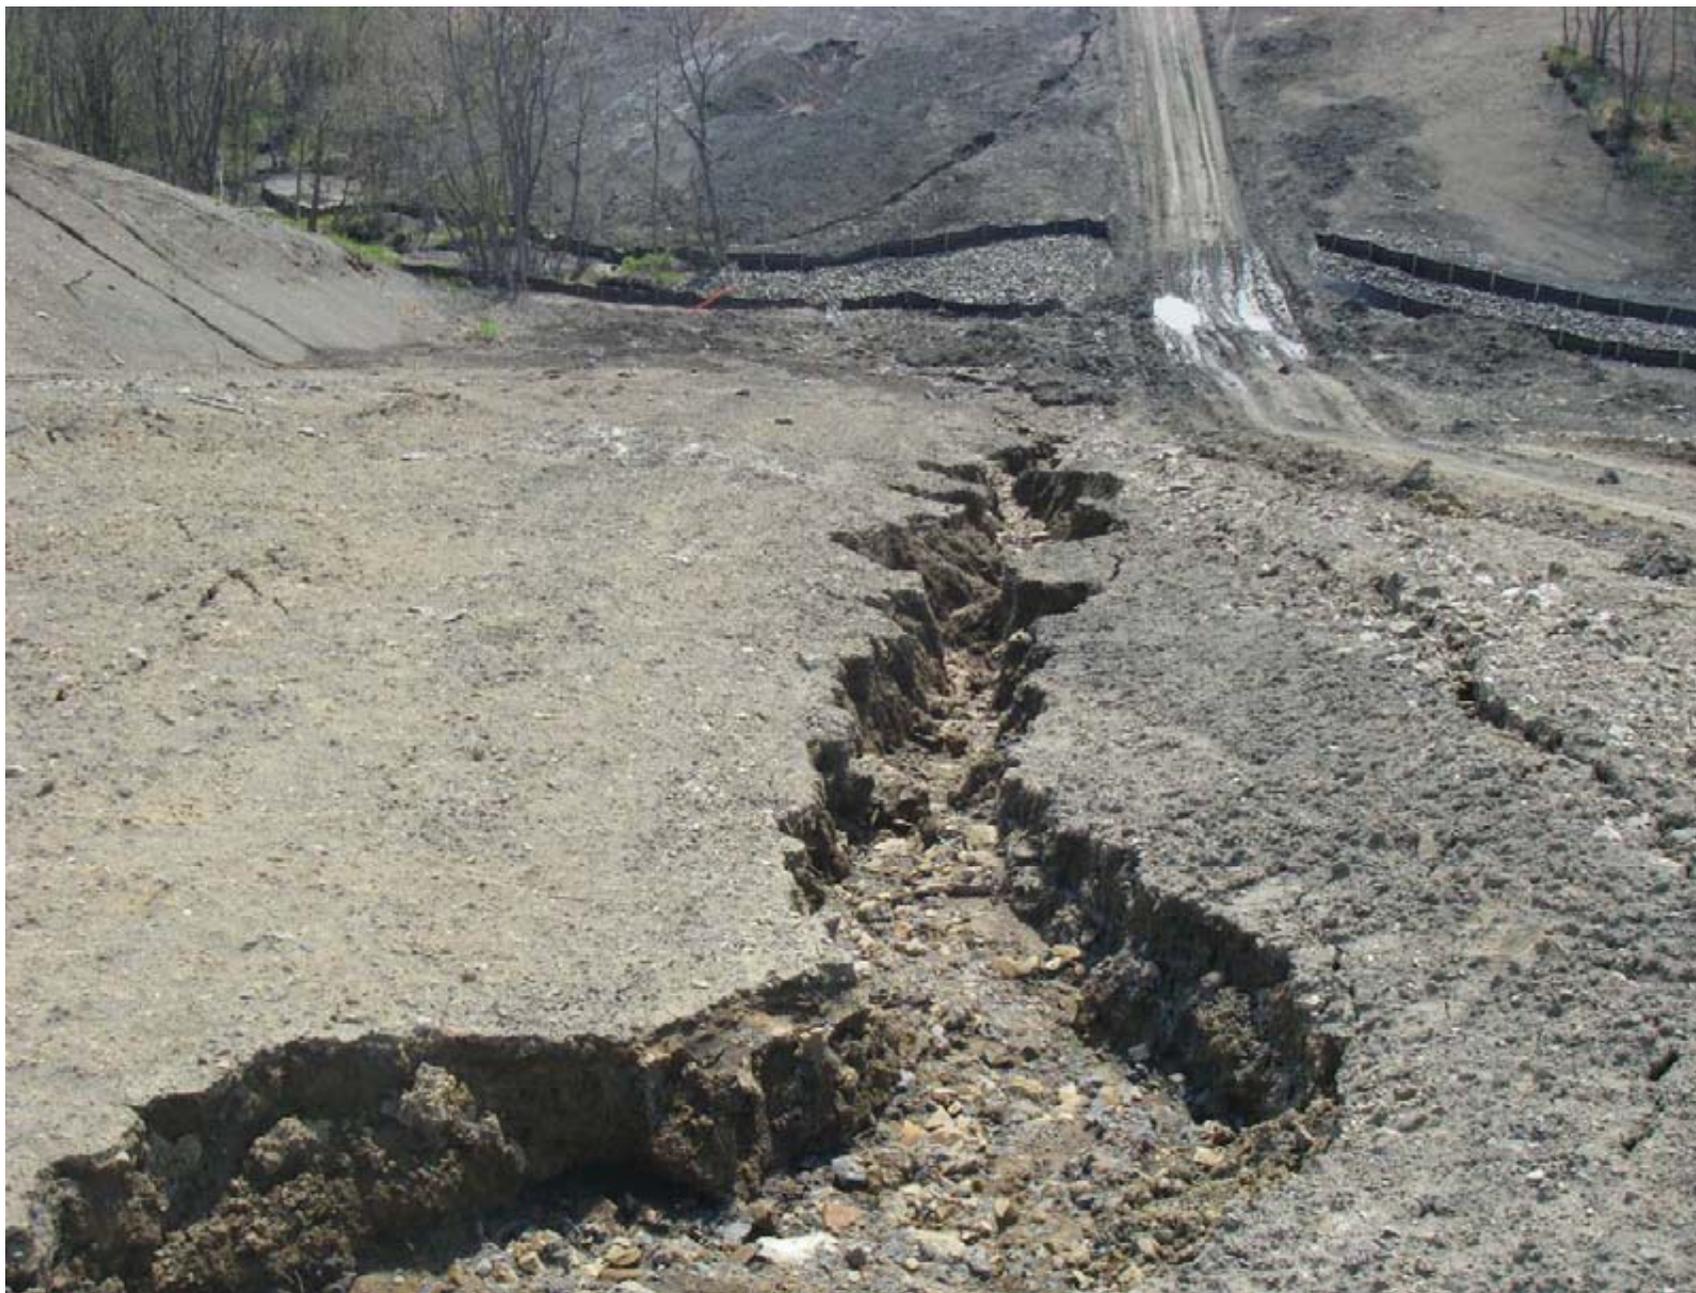
KP 403.1, Spread 3. Stream - right tributary of the Rudnaya River. Deep erosion ditch on the right bank. There are no erosion prevention and control measures.

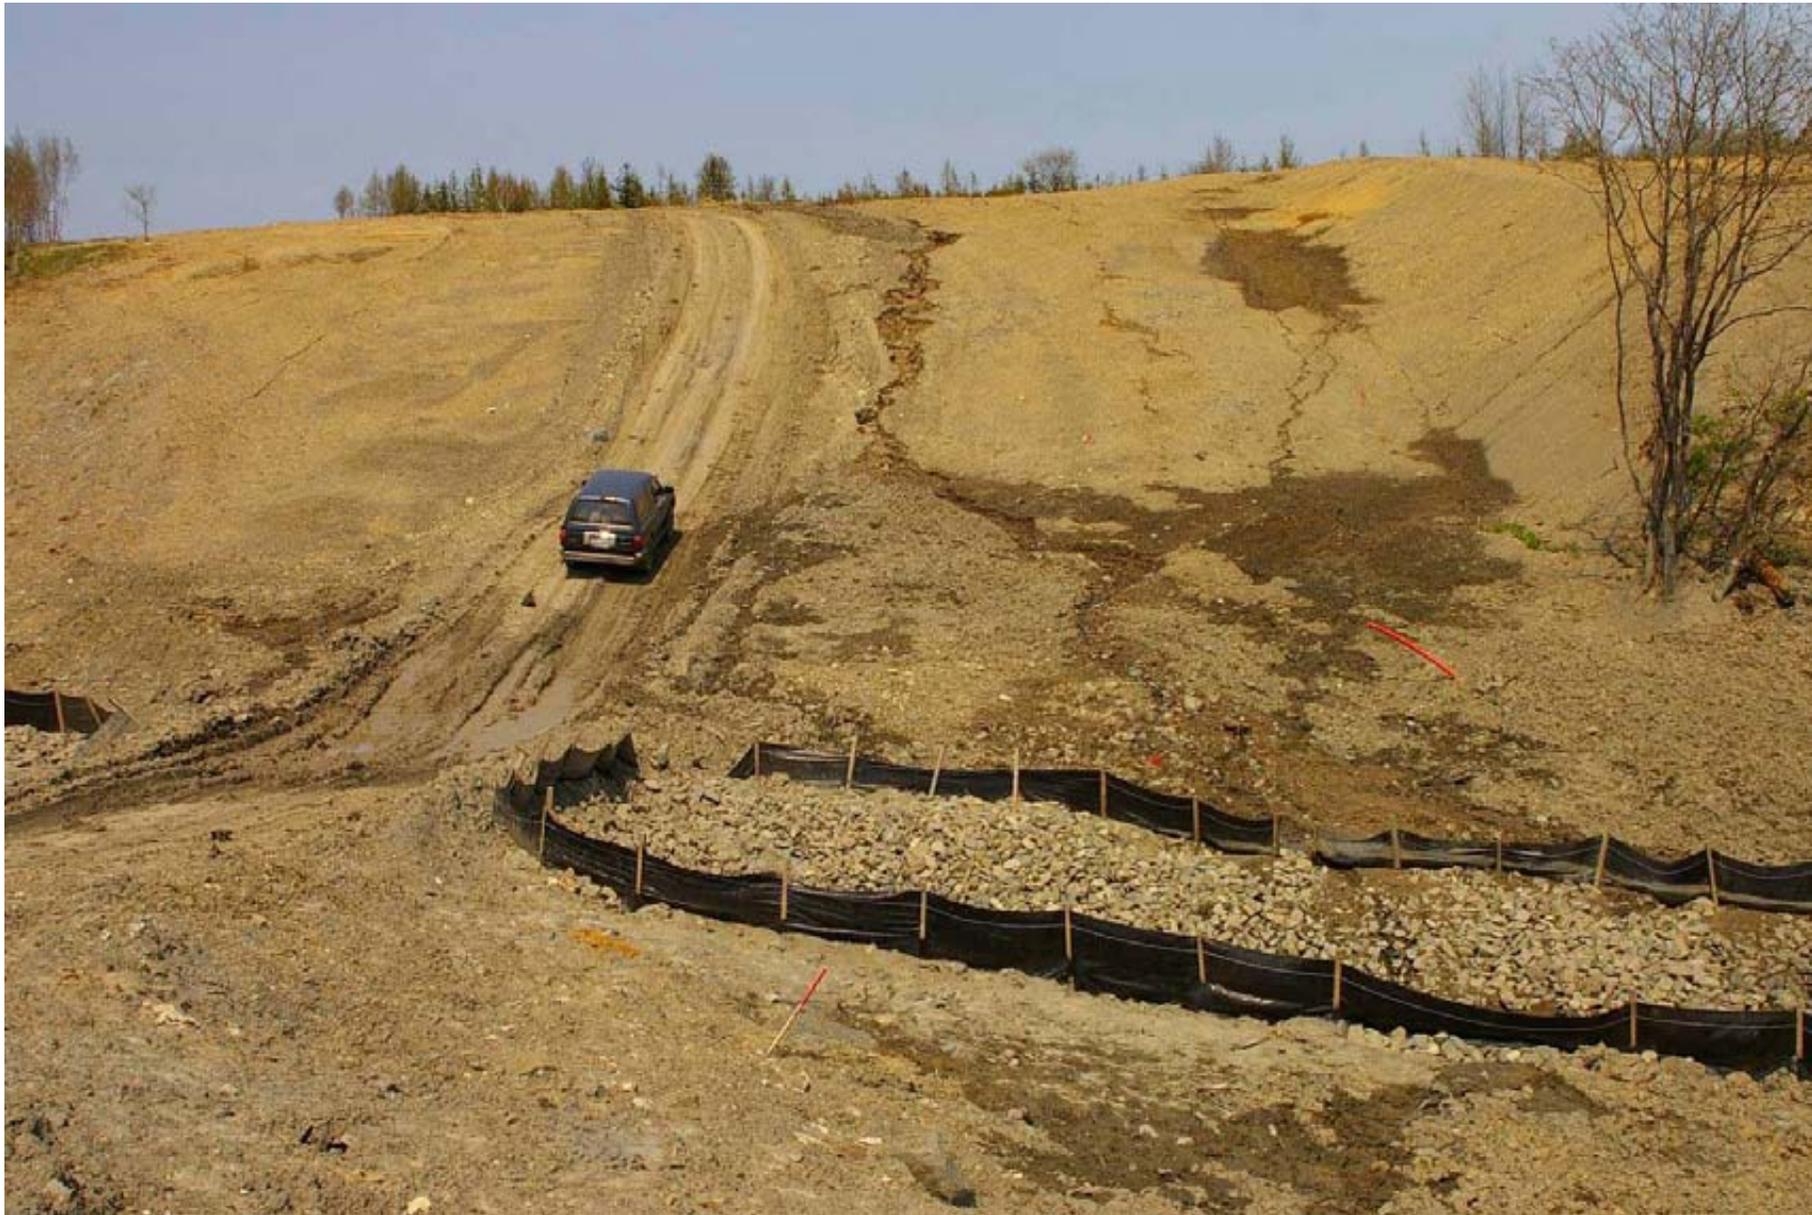
KP 402.5, Spread 3. Rudnaya River. There is a deep erosion ditch on the left bank. There are no erosion prevention and control measures. Black spots on the slope are ground water seepages. Their presence demands that temporary or permanent erosion control measures be installed. Mud flows have damaged silt fences in several places.

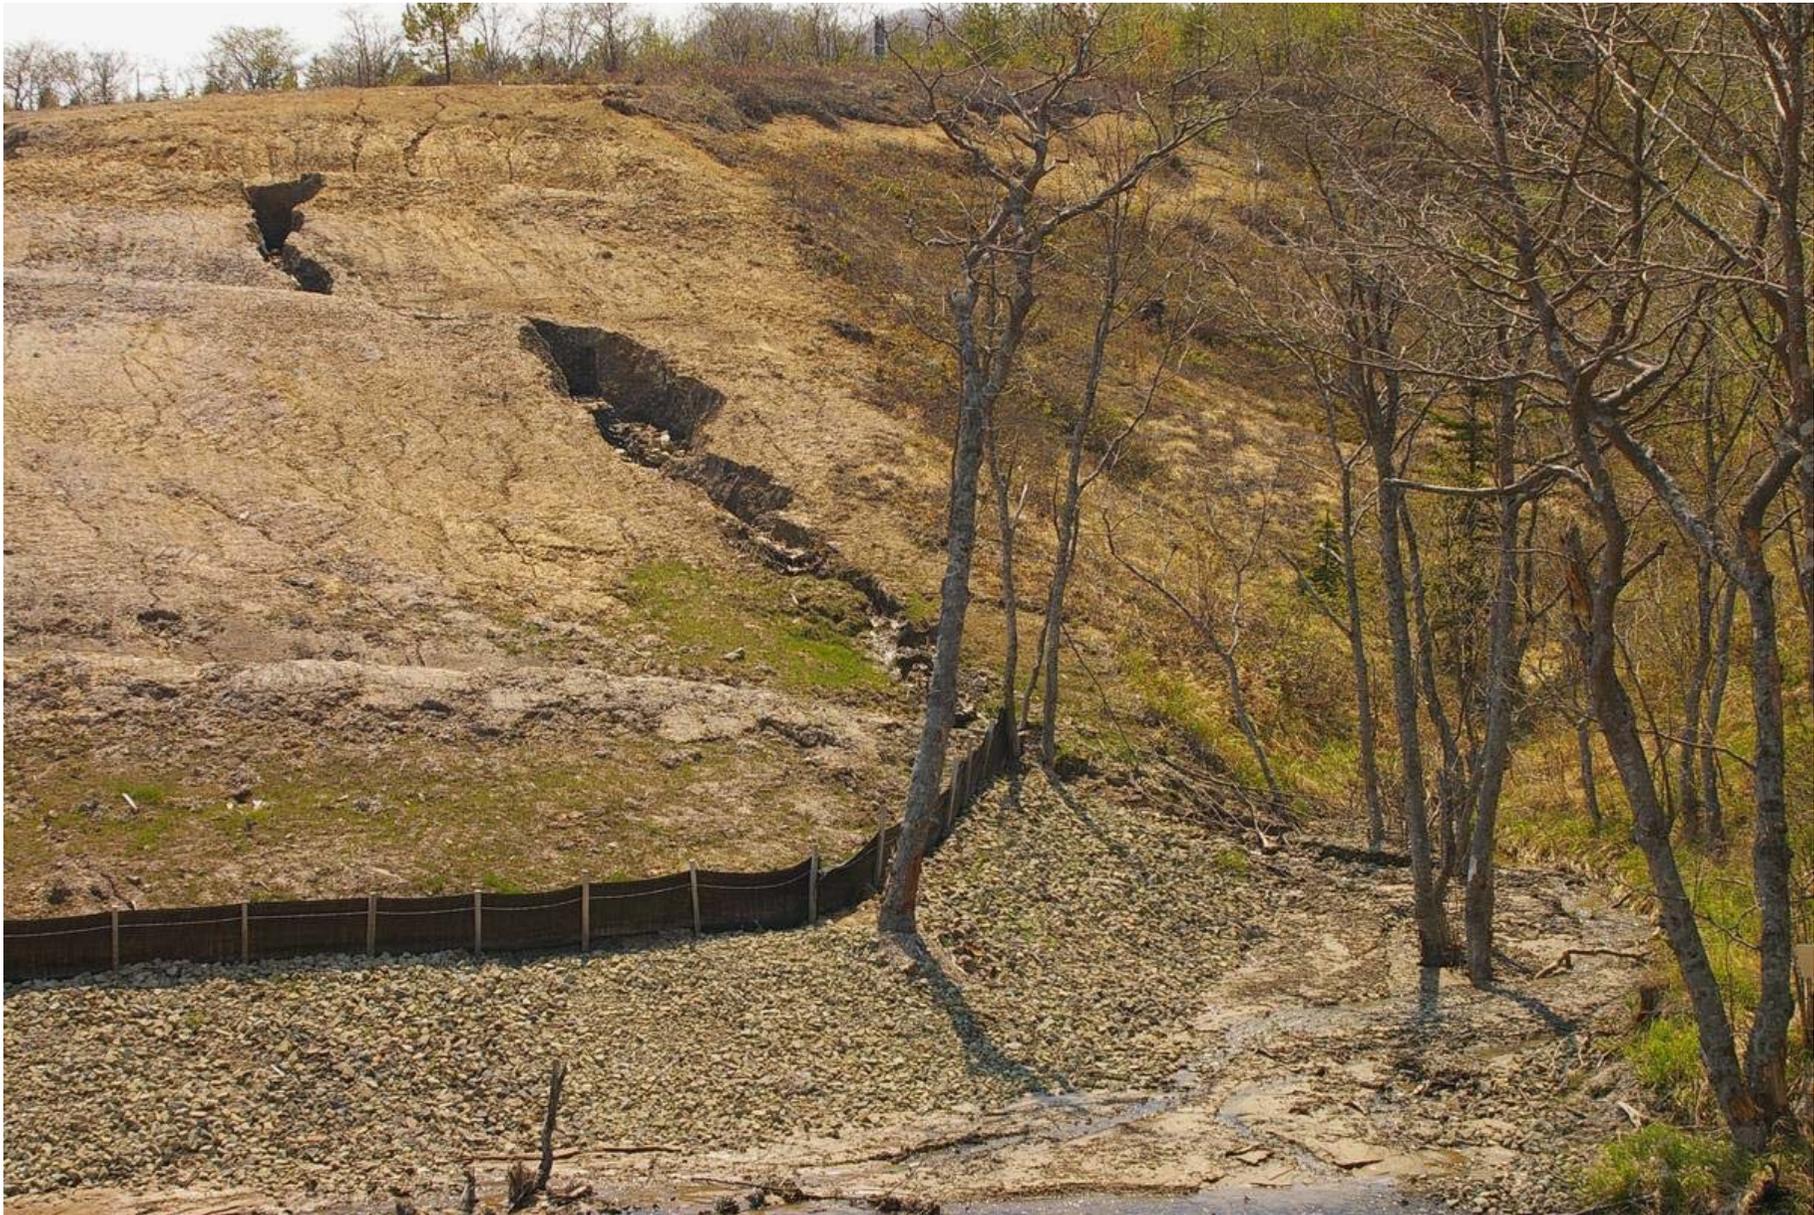
KP 400.9, Spread 3. Stream – left tributary of the Vostochnaya River. There is a deep erosion ditch on the right bank. Anti-erosion slope breakers have failed. Topsoil was not replaced on the right of way slope and the attempt to plant grass has failed, resulting in stream sedimentation.

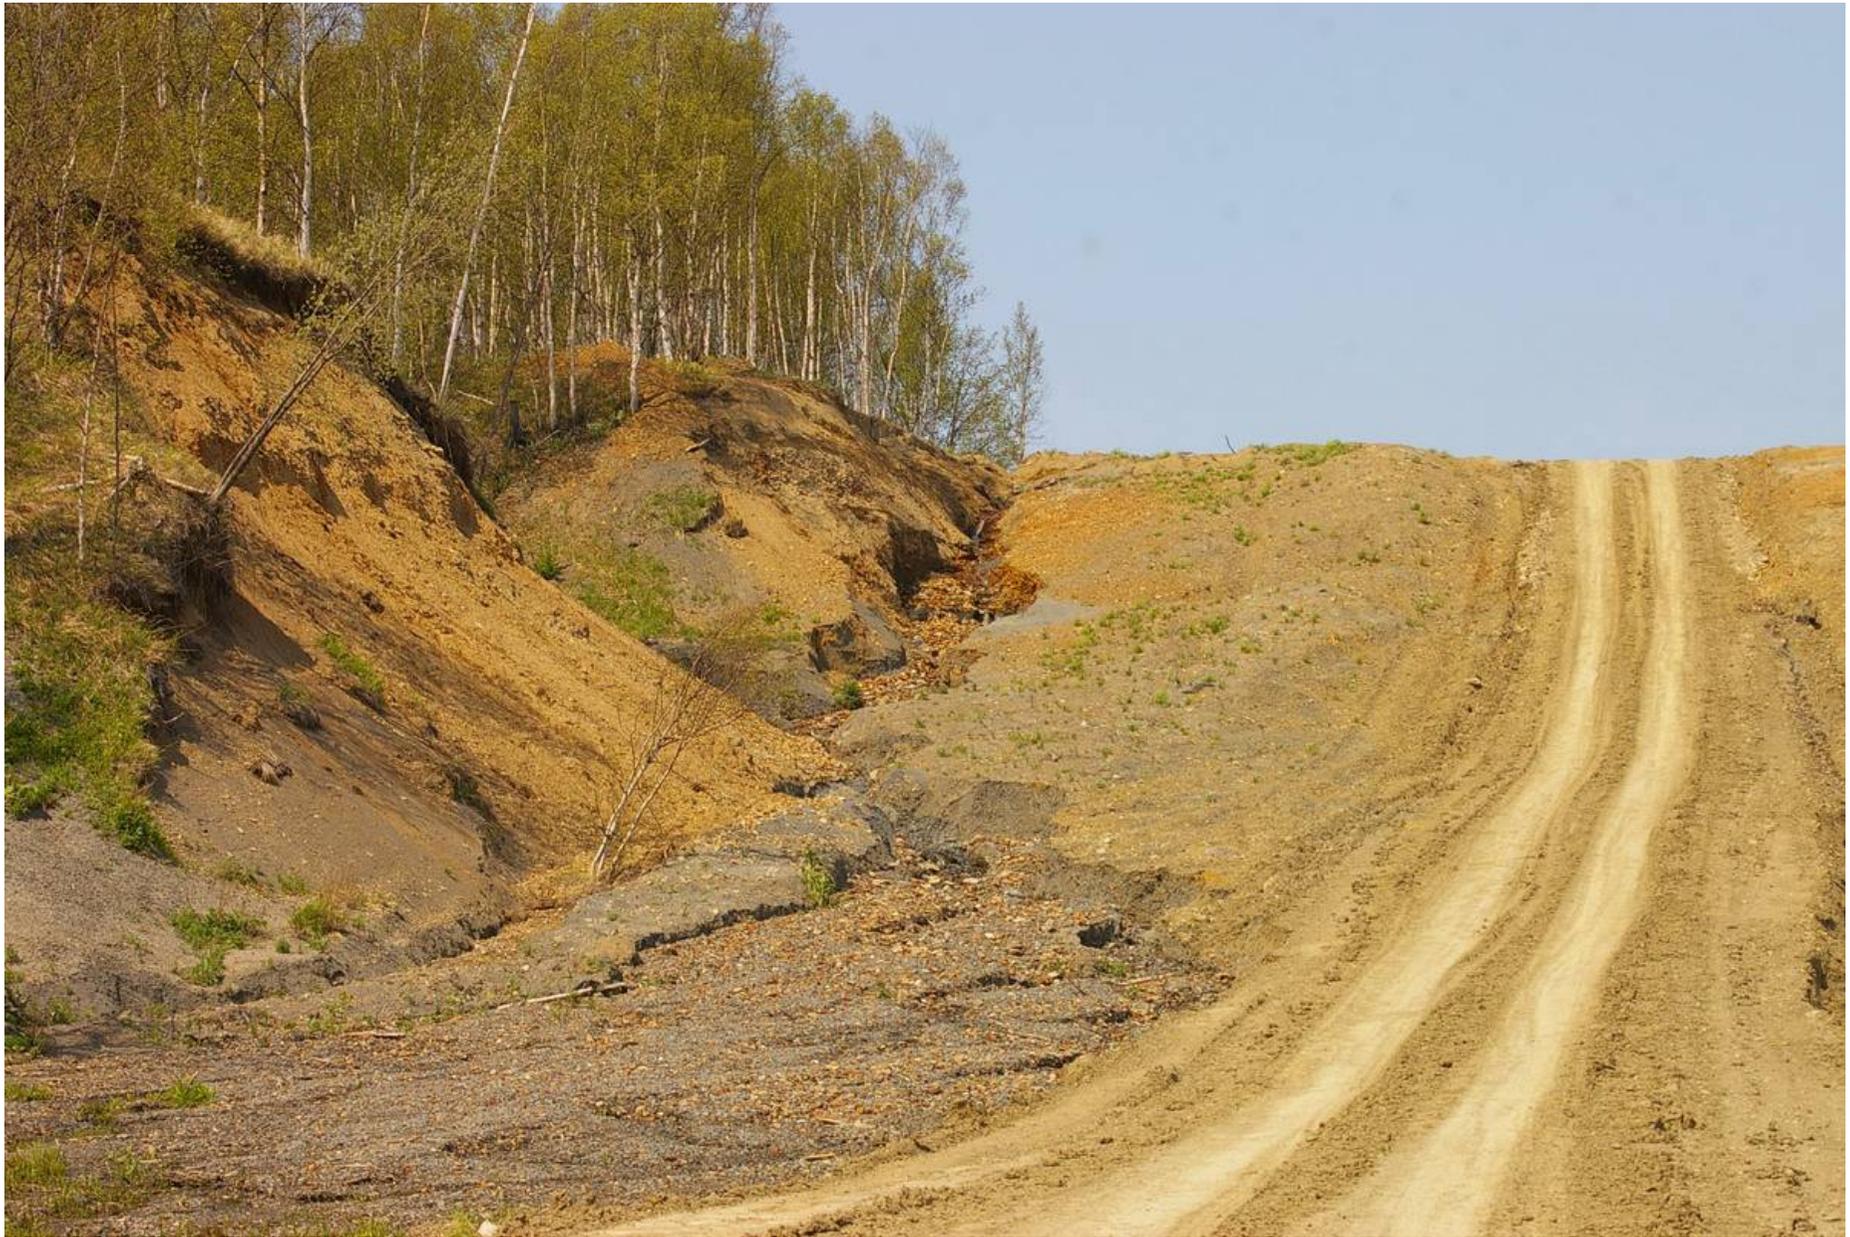
KP 390, Spread 3. Deep erosion ditch on the slope. There are no erosion prevention and control measures. The pipeline corridor at this location is a deep cut and a large volume of earth was excavated and removed, resulting in the formation of slopes along the edges of the pipeline right of way. There are active landslides at this location. Trees have fallen.
