*Pacific Environment
Friends of the Earth Japan
Sakhalin Environment Watch*

Sakhalin II Project Oil and Gas Pipeline Project Dolinsky, Makarovsky and Nogliksky Districts of Sakhalin Region Photo Report from a Fact-Finding Mission May 30 – June 1, 2008

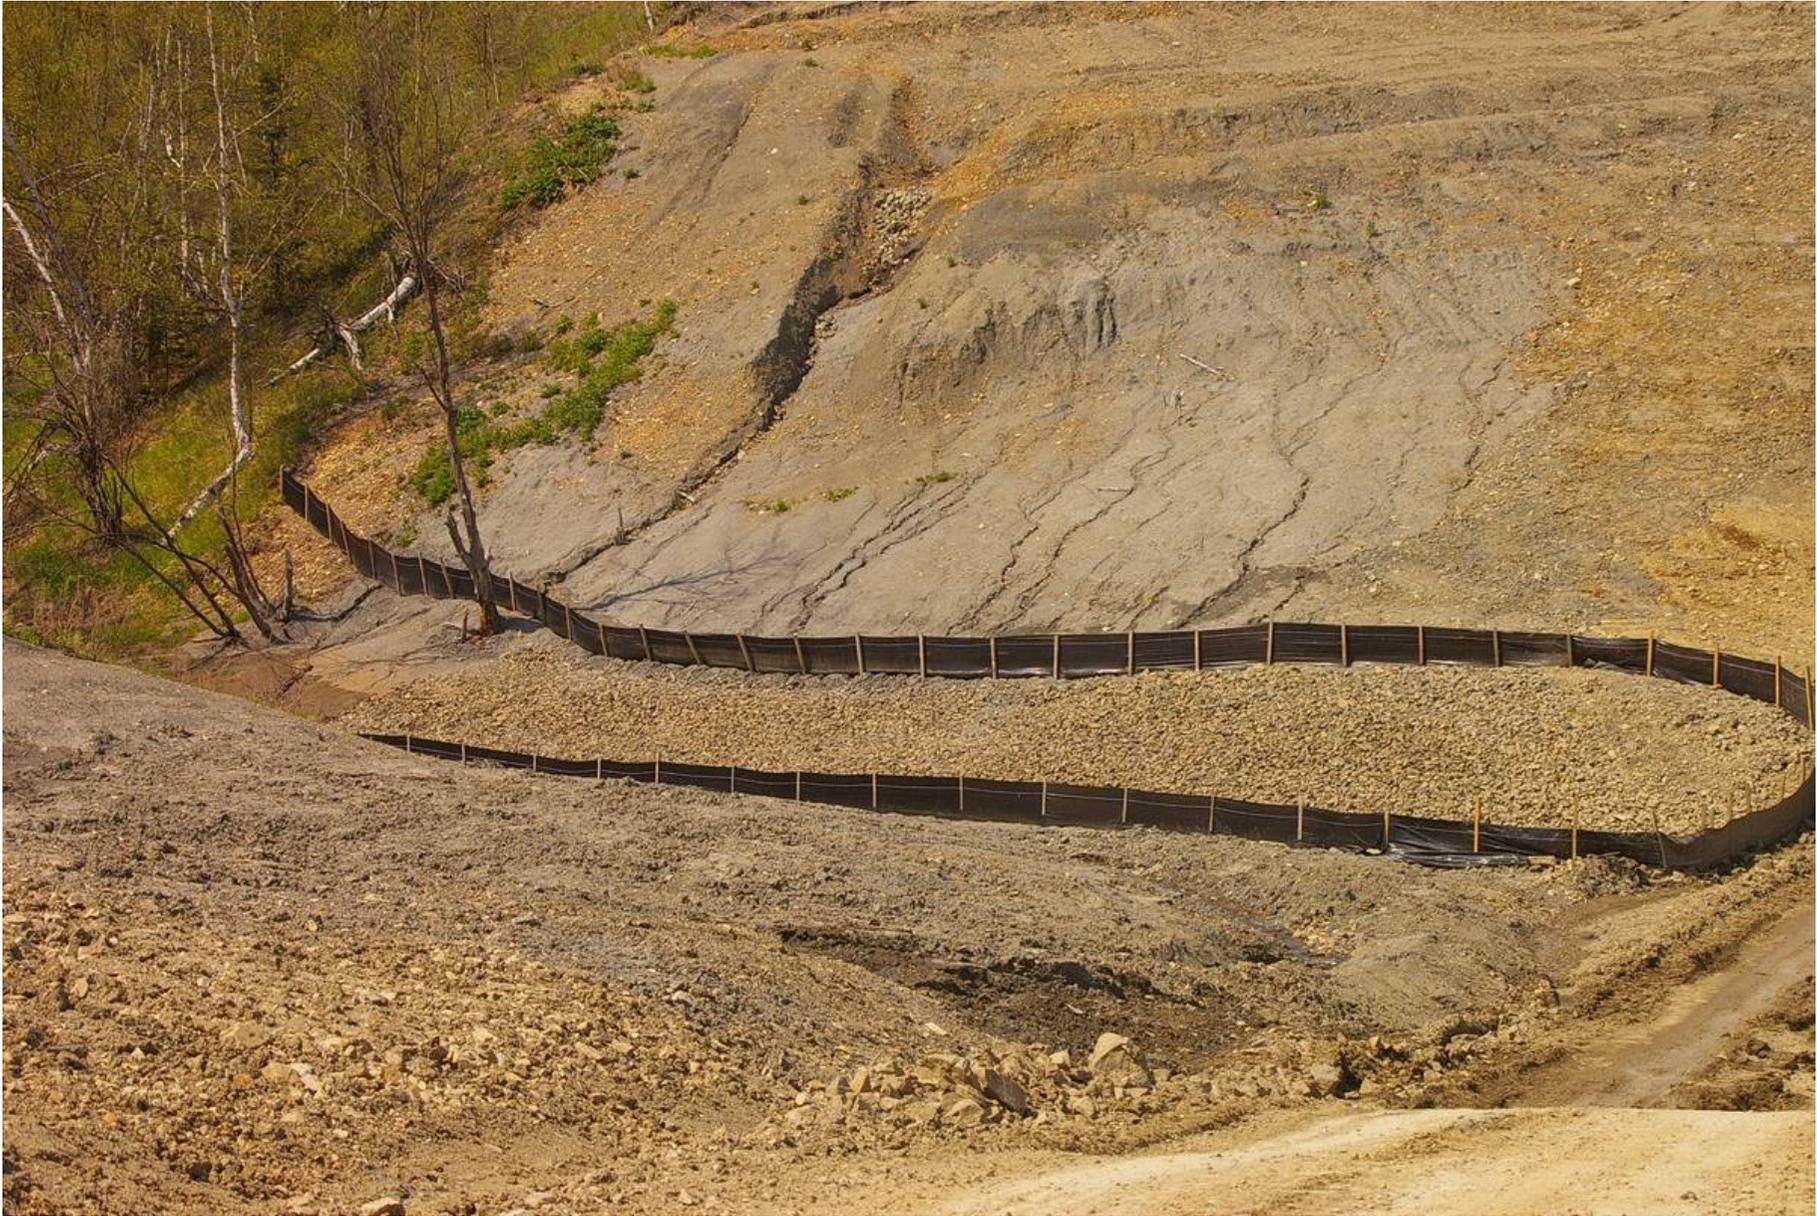
KP 387.2, Spread 3. Stream – left tributary of the Lazovaya River. Deep erosion ditch on the right bank. Slope breakers have failed. No topsoil was returned to the slope right of way.

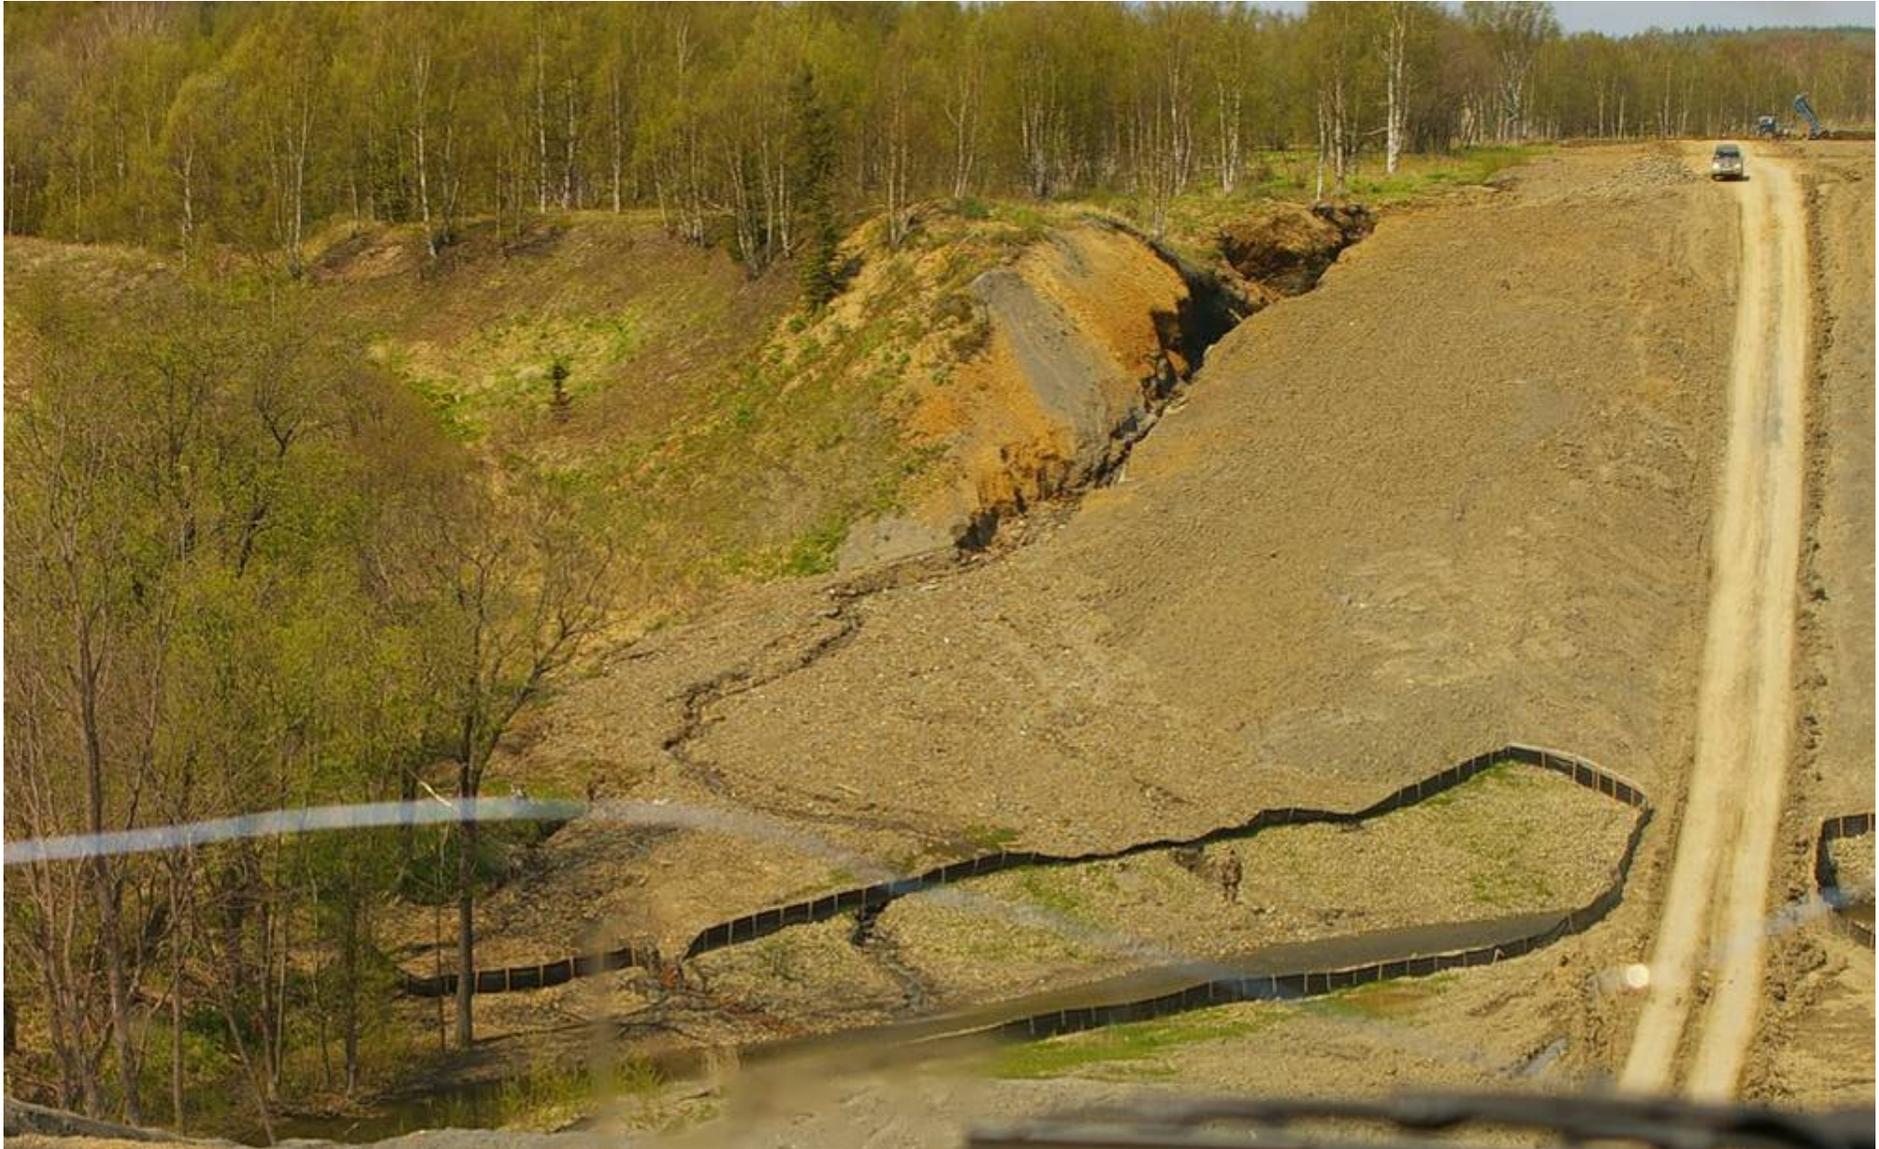
KP 386.4, Spread 3. Stream – left tributary of the Lazovaya River. Very deep erosion ditch on the right bank. Slope breakers are absent as well as topsoil and planted grass. Silt fences fail to halt the flow of mud entering the stream.

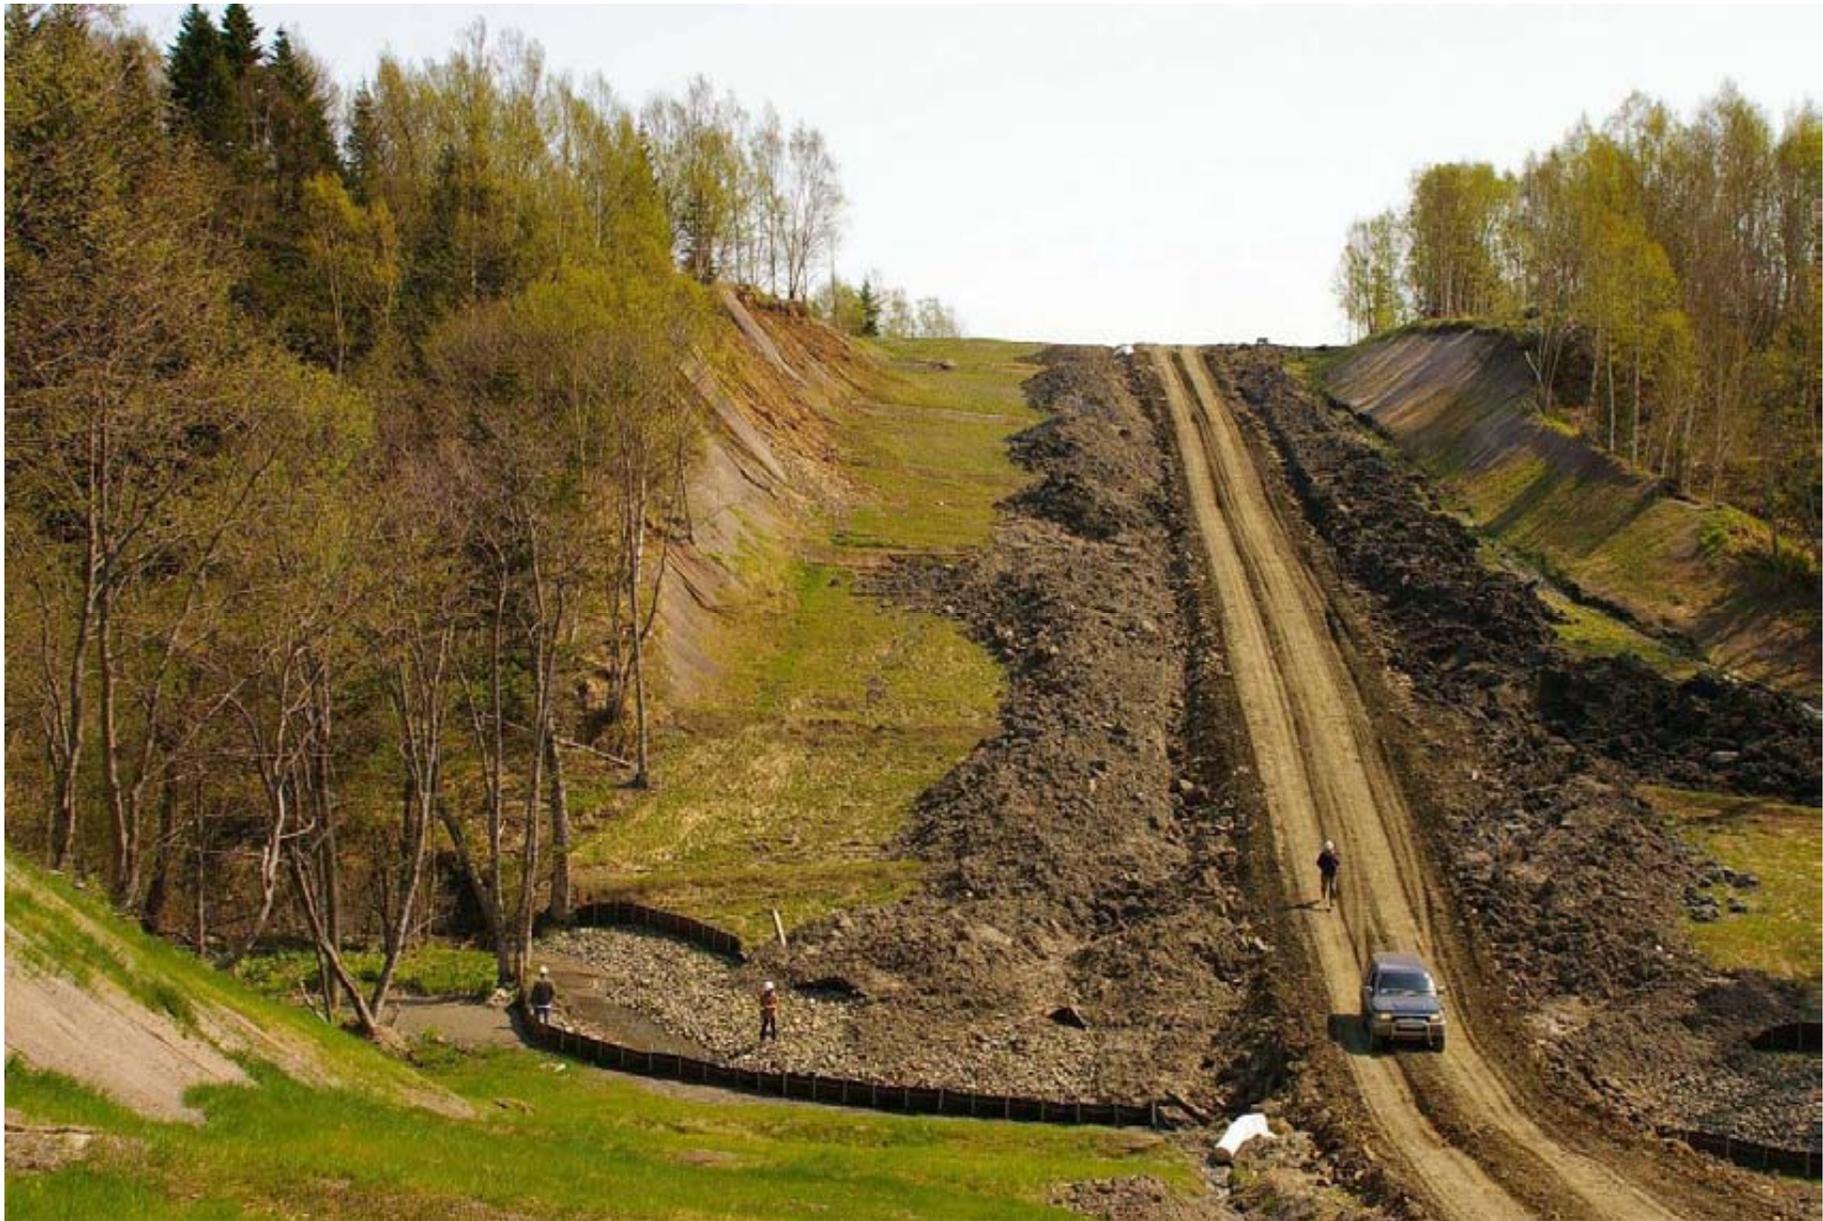
KP 384.7, Spread 3. Zagrobka River. Generally well done slope breakers, but the topsoil that was returned and the grass that was planted (except along on the slopes near the edges of the pipeline corridor) have been completely destroyed by a recently built construction road. This section of the pipeline was allegedly complete. However, poor planning resulted in the construction of a new road.

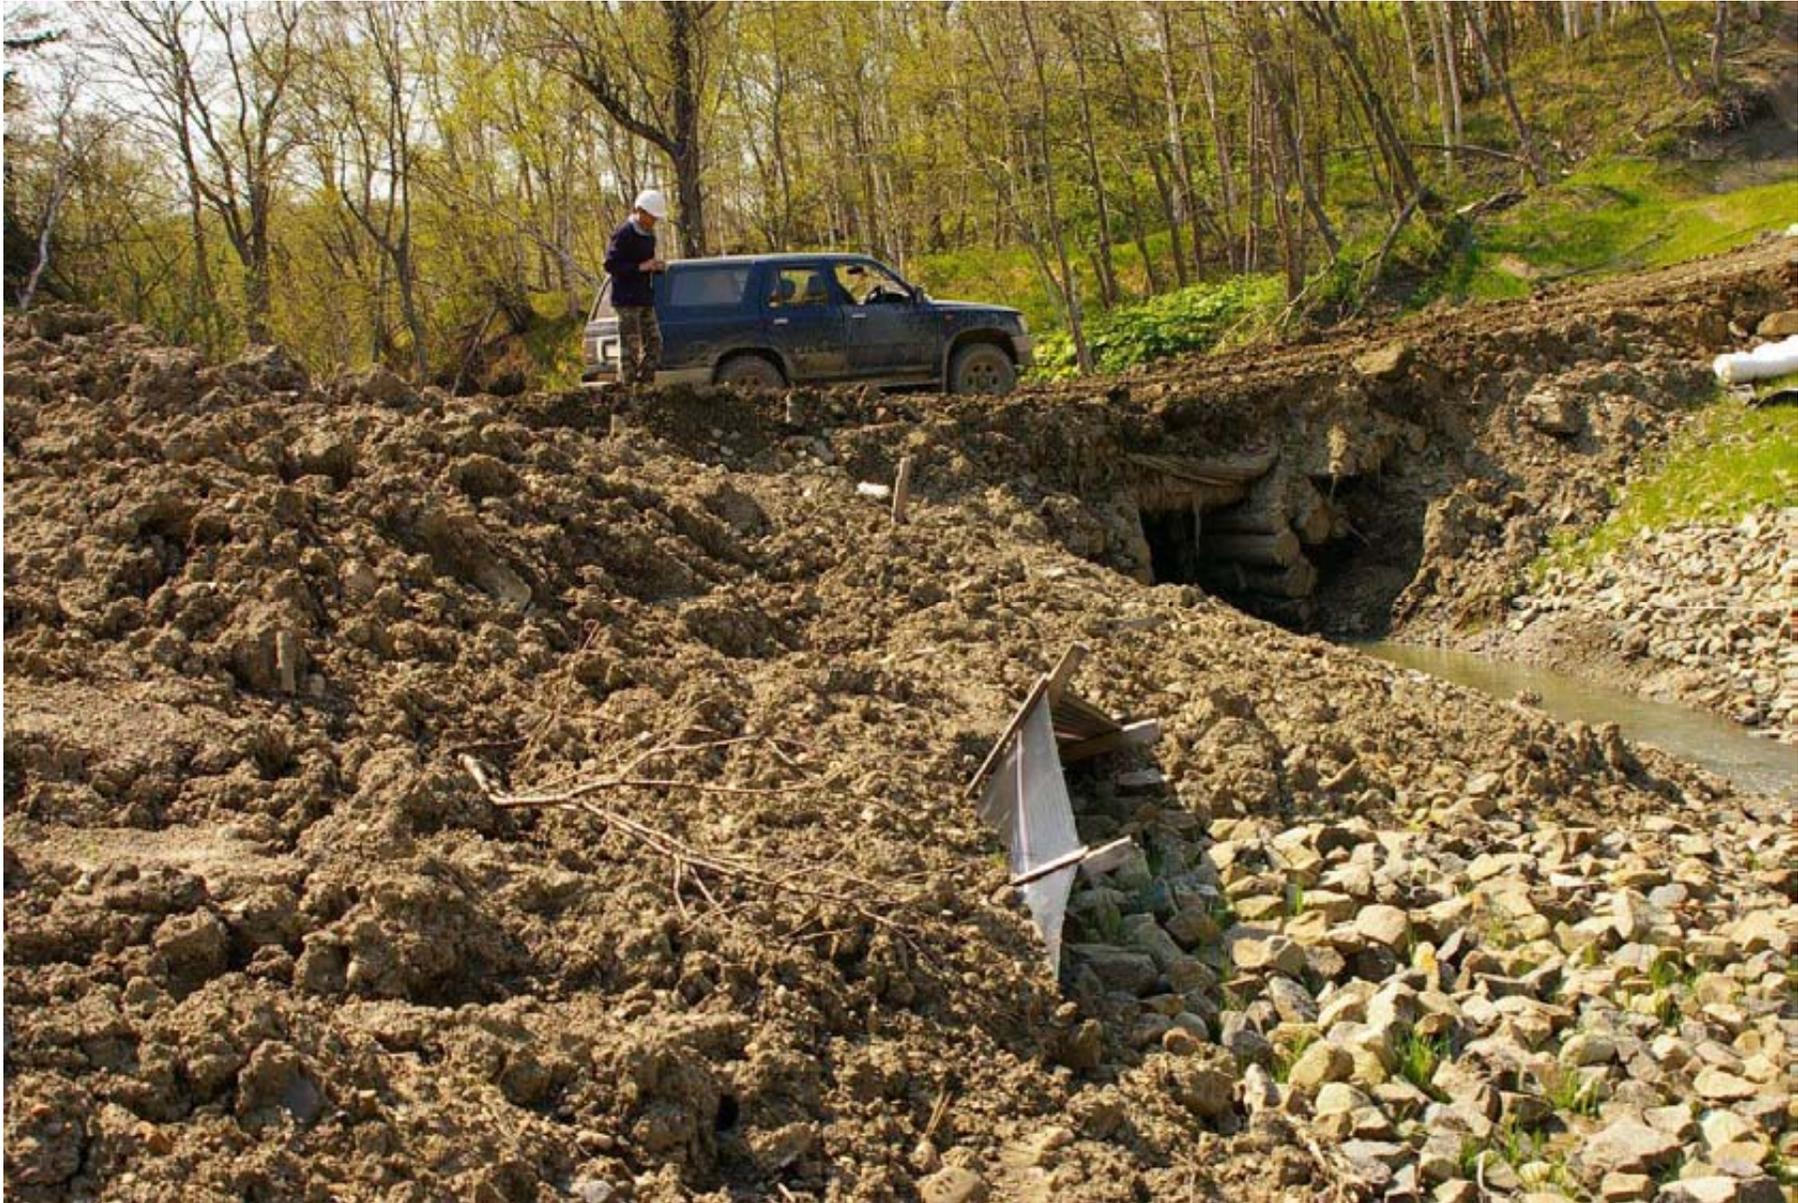
KP 384.7, Spread 3. Zagrobka River. Earth from road construction destroyed the silt fences and enters the river channel.

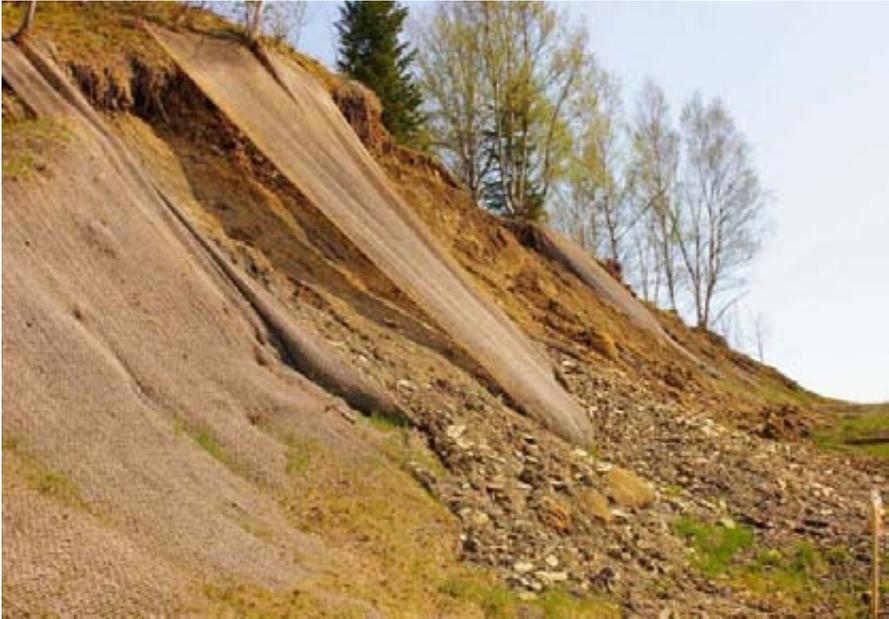
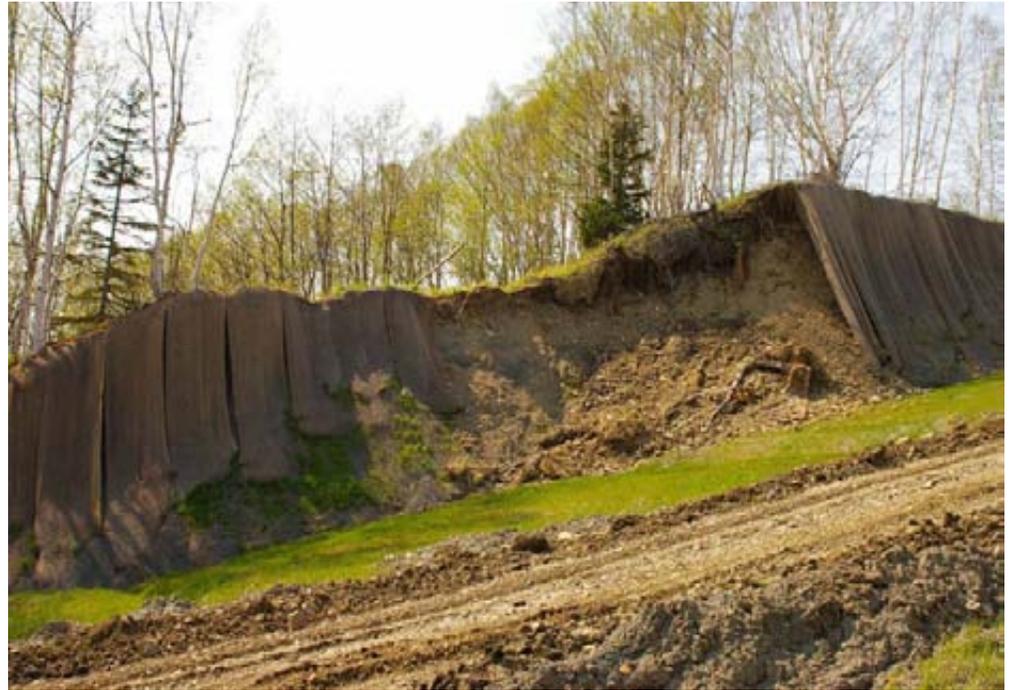
KP 384.7, Spread 3. Zagrobka River.
Slopes stabilization measures along the
edges of the pipeline right of way have failed.

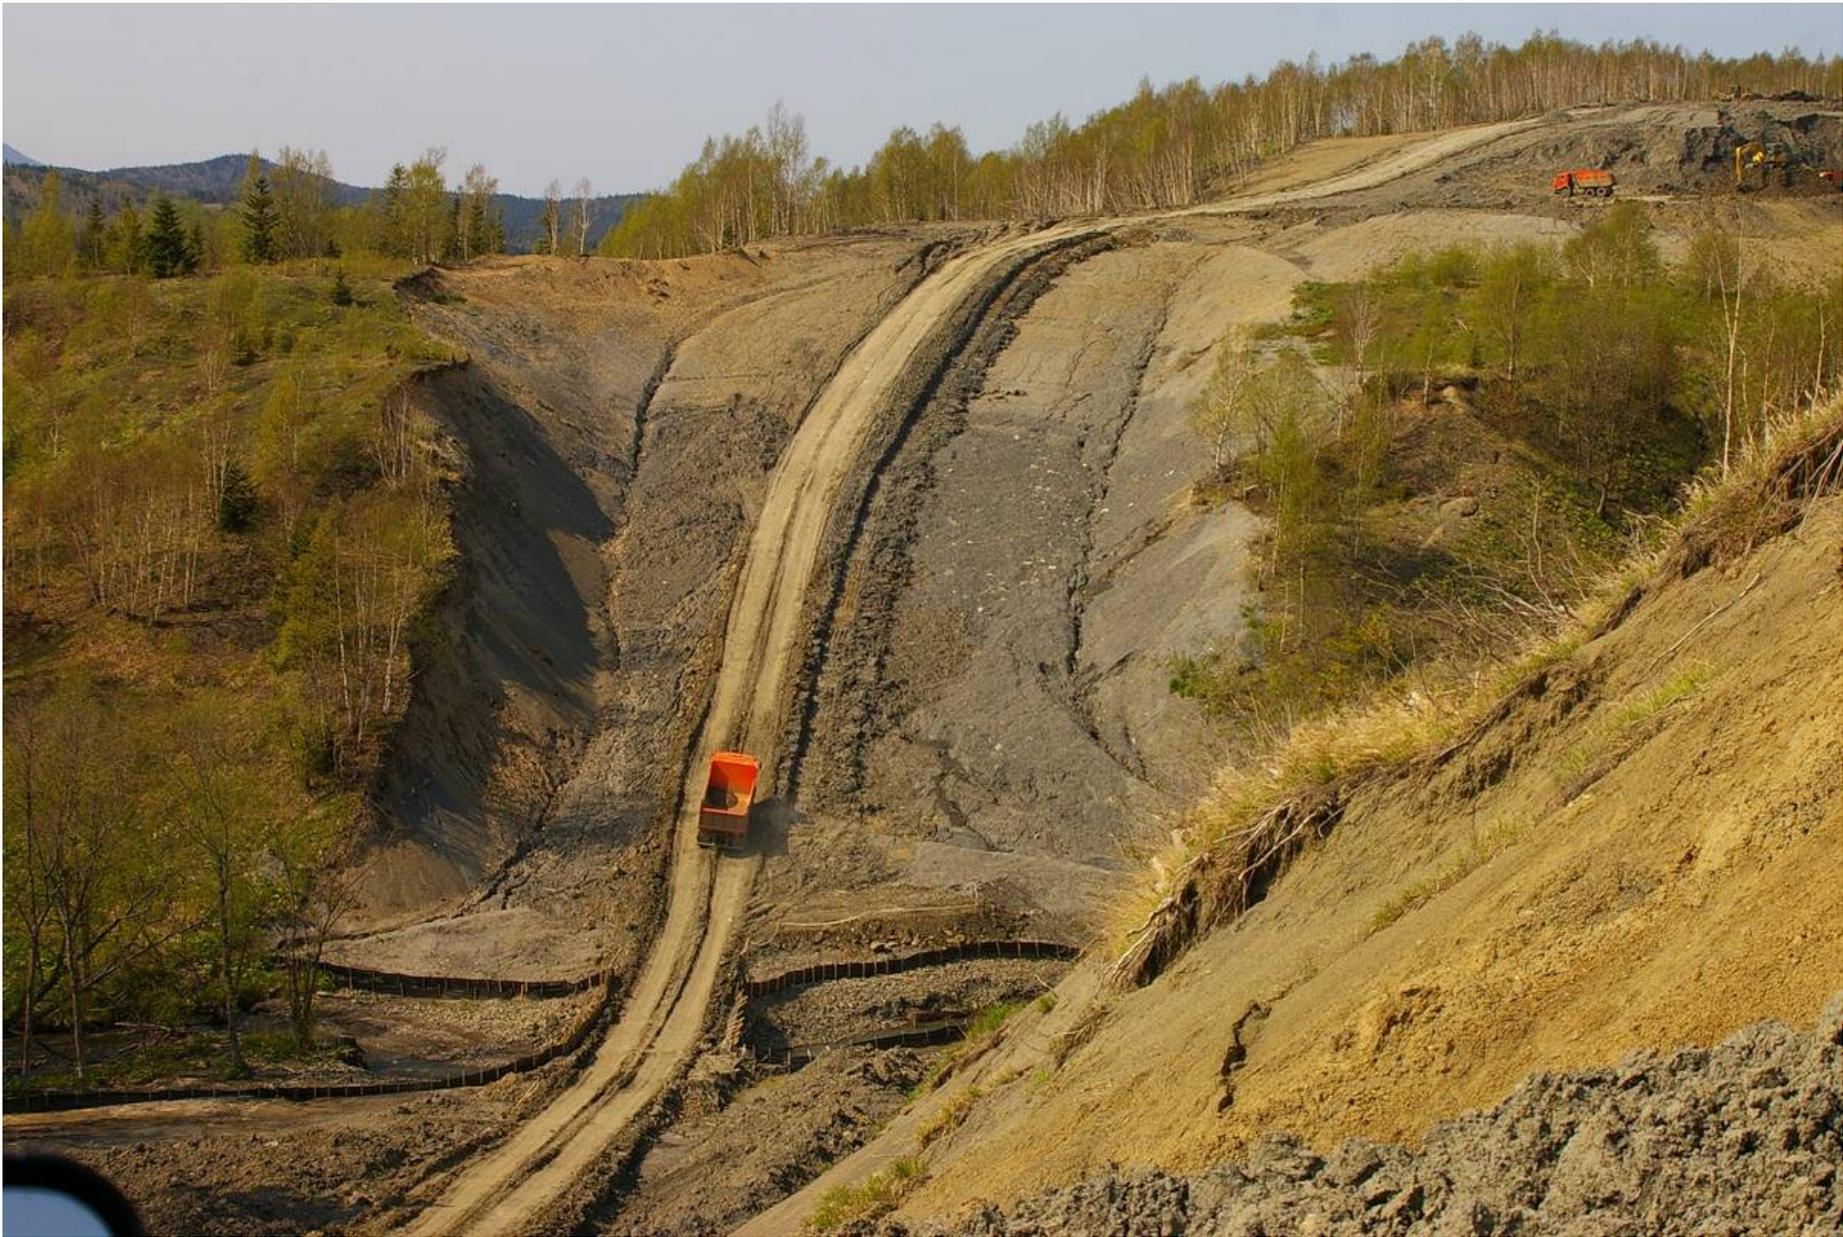
KP 381.9, Spread 3. Stream – left tributary of the Lazovaya River. There are no erosion prevention and control measures. Two erosion ditches carry sediment directly into the stream. A new drainage ditch along the side of road will be the third erosion ditch installed to carry sediment away from streams during rain.

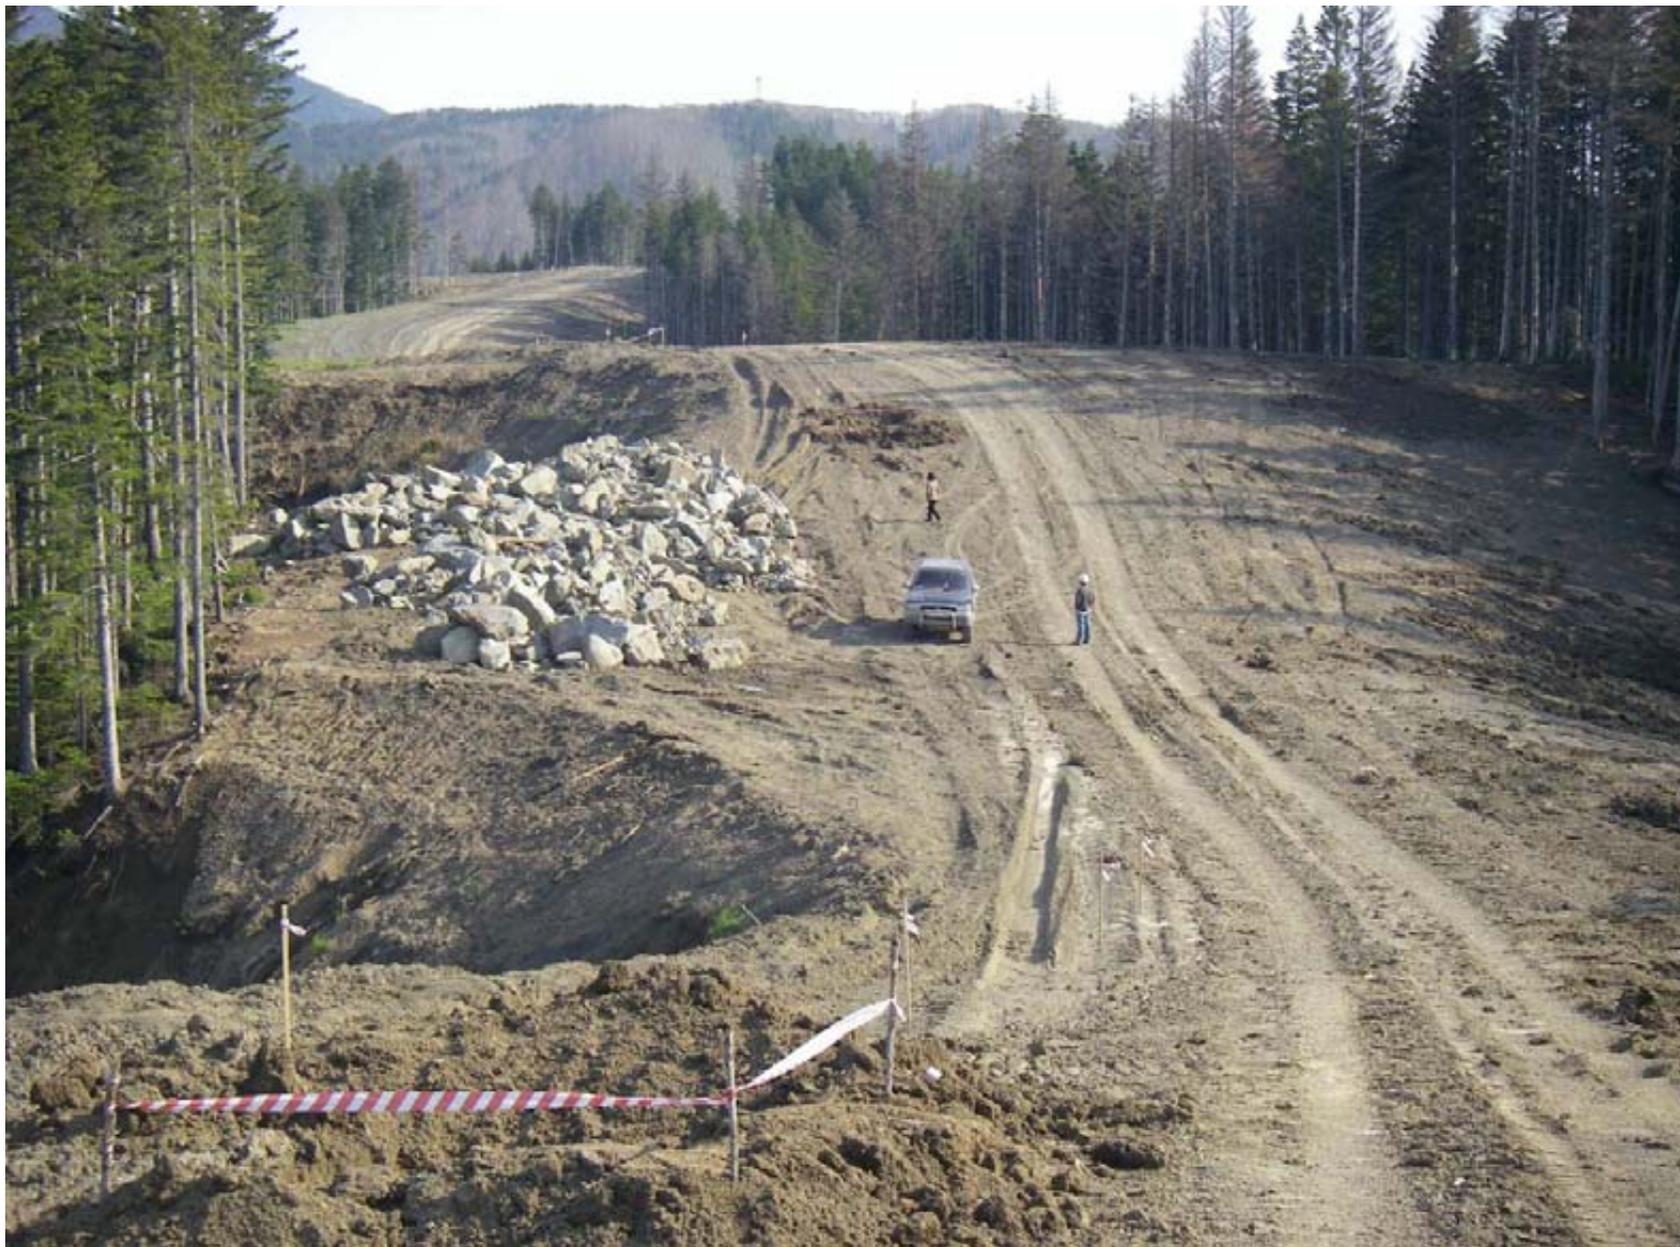
KP 364.2, Spread 3. Varvarka River watershed. Holes from two landslides threaten to undermine the oil pipeline at this location.

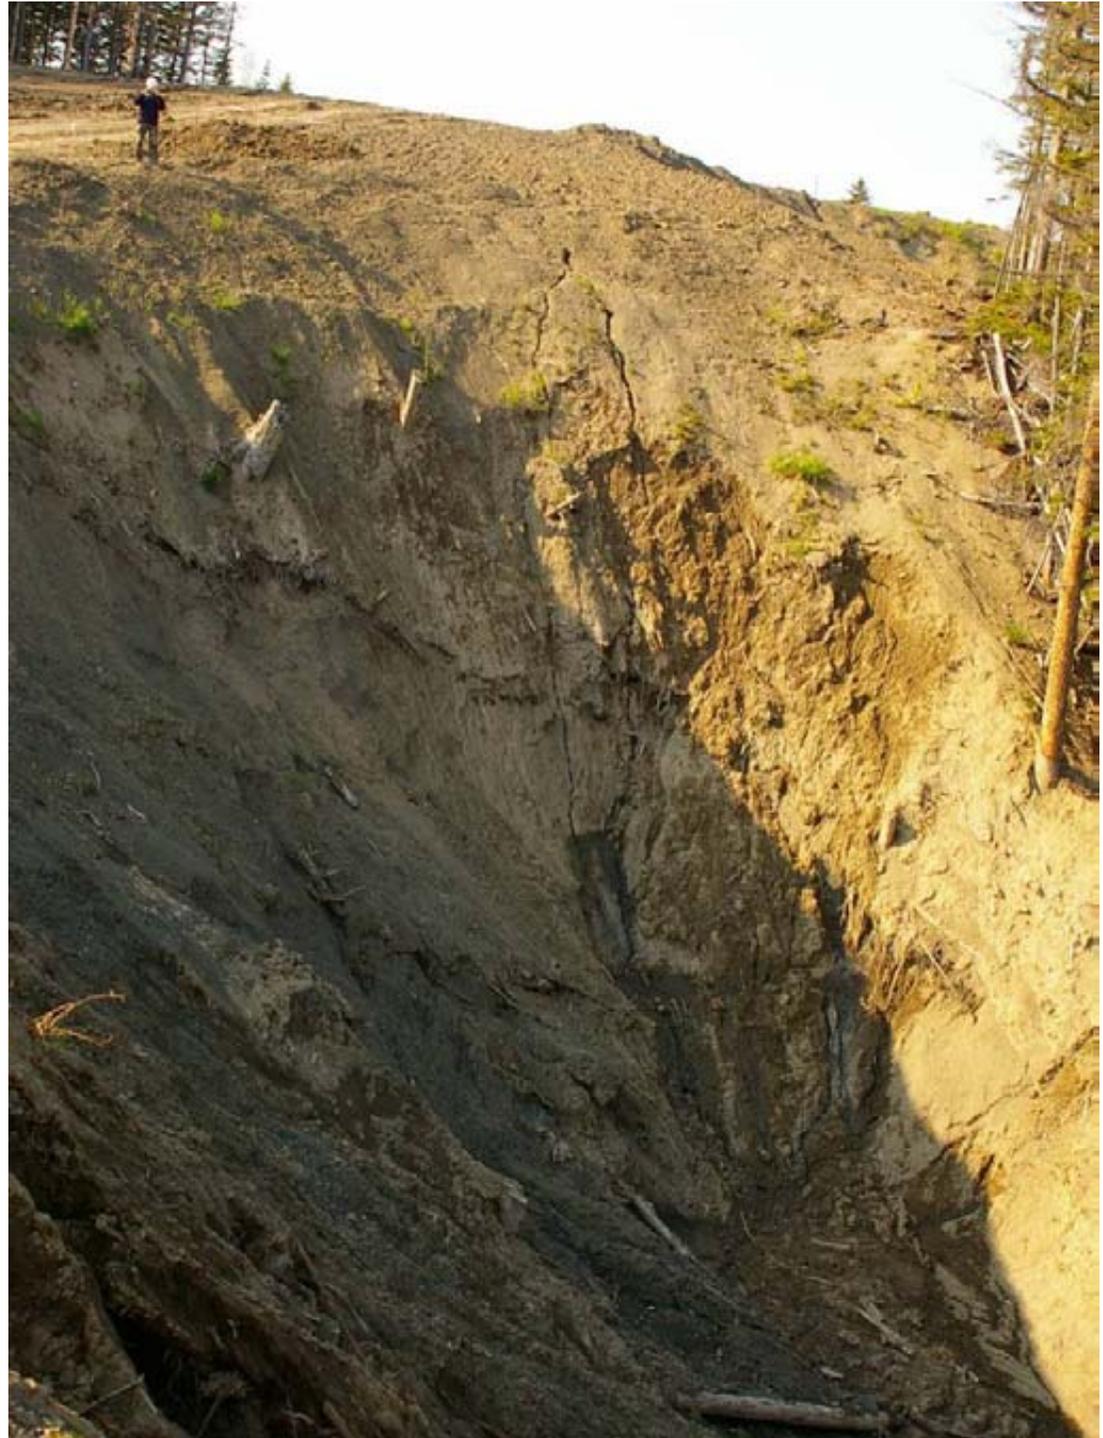
KP 364.2, Spread 3. Varvarka River watershed.
A landslide zone that undermines the oil pipeline.
Black spots on the hole's wall indicate ground water seepage, an obvious source of future landslides.

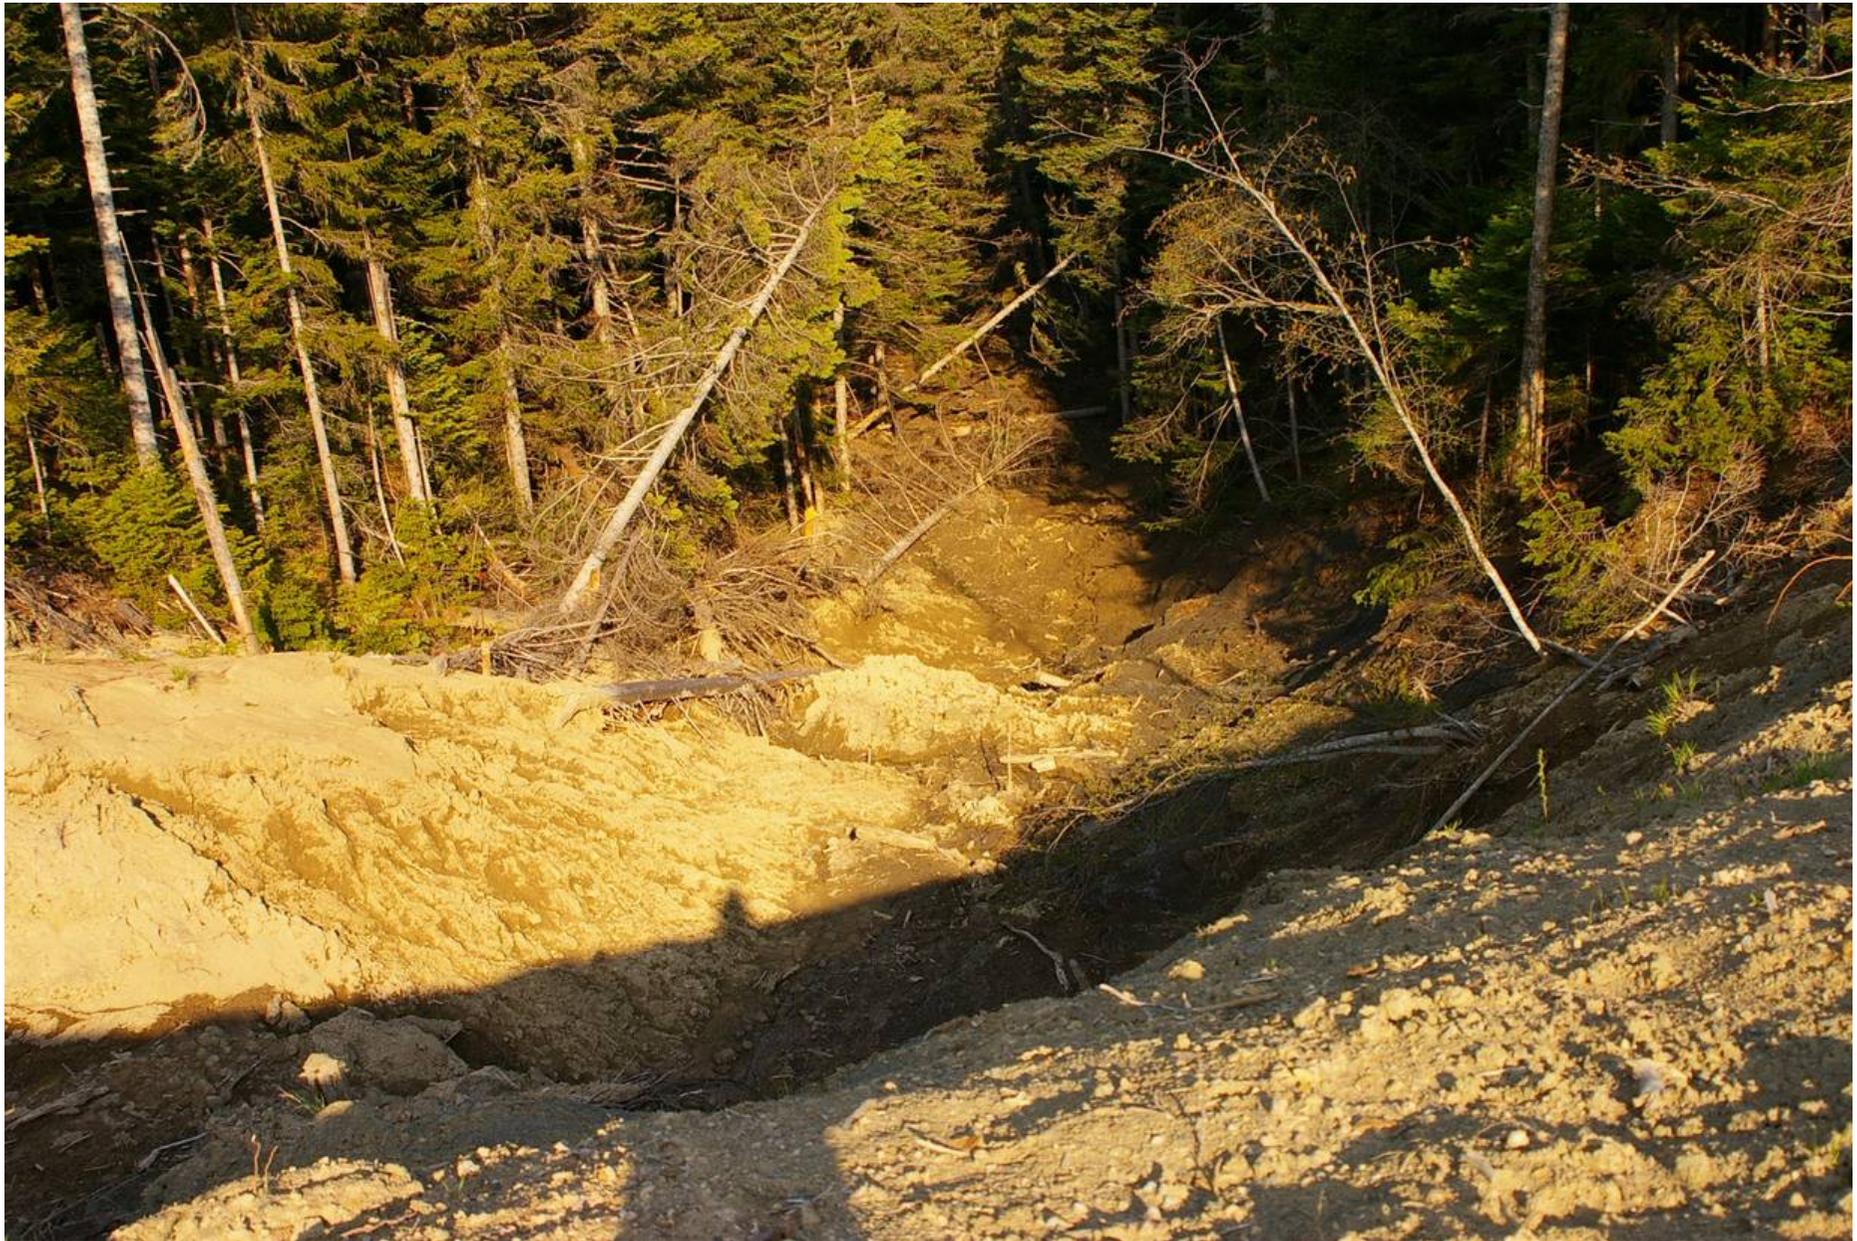
KP 364.2, Spread 3. Varvarka River watershed. Massive landslides occurred along the pipeline corridor. Numerous trees were taken down by these landslides.

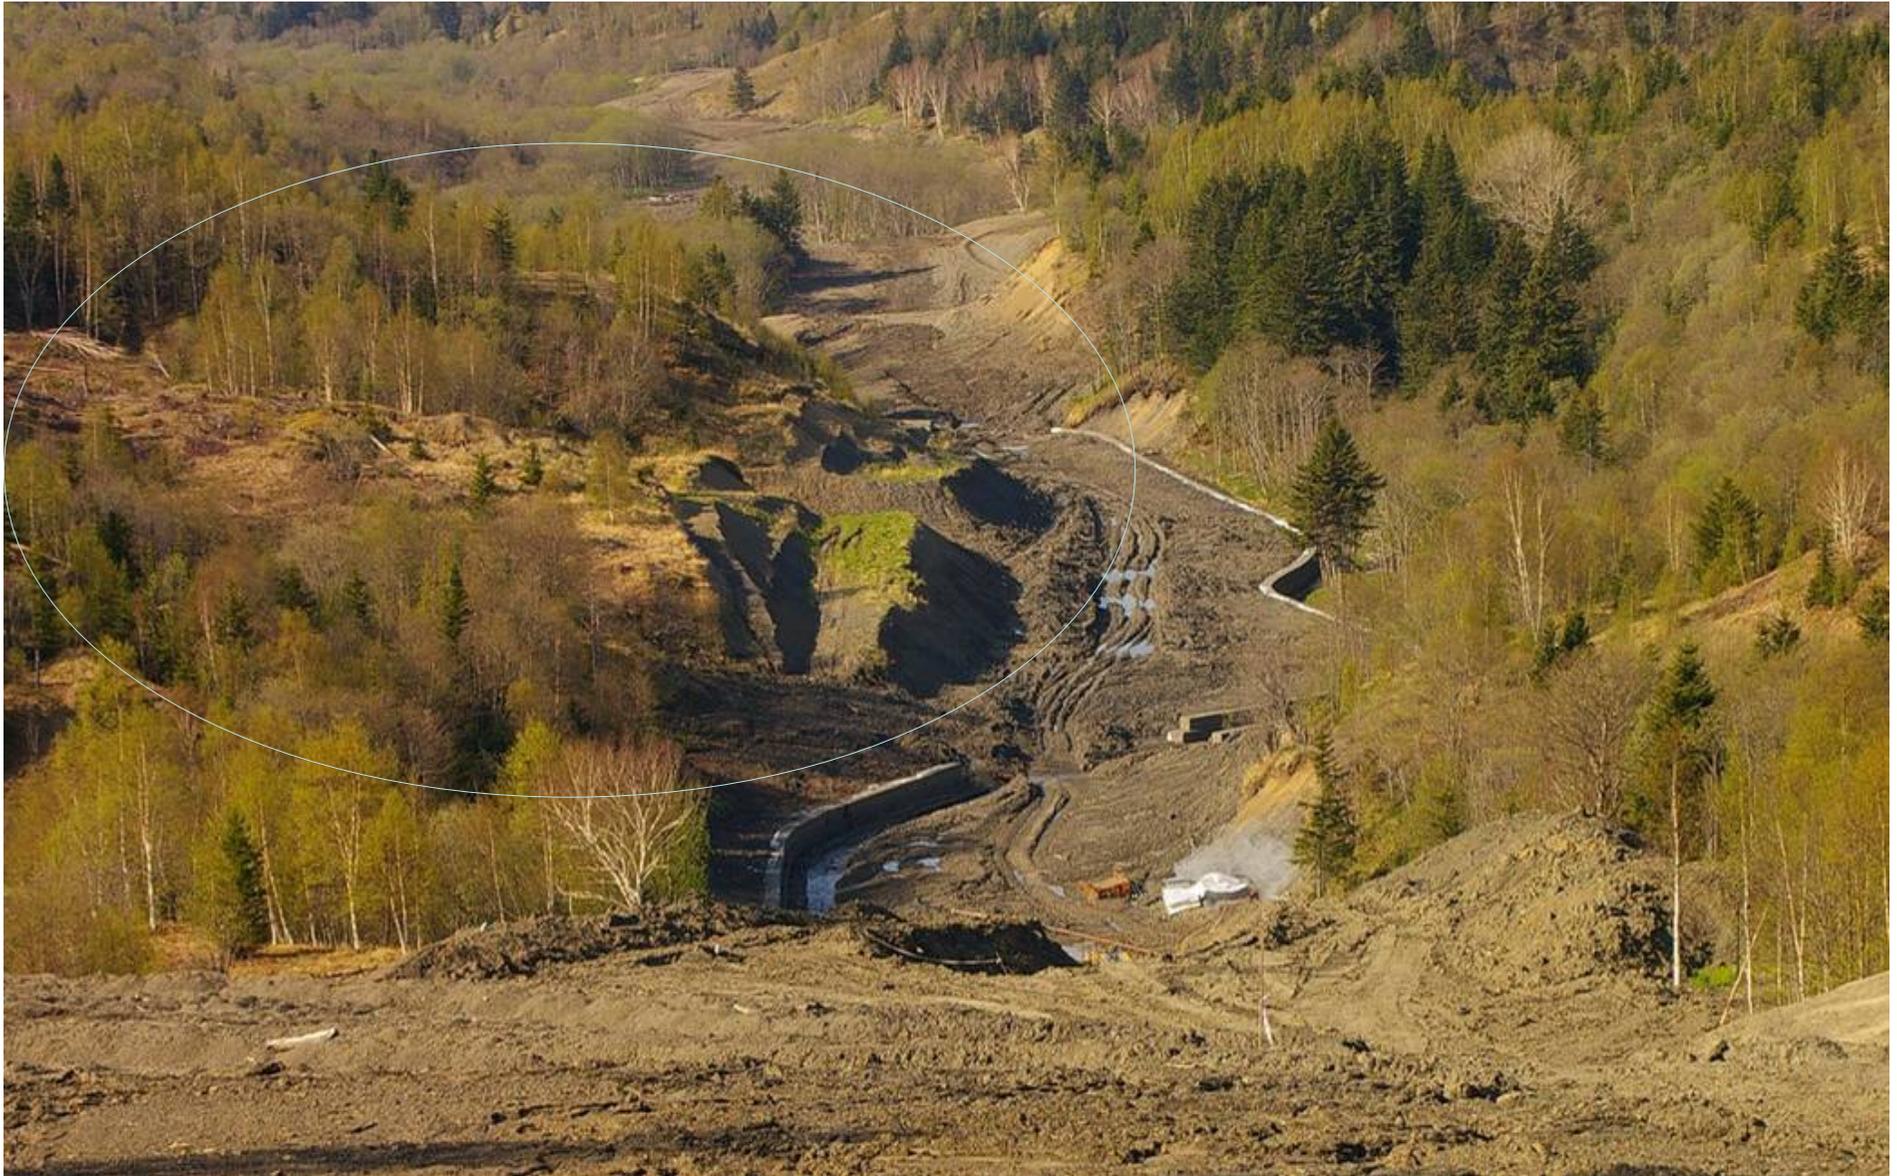
KP 362.5, Spread 3. General view of the Varvarka River valley. The blue line marks a zone of old, massive landslides. The pipeline right of way now cuts the lower portion of the zone, greatly increasing the landslide risk across the entire zone. It is unlikely that the wire-wrapped (gabion) dam that is partly constructed along river banks will halt landslides during heavy summer rains. The concern at this locations is that landslides could destroy the oil pipeline during its exploitation.

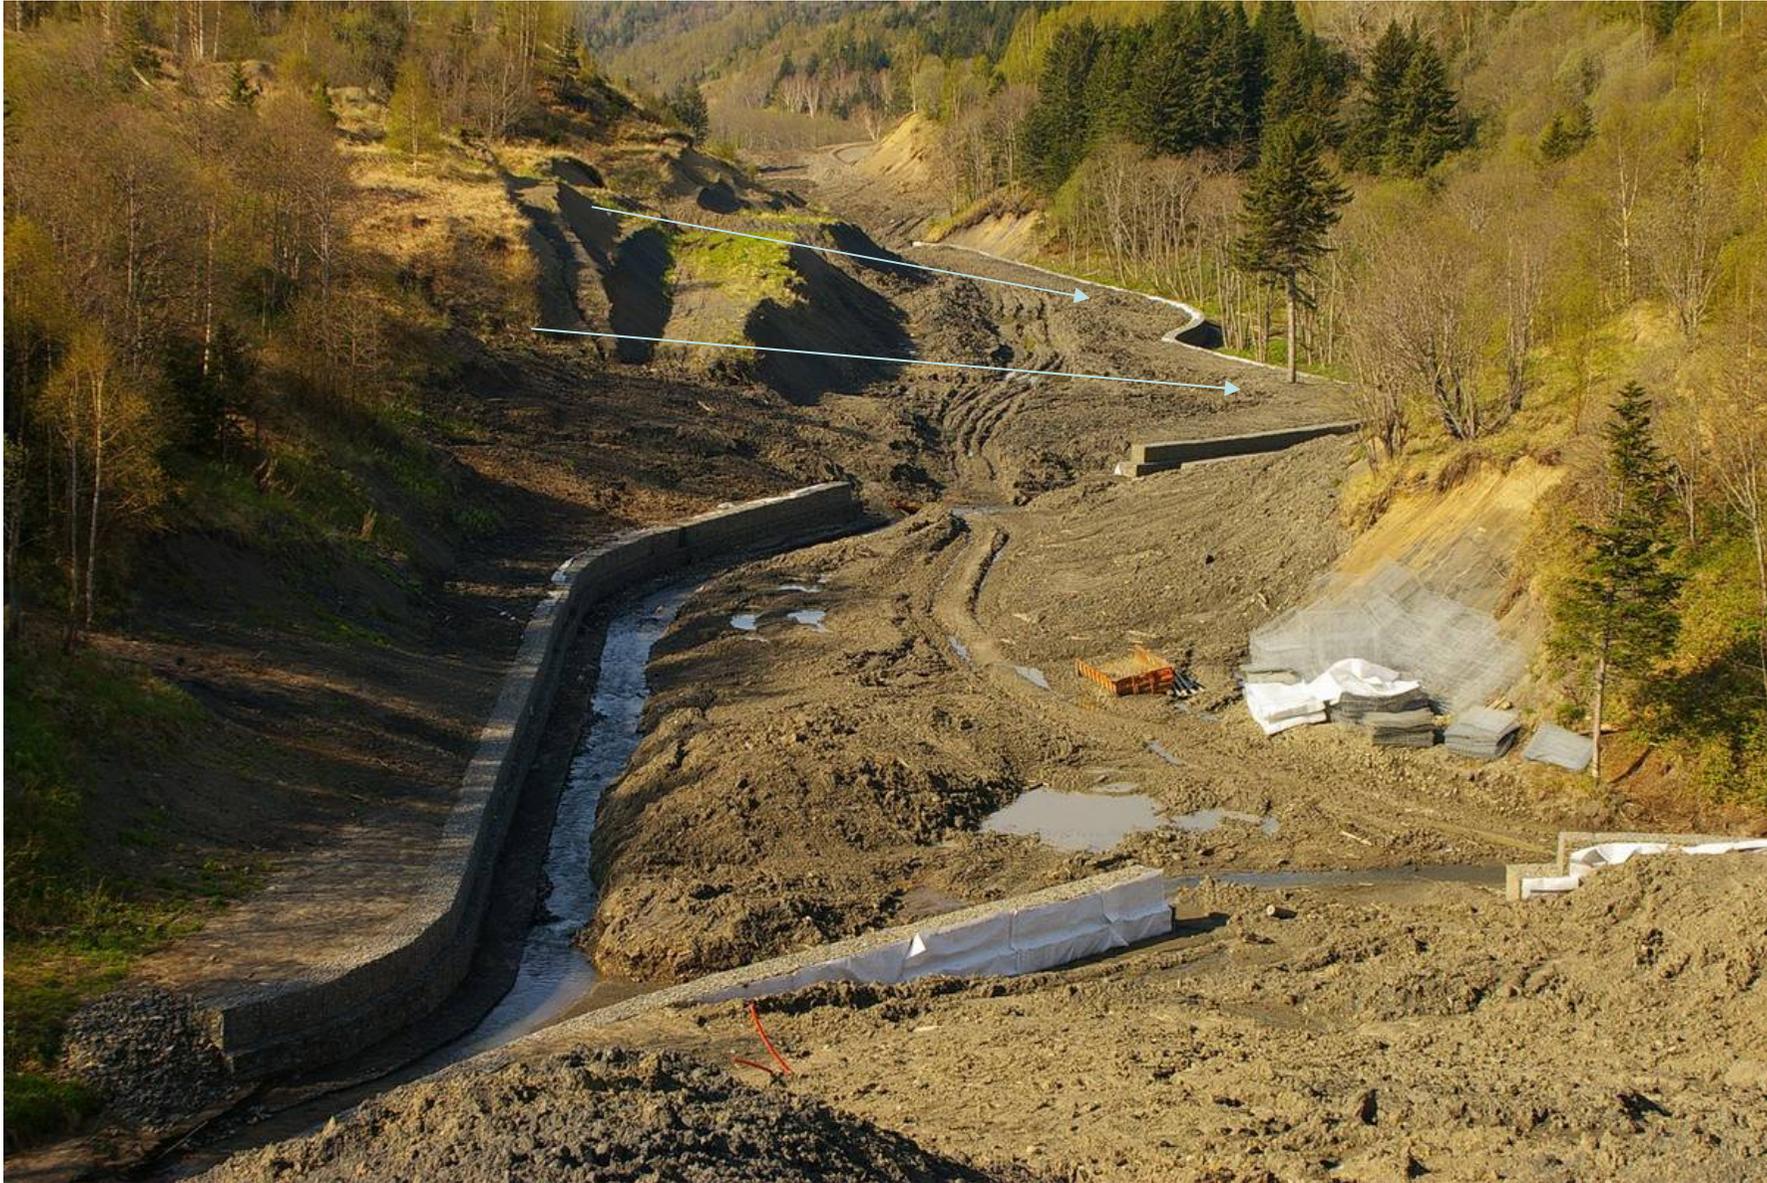
KP 362.5, Spread 3. Varvarka River. The pipeline corridor move along the bottom of the river valley. Two blue arrows show the direction of major, old landslides. Landslides threaten buried pipeline.
