*Pacific Environment
Friends of the Earth Japan
Sakhalin Environment Watch*

Sakhalin II Project Oil and Gas Pipeline Project Dolinsky, Makarovsky and Nogliksky Districts of Sakhalin Region Photo Report from a Fact-Finding Mission May 30 – June 1, 2008

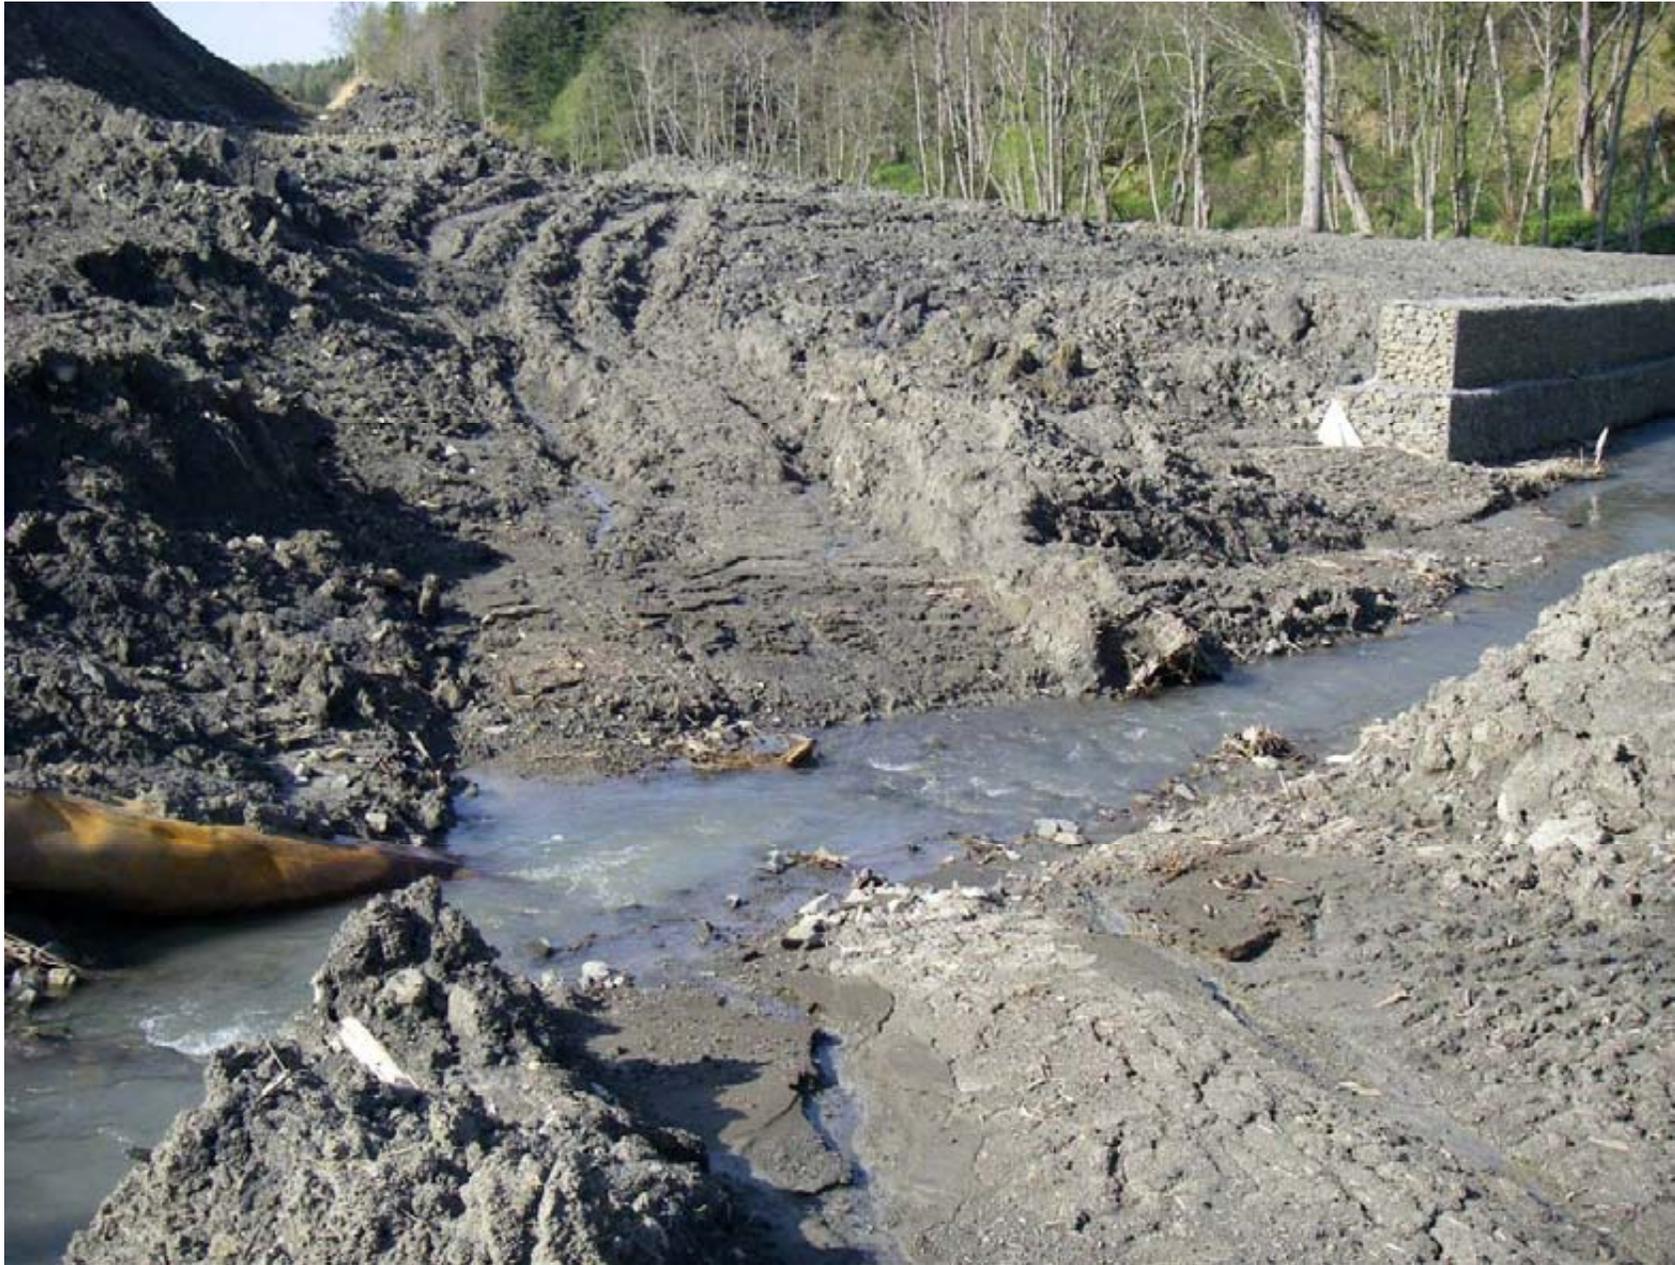
KP 362.5, Spread 3. Varvarka River. The wire-wrapped (gabion) dam was built last autumn. However, gaps were left in the barrier for construction vehicles. Vehicle crossings result in serious water contamination and promotes ground creeping.

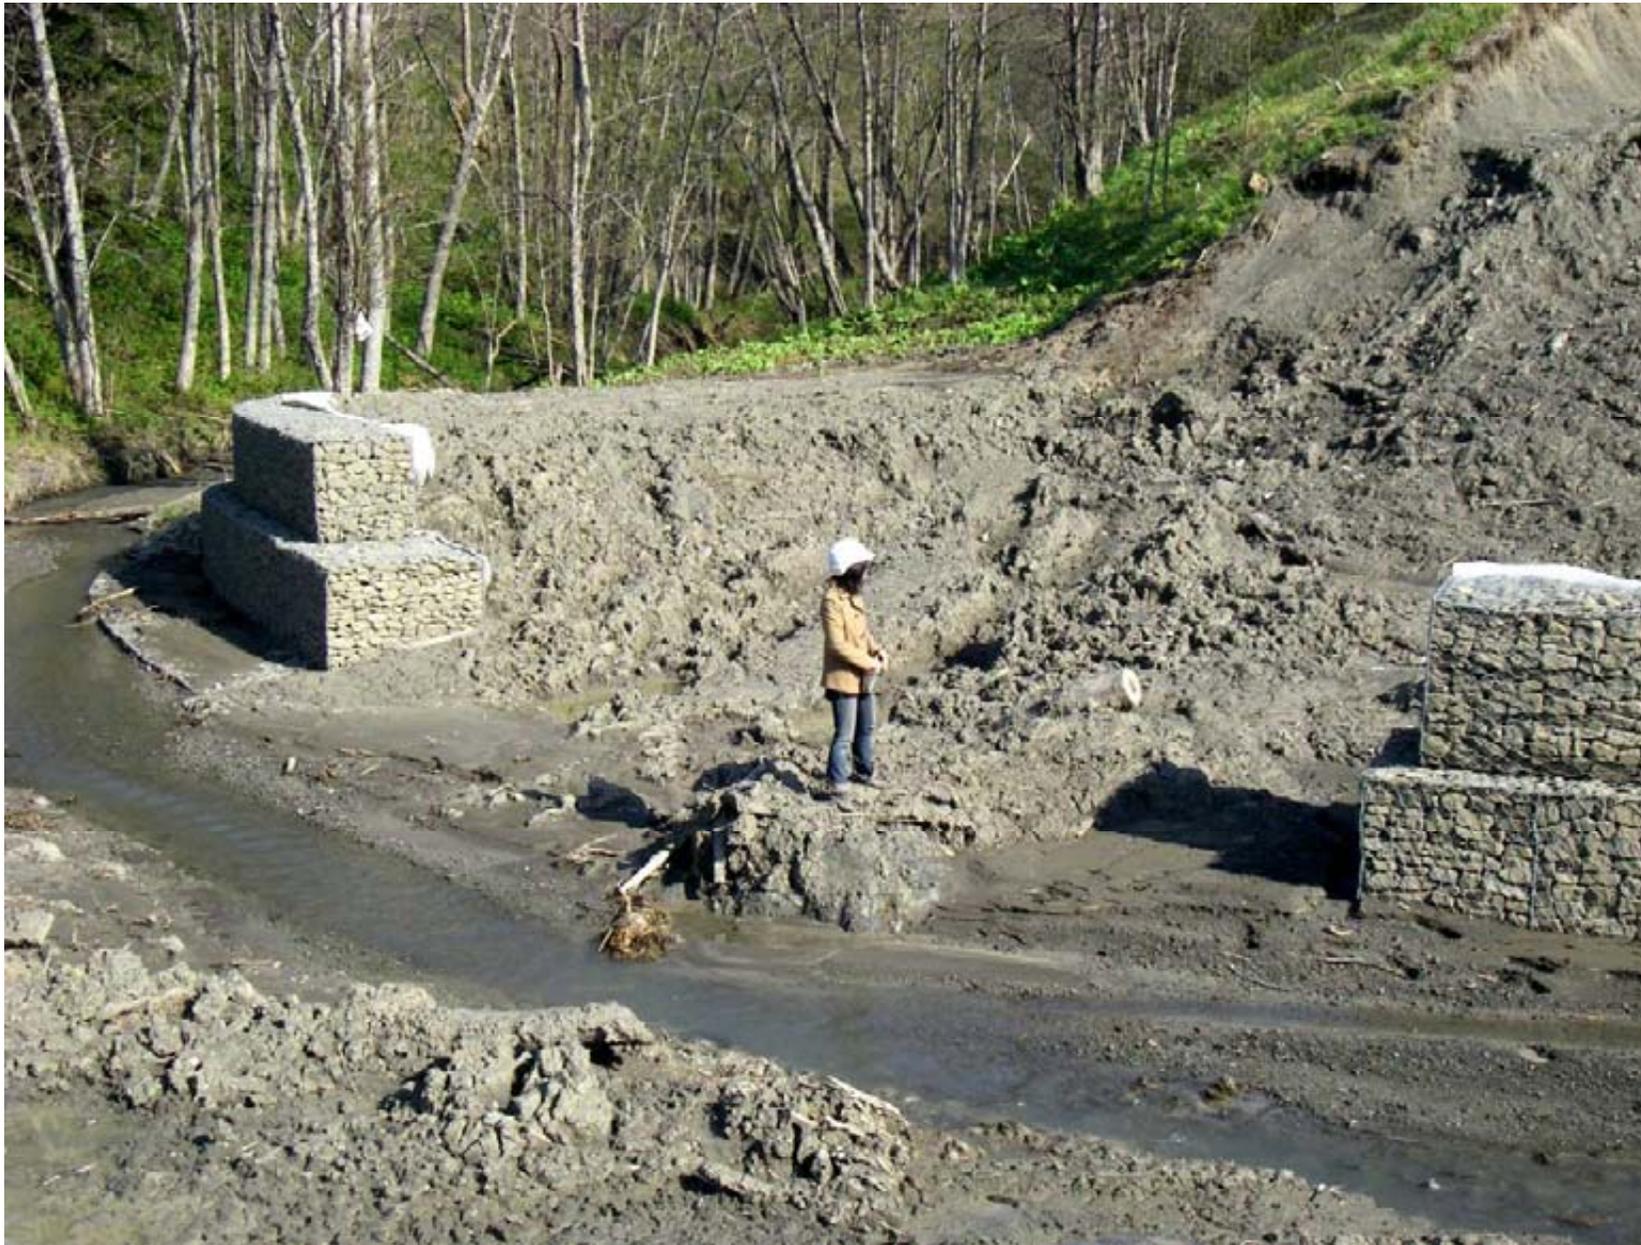
KP 362.5, Spread 3. Varvarka River. Eroded soil continually washes into the river through the gap.

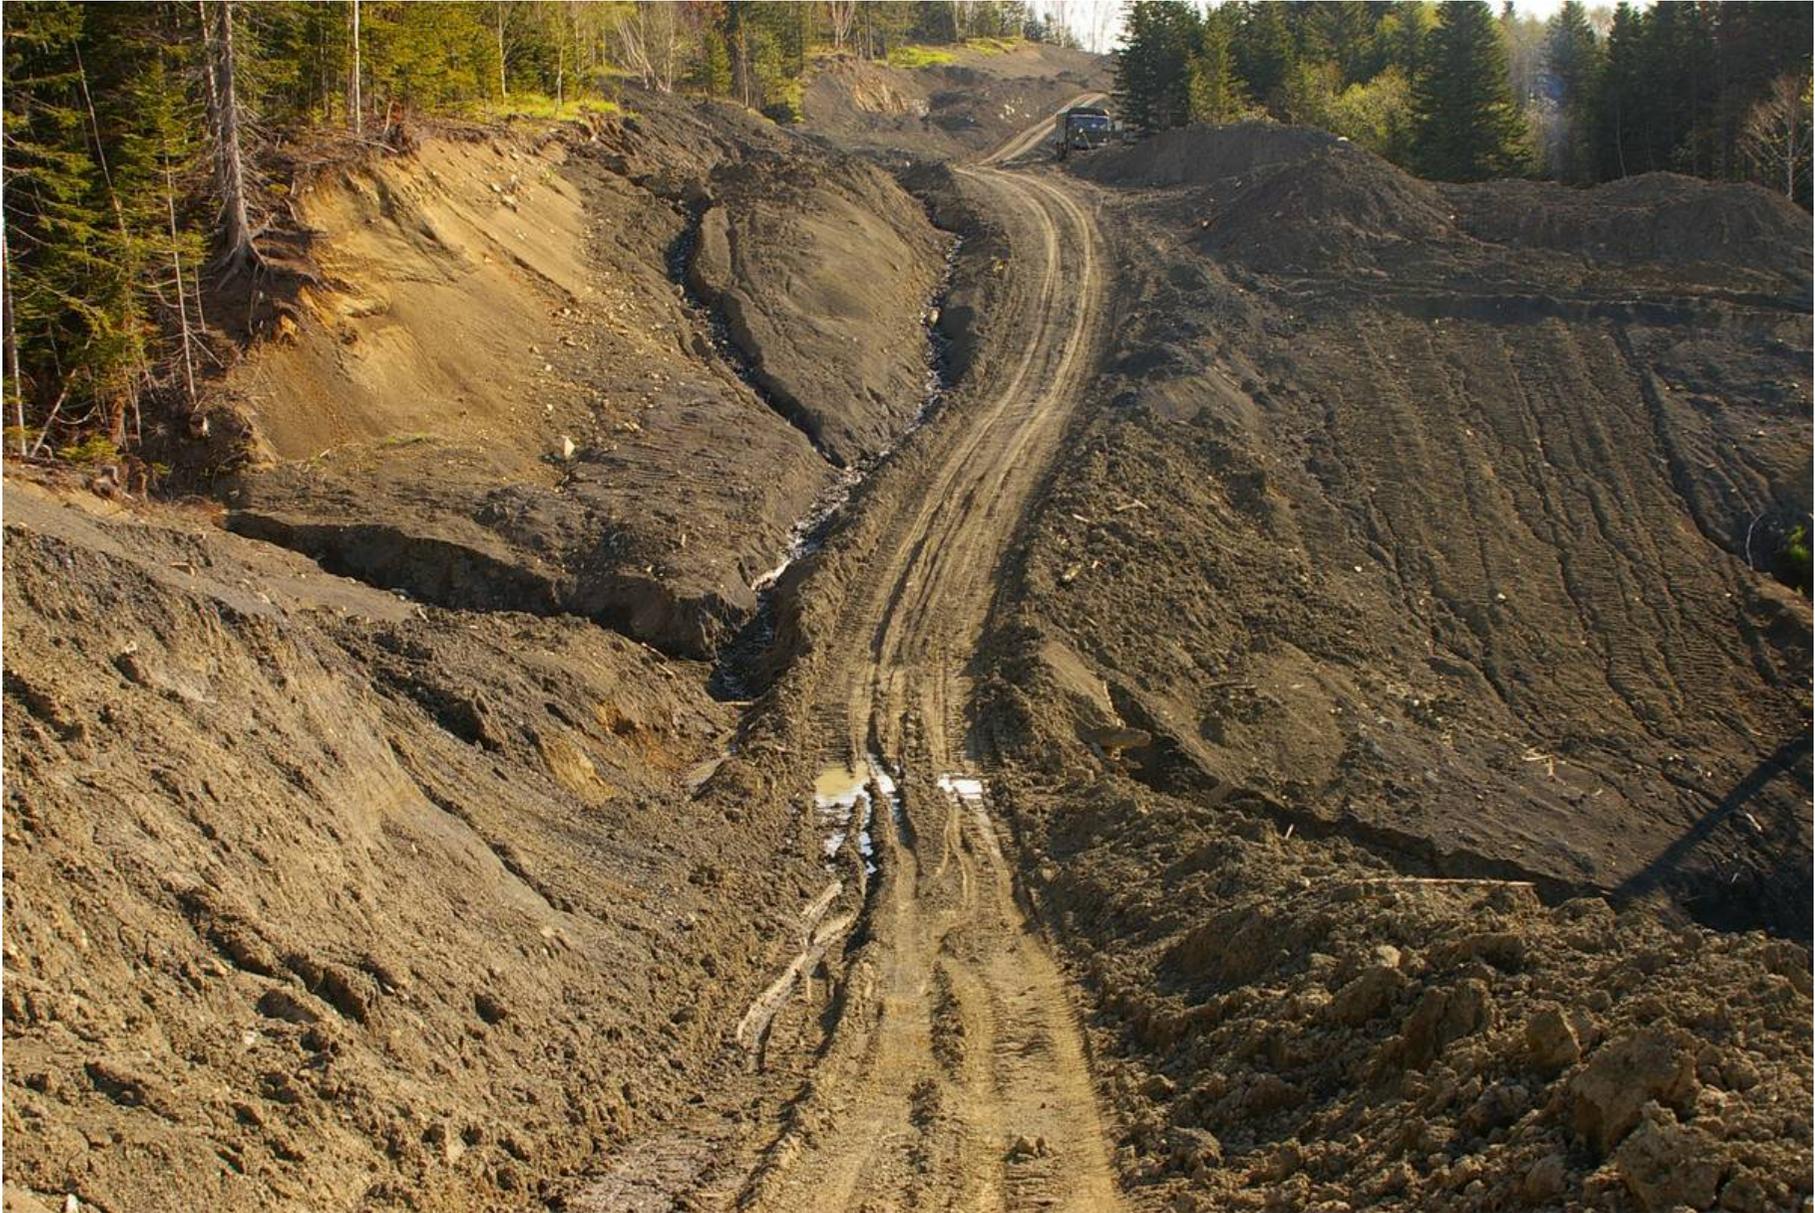
KP 361.4, Spread 3. A pass between the Varvarka and Sosnovka River watersheds. Deep erosion ditches, no erosion control measures.

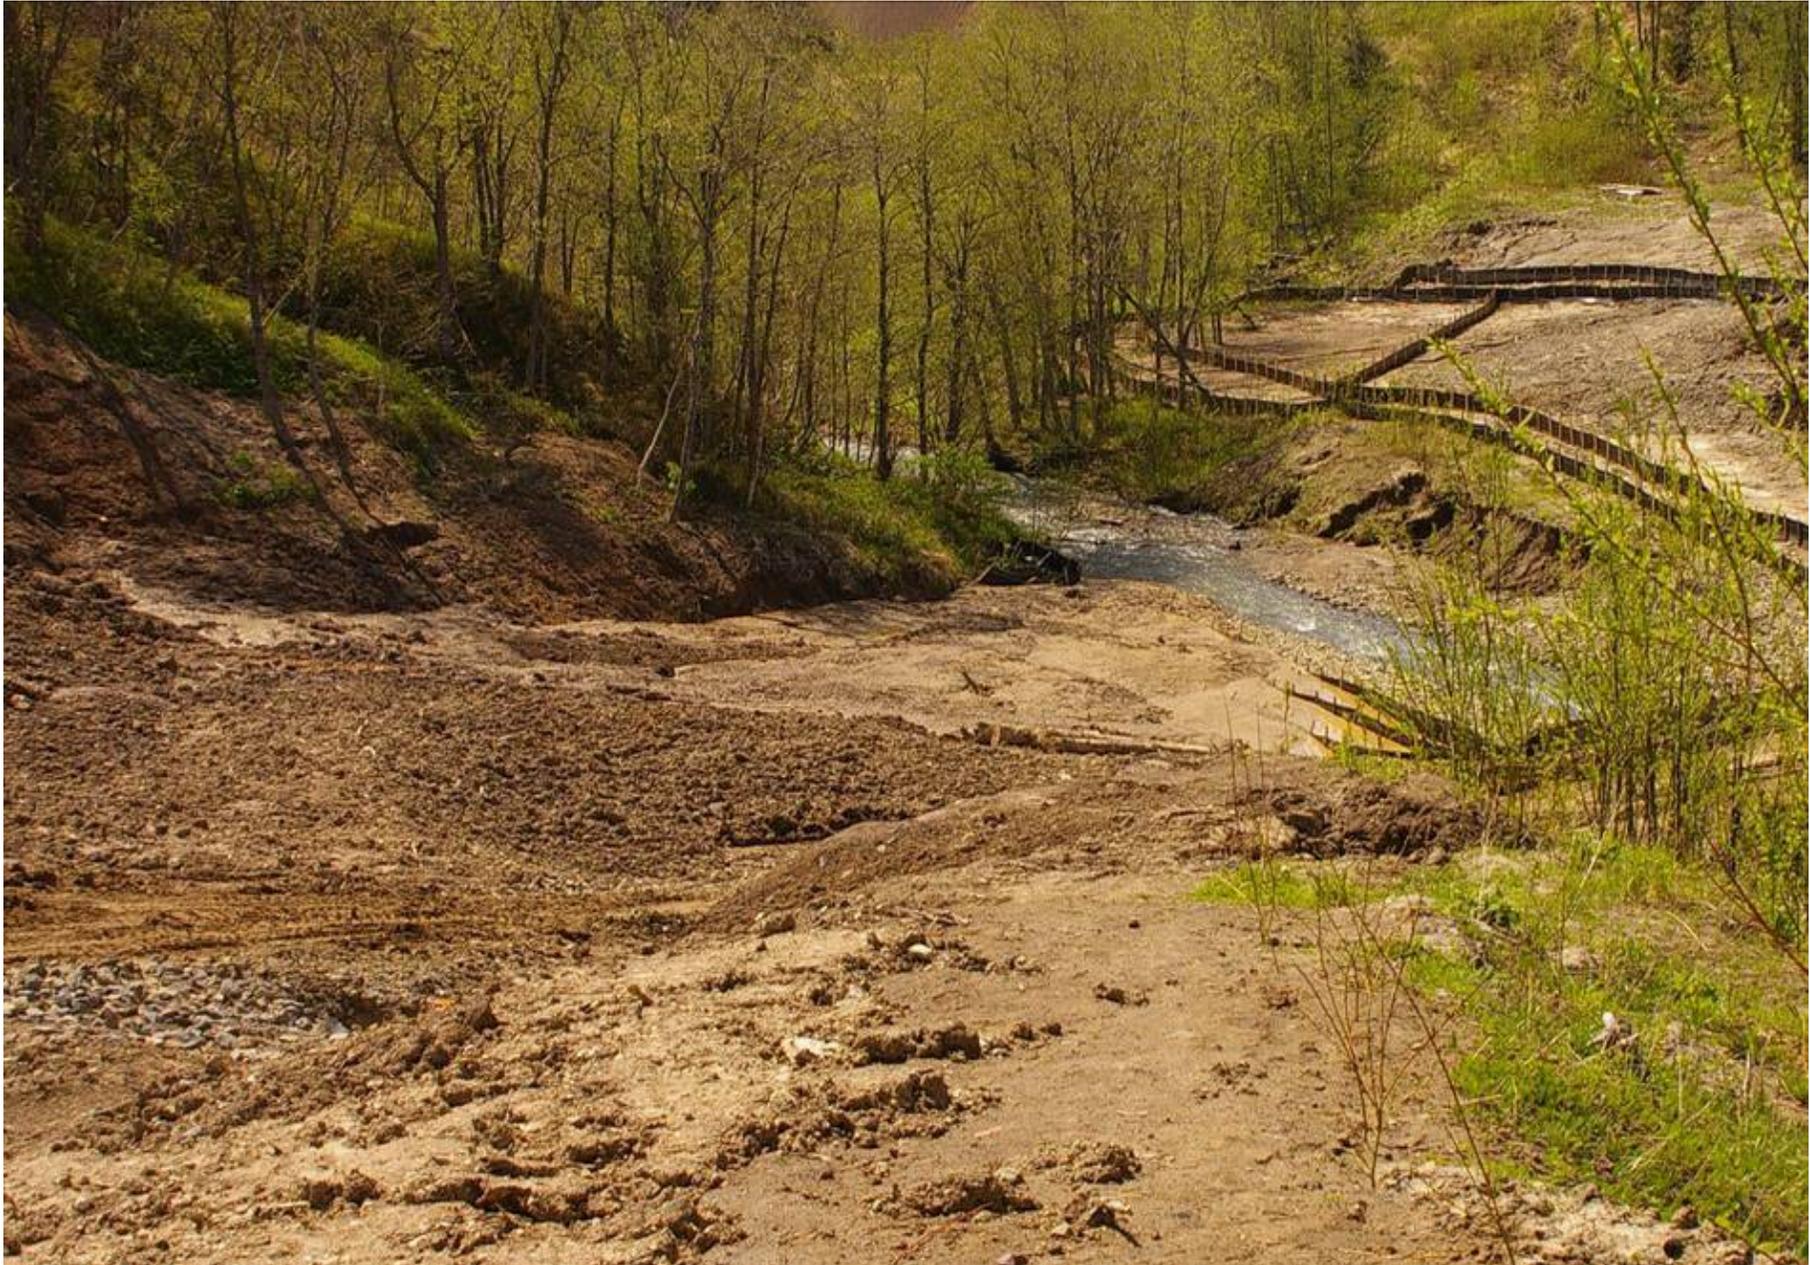
KP 348.7, Spread 3. Krinka River (left channel). Mud flows on the left bank are continuous because of ground water seepage on the upper slope. Recently installed silt fences sink into the water saturated ground at this location.

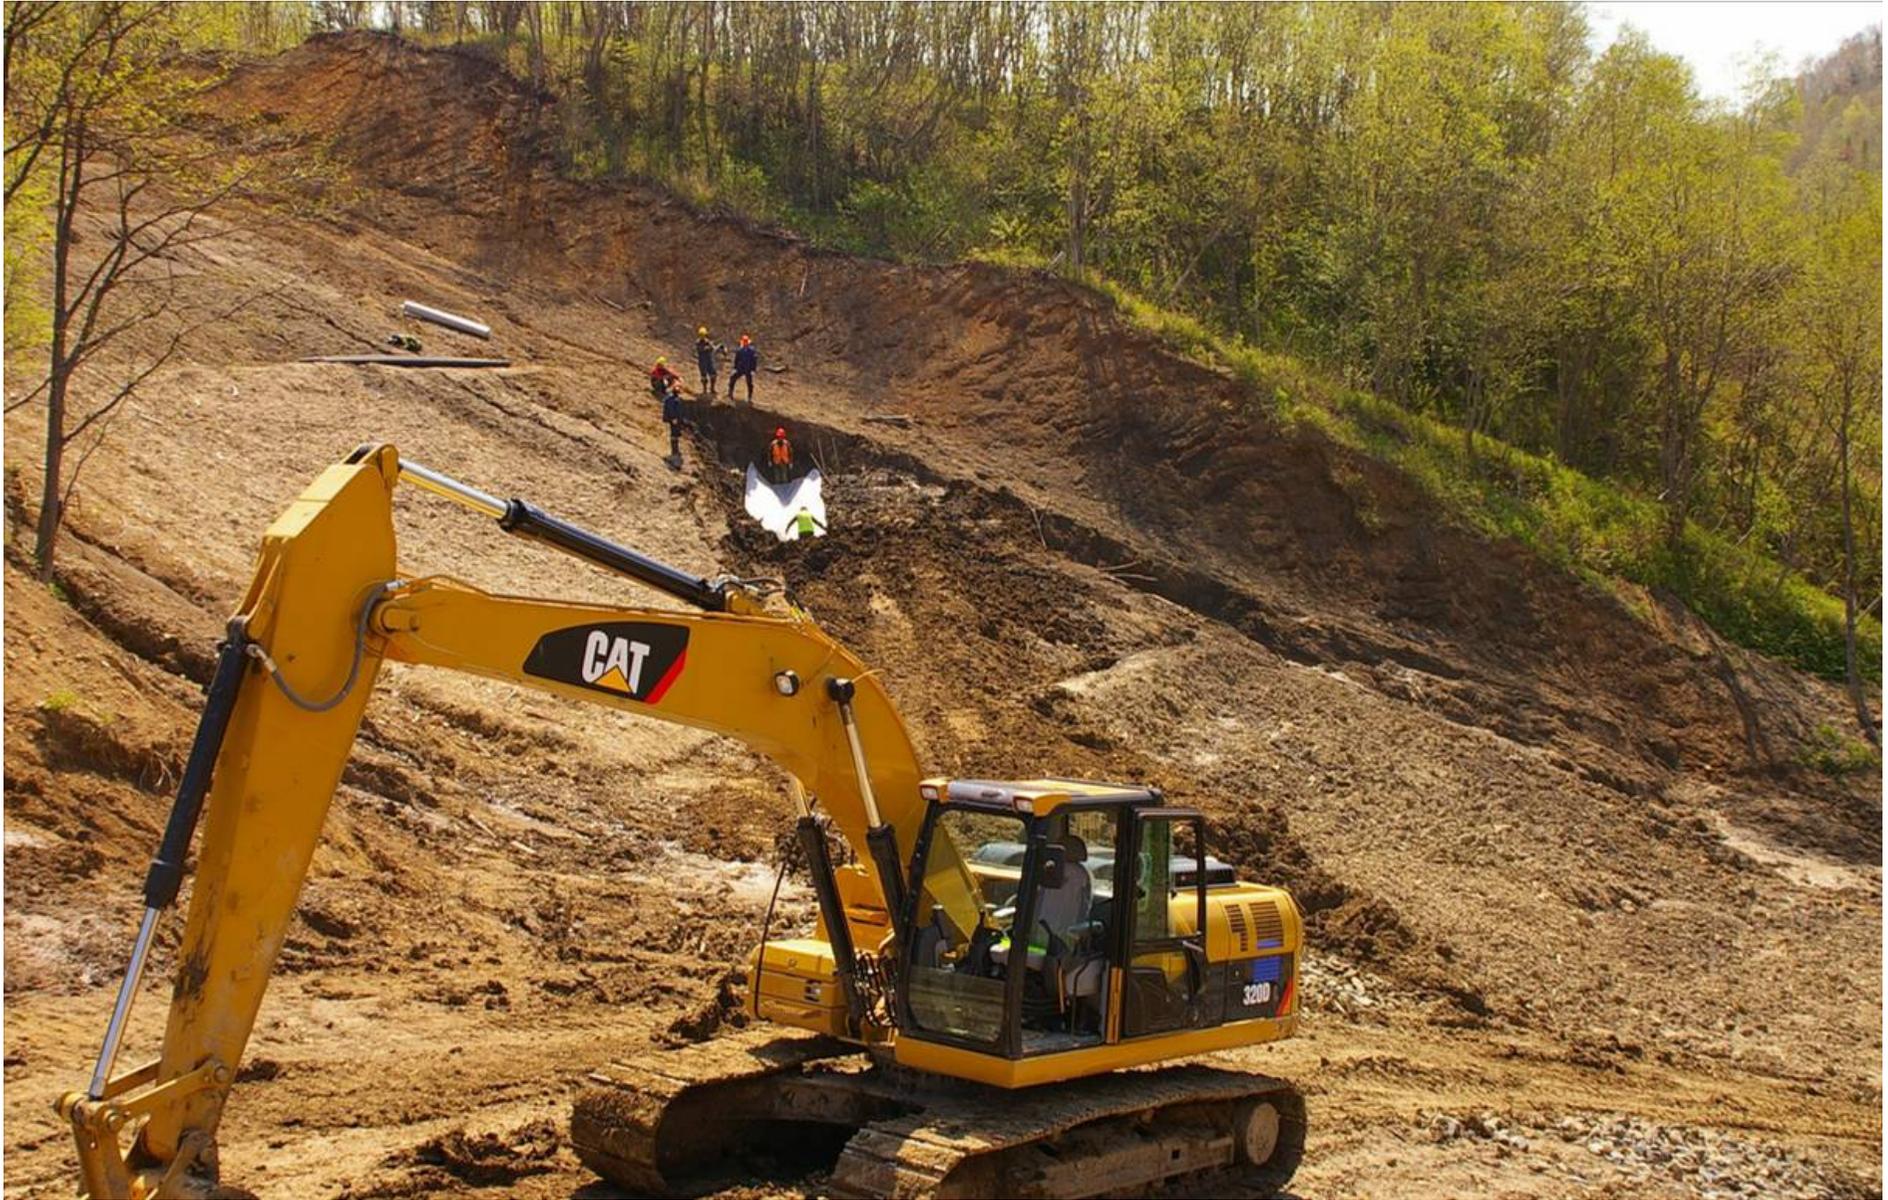
KP 348.7, Spread 3. Krinka River (left channel). A zone of ground water seepage on the slope. First attempt (after 4 years of continual construction at this location) to install some type drainage and to divert ground water flow across the slope.

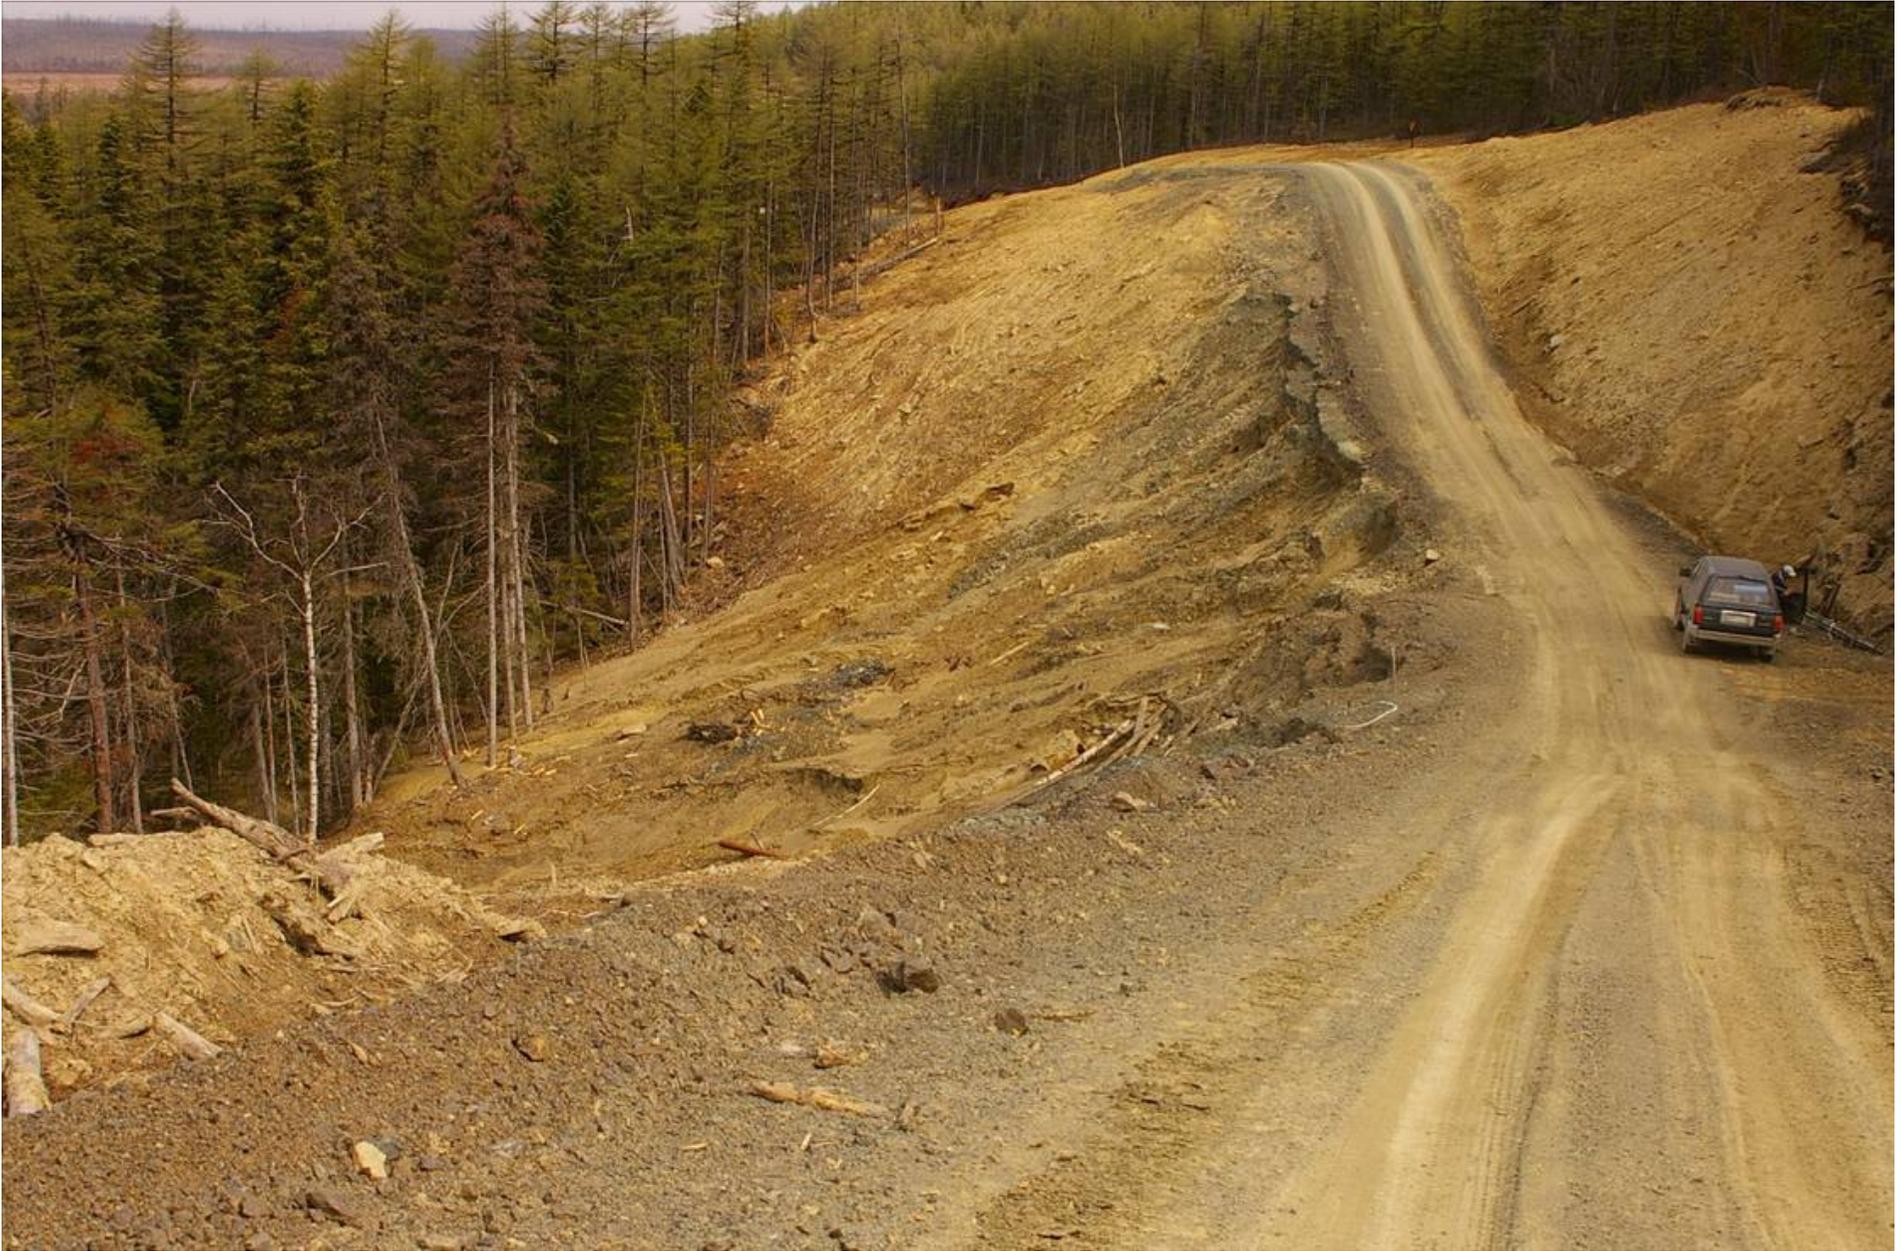
KP 102.0, Spread 1 (Nogliki District). Near a right tributary of the Bolshaya Veni River. General view of a mud flow area that is undermining a construction road corridor along the pipeline. No mud flow, land slides or erosion prevention measures have been taken.

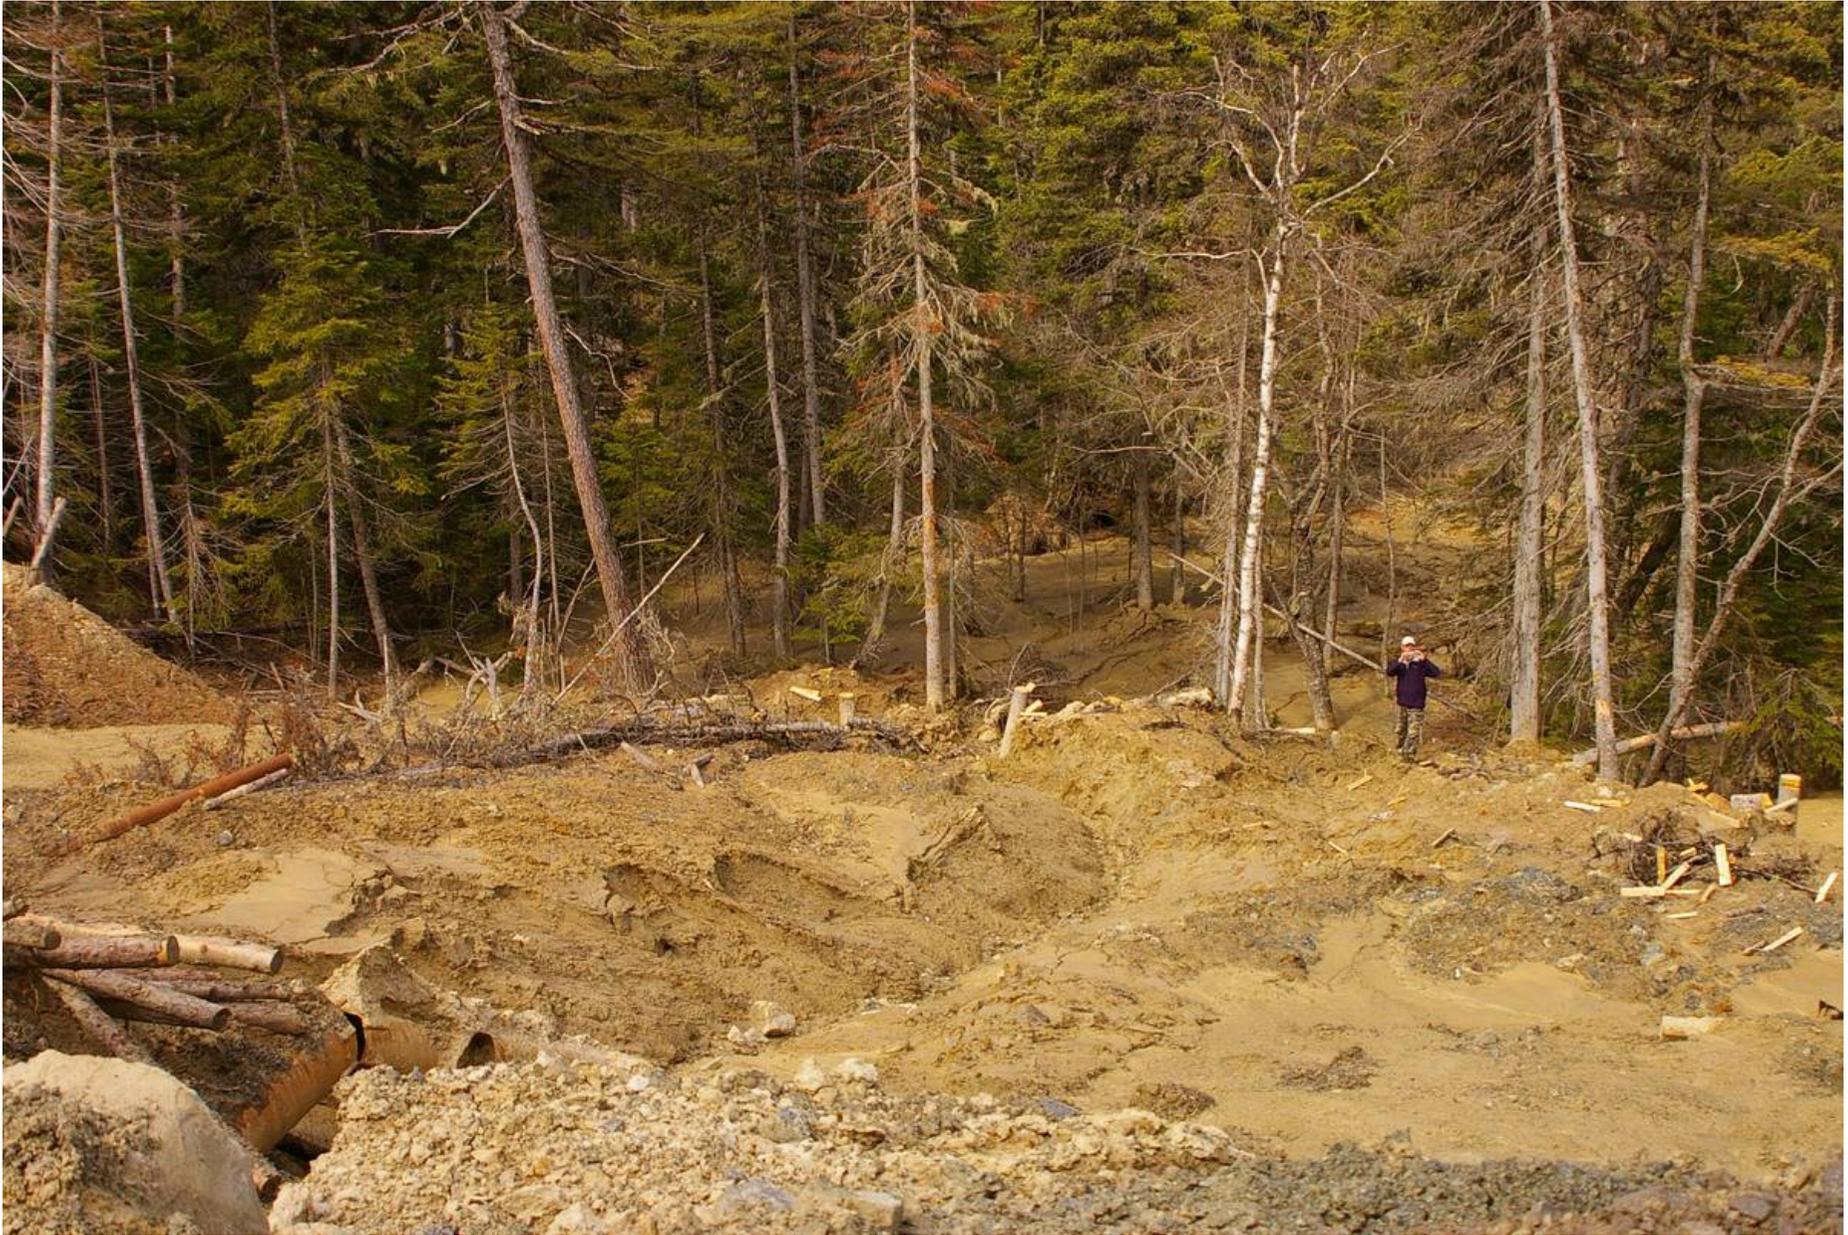
KP 102.0, Spread 1 (Nogliki District). Near a right tributary of the Bolshaya Veni River. Mud has entered the forest from the pipeline right of way.

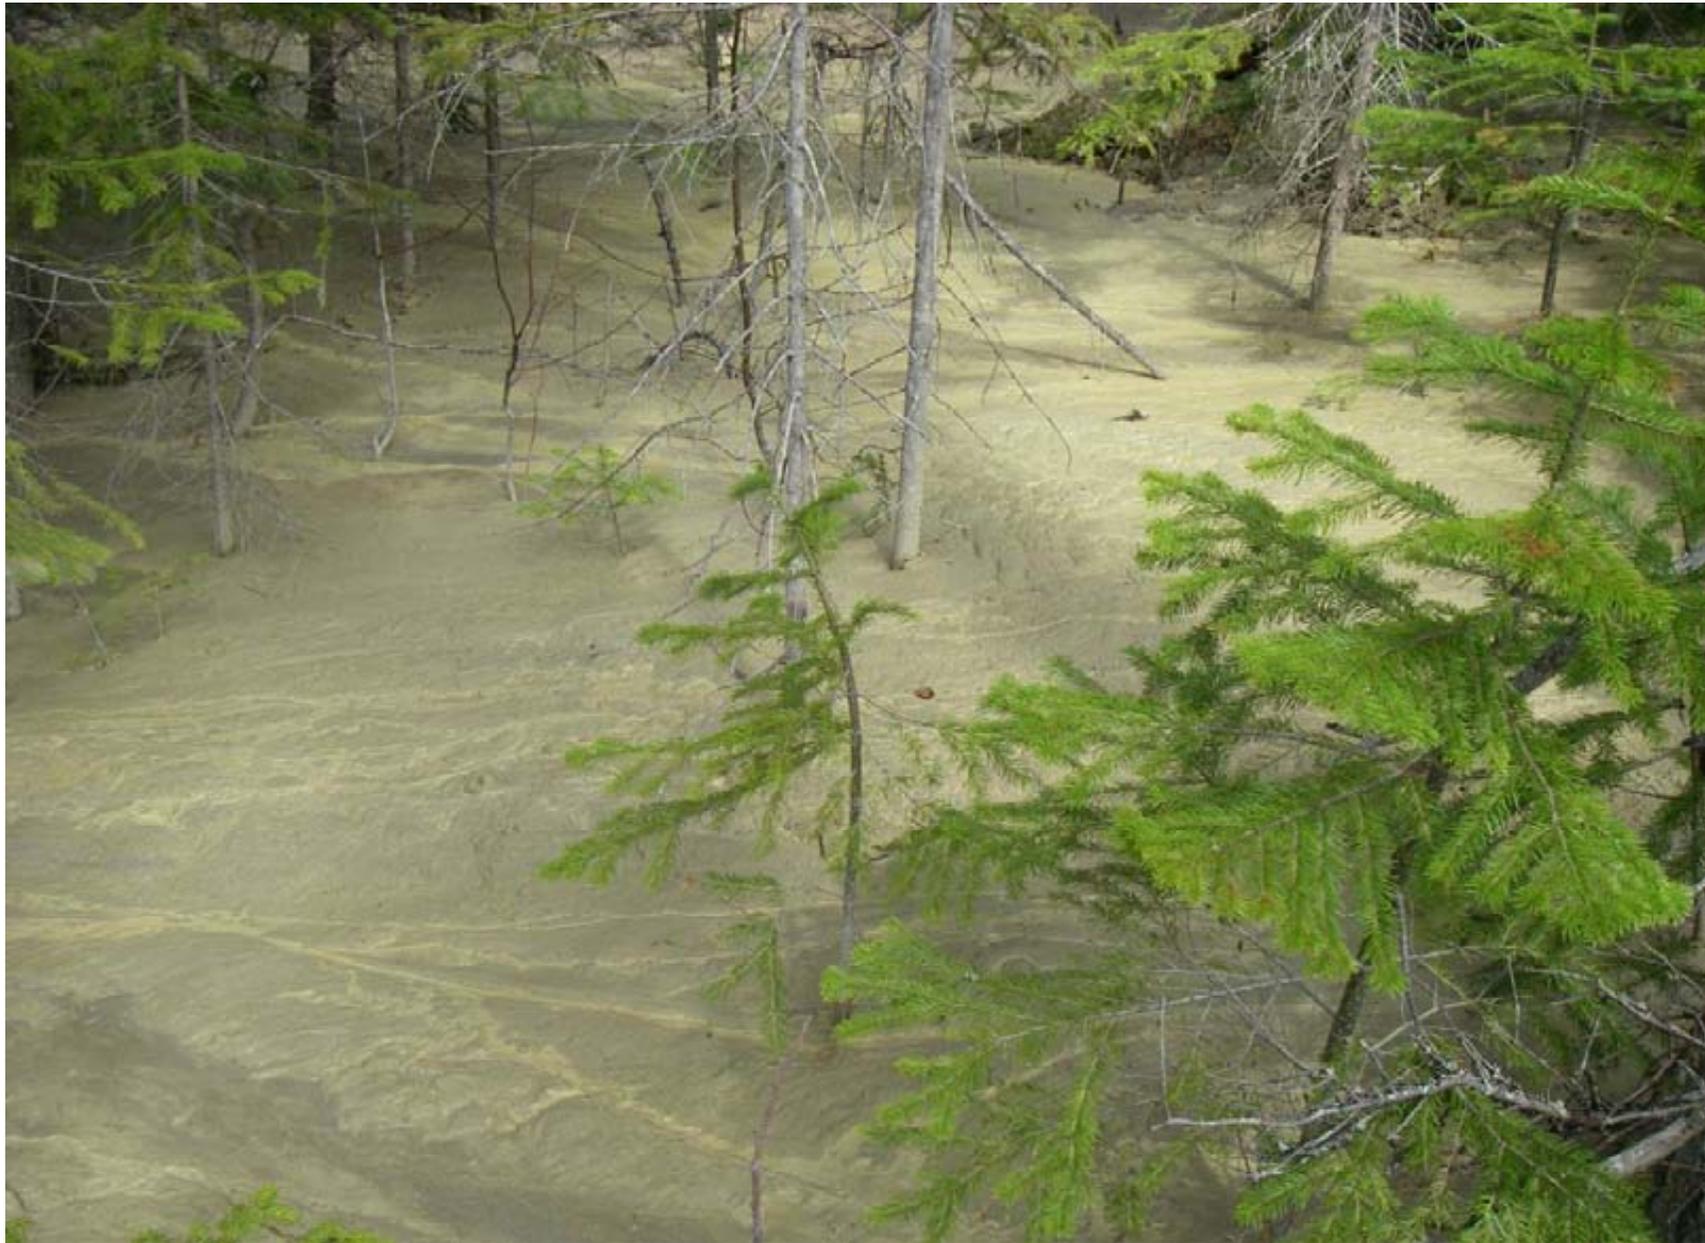
KP 102.0, Spread 1 (Nogliki District). Near a right tributary of the Bolshaya Veni River. The forest, approximately 50 meters to the side of the pipeline right of way, is flooded with mud.

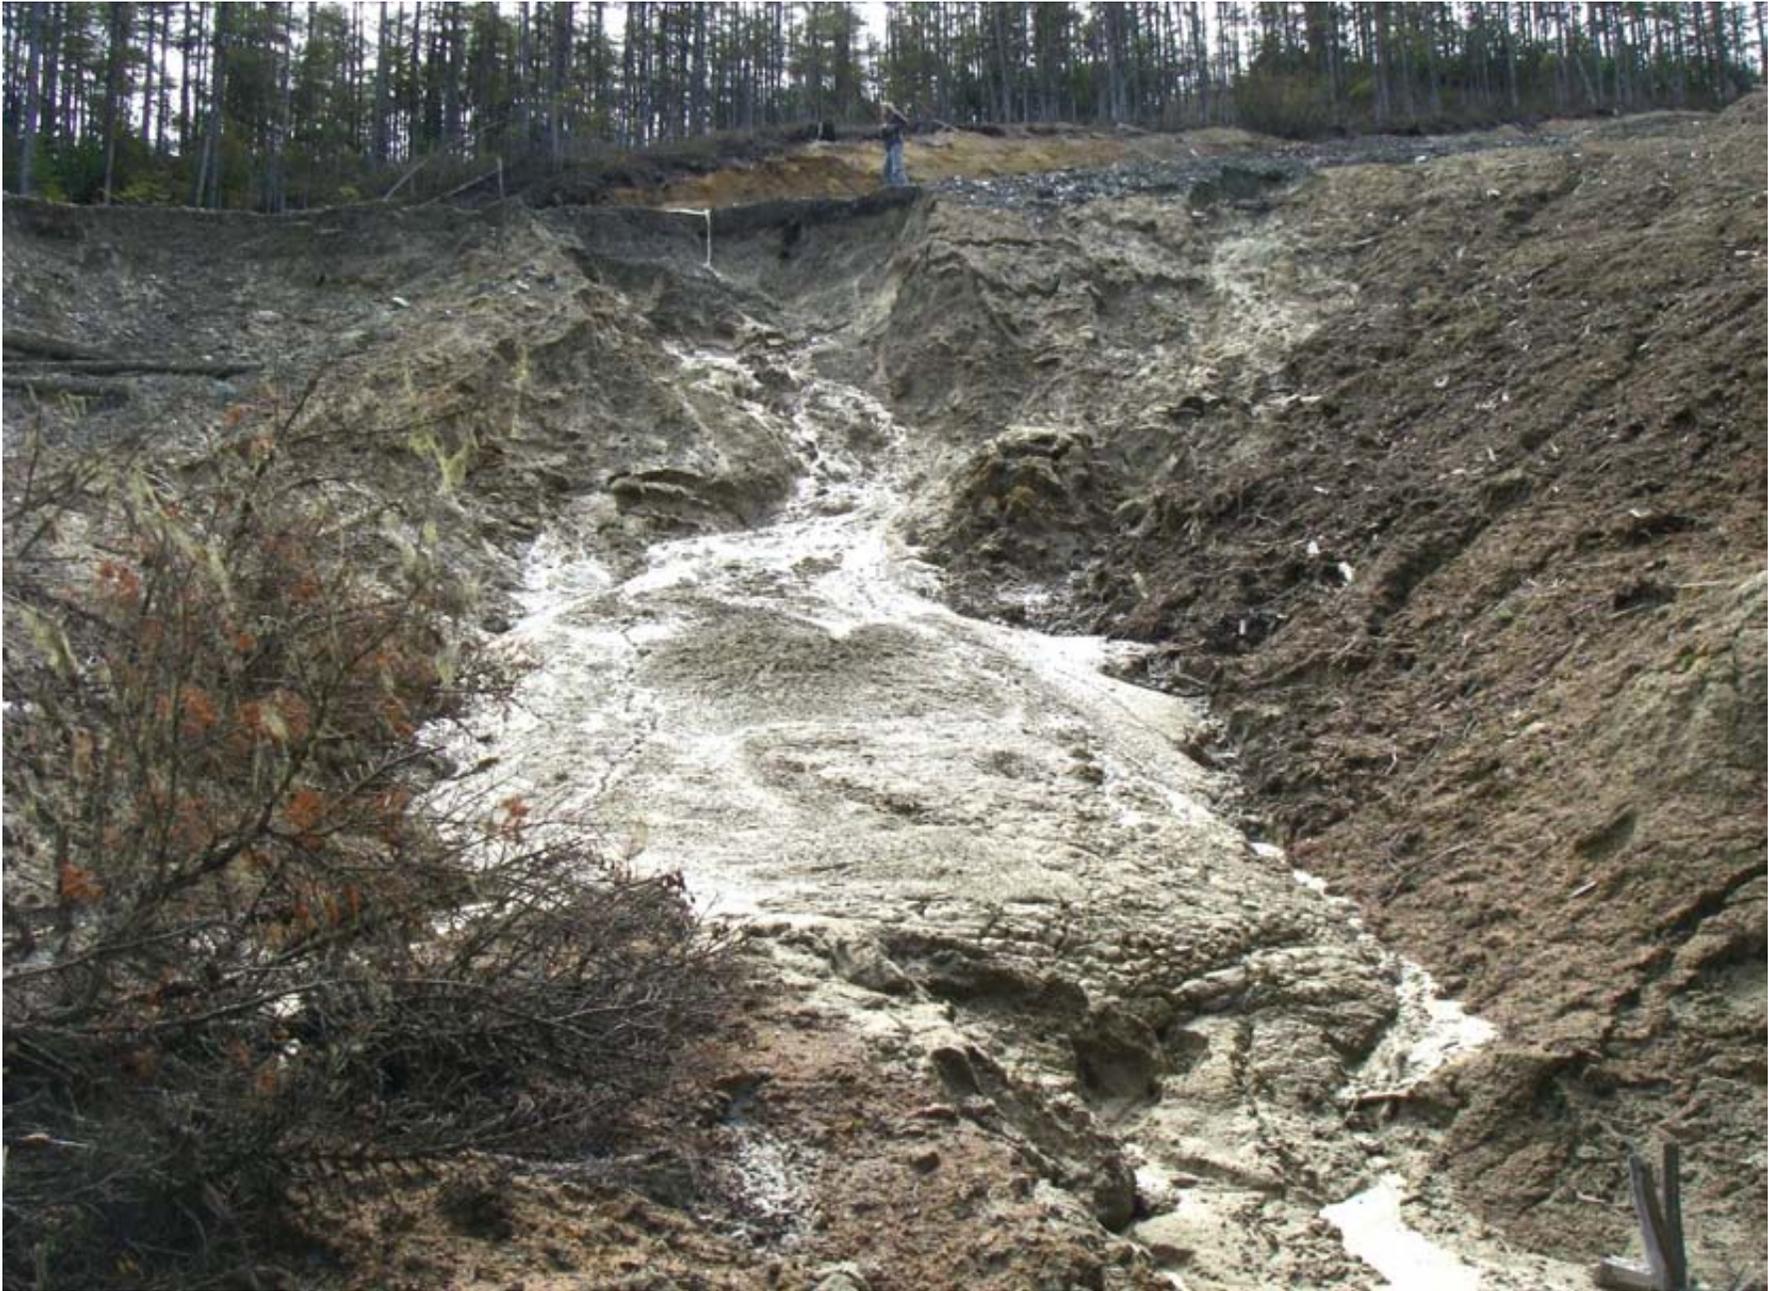
KP 102.0, Spread 1 (Nogliki District). Near a right tributary of the Bolshaya Veni River. Section of a massive mud flow viewed from the flooded forest.

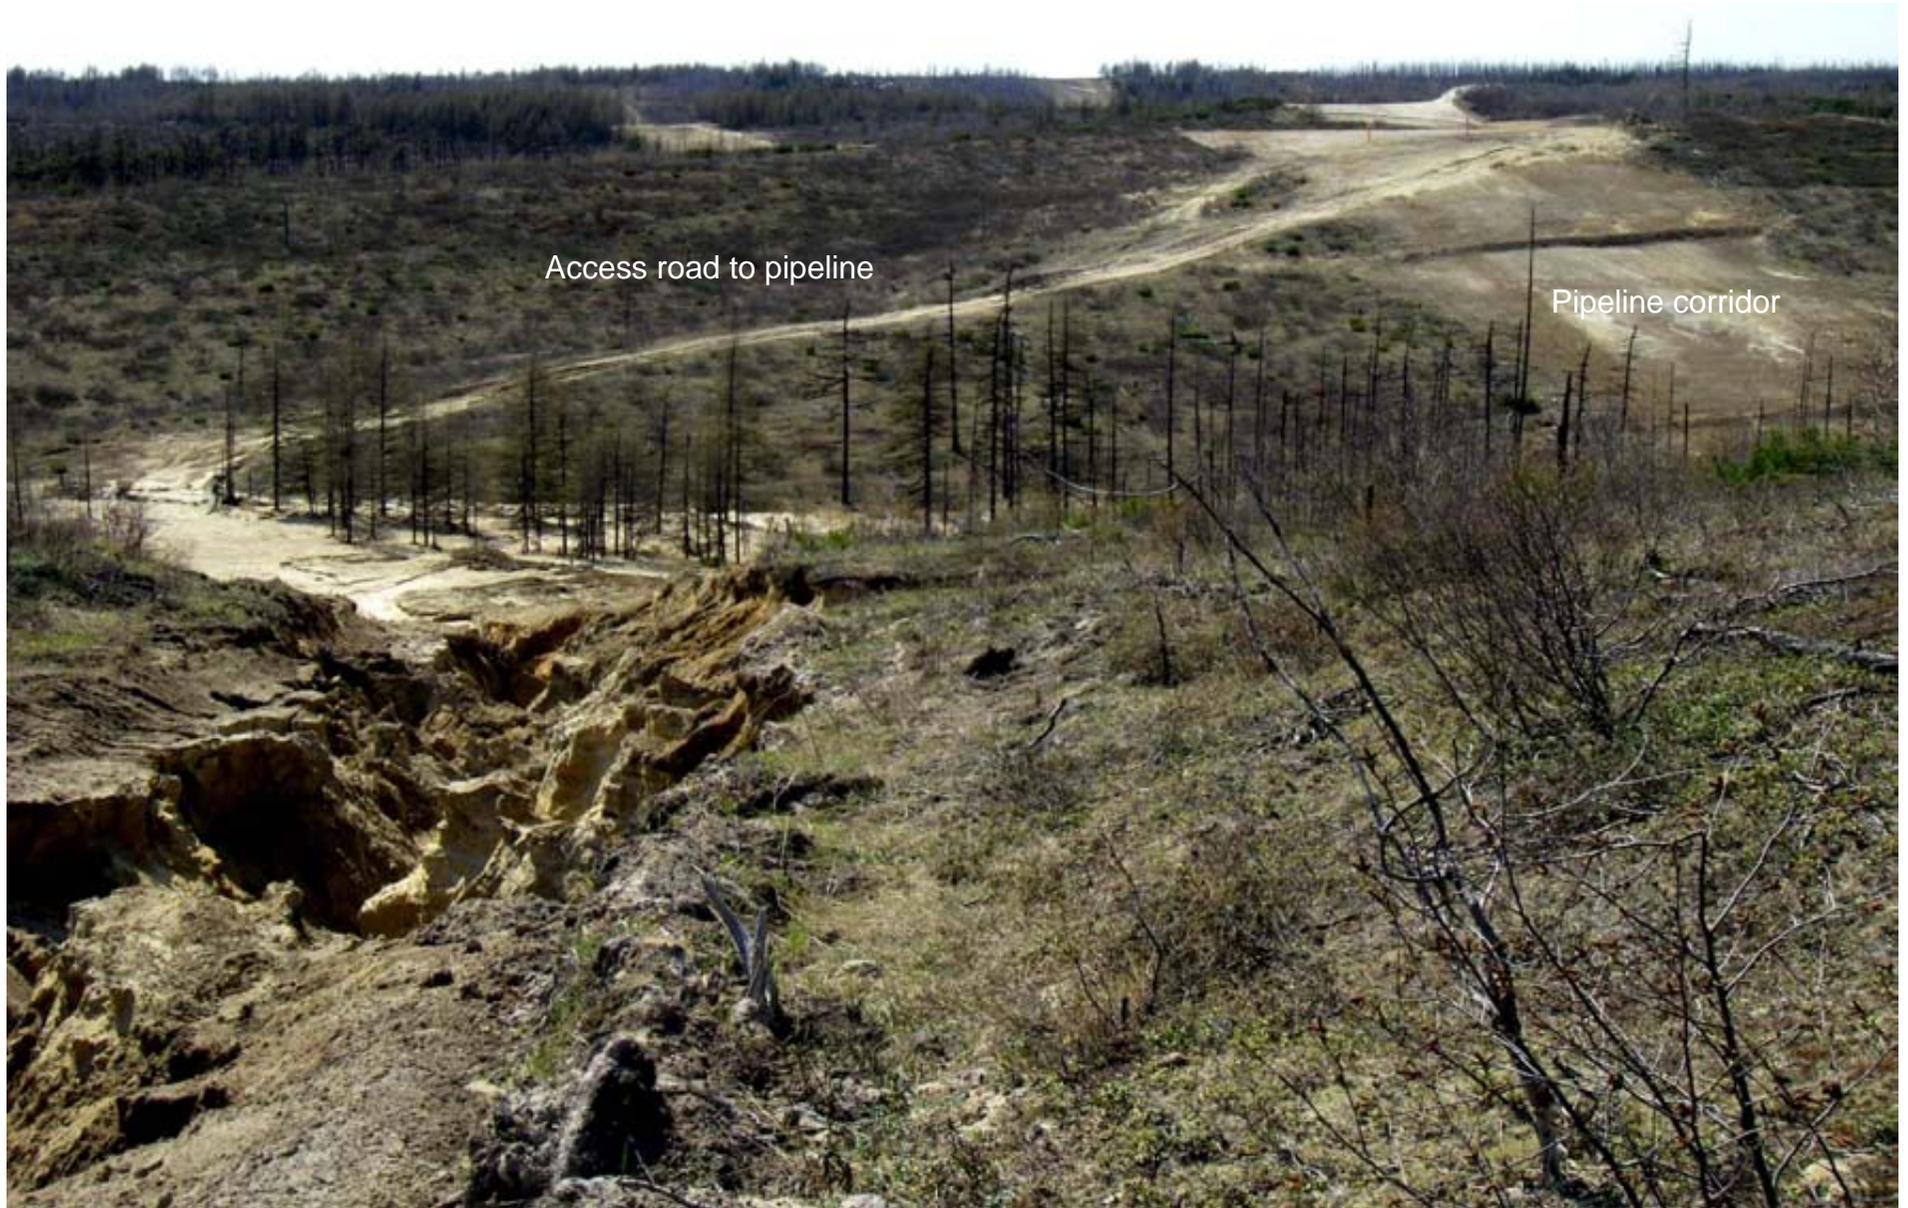
KP 17.0, Spread 1 (Nogliki District). Upstream of the Hoyambusibin River. General view of the pipeline right of way and of an abandoned access road. Deep, wide erosion canyon on the access road in the foreground.
