*Pacific Environment
Friends of the Earth Japan
Sakhalin Environment Watch*

Sakhalin II Project Oil and Gas Pipeline Project Dolinsky, Makarovsky and Nogliksky Districts of Sakhalin Region Photo Report from a Fact-Finding Mission May 30 – June 1, 2008

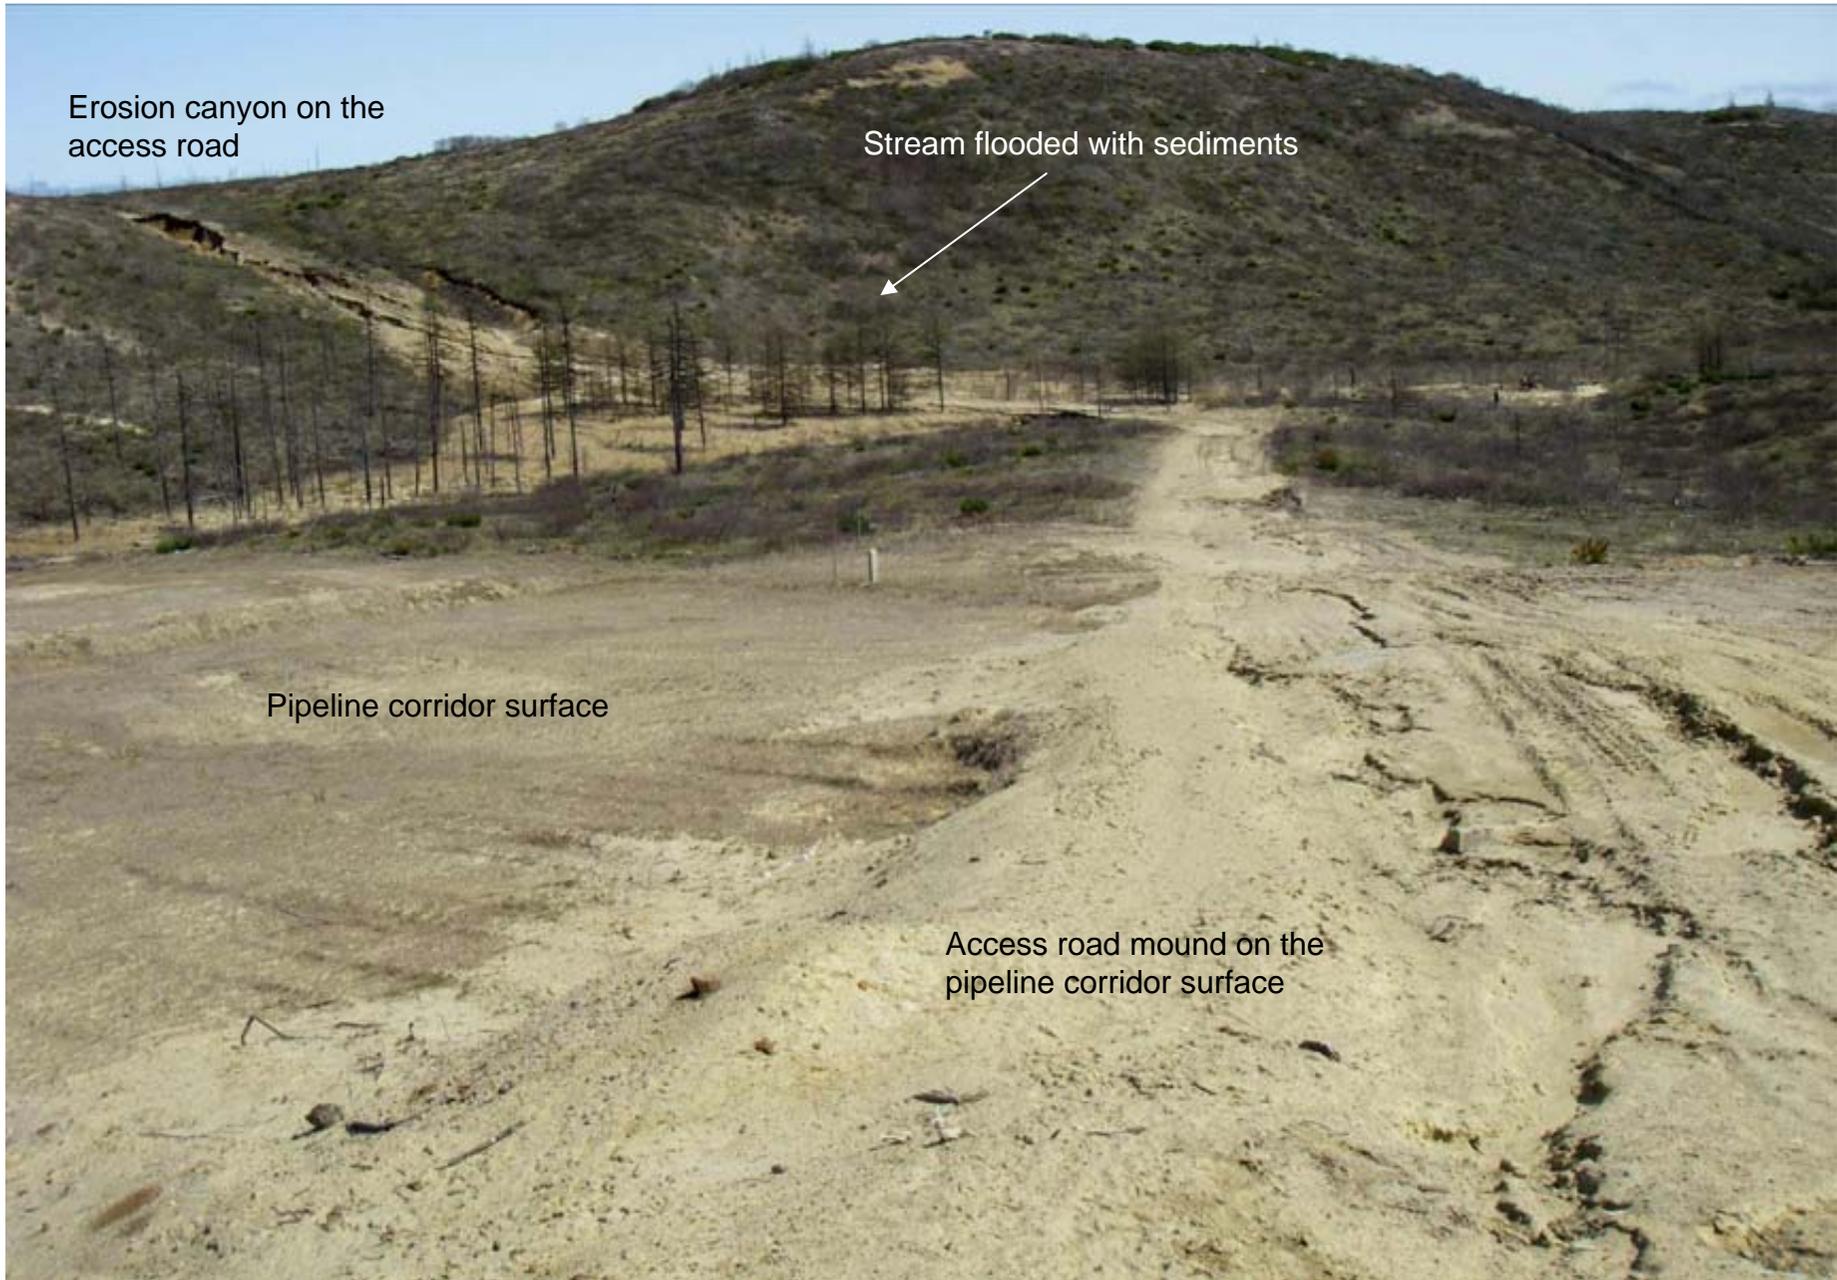
KP 17.0, Spread 1 (Nogliki District). Upstream of the Hoyambusibin River. General view of the pipeline section and abandoned access road from the opposite side of the pipeline right of way. The road mound was built after the pipeline was already in place.

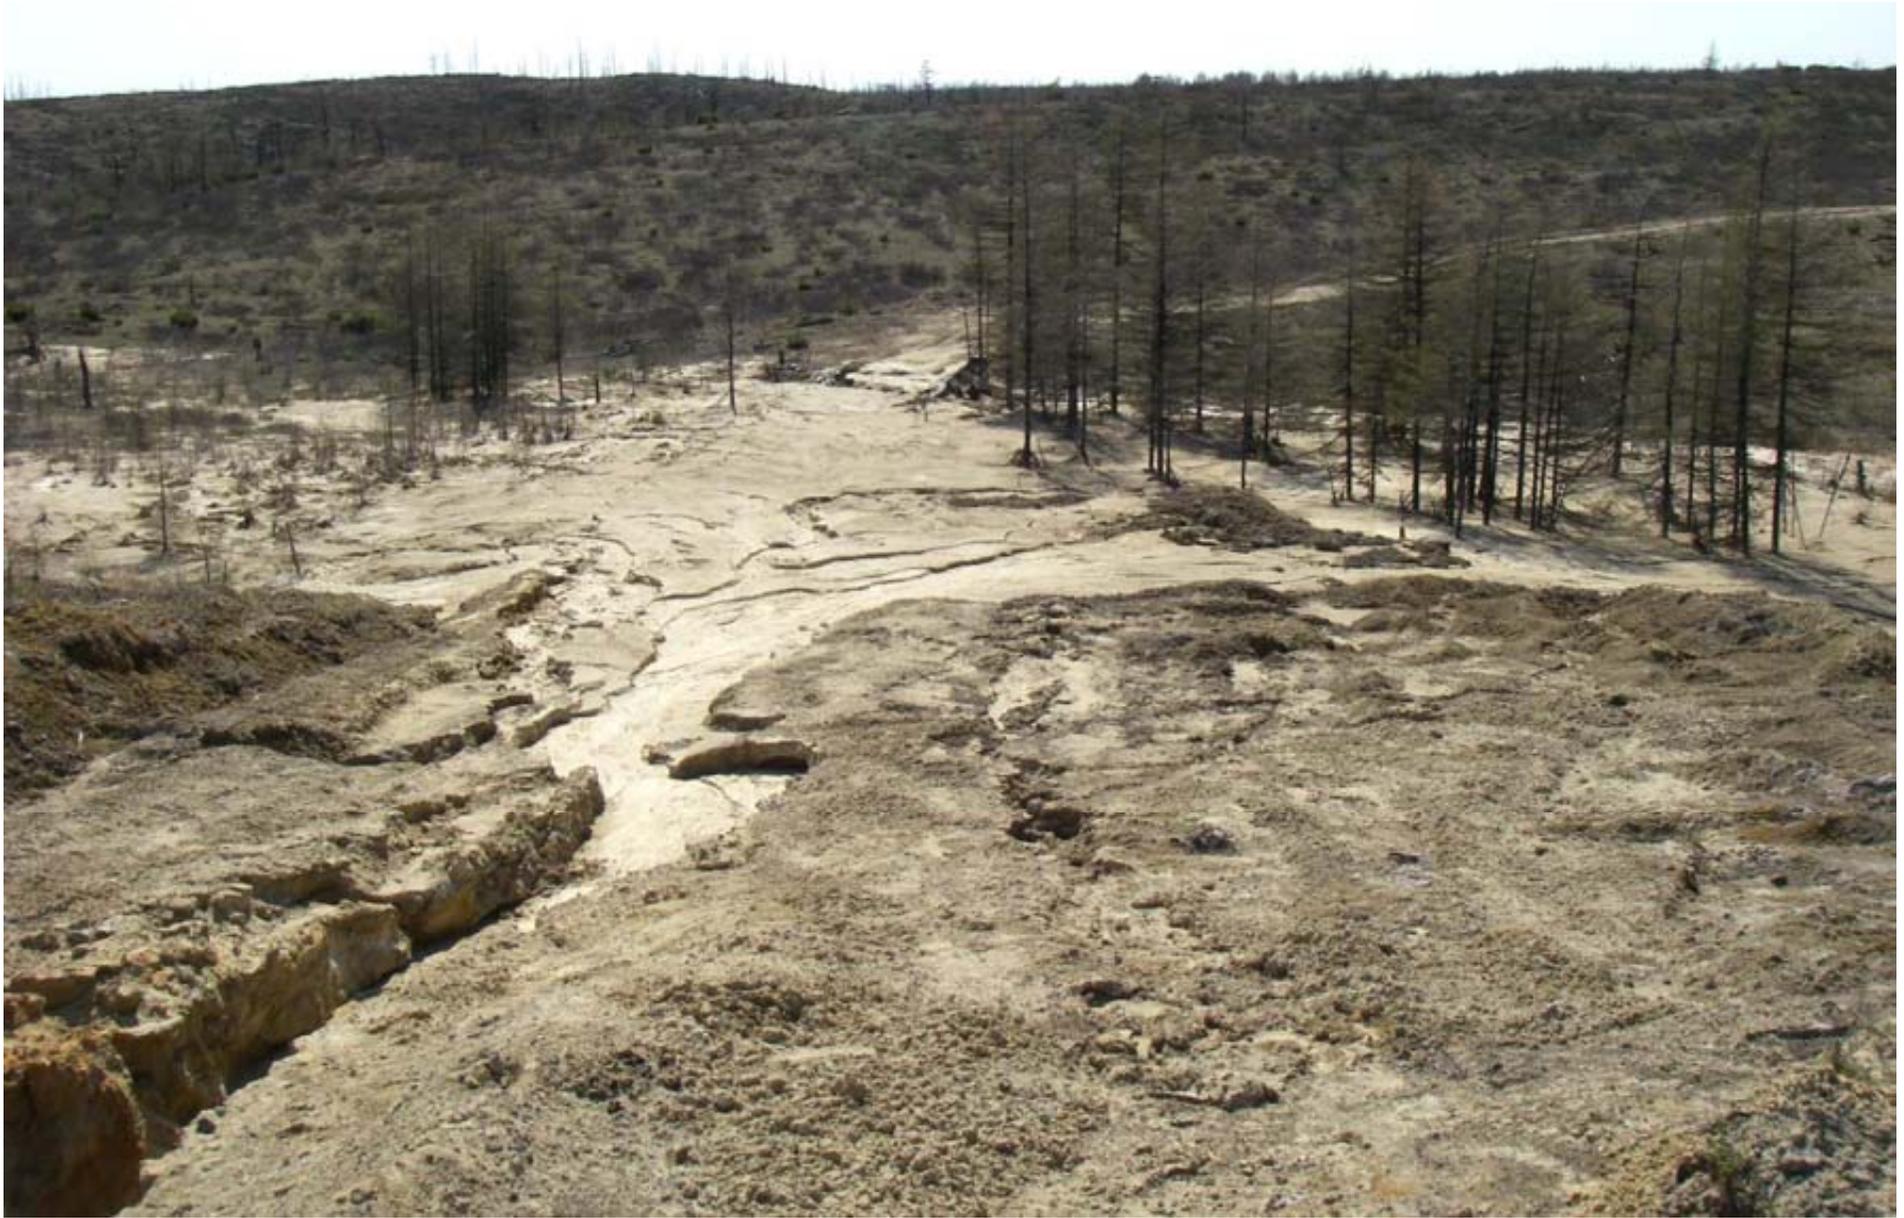
KP 17.0, Spread 1 (Nogliki District). Upstream of the Hoyambusibin River. General view of the stream flooded with sediments that have washed down from an eroded access road.

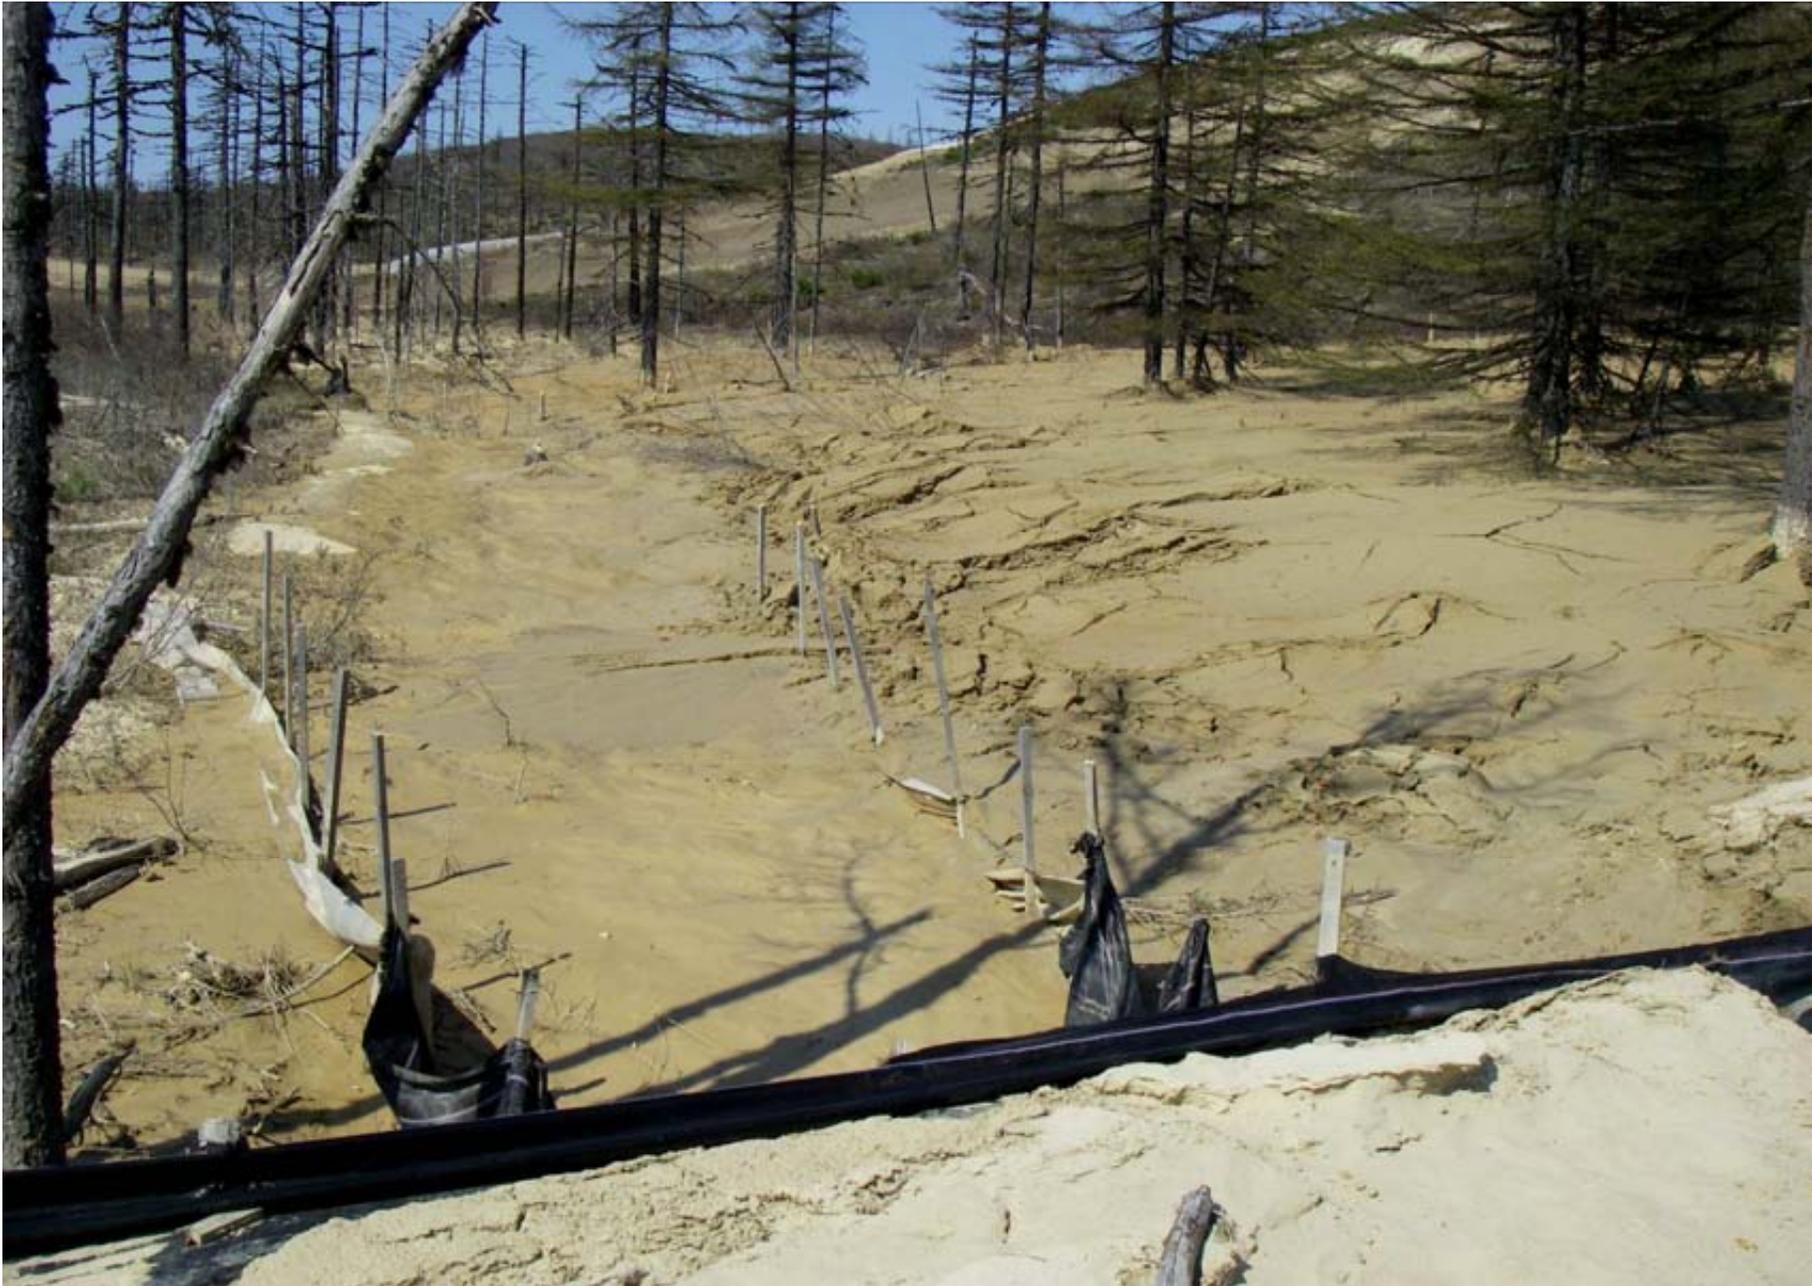
KP 17.0, Spread 1 (Nogliki District). Upstream of the Hoyambusibin River. The stream is completely flooded with sediments that have washed down from an eroded access road. Ineffective silt fences are seen in the foreground.

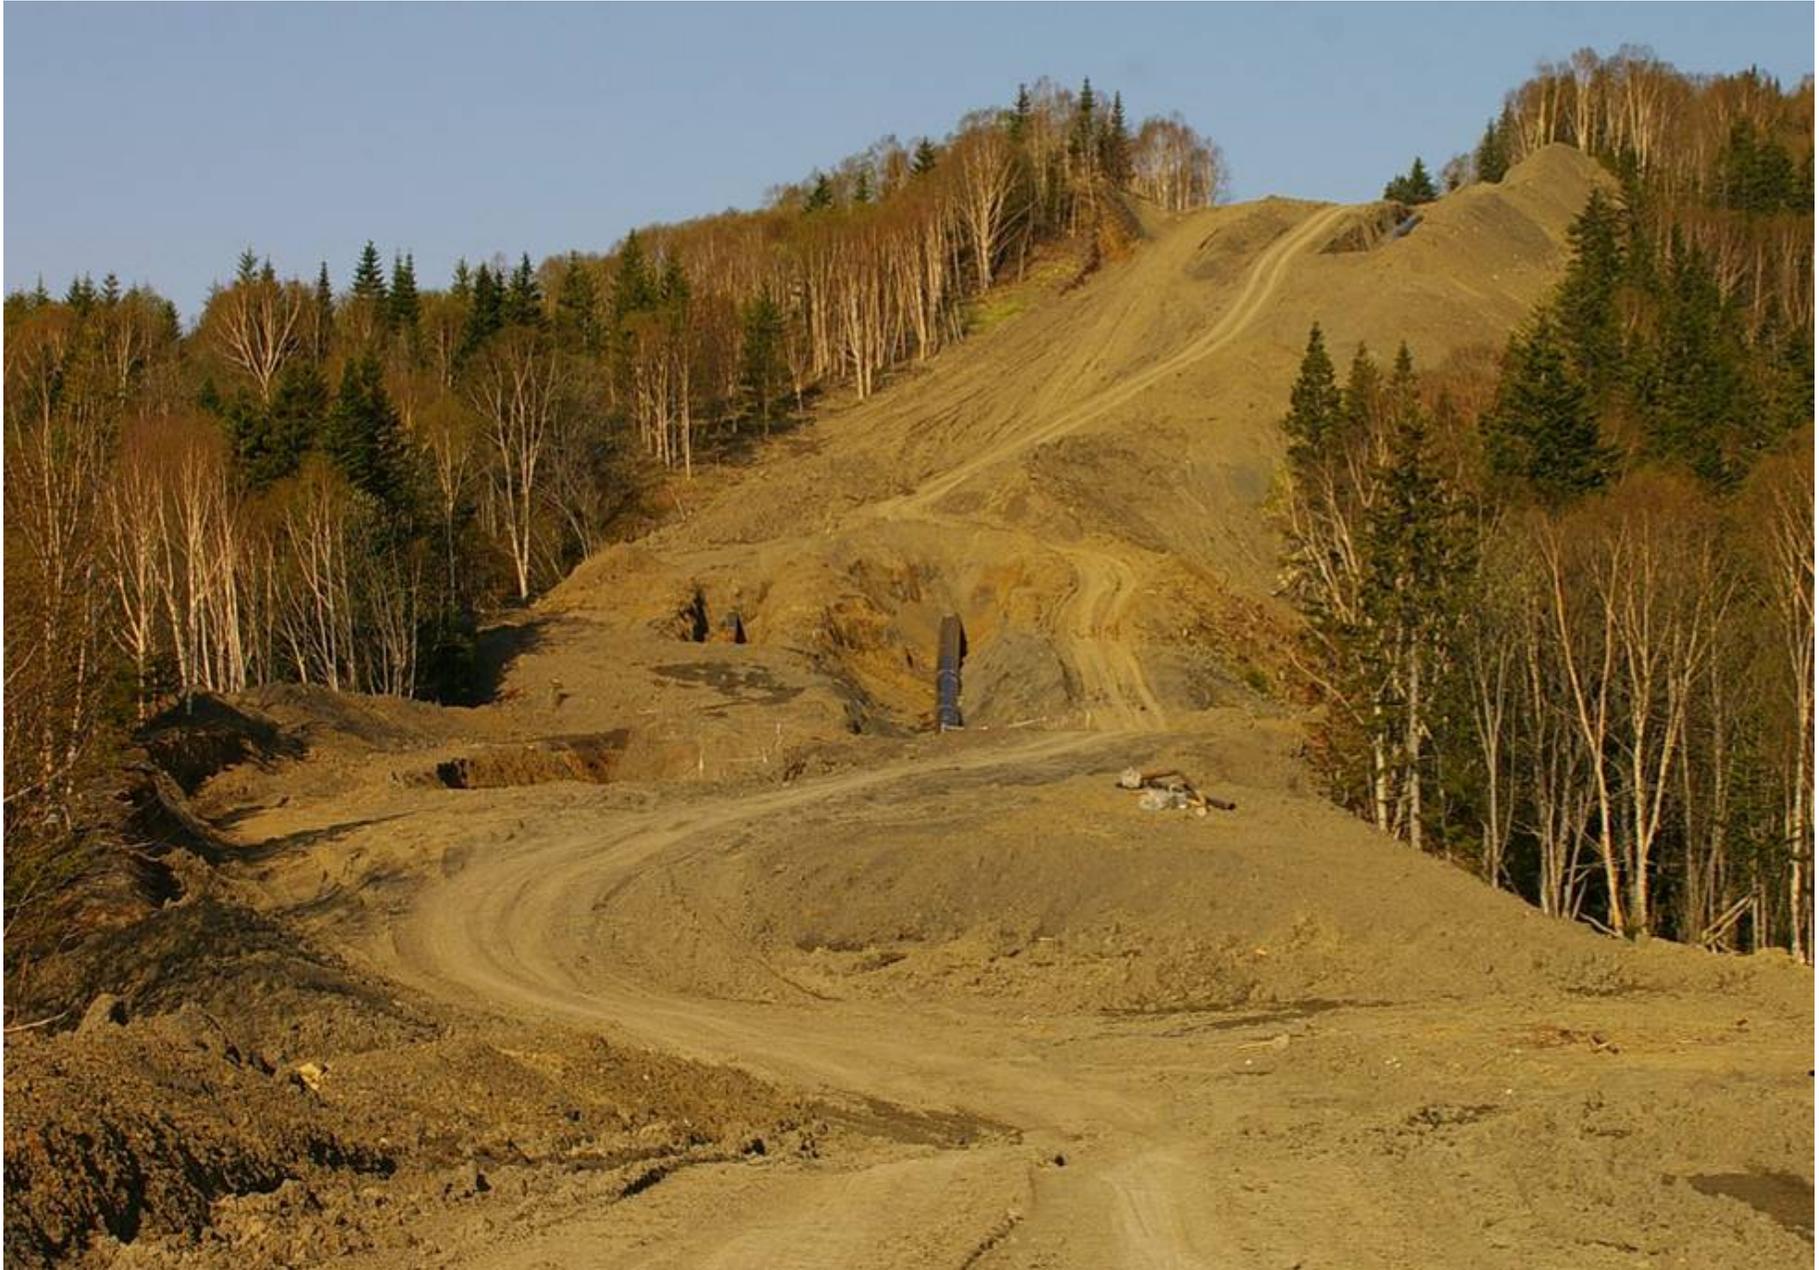
KP 360.3, Spread 3. Sosnovka River watershed. Four sections of pipeline recently excavated after testing showed various problems.

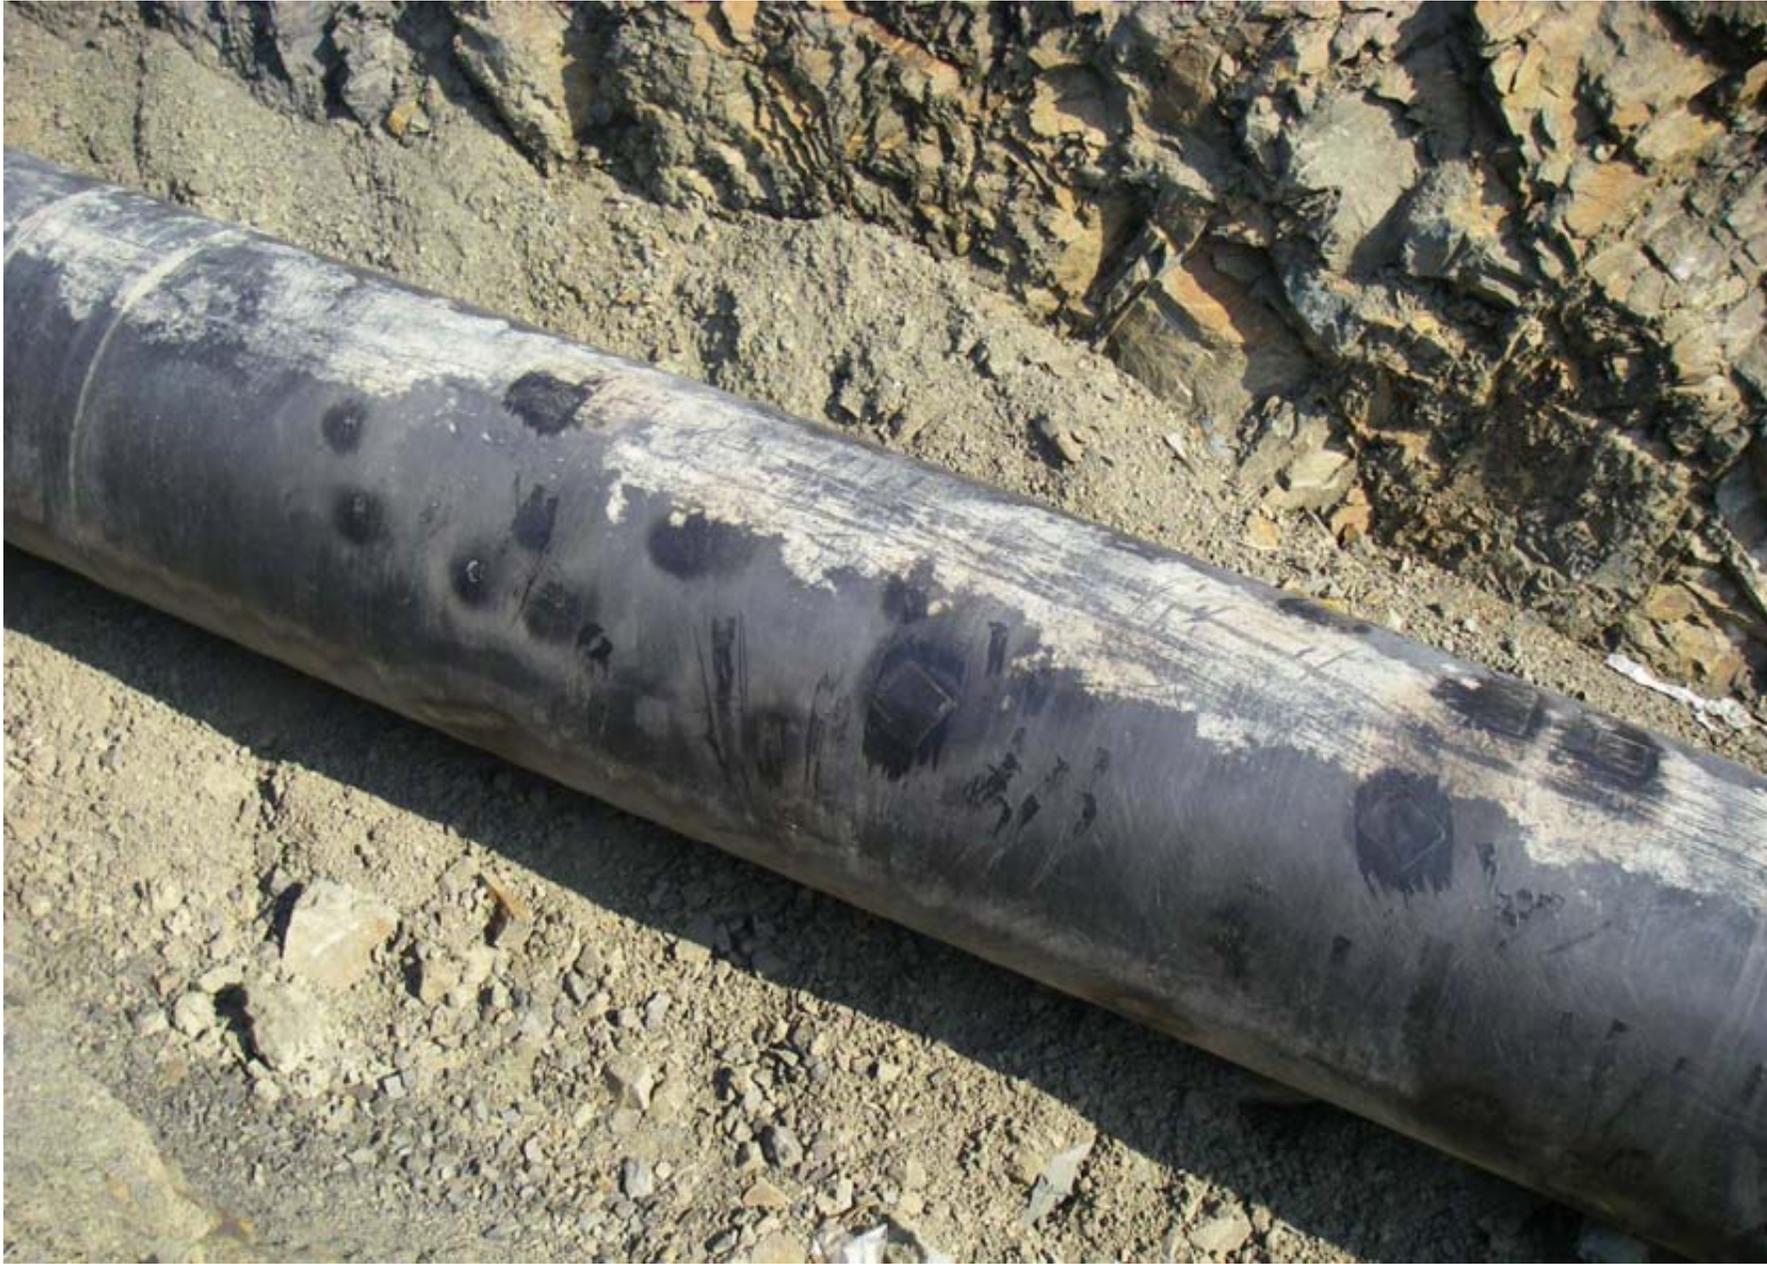
KP 360.3, Spread 3. Sosnovka River watershed. Typical example. This section was placed in the trench and buried, but then dug up because of surface deformations discovered during testing; the cause of the problem are large, sharp stones.
