## PHOTO REPORT

**Small hydropower plant ref. no. 45 – Krapska reka,  
Makedonski brod municipality, Macedonia**

**April 2019**

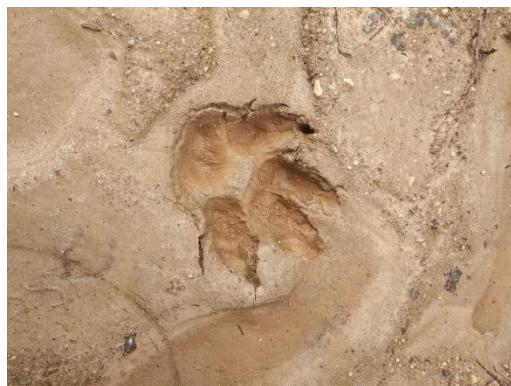
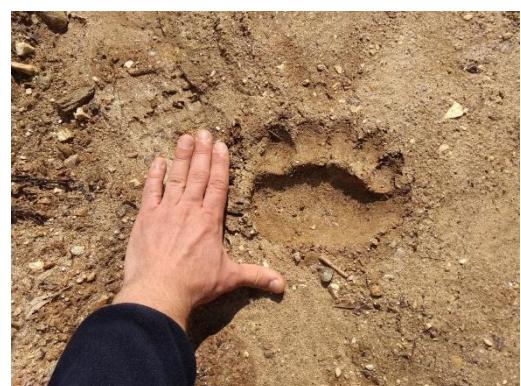
As a result of our investigation and consultations with experts we claimed that “the southern slopes of the Jakupica mountain range where Krapa is located are the only remaining migratory route for large mammals [lynx, bears, wolves] from NP Mavrovo and the surrounding protected areas to Jakupica and back”. Visiting the location in mid-Spring puts this into perspective - all along the access road there were tracks of mammals: bears, wolves, foxes, boars, to name a few.

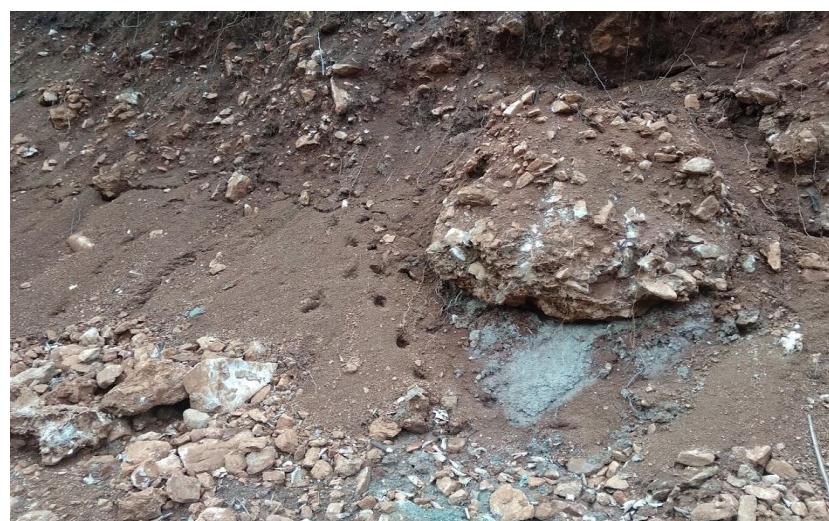
It was really sad to see how some of the smaller ones were obviously struggling to move from the forest to the river and back on the eroded sides of the access road.

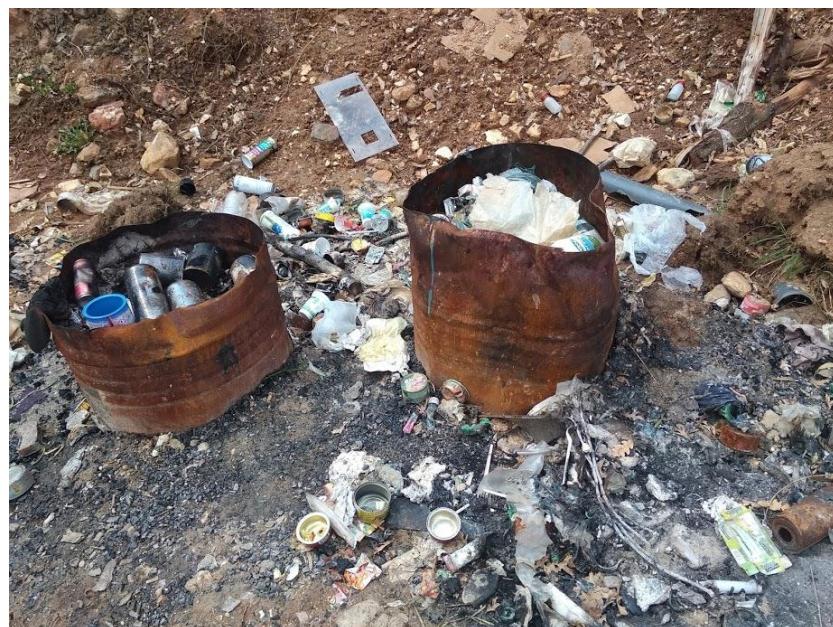
At the very entrance to the location of the power plant, a dozen meters from the powerhouse, there was a pile of burned waste which indicates further violation of the waste management practices that are outlined in the environmental study. The workers should have been trained in proper waste disposal procedures that would mitigate soil and air pollution. Additionally, open fires in forested areas are strictly forbidden by national legislation.

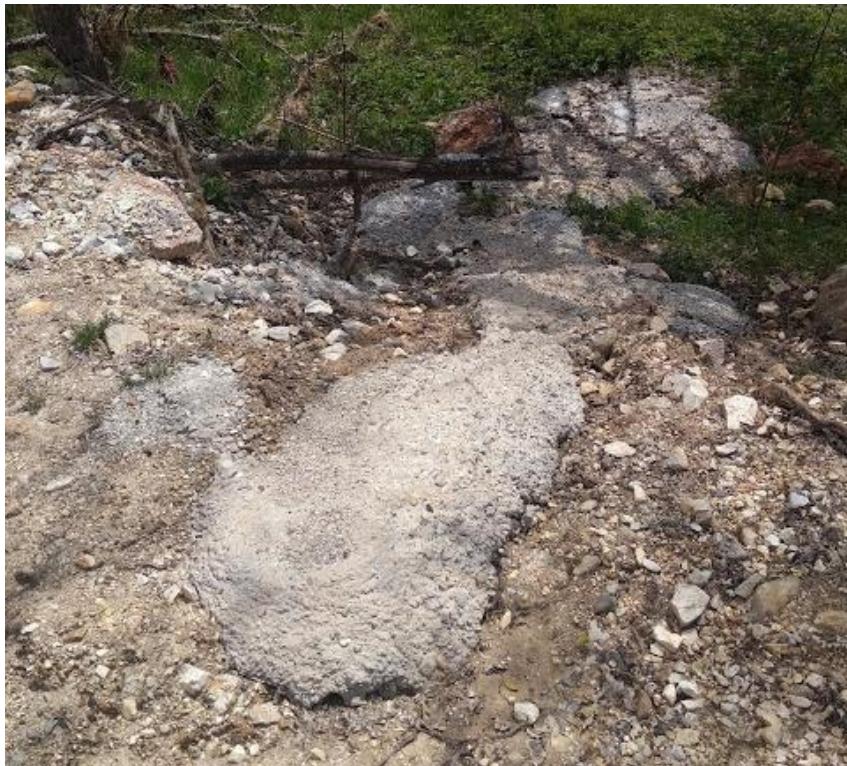
Cement spills on the side of the access road contribute to additional pollution of the area and unnecessary destruction of habitats.

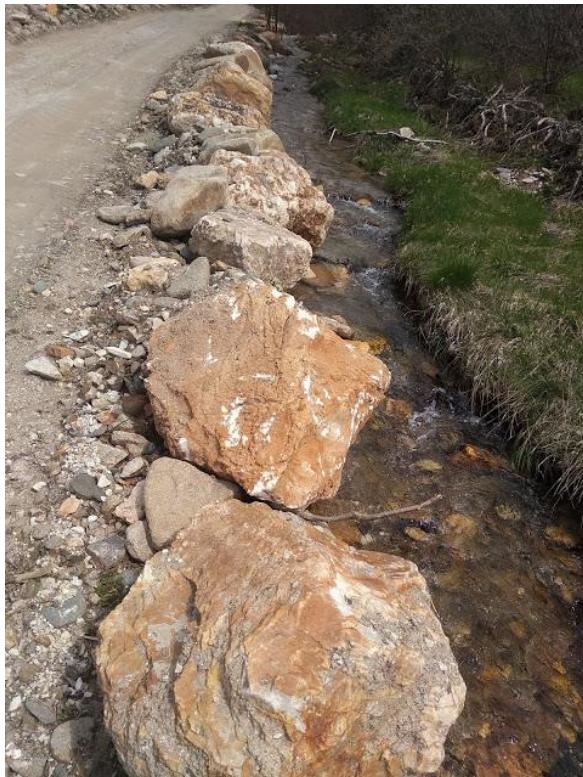
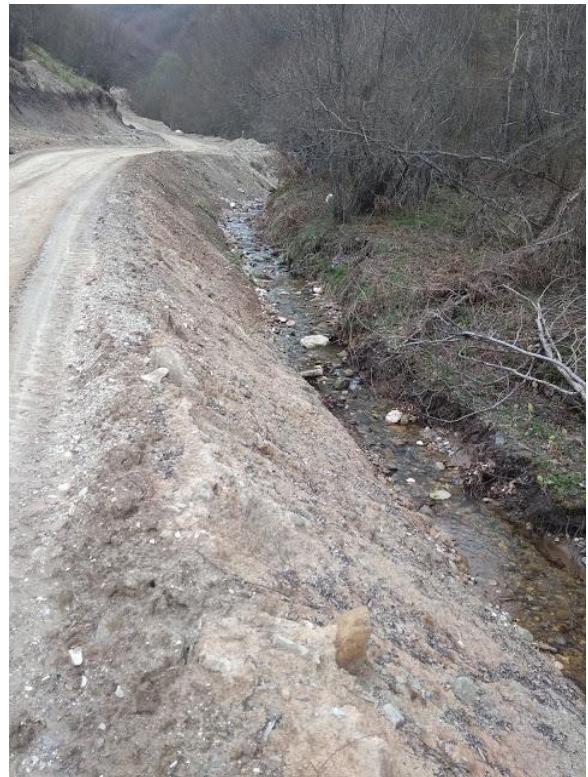
One side of the river bank is completely covered by excess material pushed during the digging of the access road. The river bed is narrowed by this material and access to the river is blocked for amphibians, contrary to the biodiversity study where safety road crossing structures in the form of tunnels are recommended.

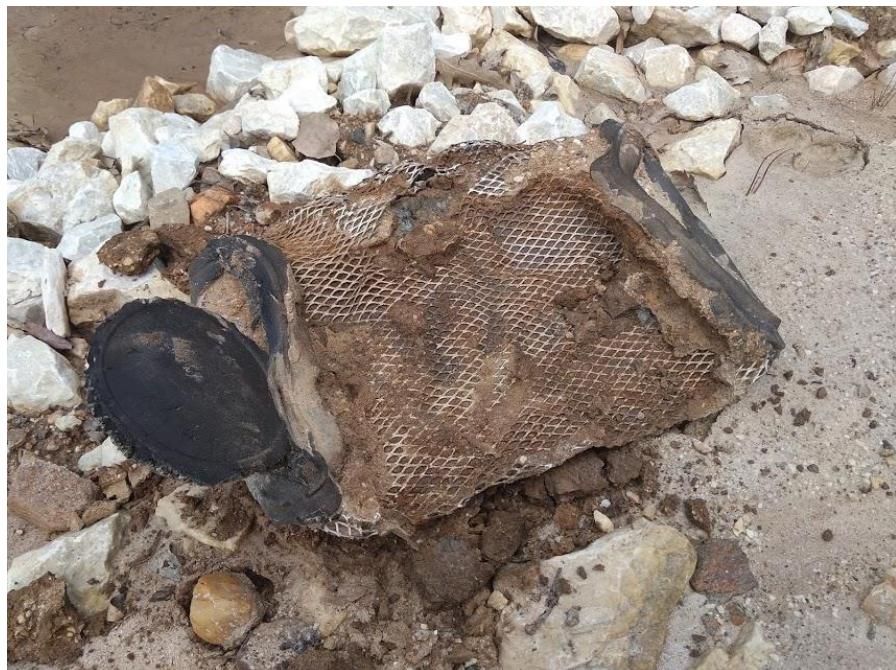
Leftover waste from maintenance works on the construction machinery can be found

along the access road. This specific filter pictured here, aside from the obvious solid waste pollution, contributes to chemical pollution of the soil.

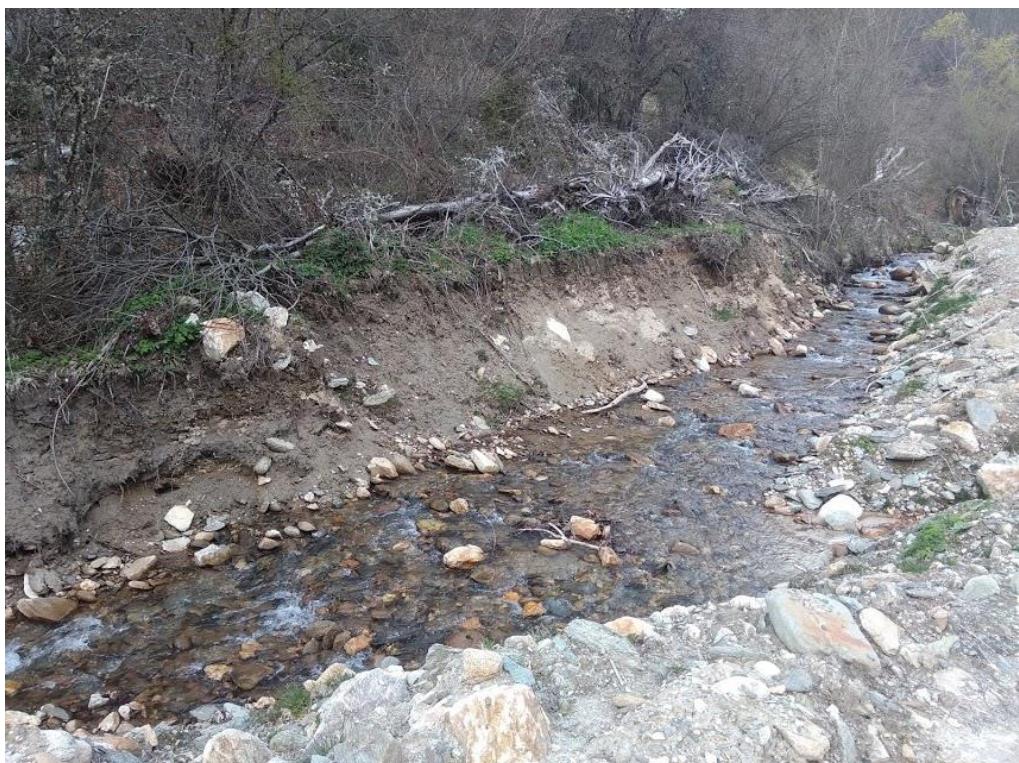
A picture of a location included in the previous photo report showing that digging was done in the riverbed. As can be seen from this update, the riverbed has not undergone any rehabilitation and it remains inaccessible to wildlife.

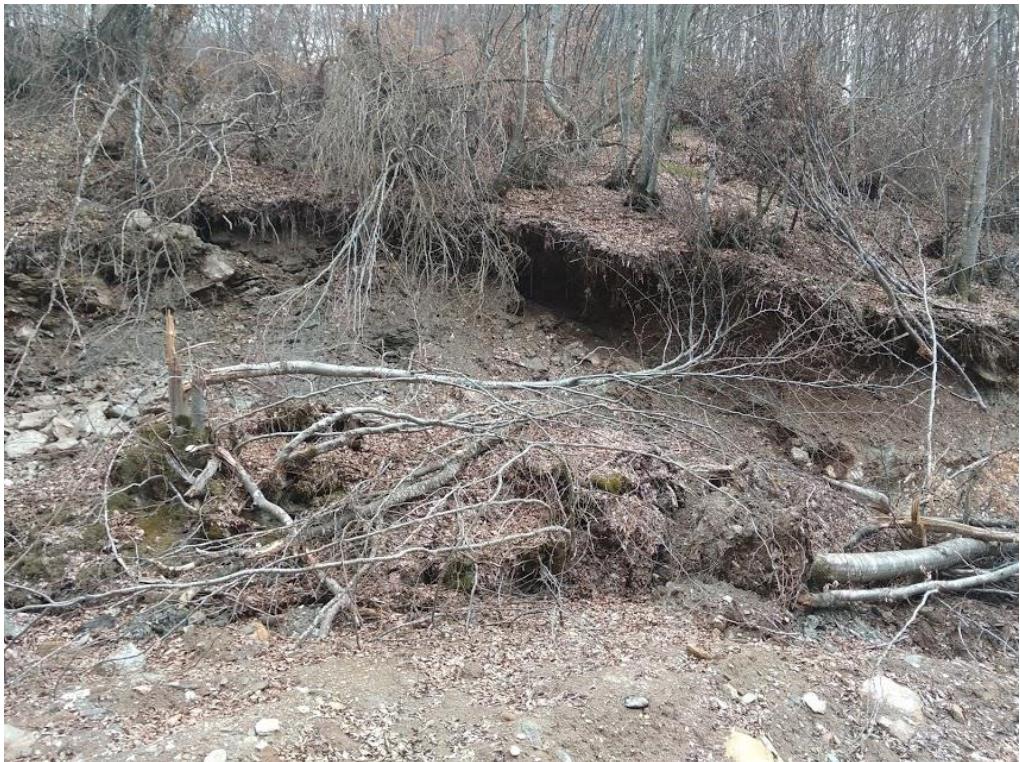
There are clear signs of erosion along the access road and no measures are taken to mitigate this. Entire patches of forest are sliding down.

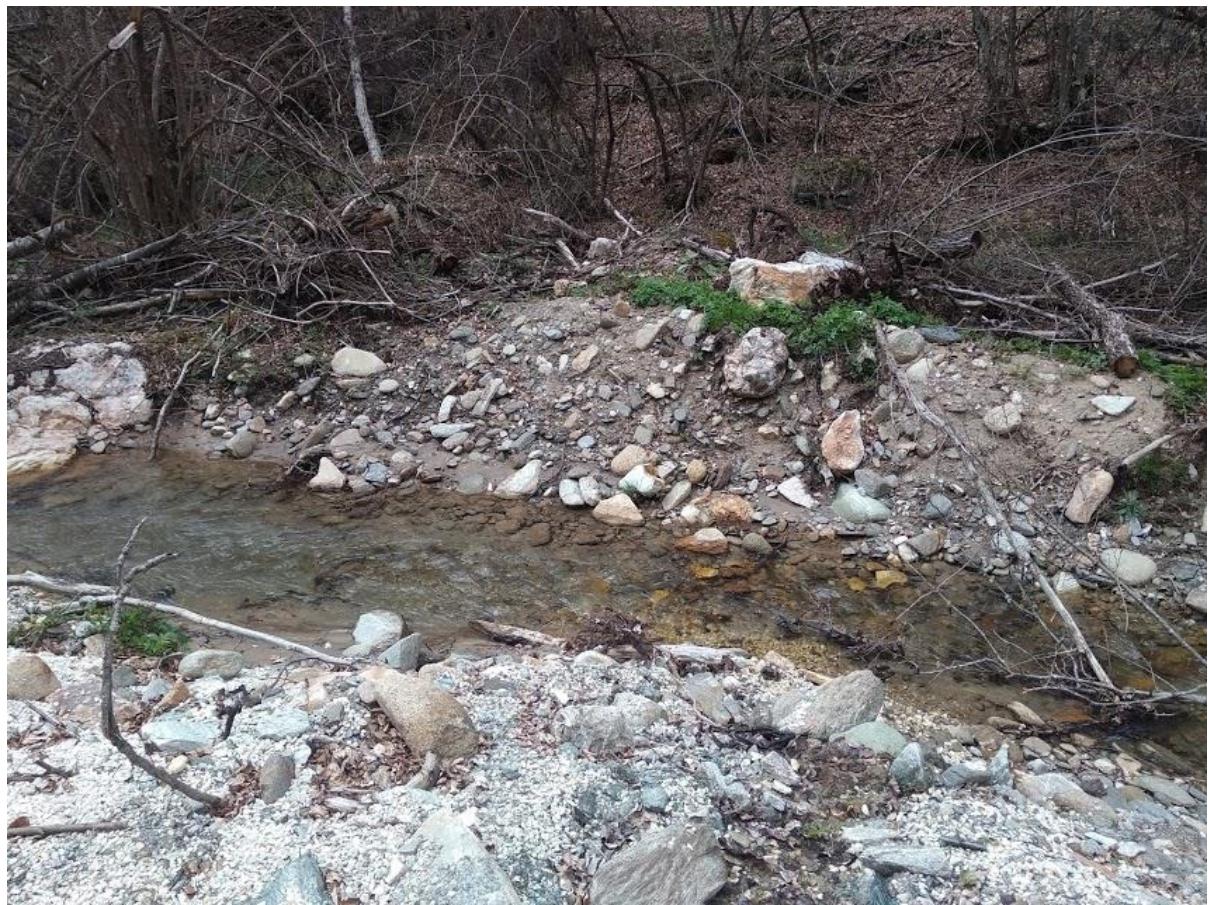
At several locations the river was diverted into an “artificial” riverbed, probably to lay the pipes in a straighter line and to increase the kinetic energy of the water. Digging in the river bed and diverting rivers is forbidden by national legislation and goes against the recommendation for proper riverbed maintenance that would ensure the conservation of the fish habitat.

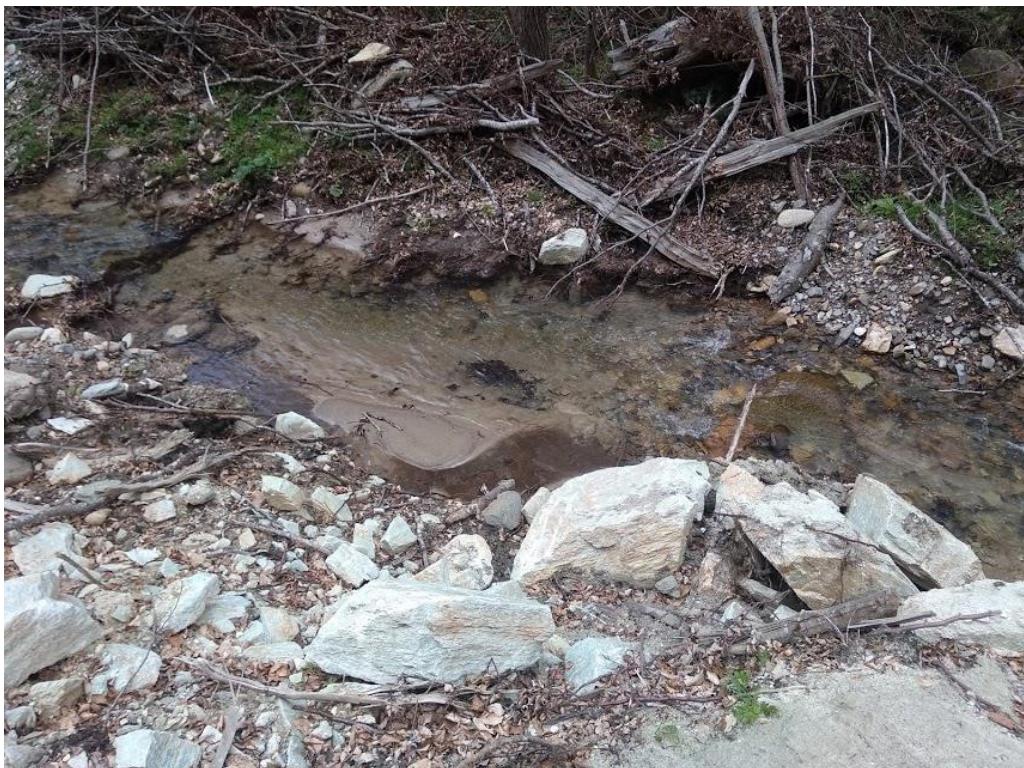
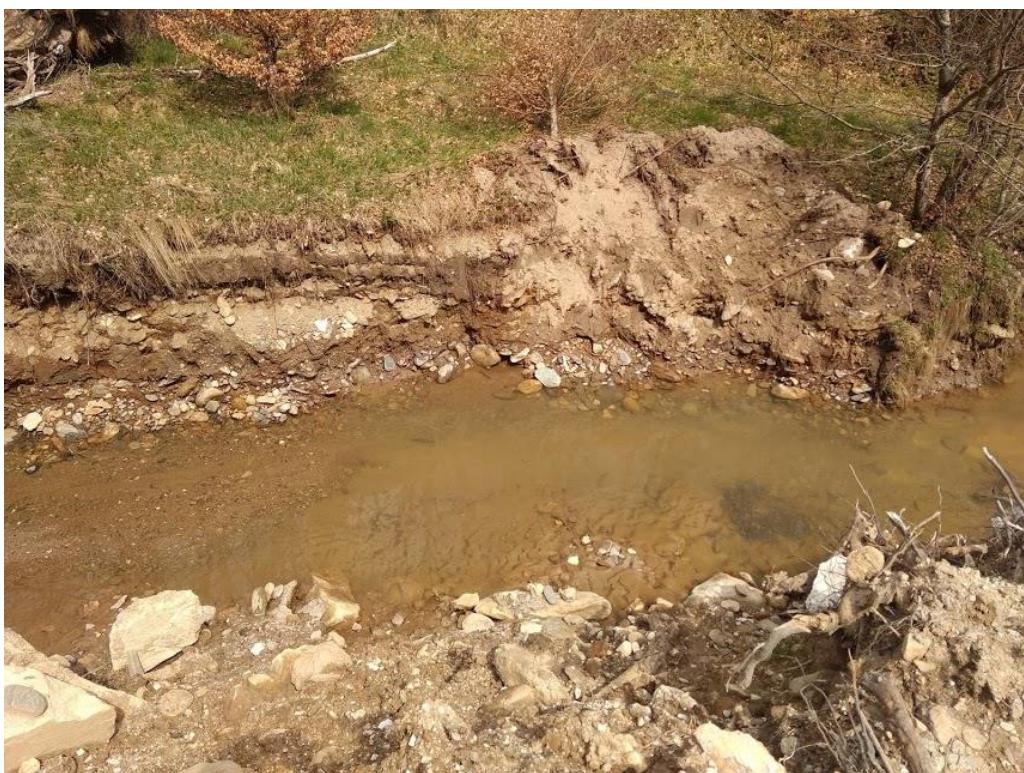
Construction work in and around the riverbed have caused significant sedimentation which in turn reduces water quality and makes the habitat inappropriate for the endemic Macedonian trout identified in the aquatic biodiversity study. Debris from soil and vegetation pushed into the river is still present and contributes to further deterioration of the river and the riverbed.

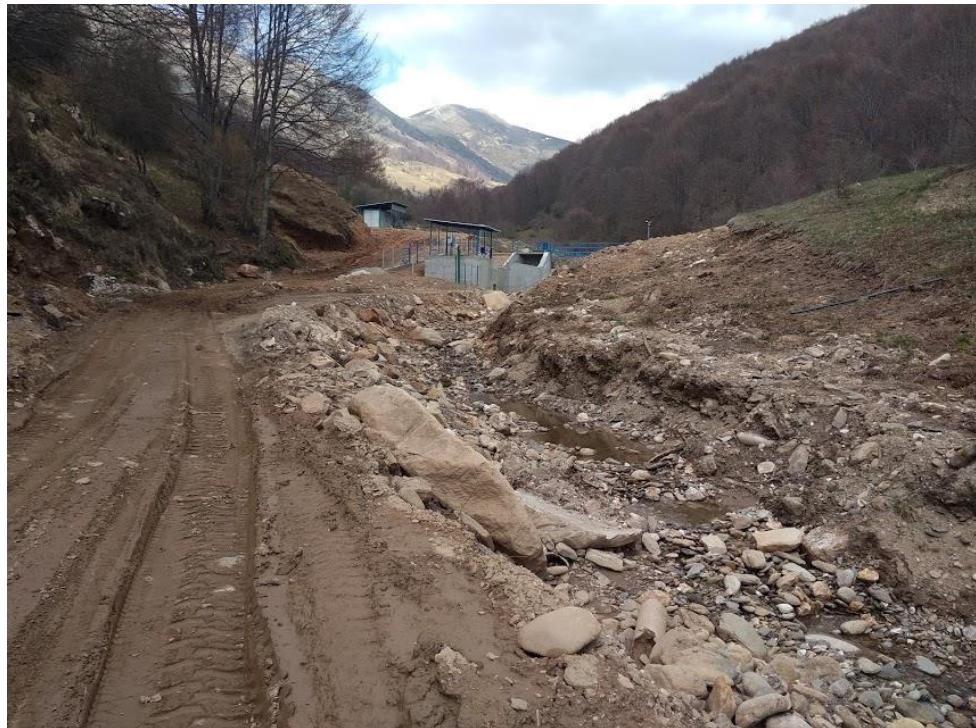
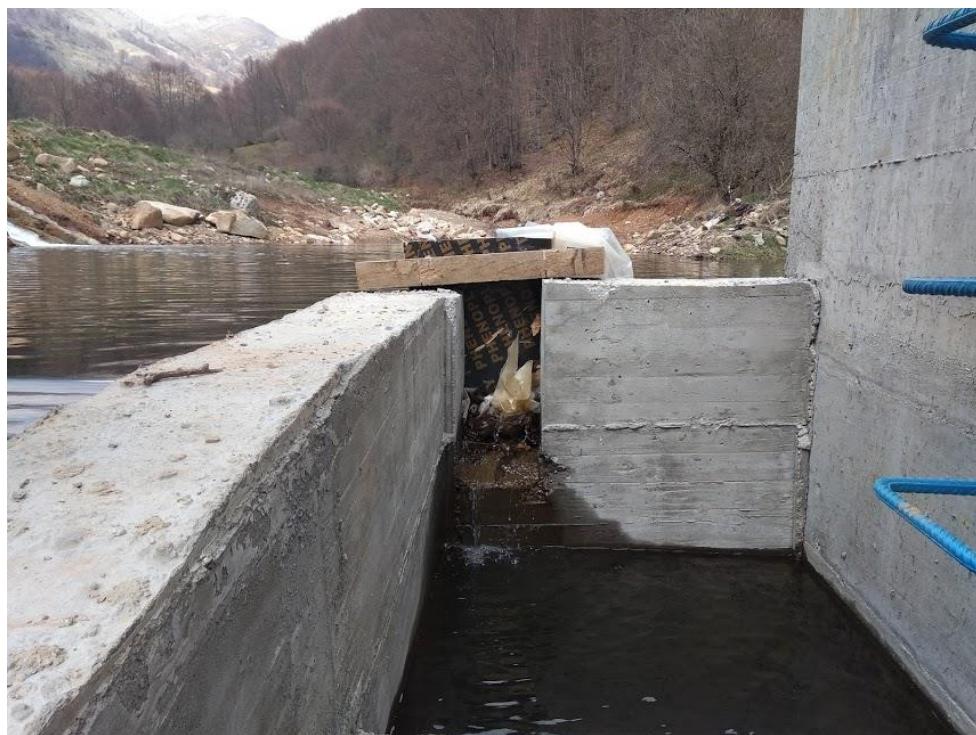
Below the intake the river is almost completely dry. As can be seen from the next set of pictures, this is because the fish pass is intentionally blocked by a wooden contraption and the environmental minimum flow is not released into the river. We have witnessed this on several occasions at different small hydropower plants operated by different investors and it can be considered common practice, rather than an exception.

There are also two tributaries diverted into the intake so it remains to be checked whether they were taken into account when the minimum flow was calculated.

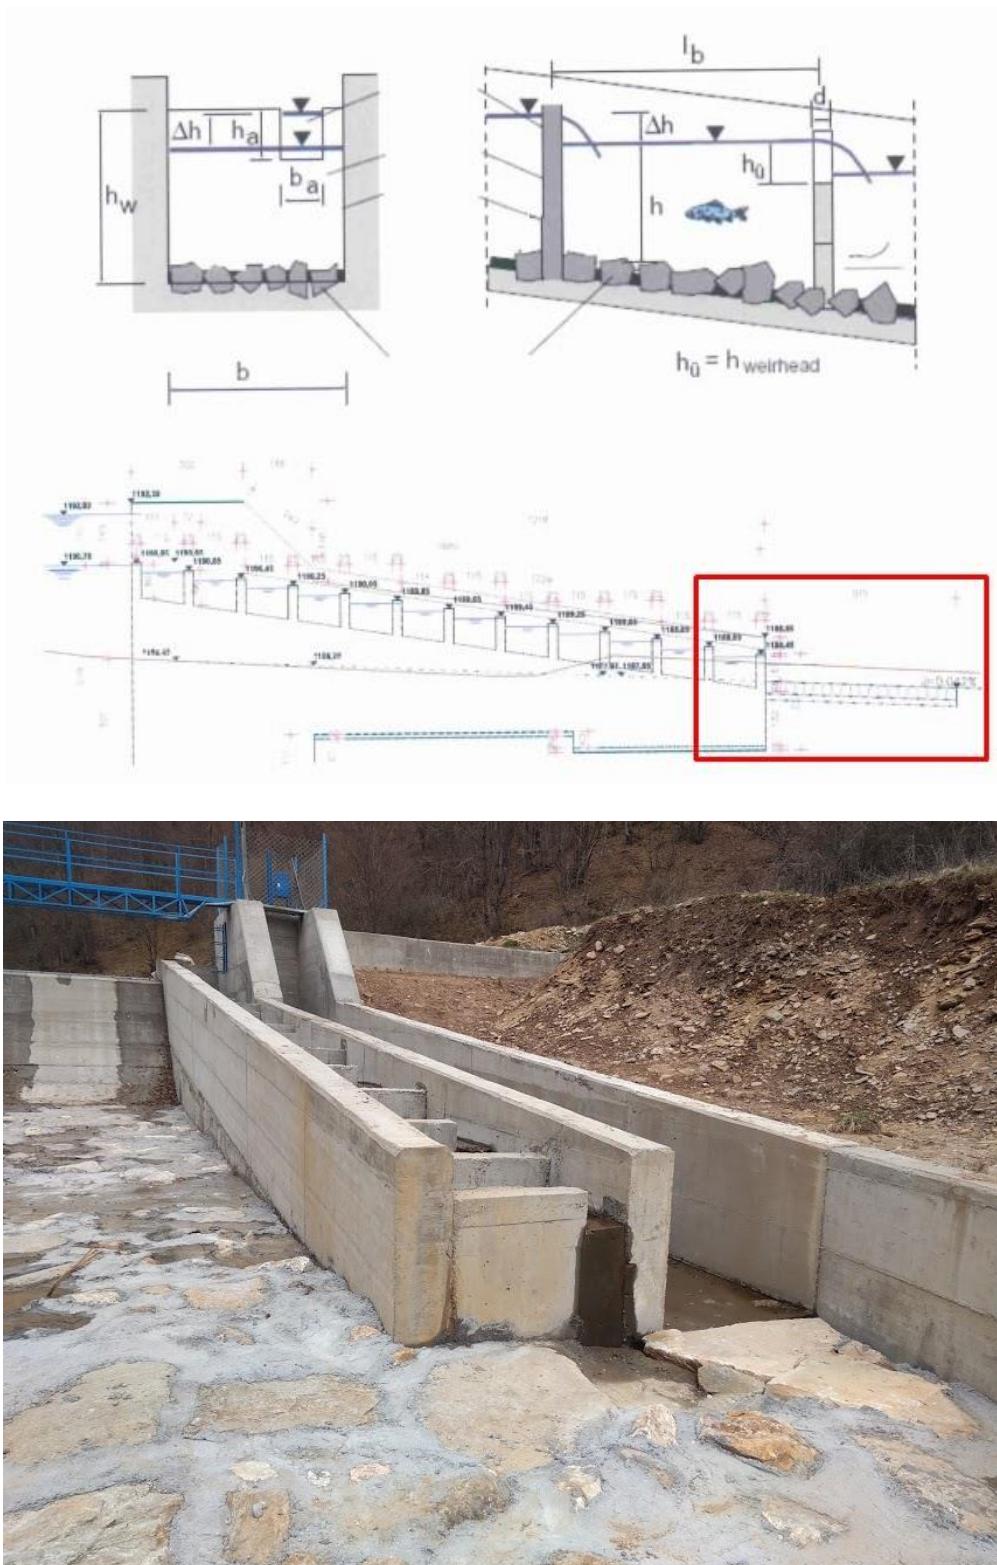
The fish pass is not built according to the design specifications provided in the environmental study. The lowest point is 50 cm above the ground which makes it practically useless.

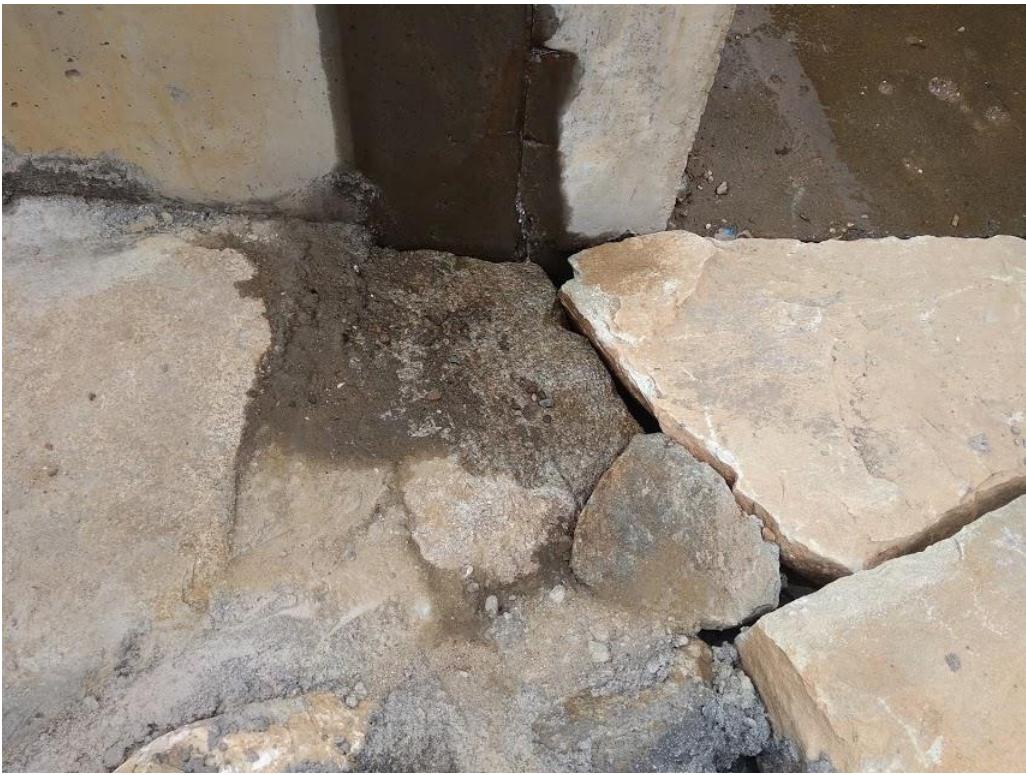
In addition, the tiny amount of water flowing from the fish pass sinks into the constructed stone floor and flows underneath it for several meters before reaching the river.
