PHOTO REPORT

**Small hydro power plant ref. no. 45 – Krapska reka,
Makedonski brod municipality, Macedonia**

July 2018

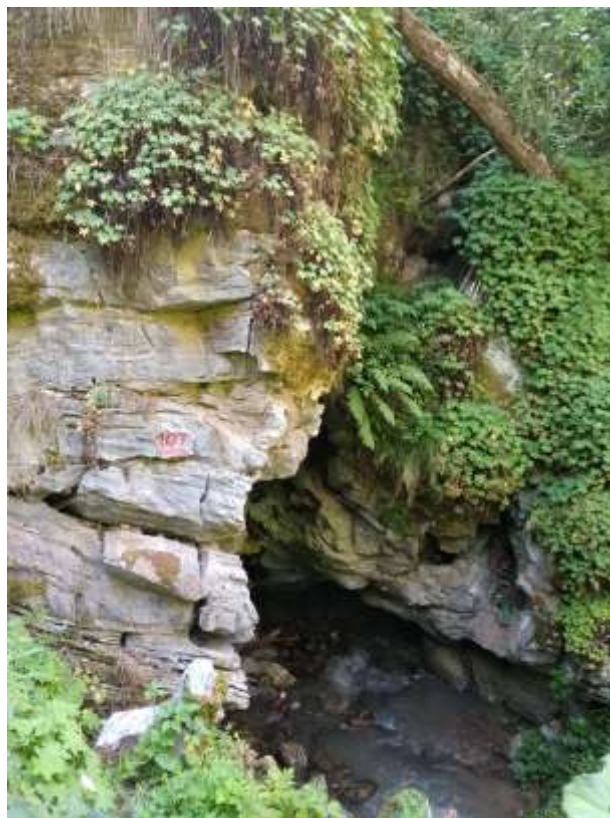
Picture 3. The location where Krapska reka enters the underground cave system. A lot of plastic bottles can be seen around the entrance and compared to the findings at the construction site it is very possible that their origin is from the workers.

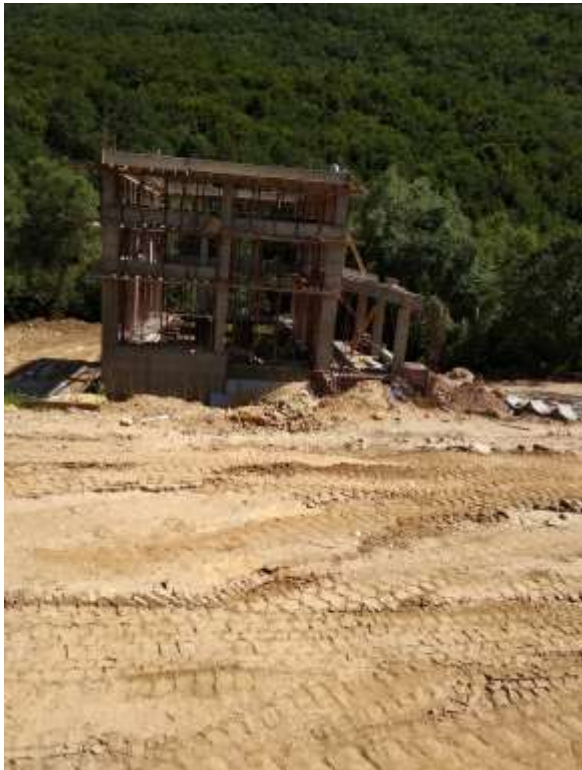
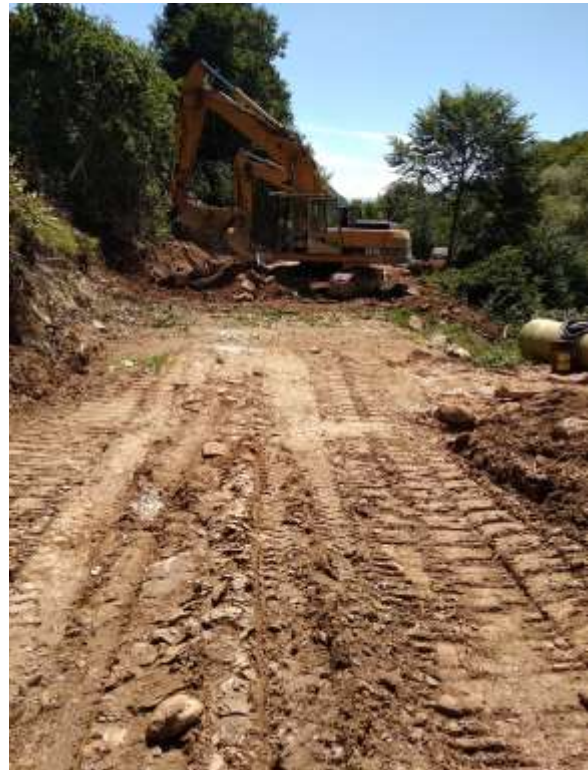
Because the area is an important migratory route for large mammals it is extremely important to prevent them from entering the construction sites. Contrary to the recommendation, none of the construction sites were properly enclosed at the time of the field visit.

Pictures 4 and 5. Depicting the powerhouse and a location halfway through to the intake. Construction works were performed at the time of the visit.

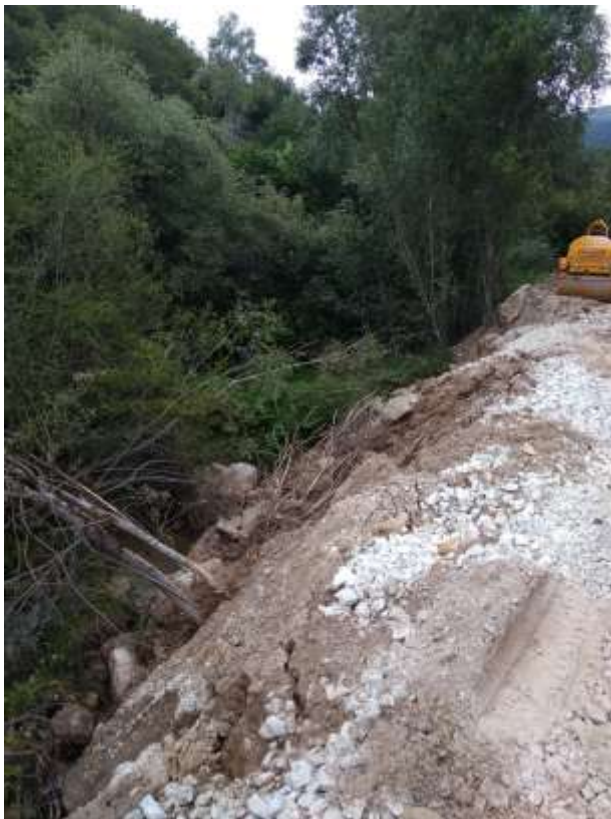
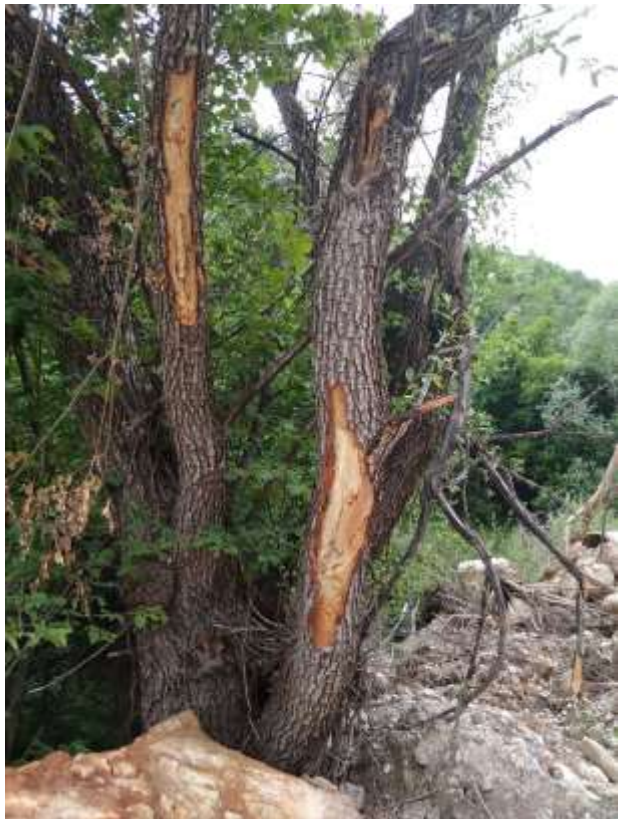
There is a lot of vegetation destroyed along the entire route of the pipeline, mostly for the purpose of widening the road so that the construction machinery can go through. A lot of trees that are along the edge of the road and don't particularly contribute to the accessibility of the road seem to be unnecessarily destroyed. Additionally, many of those are just pushed toward the river bed and create obstacles for the water flow.

Pictures 6 and 7. Unnecessary destruction of vegetation.

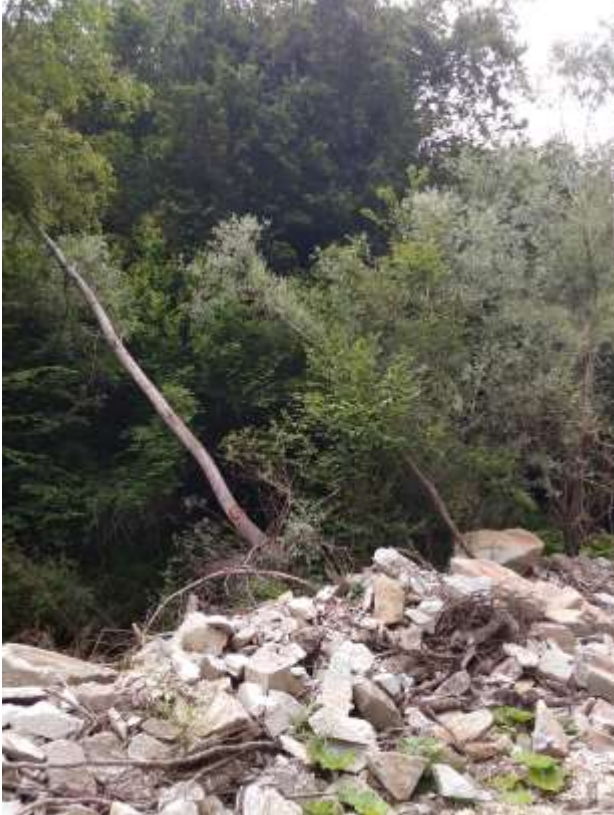
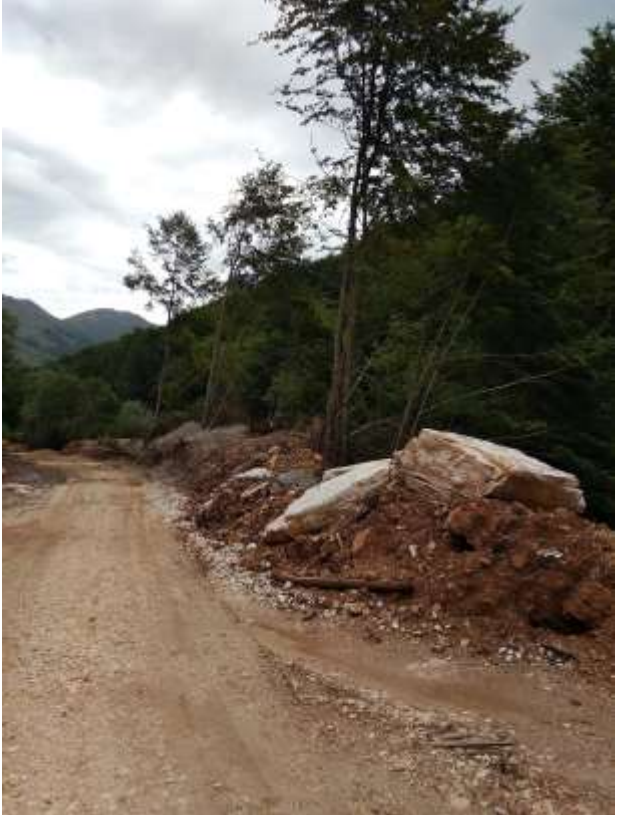
Pictures 8 and 9. A lot of trees are destroyed simply by reckless pushing of rocks and debris towards the river bed.

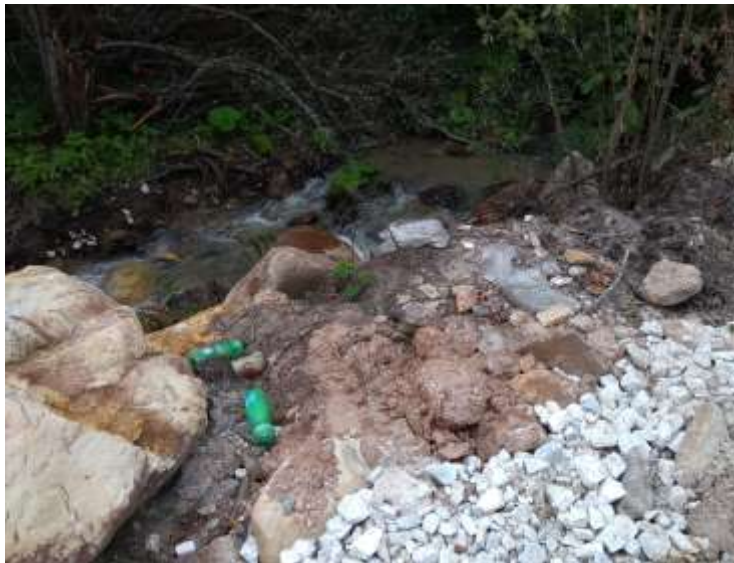
Along the entire route of the construction works there are clear signs that the employees not only do not reduce the waste, but they also do not make sure it is properly treated. The types of waste range from plastic bottles to residues of construction materials.

Picture 10. Plastic bottles and bags on the riverbank.

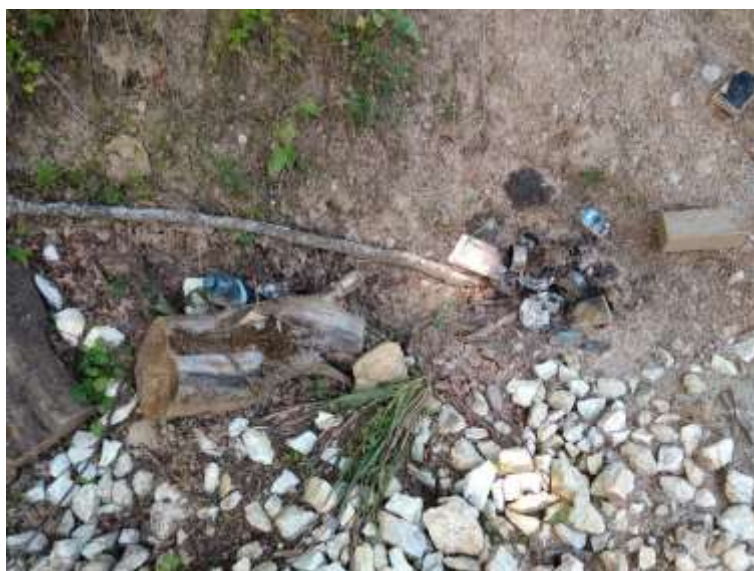
Picture 11. Food cans and plastic bottles were burned just next to the small workers cabin.

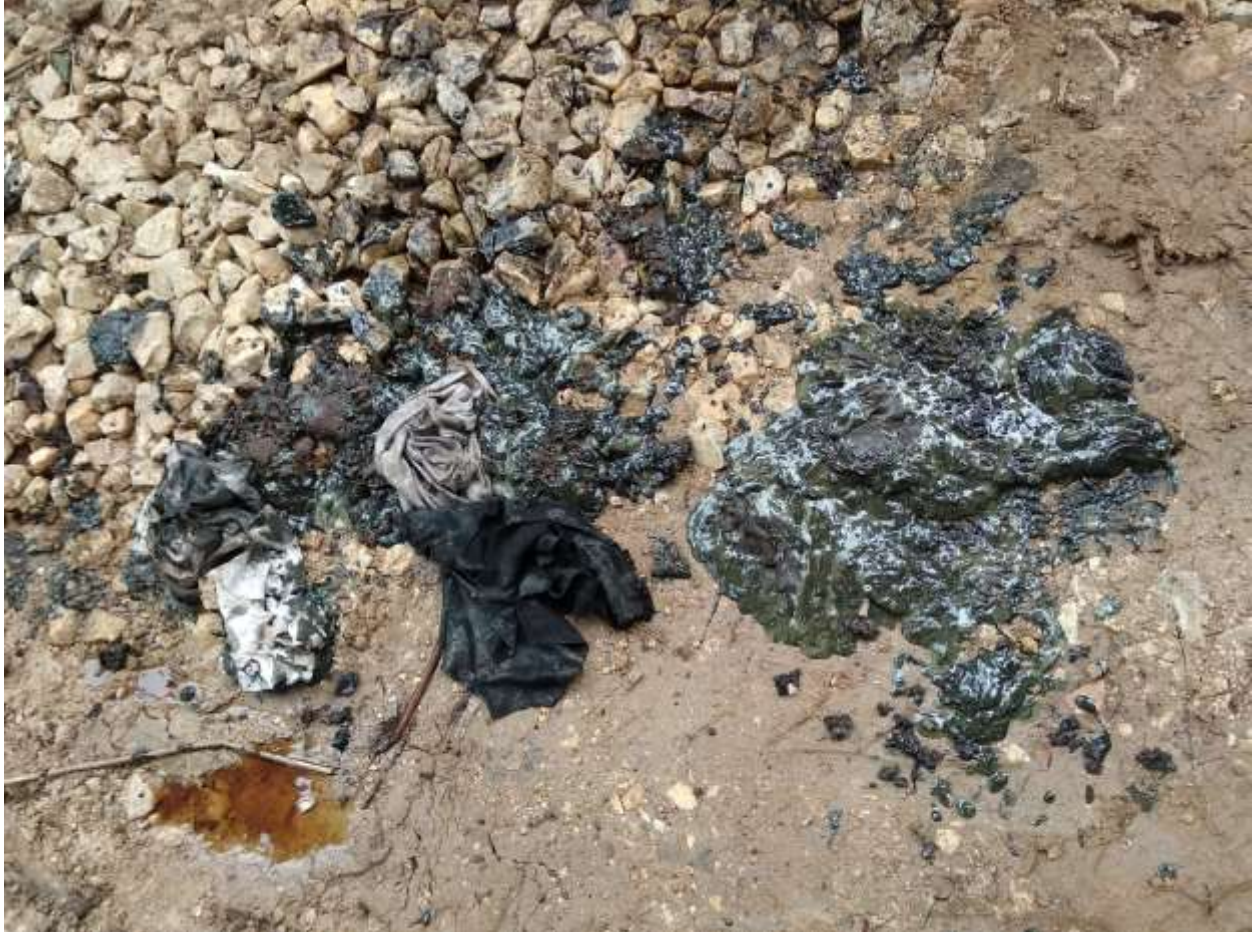
Picture 12. A location where probably maintenance on the construction machinery was performed. Hydraulic fluids and oil leaks are clearly left unattended and are not properly treated.

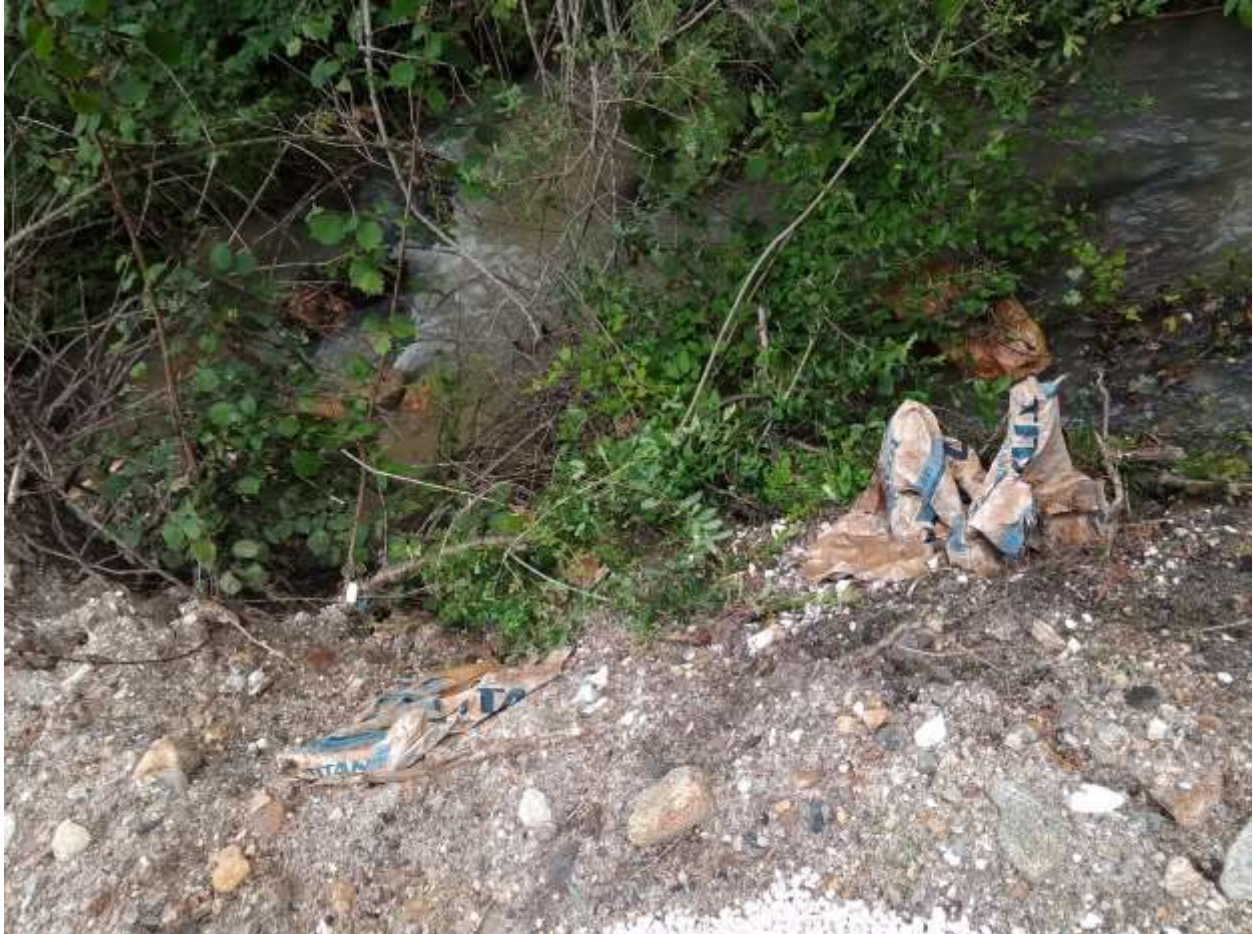
Picture 13. Cement bags were being disposed of directly into the river.

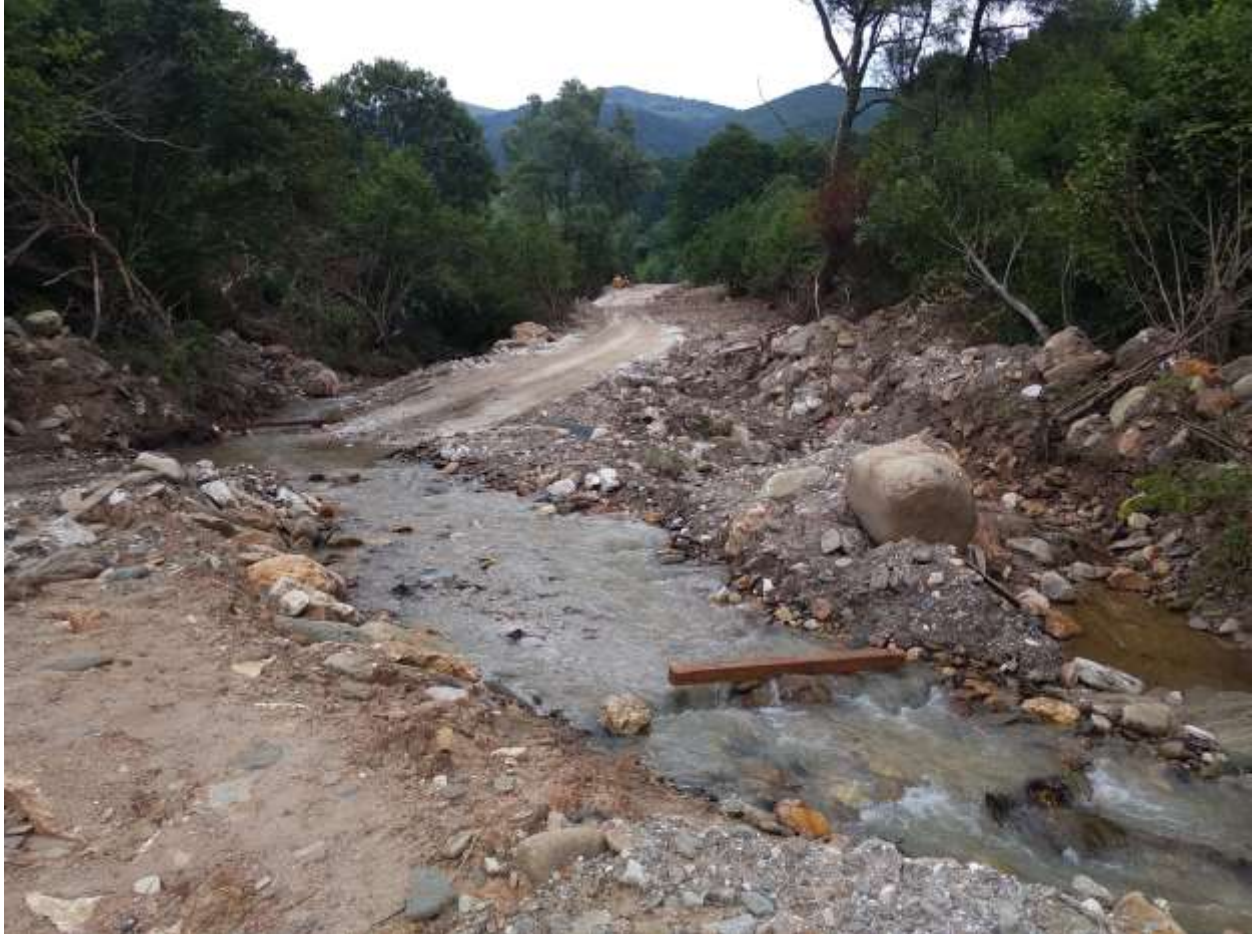
Picture 14. Huge amounts of debris were dumped at the river crossing blocking the river flow and creating conditions for future sedimentation, especially during construction works when a lot of soil is flowing downstream.

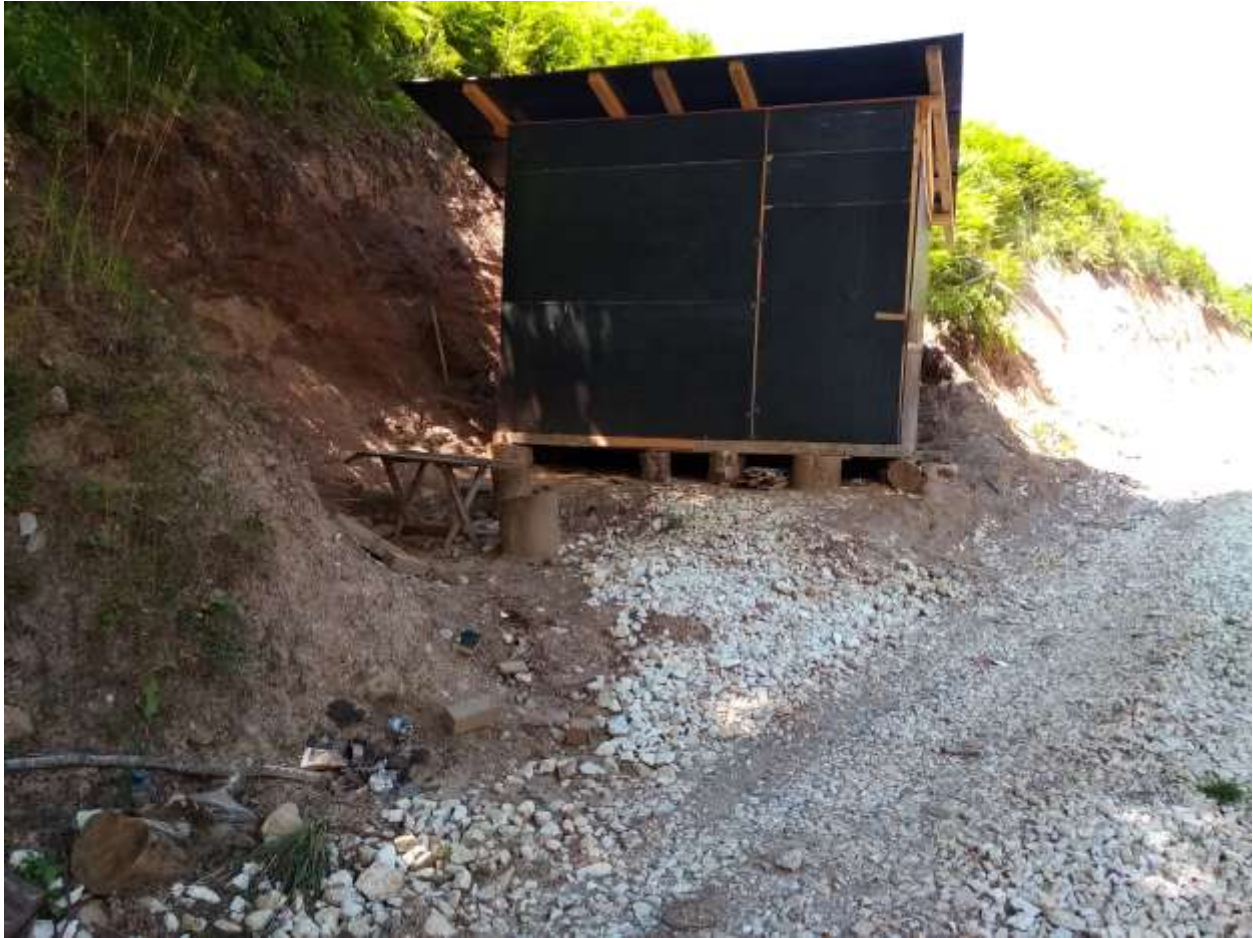
At none of the construction site prefabricated toilets were present.

Picture 15. The improvised workers cabin, equipped with one table for eating near the intake of the SHPP. The burned waste mentioned before can also be seen in the lower left corner of the picture.

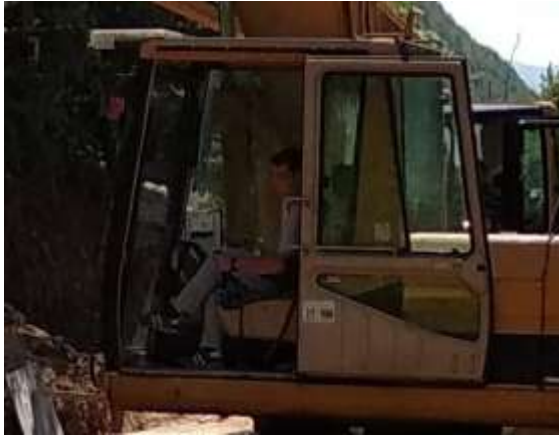
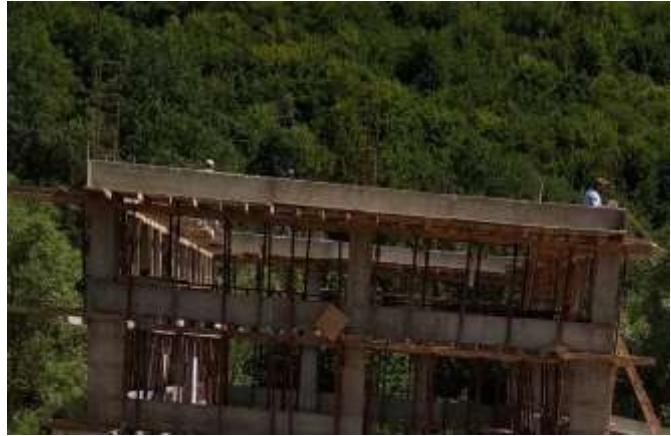
As can be seen on the details from previous pictures, almost none of the construction practices and personal protection recommendations that ensure the safety of the workplace were implemented. The workers were not wearing any protective equipment and there was not a protective fence on the scaffolding.

Pictures 17 and 18. Details depicting construction workers without personal protection equipment.
