Administration of Rosprirodnazor
(Federal Service for Supervision of Natural Resource Usage)
of Sakhalin Region

Photo-supplement attached to Act 01/22-LK:
Scheduled review of the fulfillment of legislation requirements
by LLC “Starstroj” during the construction of the main
pipelines for “Sakhalin II” project in the Makarov District
of Sakhalin Region

July 26, 2007

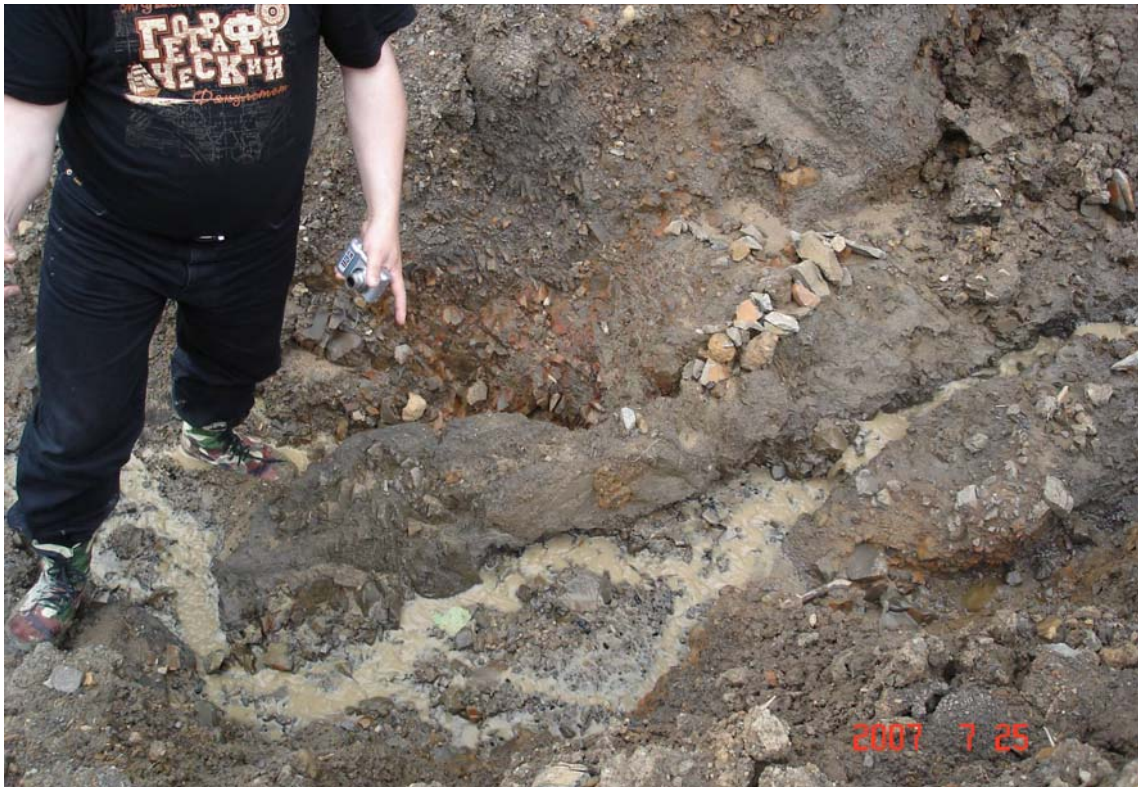
Left shore of the Krinka River, river valley slope. Active erosion processes on the pipeline route. Excavation in this section has been going on since 2005, although anti- erosion measures on the slope have been absent during this entire time.

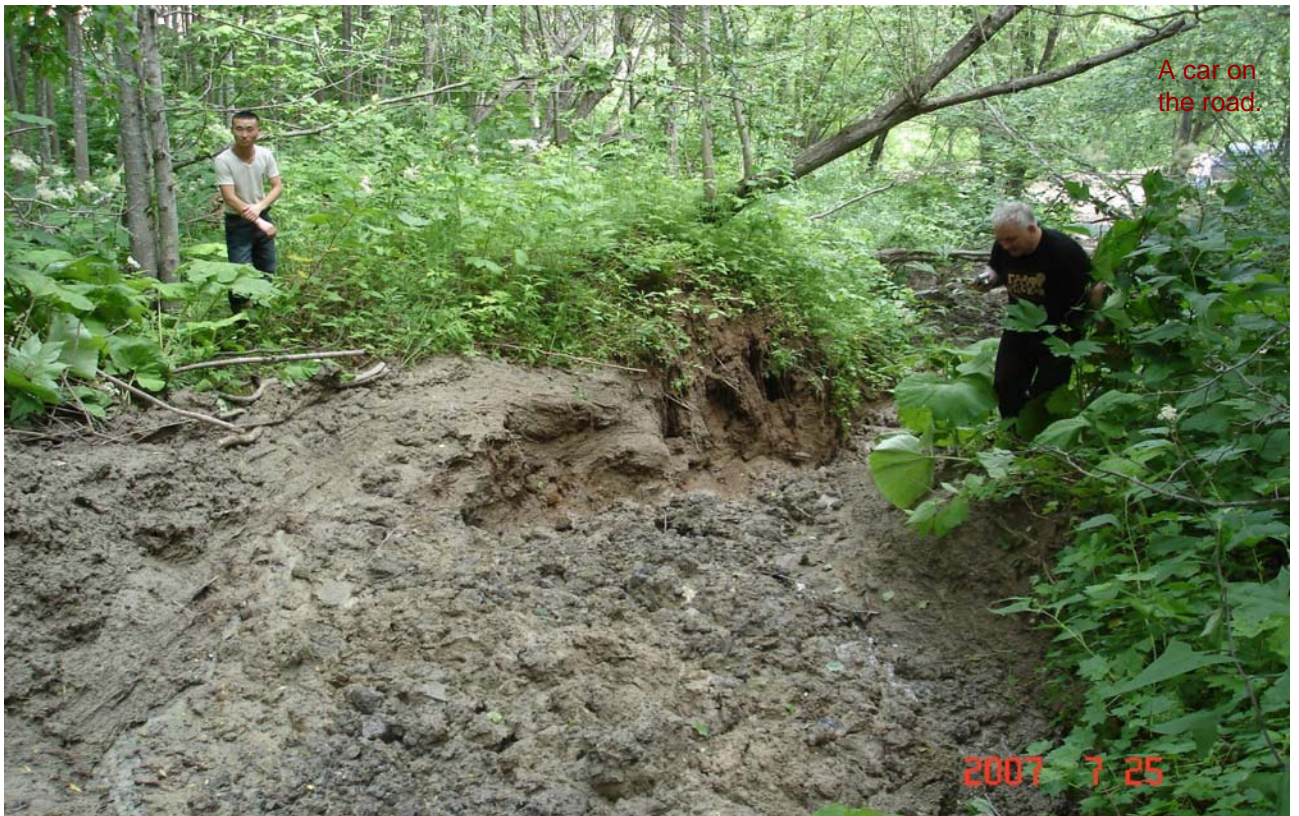
July 25, 2007. A mudflow about 100 meters in length, flowing down from the pipeline route along a forested slope of a mountain down to the access route, in a section that is adjacent to the right shore of the Krinka River.

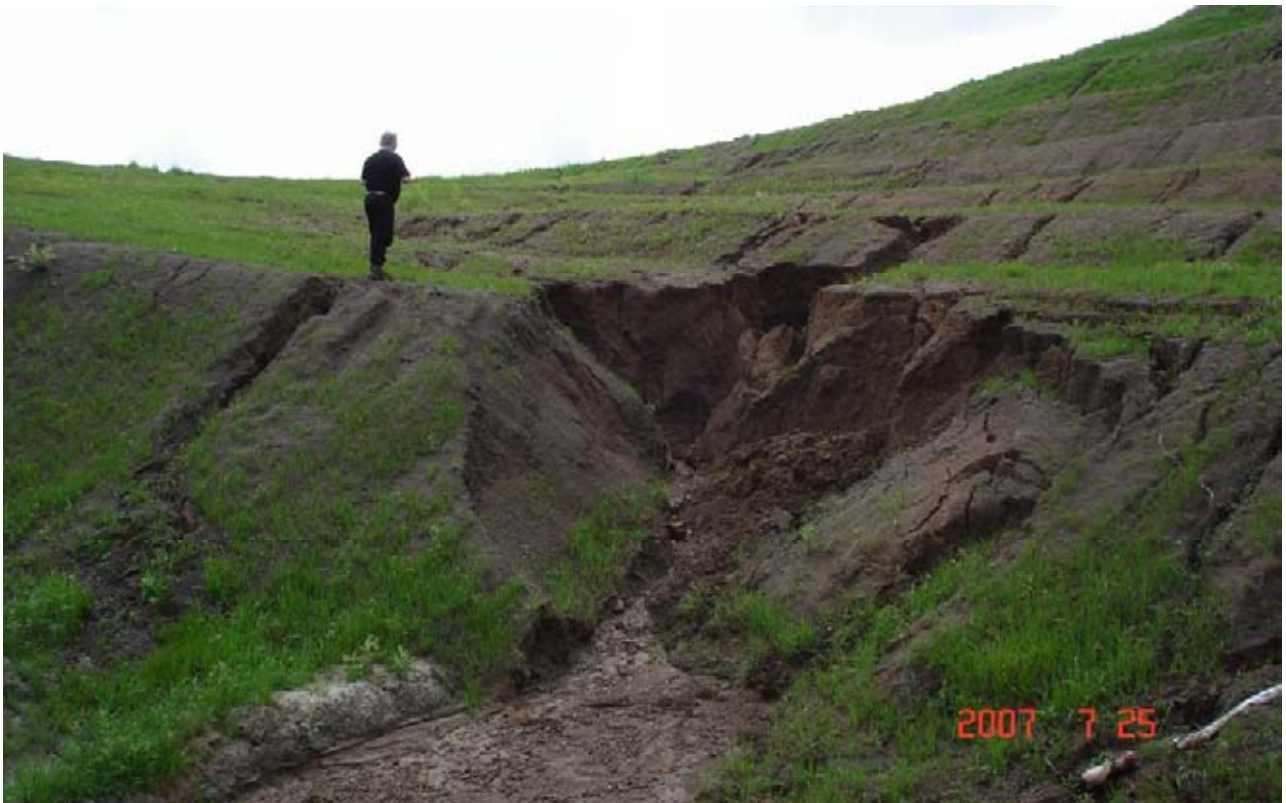
July 25, 2007. A section of the Krinka River watershed and its right tributary (Left Krinka), downstream from the pipeline route. A pile of waste construction soil that was extracted from the pipeline route, beyond the right-of-way. Despite the terracing of the slope and planting of grass, erosion is beginning on the pile.
