*Pacific Environment
Friends of the Earth Japan
Sakhalin Environment Watch*

Sakhalin II Project Oil and Gas Pipeline Project Dolinsky, Makarovsky and Nogliksky Districts of Sakhalin Region Photo Report from a Fact-Finding Mission May 30 – June 1, 2008

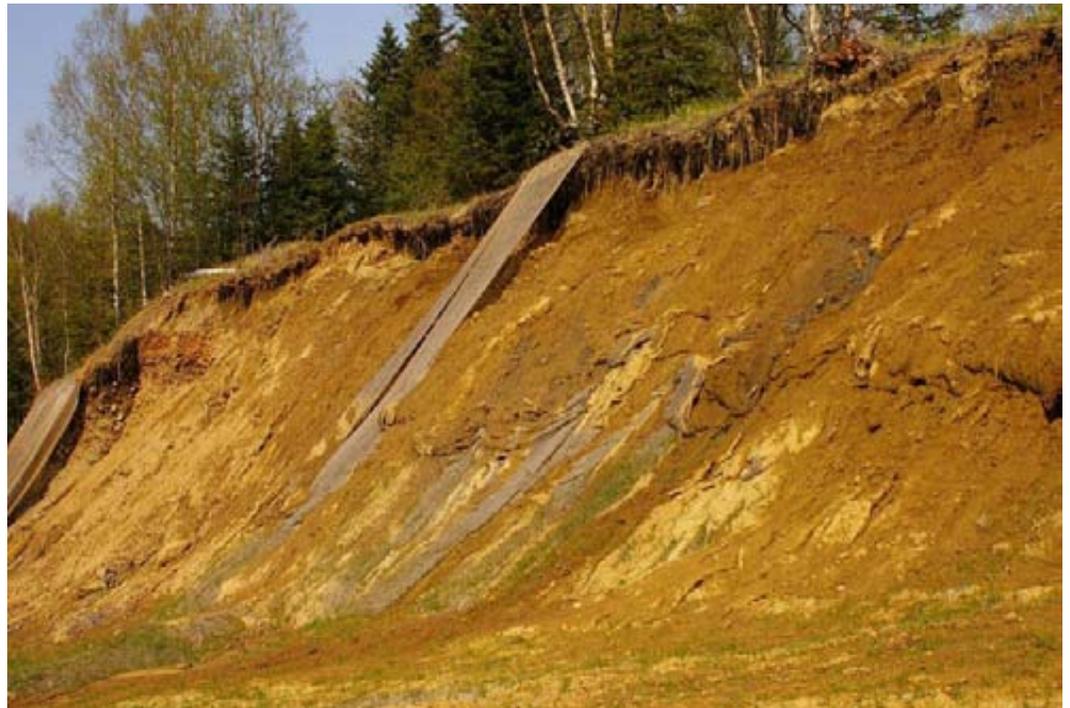
KP 384.7, Spread 3. Zagrobka River.
Slopes stabilization measures along the
edges of the pipeline right of way have failed.
