## PHOTO REPORT

**Small hydropower plant ref. no. 45 – Krapska reka,  
Makedonski brod municipality, Macedonia**

**April 2019**

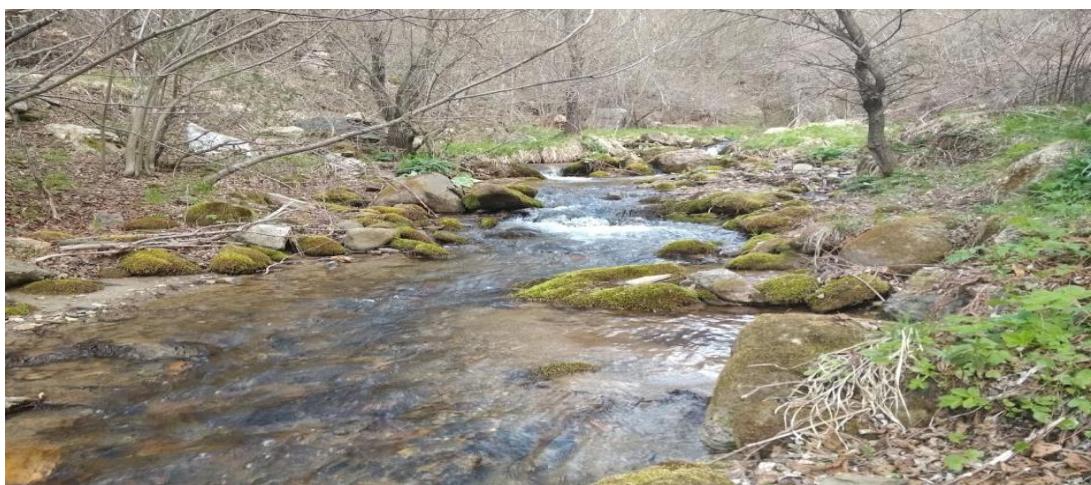
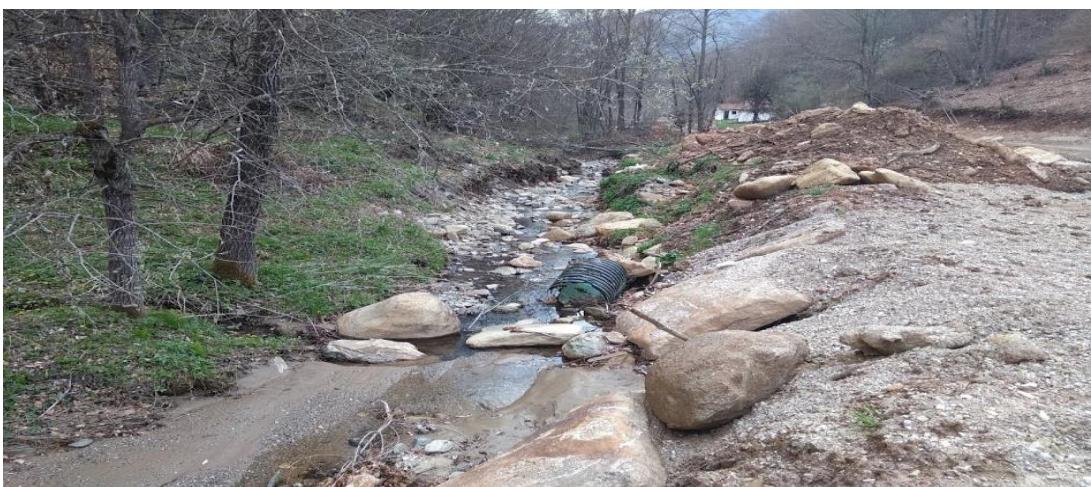
To mitigate some of the identified risks to this species, the biodiversity study also offers a mitigation strategy with specific measures for the construction and operational phase. The purpose of this strategy is to maintain the clean water ecosystem and to provide easy access to the river for the semi-aquatic species. Pictured below is the difference between the ecosystem of the unspoiled stretch of Krapska and the parts where construction works have been done.
