Overview

he Blagoevgradska Bistritsa hydropower cascade in Bulgaria consists of eight small hydropower plants installed on pipelines that supply the town of Blagoevgrad with drinking water. The plants were developed by the private company Blagoevgradska Bistritsa Ltd. and have been operational since 2012 with a total installed capacity of 6,375 kW.¹ Until 2013 the company was owned by Grisha Ganchev,² 'a known money launderer and organised crime figure', according to a cable from the US Embassy in Sofia.³ Afterwards, Ganchev sold his hydropower business, and Blagoevgradska Bistritsa Ltd. is now the property of the Bulgarian company Union Group.

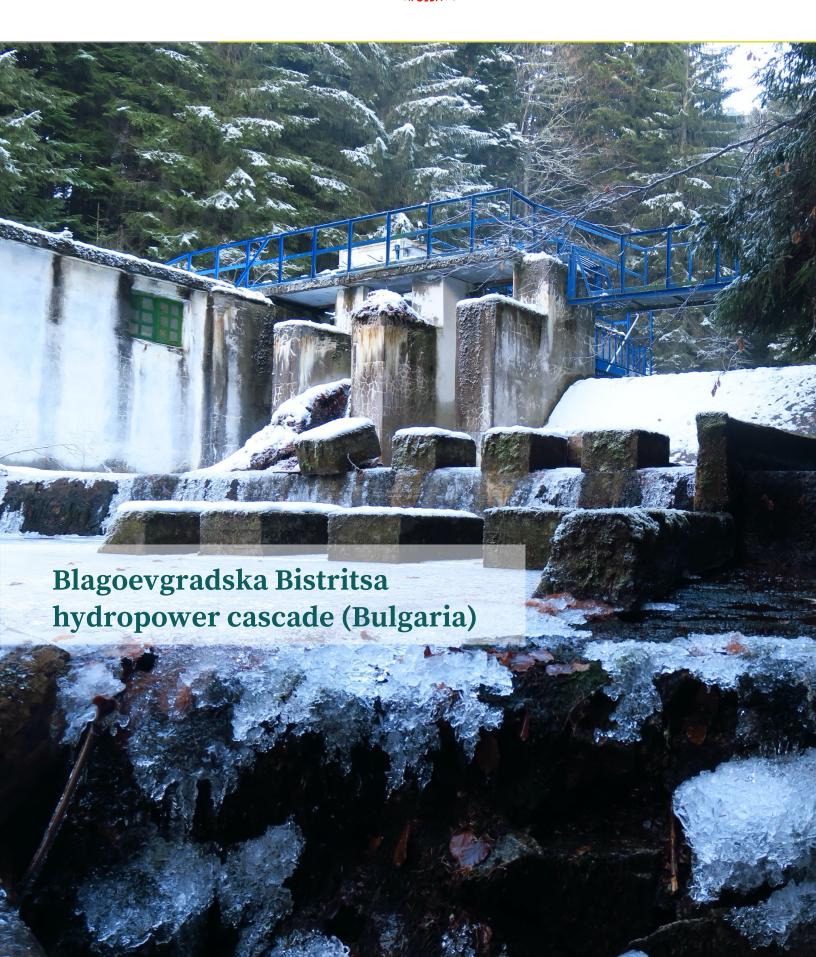
Cover Photo: Kartala intake in Rila National Park, 21 December 2020, Photo: CEE Bankwatch Network

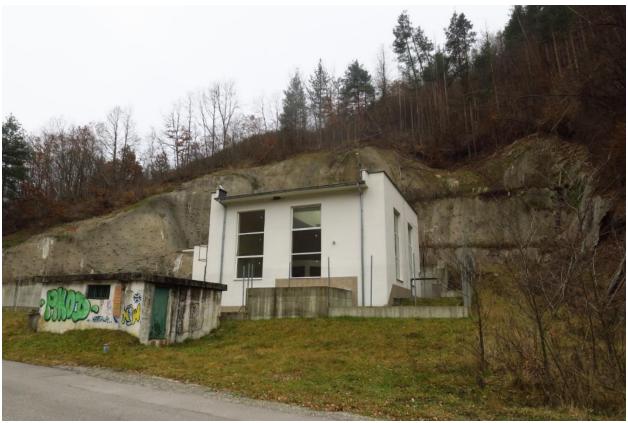
One of the eight powerhouses of the Blagoevgradska Bistritsa cascade, 21 December 2020, Photo: CEE Bankwatch Network

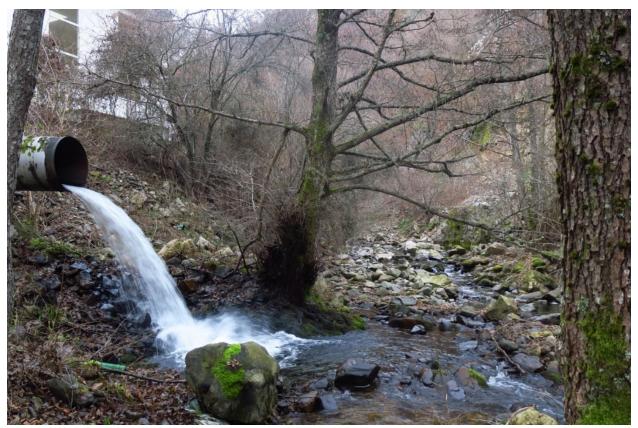
Discharge of water below Blagoevgradska Bistritsa-8 HPP not described in the EIA/AA screening decision, 21 December 2020, Photo: CEE Bankwatch Network

In theory, since the plants use the drinking water for the turbines, once the water has passed the last plant, it should continue towards the town. But footage¹⁵ from the lowest plant of the cascade shows **a** large pipe which discharges water used in the hydropower production process directly back into the river, thus proving that the energy production is using water that is not carried further for the town's water consumption. Apparently, the eight plants use all the water caught by the intakes and divert it from the river even when the town of Blagoevgrad does not need it. This directly contradicts the information from the investment proposal and EIA screening decisions which state that all the water will be returned back into the drinking water pipeline. It is not mentioned at all that extra water will be used and discharged into the river below that plant. Thus, the plants were not built in line with the environmental permitting conditions from the EIA screening decision.

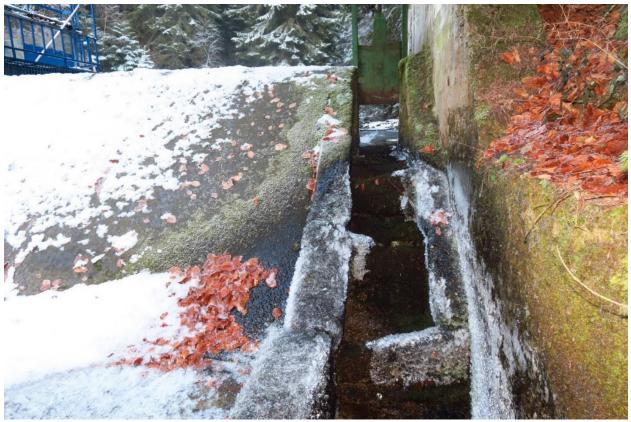
Completely dry fish pass at Kartala Intake, 21 December 2020, Photo: CEE Bankwatch Network

The river below Kriviya Uluk intake was completely dry during all visits, while Kartala barely trickled. Balkanka estimates the water flow below Kartala intake to be between 2 and 15 l/s. The fish passes were blocked and made fish migration upstream impossible. Silt was filling up the reservoir behind the Kartala intake, which affects the quality of the water, and no regular cleaning was being done. Additionally, the design of the fish passes was completely inadequate for this types of mountain rivers.

On 09 December 2020 after another notification from Balkanka, the Directorate confirmed³⁰ that there were no measuring devices for the water released below Kriviya Uluk and Kartala intakes, which should amount to 15 l/sec and 22 l/sec respectively. It also confirmed that no water was flowing through both fish passes. Because of these findings and the 'great public interest the river has' the Directorate obliged the state-owned company V i K Ltd. – Blagoevgrad, which manages the drinking water intakes, to carry out the following:

- To release continuously the 'ecological' amount of water in both rivers according to the water permits;
- To create conditions for these amounts to flow through the fish passes;
- To create conditions for measuring minimum water release within six months;
- To not allow larger water quantities in the drinking water pipeline connected to the HPPs of Blagoevgradska Bistritsa Ltd. above the limits for drinking water for the normal functioning of the river ecosystems according to Article 50 of the Water Act.

Blagoevgradska Bistritsa Ltd. has not been given any additional obligations related to the river. On 21 December 2020, Bankwatch confirmed that again no water was released in the river at the Kartala intake.
